University of Arizona Letter

December 17, 2009

Regarding: Uranium in Former Evaporation Pond Area at Monument Valley

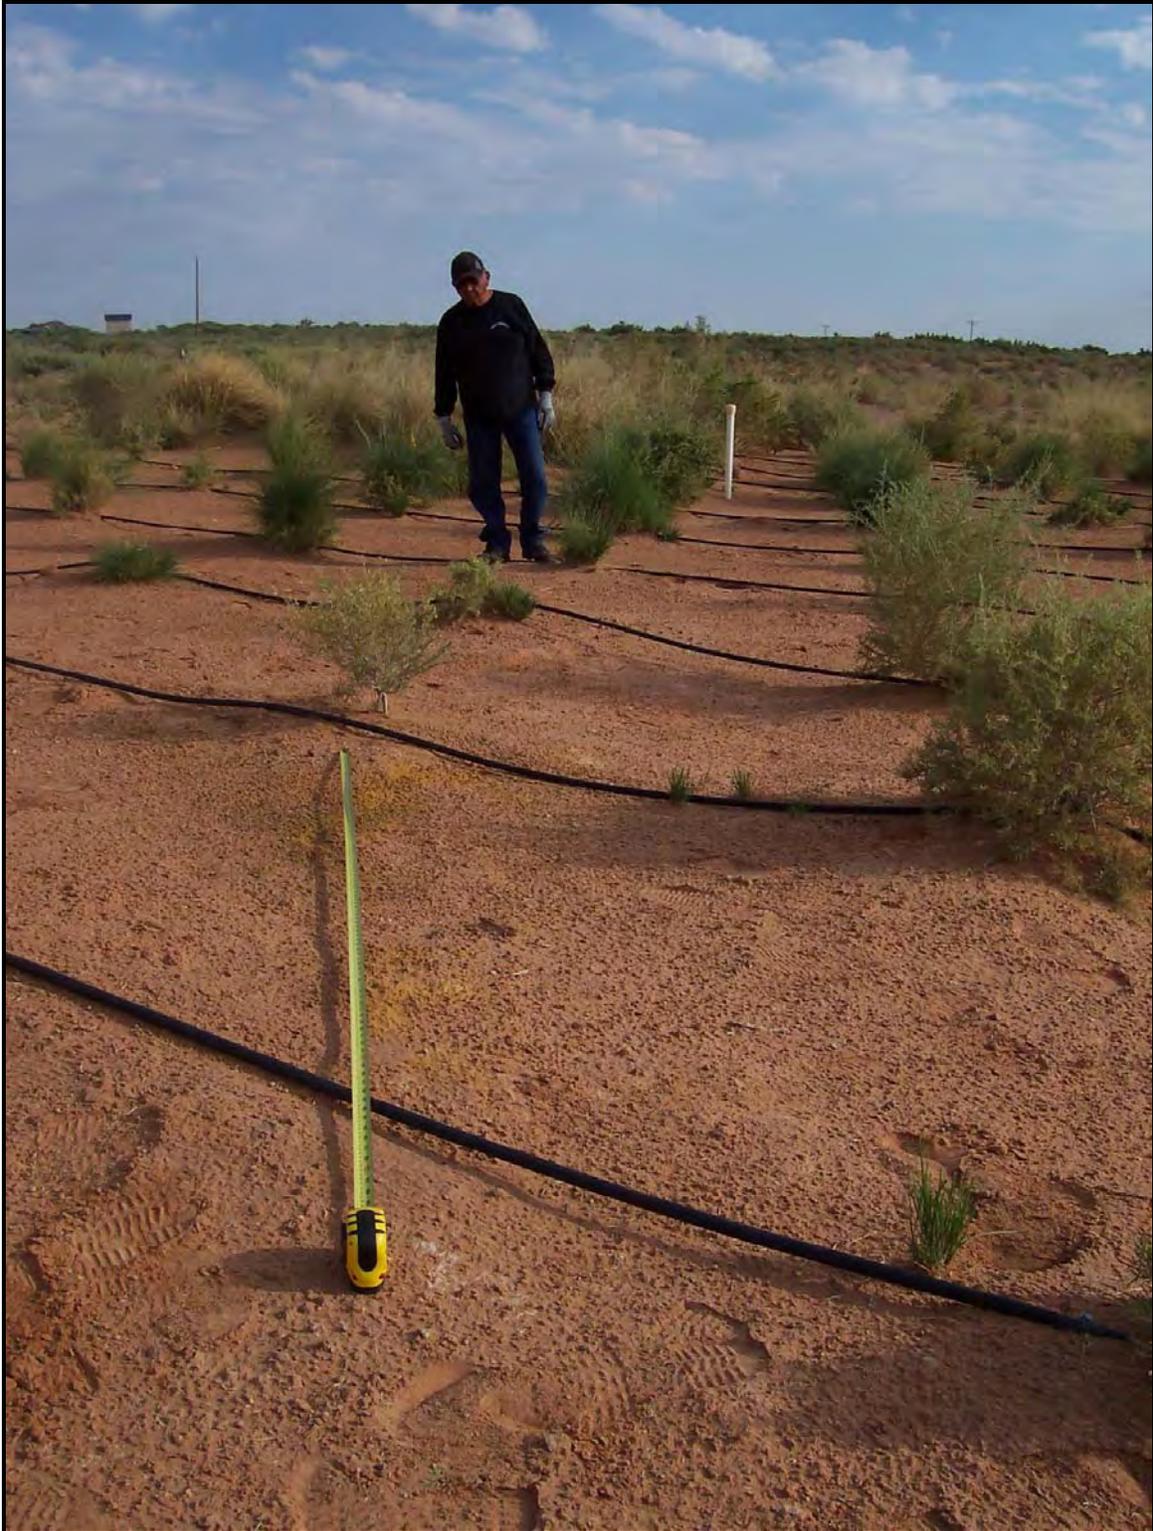
EP Y Evaporation Pond – Yellow 1st and 2nd photos
 Collected from Evaporation Pond between rows 14 & 15 N to S, 14 paces in W to E.
 Stained area for yellow and yellow/green samples was approximately 4' (W/E) by 7' (N/S).

EP YG Evaporation Pond – Yellow/Green Area in 1st photo; stain not visible

Yellow sample taken from foreground, tape measure area. Yellow green taken from near Ben Stanley.

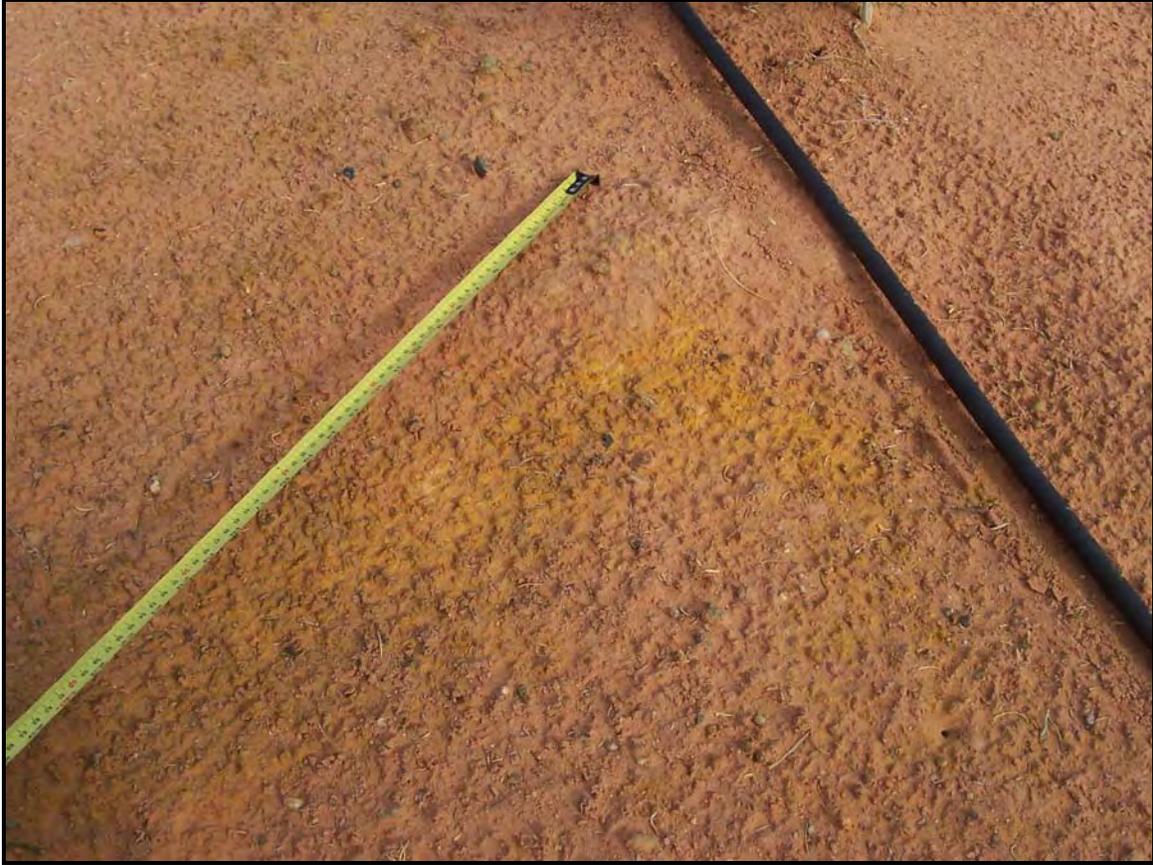
In the Evaporation Pond, a solenoid had failed and there was no irrigation water for the week preceding this site visit. That combined with rain which preceded the visit resulted in the prominent red/green stained soil noted in the July trip fading away. While red/green had been common throughout the Evaporation Pond, it was not available for collection there. The yellow and yellow/green stained areas were still there as can be seen in the following photos. There was just one yellow stained area in the Evaporation pond, located in the northwest portion of the field.

Close-up of yellow stain in former evaporation pond area.

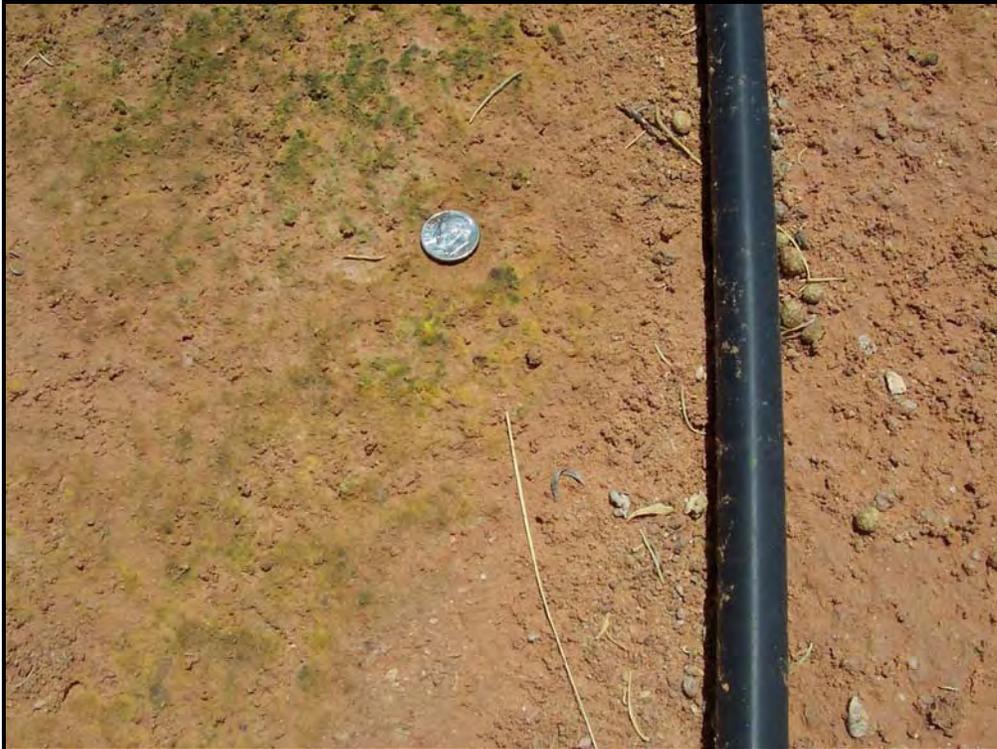
Stained soil yellow/green (July 09)

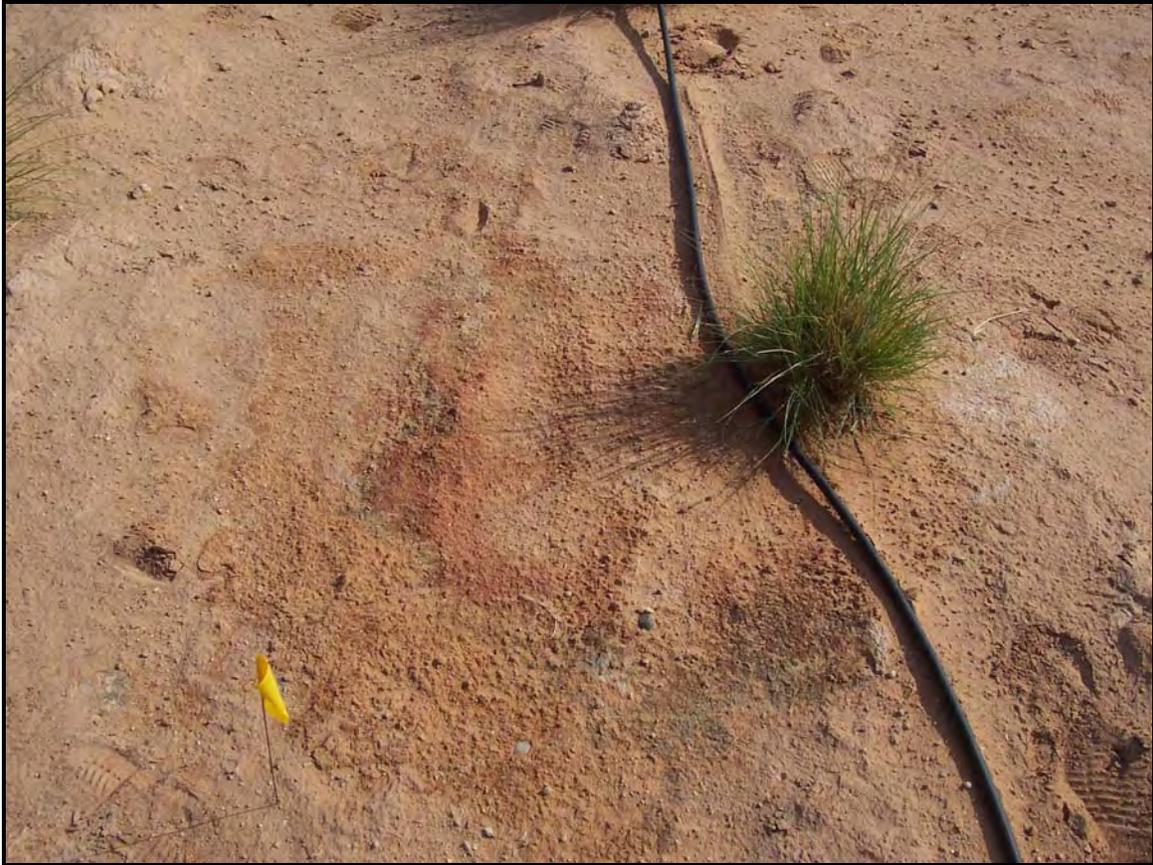
We collected red and green stained soil from the Extended Field West. We found one fairly good sample as can be seen in the photo but most of the stained soil was faded there too, compared to July when it was much more common and darker.

EFW R Extended Field West – Red 3rd photo

EFW G Extended Field West – Green 3rd photo

Both red and green collected from Extended Field West Row 14 W to E, at plant 9 S to N. Stained area was approximately 4' x 4'.

Red and green sampled here.
