**Formerly Utilized Sites  
Remedial Action Program**

**Niagara Falls Storage Site Vicinity  
Properties, New York: Review of  
Radiological Conditions at  
Six Vicinity Properties and  
Two Drainage Ditches**

**October 2010**

**U.S. DEPARTMENT OF  
ENERGY**

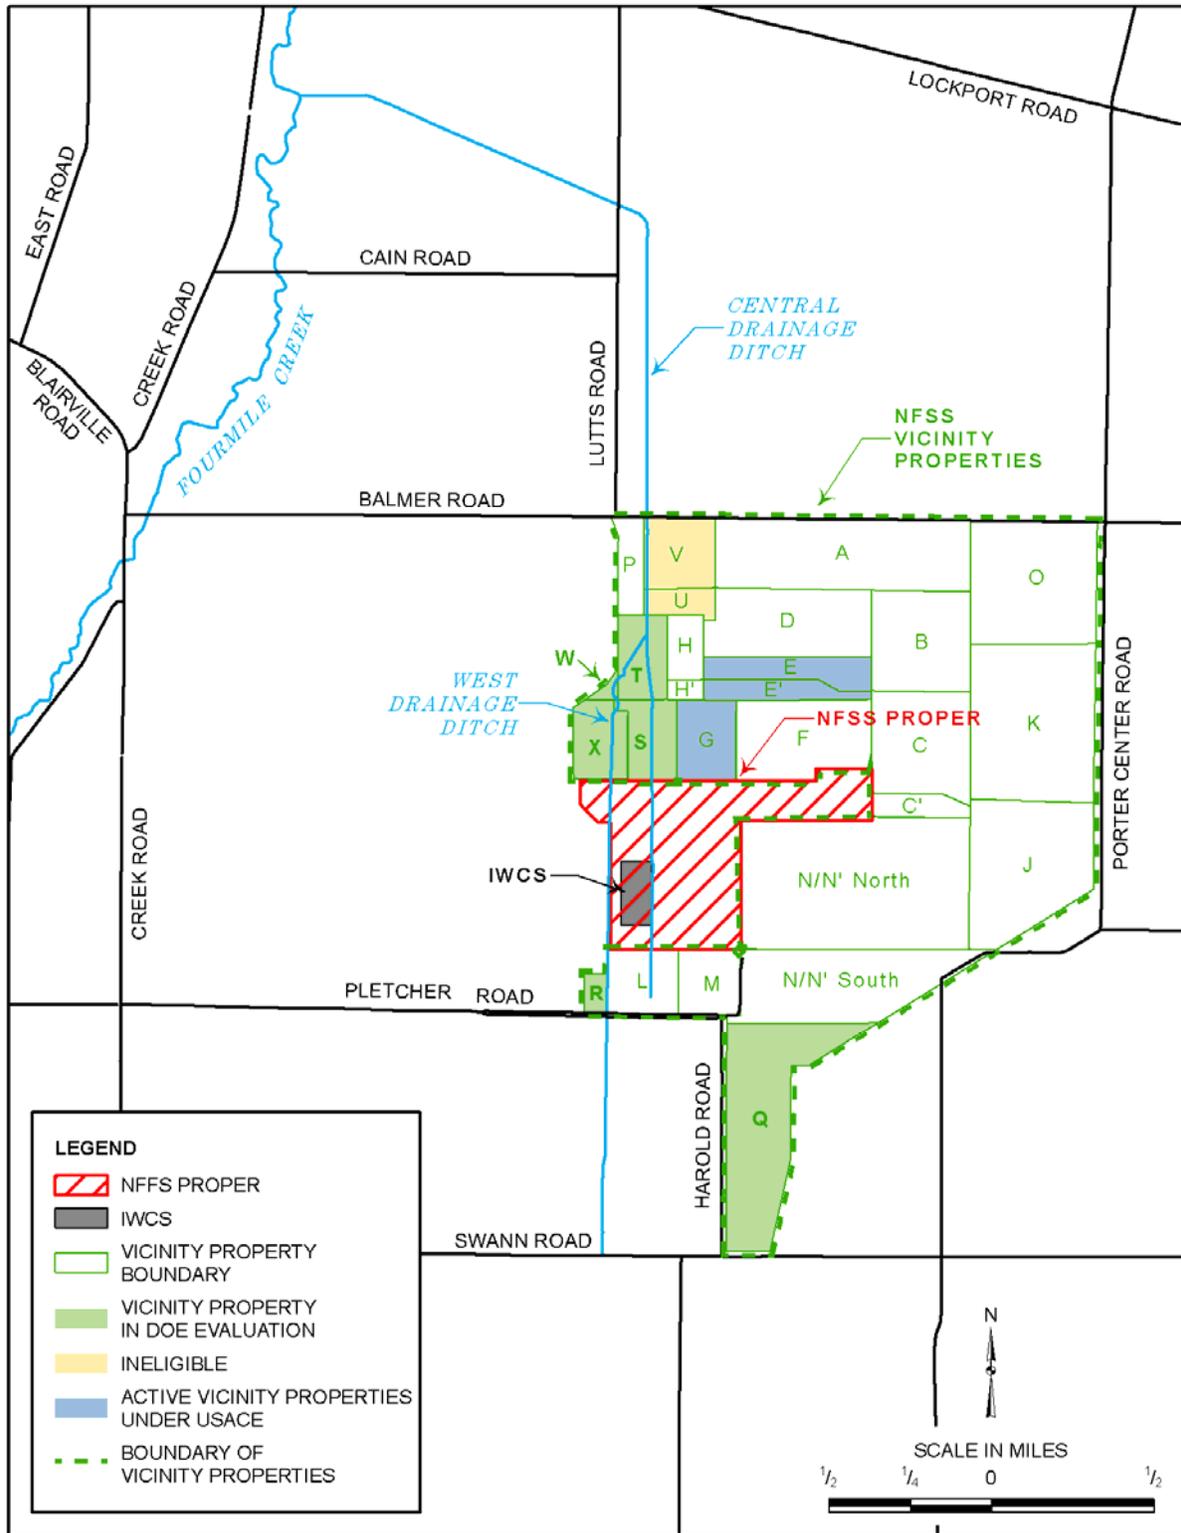
Figure 1-2. NFSS Vicinity Properties Addressed by the Review

This desktop review included (1) current land use and final radiological conditions for all of the completed VPs and (2) a more detailed records review of six VPs (VP-Q, VP-R, VP-S, VP-T, VP-W, and VP-X) and associated drainages (Figure 1–2). These six areas were selected by DOE based on specific stakeholder inquiries, the accessibility of the properties, and proximity to former operations on the NFSS.

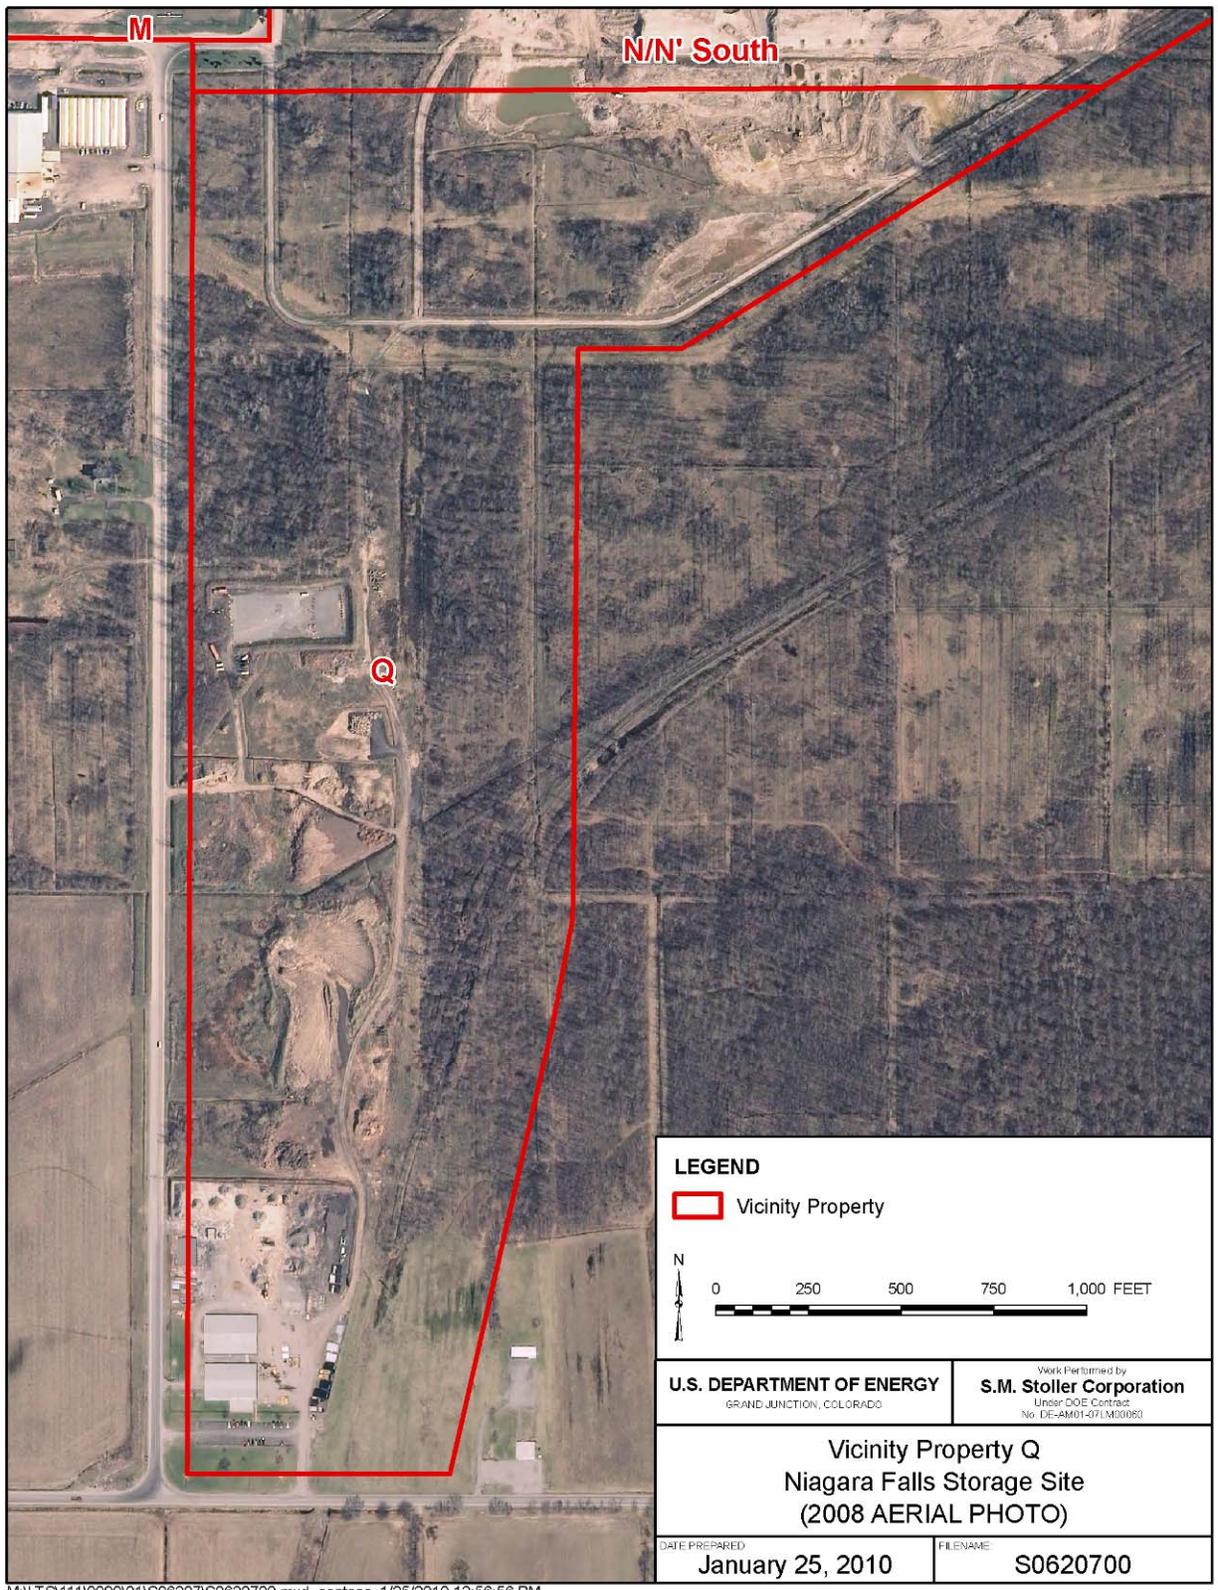
Figure 5–1. 2008 Aerial Photo of Vicinity Property Q

A former railroad grade can be observed in aerial photographs (2008 and 1951) running from southwest to northeast and also north and south across the property. The central portion of the property is accessible to the public.

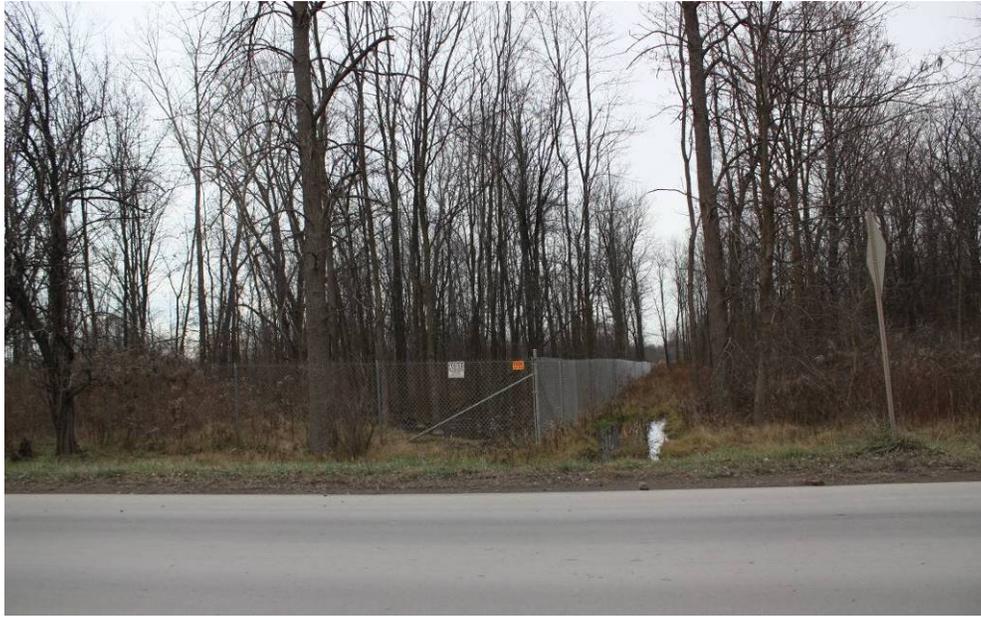
*Figure 5–3. VP-Q: Fenceline Separating Modern Landfill and Small-Arms Range (East from Harold Road)*

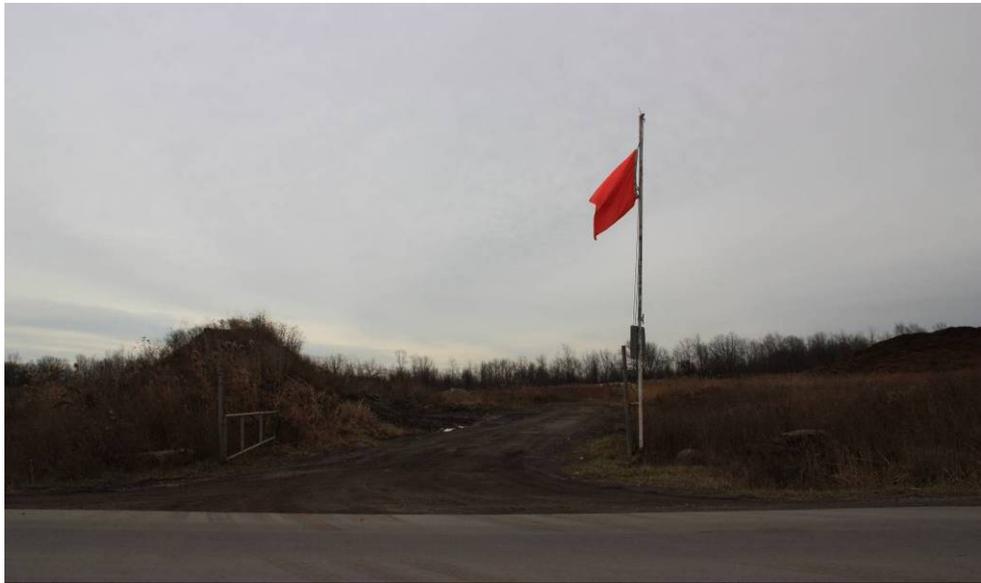
*Figure 5–4. VP-Q: Entrance to Small-Arms Firing Range (Central to the Property, East of Harold Road, and North of Town of Lewiston Maintenance Shops)*

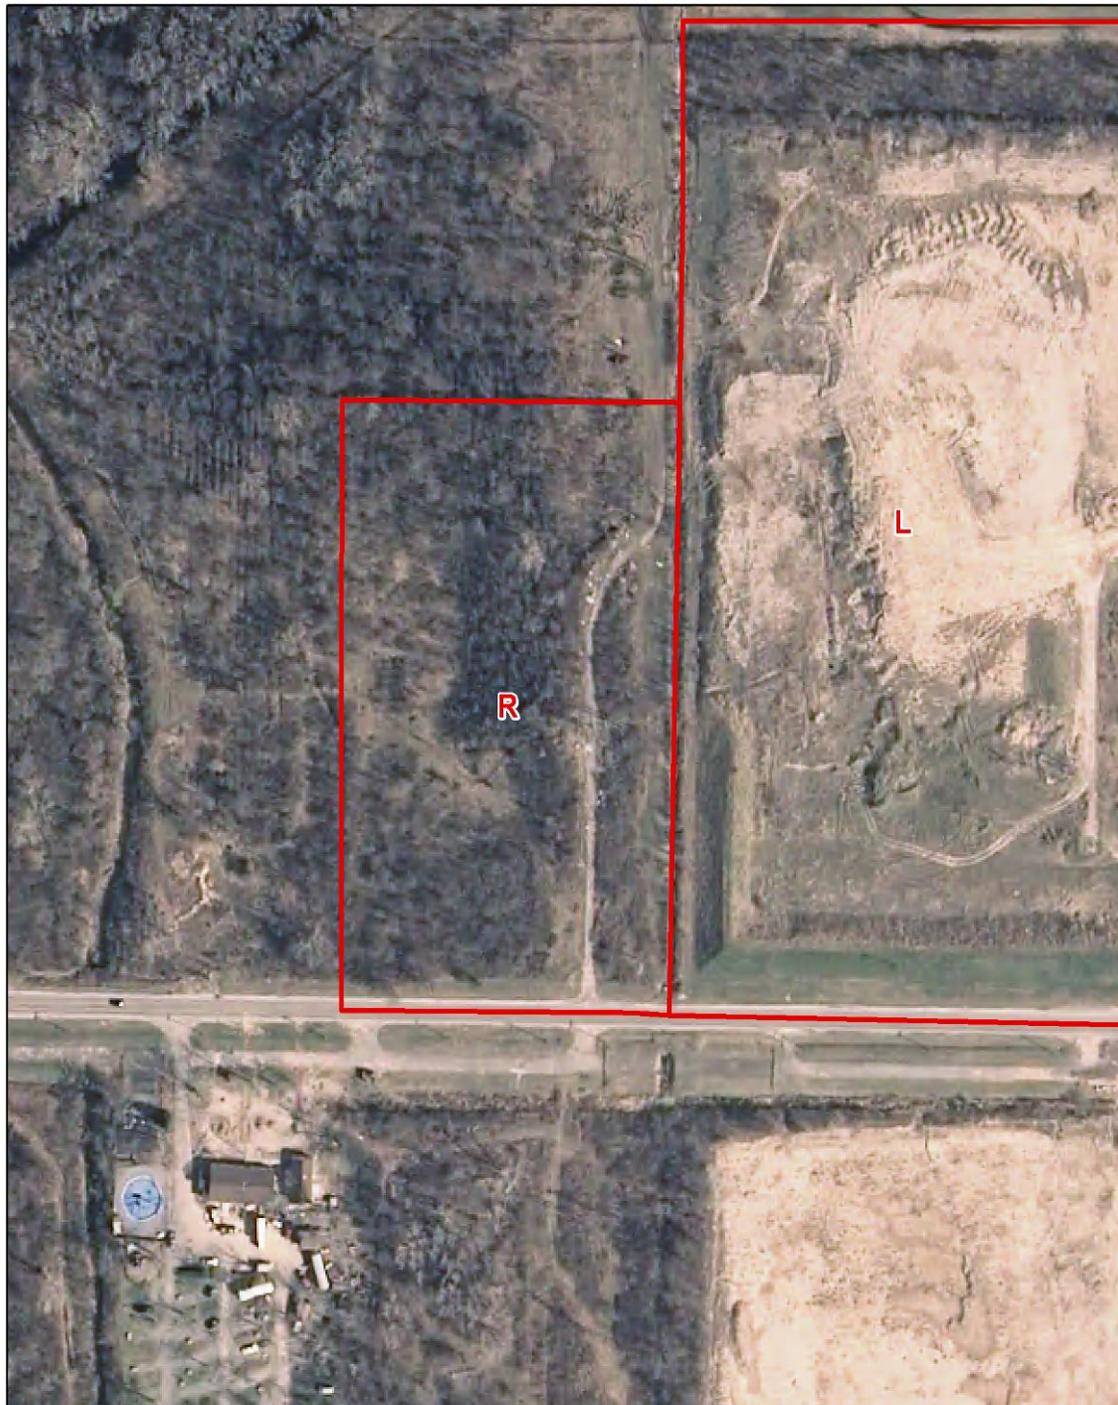
Figure 5–6. 2008 Aerial Photo of Vicinity Property R

Gamma exposure rates in and near the remediated area were slightly elevated (12–14  $\mu\text{R}/\text{h}$ ), but soils samples were generally within baseline levels. All samples met DOE guidelines.

Further remediation was performed at areas of isolated elevated gamma exposure rates (29–34  $\mu\text{R}/\text{h}$ ). Follow-up samples were less than 15 pCi/g, and exposure rates were 13–14  $\mu\text{R}/\text{h}$  before the area was backfilled.

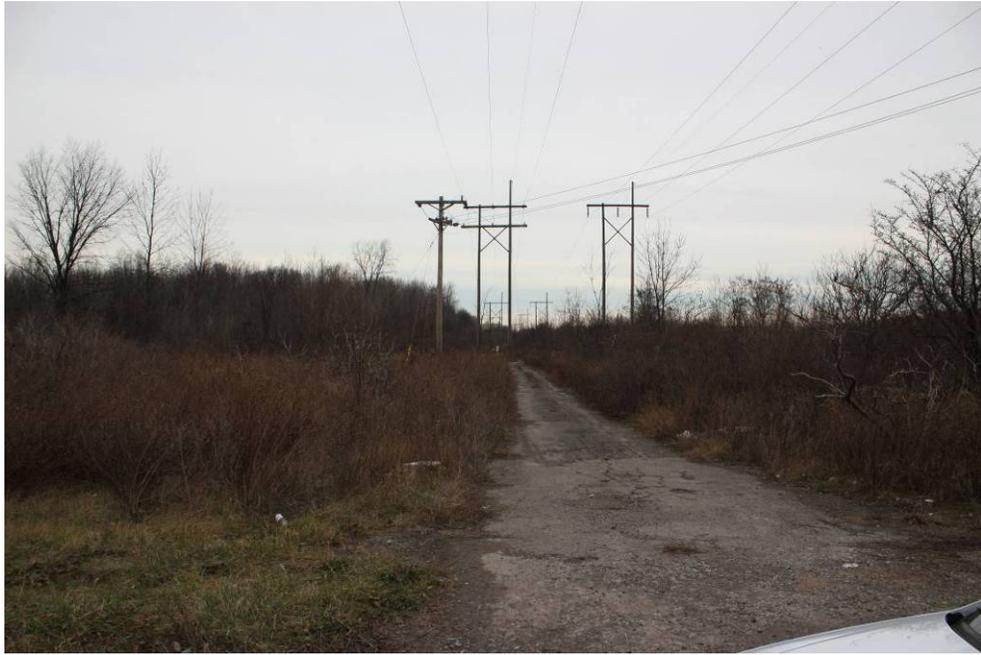
*Figure 5–8. VP-R: View of Access Road that Parallels the West Drainage Ditch (December 2009)*

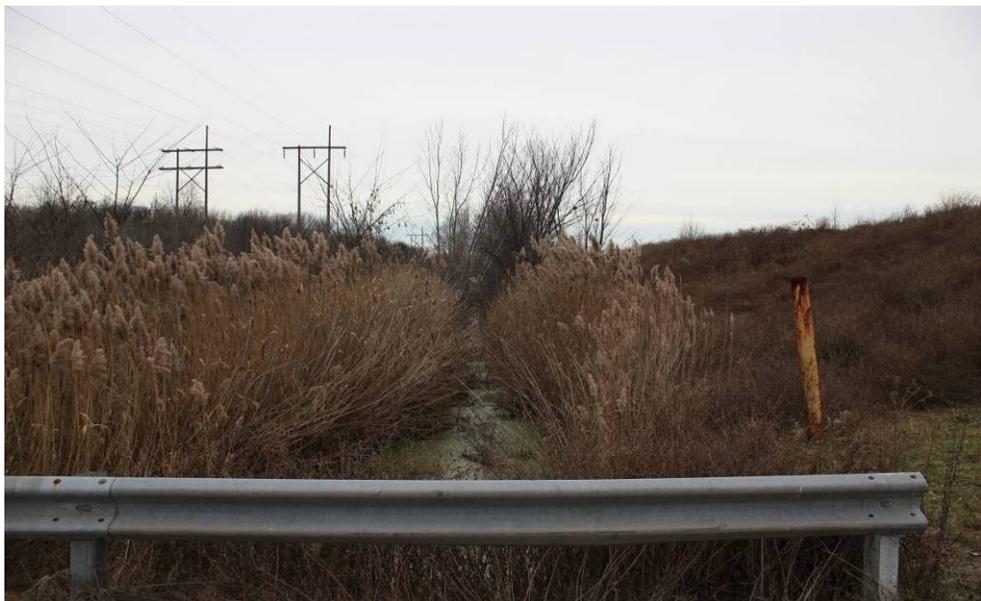
*Figure 5–9. VP-R: View North of West Drainage Ditch that Flows Through the VP*

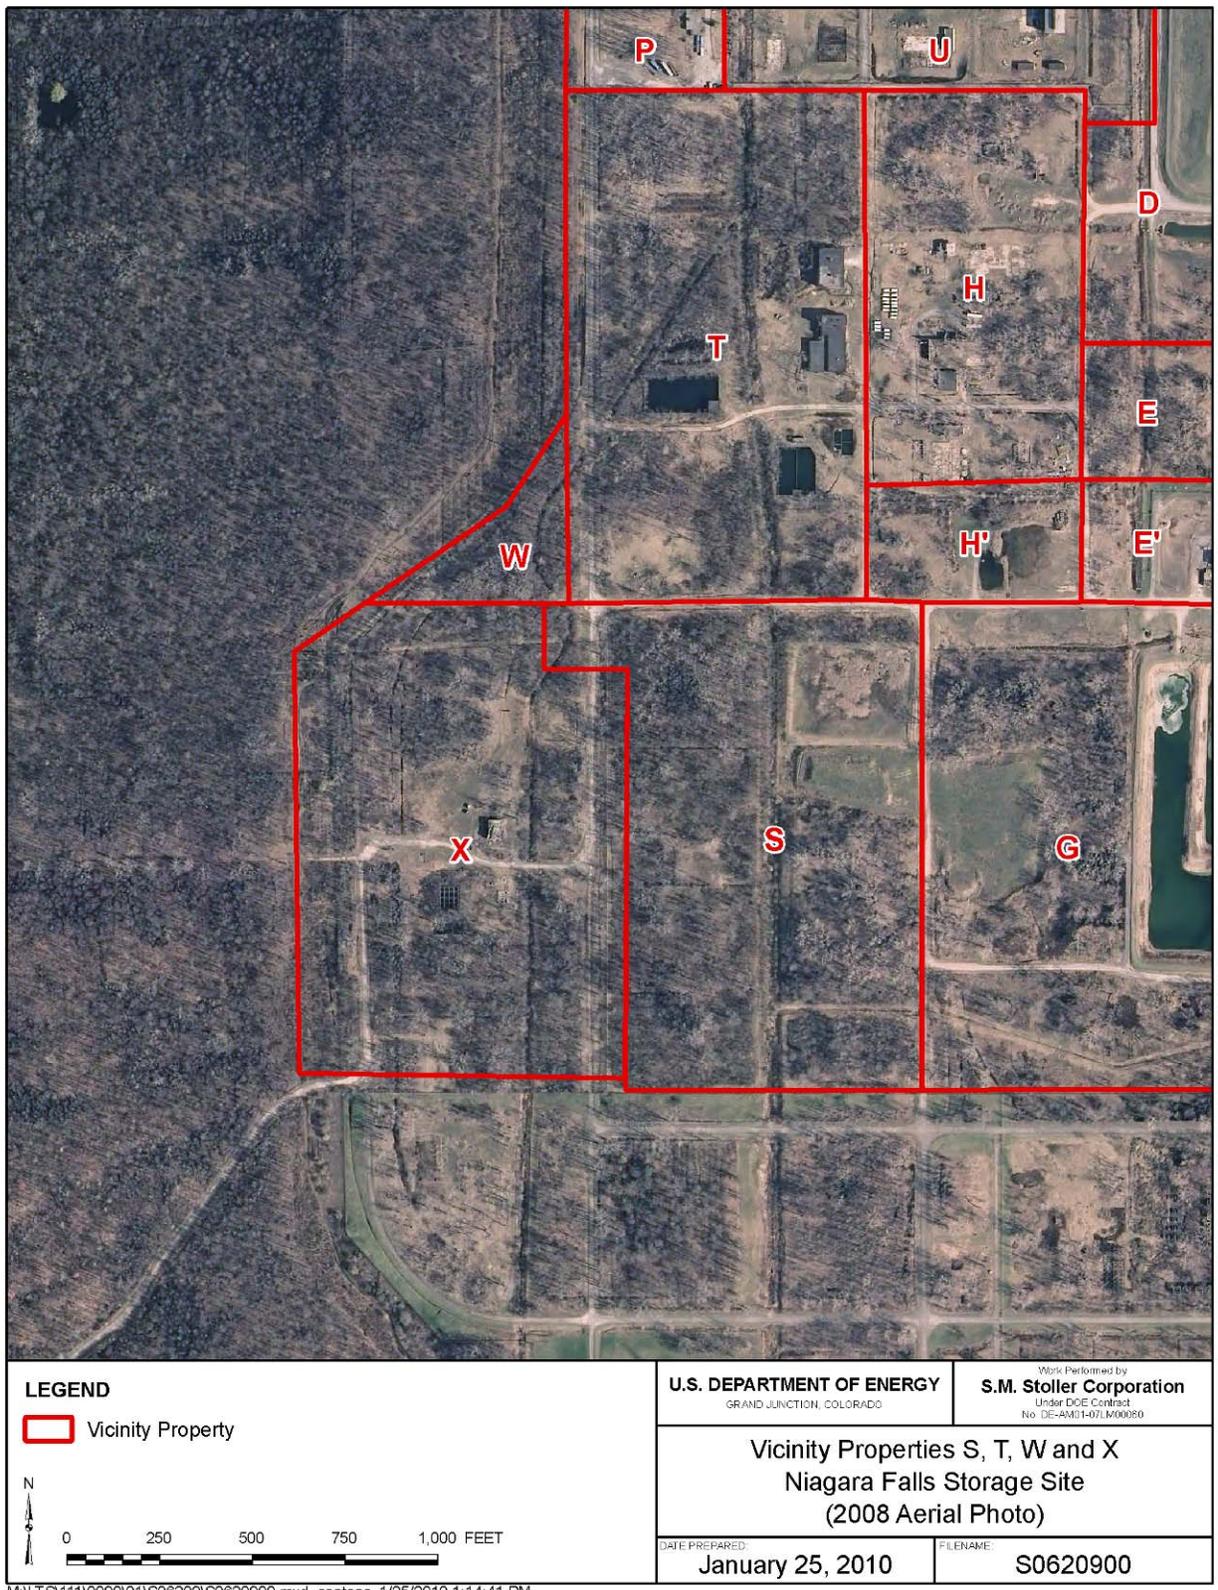
Figure 5–10. 2008 Aerial Photo of Vicinity Properties S, T, W, and X

VP-S is currently owned by Chemical Waste Management as part of their hazardous waste landfill operations. The property is well vegetated and undeveloped. Figure 5–10 and Figure 5–11 show the property in 2008 and 1951.

Gamma scans identified regions of elevated contact radiation along the banks of the Central Drainage Ditch and the haul road areas adjacent to the Central Drainage Ditch. These areas were remediated further by BNI and follow-up direct monitoring and sampling confirmed that efforts were effective in reducing residual activity to acceptable levels. Final gamma exposure rates at 1 m above the surface ranged from 7 to 17  $\mu\text{R}/\text{h}$ . Results of the verification sampling (Table 11 in Verification section of Appendix D) identified small areas of residual Ra-226 activity in excess of the 15 pCi/g guideline levels for subsurface soil at grid coordinates N2516,E76; N2814,E273; N2475,E495; N2720,E365; N2795,E435; N2905,E355; N2905,E395; and N2910,E430. Maximum Ra-226 level in samples from these locations was 103 pCi/g. Direct

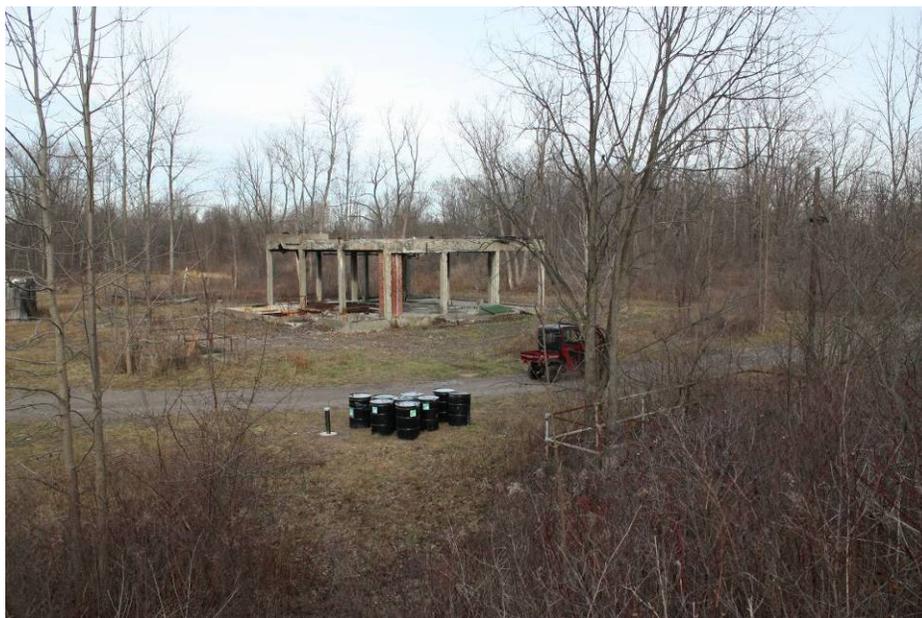
The property is currently derelict and in disrepair but a four-wheeler access road allows the area to be monitored for trespassing. VP-X is currently owned by the Town of Lewiston, which is planning to construct a fence surrounding the property to deter trespassing and to prevent injury from animals or humans falling into the open tanks or foundations.

Figure 5-12. VP-X: View Northeast from IMHOFF Tank to Remains of Pump House

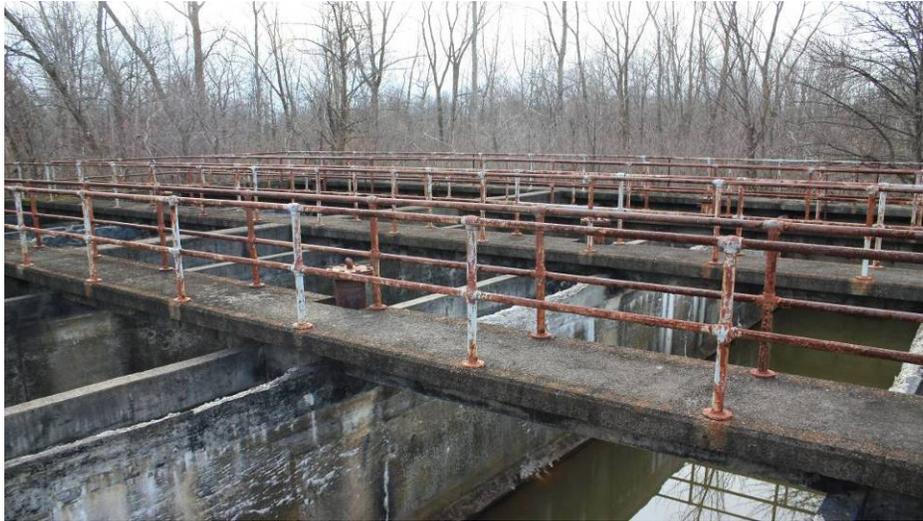
*Figure 5–13. VP-X: IMHOFF Tank*

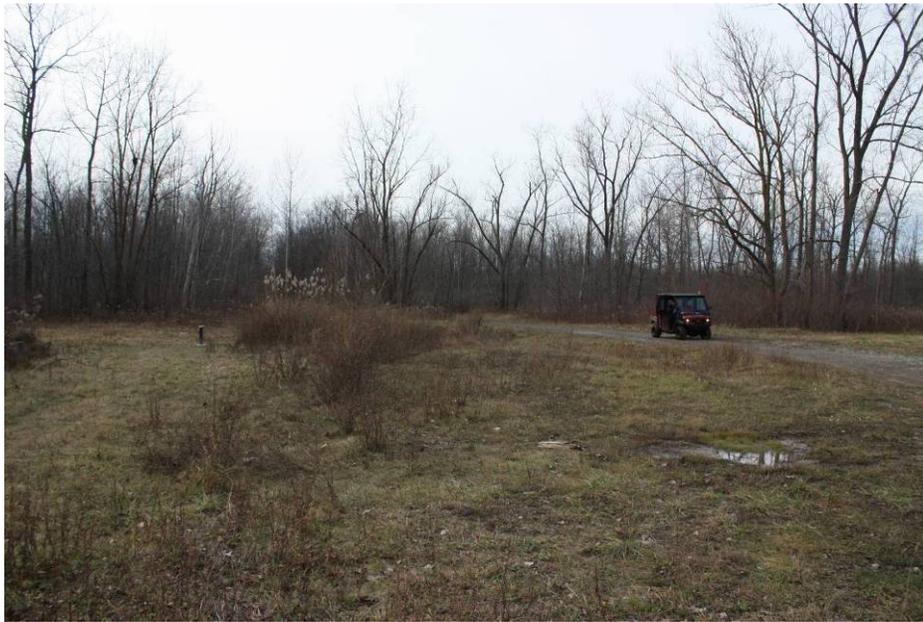
*Figure 5–14. VP-X: View West from IMHOFF Tank at Access from the Holding Ponds Off-site*

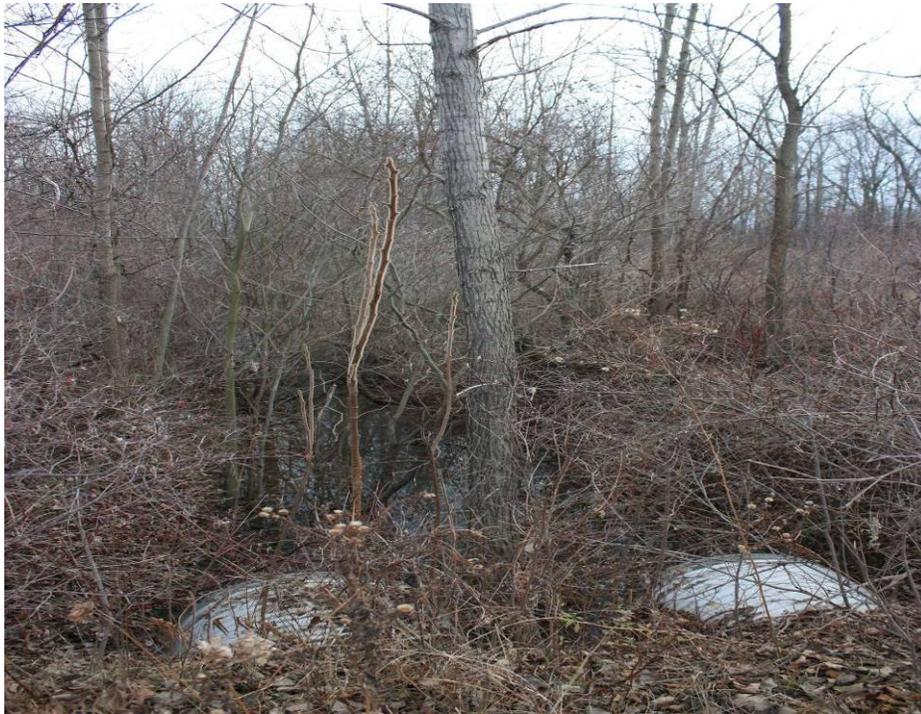
*Figure 5–15. VP-X: West Drainage Ditch within VP-X (West of the Sewage Treatment Plant)*

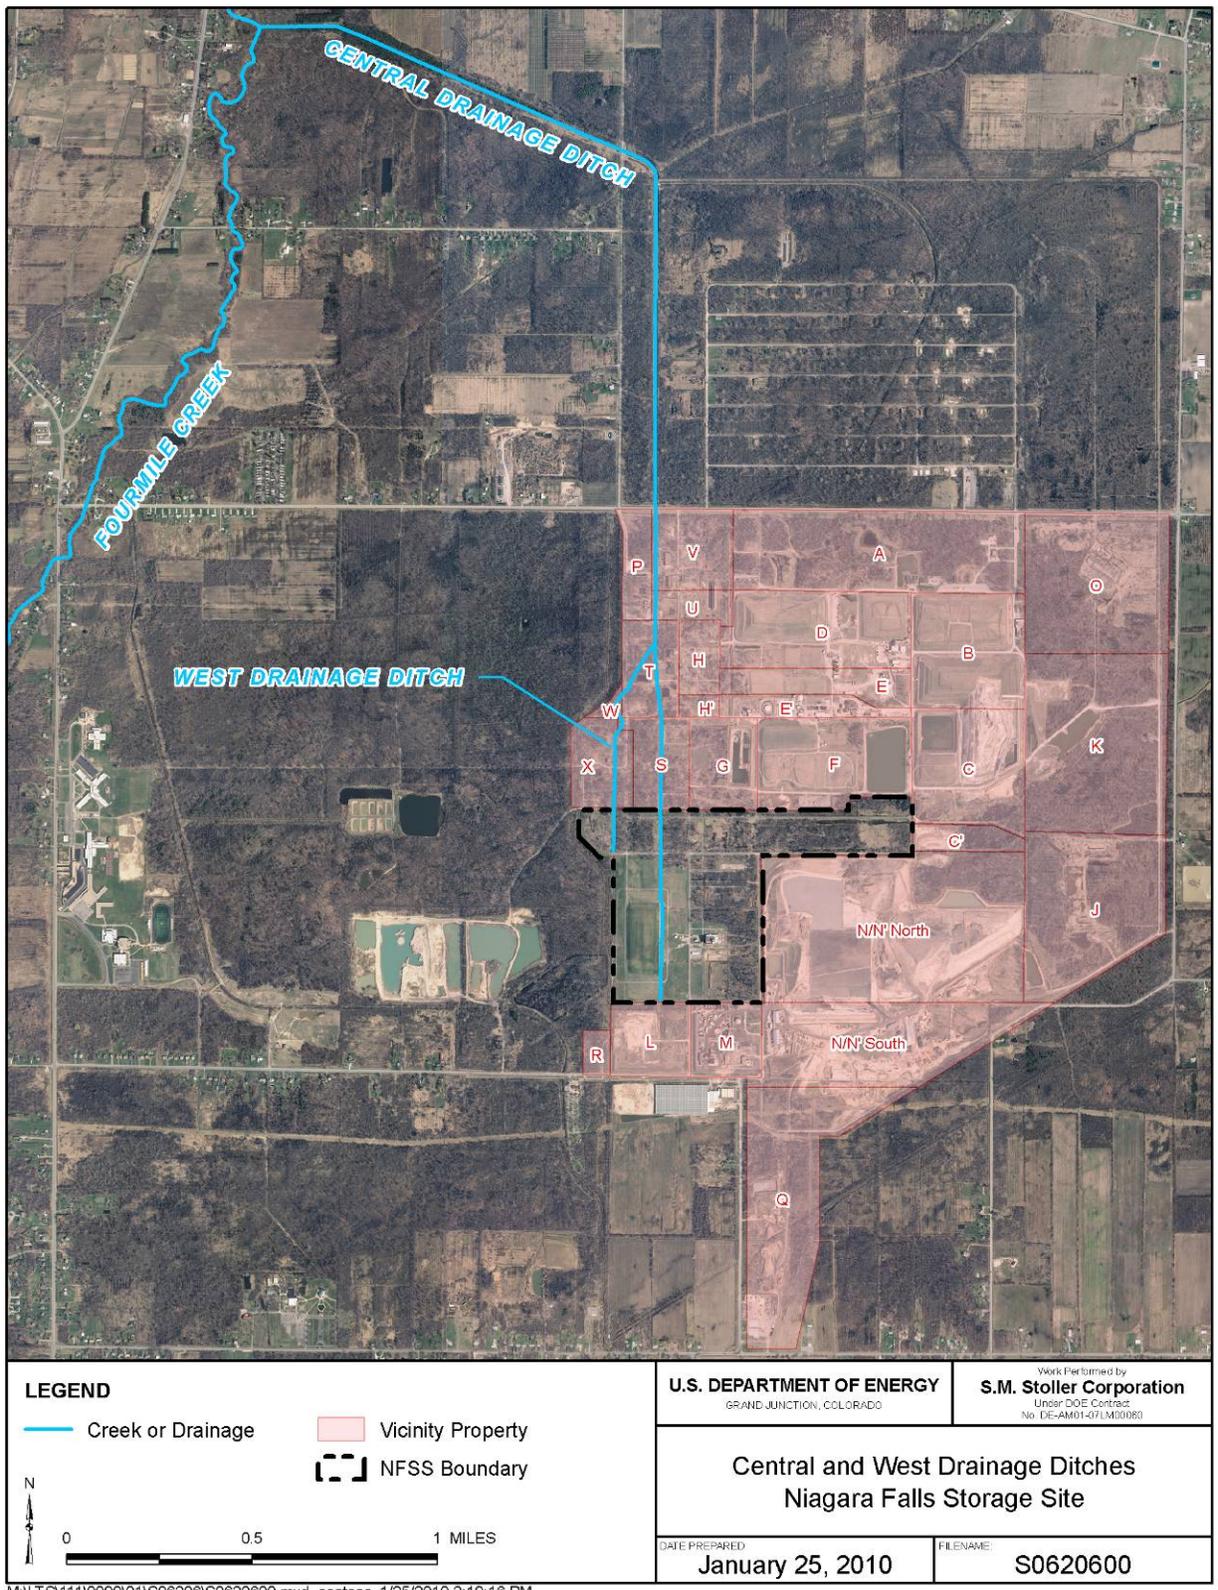
Figure 5–16. Central and West Drainage Ditches (Niagara Falls Storage Site)

The ditches continue to drain the NFSS and VPs and are heavily vegetated. No change in land use is anticipated.

Contact exposure rates in the West Drainage Ditch were 17–42  $\mu\text{R}/\text{h}$ . These areas were located mainly along the lower banks and were  $< 1 \text{ m}^2$ , isolated occurrences, therefore it was determined that no further remediation was necessary. Verification soil samples were collected at 200 ft intervals along the ditch between DOE property and its intersection with the Central Drainage Ditch and were found to meet the DOE guidelines (Oct 1989; 1983 and 1984 Verification Survey). No further remediation was performed.

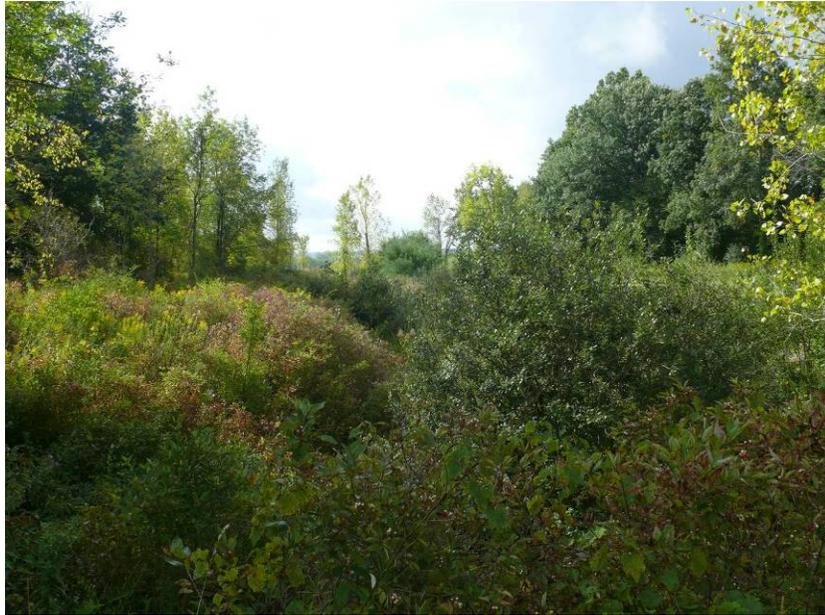
*Figure 5–17. Central Drainage Ditch South from Balmer Road (September 2009)*

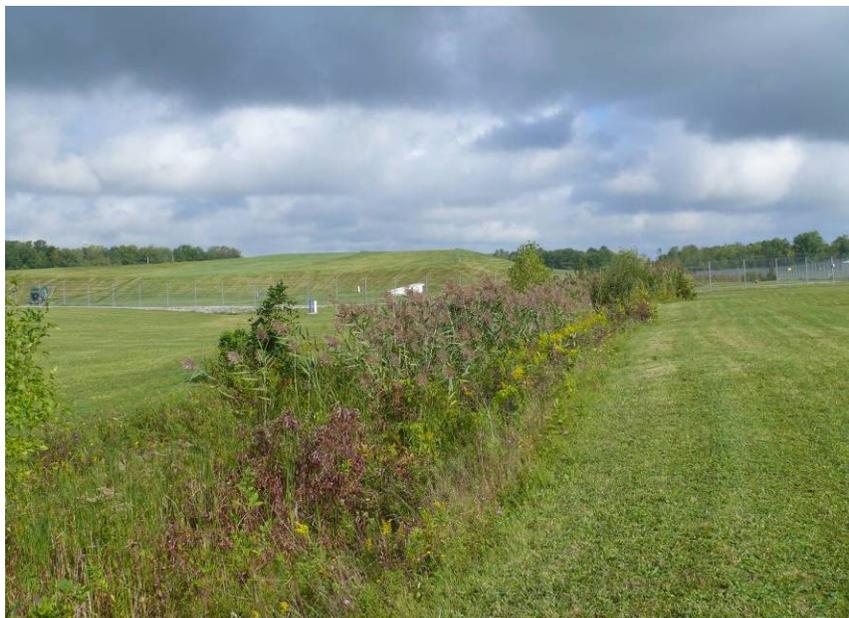
During the 2001 site-wide gamma walkover survey of the NFSS property, gamma radiation in surface soil above background was detected on the western border of the NFSS property adjacent to the National Grid property within EU9 north of the VP-R. The Corps continued the gamma walkover survey from the NFSS fenceline westerly into the west ditch on National Grid property. A strip of ground, including the ditch, approximately  $60 \text{ ft} \times 820 \text{ ft}$  was surveyed. Several isolated spots in this area displayed elevated radioactivity two to three times the natural background level of approximately 9,000 to 13,000 counts per minute (USACE 2008).

*Figure 5–18. Central Drainage Ditch View North Toward IWCS (September 2009)*
