# 2016 Annual Inspection Report of the Burris Park, California, Site

February 2017

Legacy  
Management

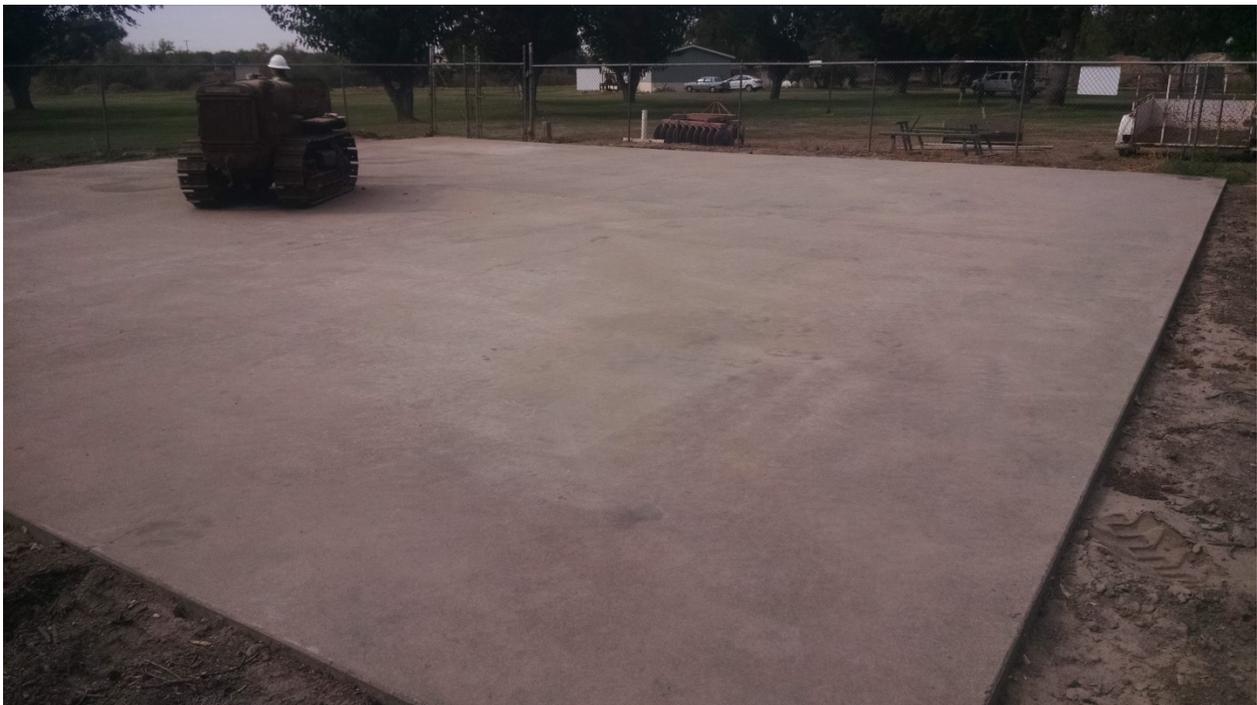
Antique farm equipment, wood debris, and two fallen dead trees were removed from the concrete pad in March 2015. Two live trees were cut down and also removed at this time to ensure continued protectiveness of the concrete enclosure. The surface of the concrete pad was washed off and inspected. Minor cracks were scanned by a radiological control technician; no results were above background. The historical bronze plaque located on the southeast corner of the pad was cleaned of dust and debris and remains in good condition. No maintenance or deferred maintenance needs for these ICs were identified. PL–1 through PL–3 are representative photographs that show the current condition of the ICs.

*PL-1. Concrete pad surface looking northeast*

The overall site condition was determined to be good. A few minor improvements will be made during the 2017 site visit or by the park custodian. These include: removing grass clumps that are emerging, removing dead vegetation that is beginning to collect within the fenced area, adding more wire clips to better secure the fence to the posts, and adding sealant to a few cracks in the concrete pad to prevent water intrusion.

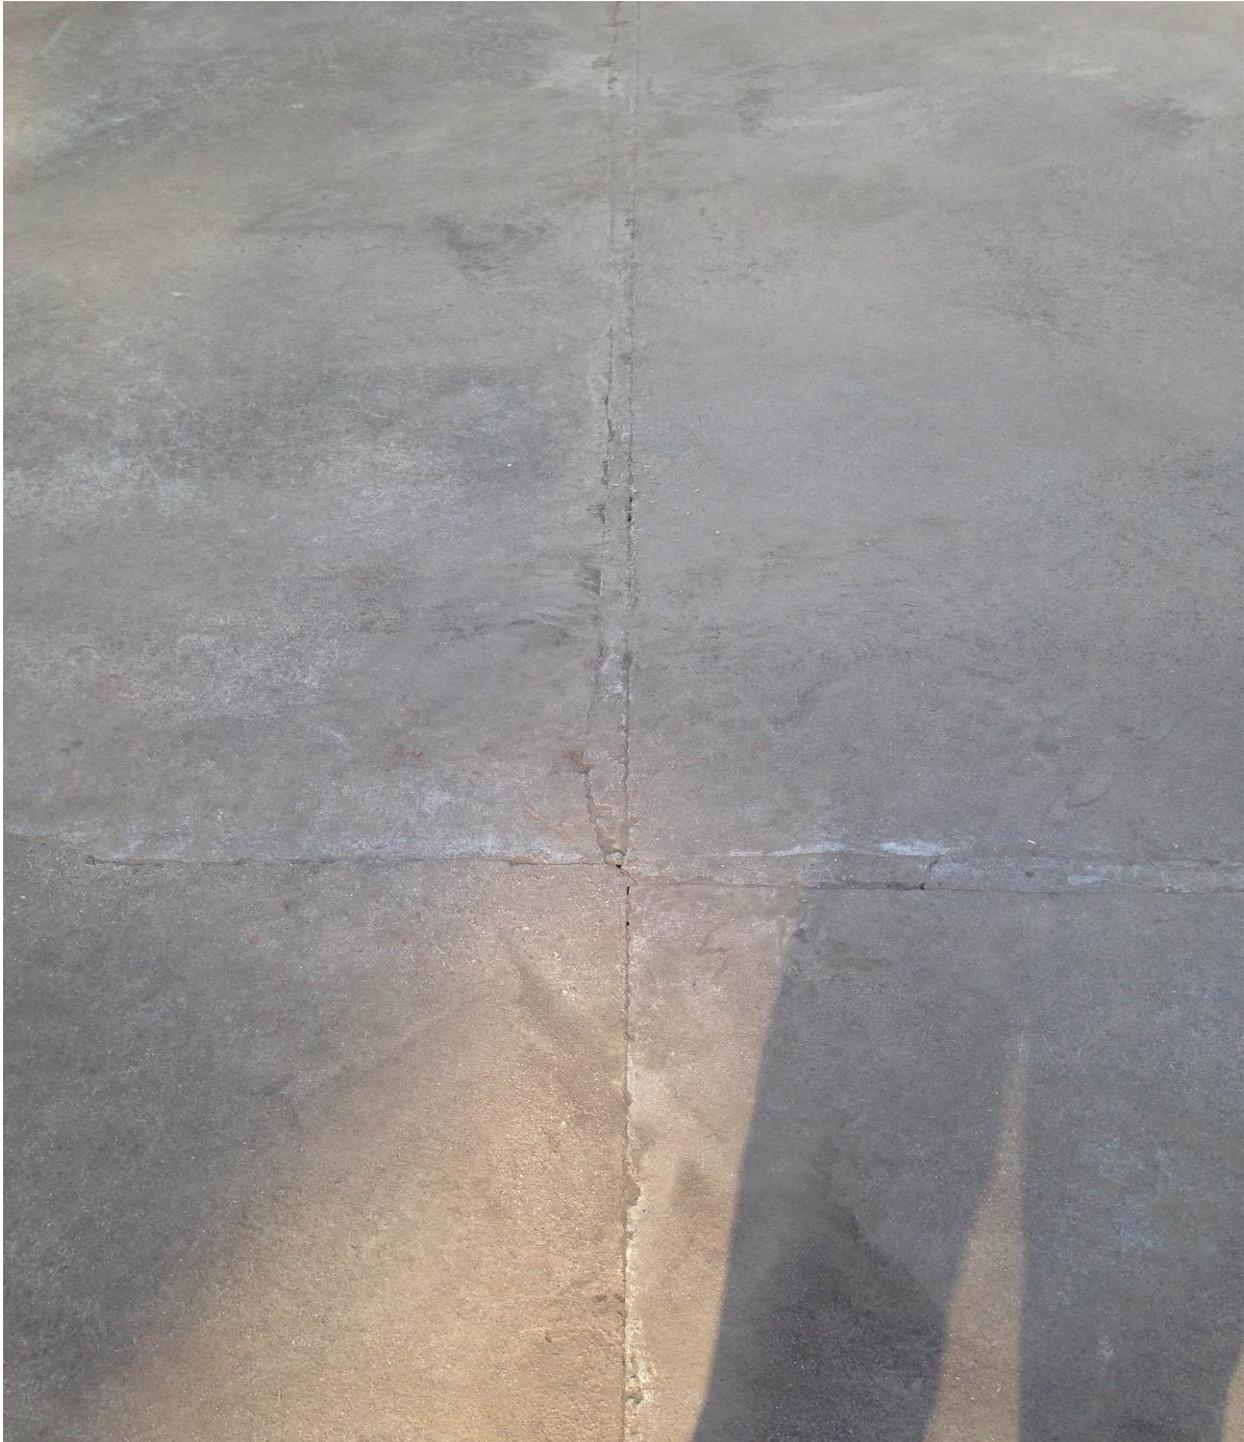
*PL-2. Concrete pad surface looking east*

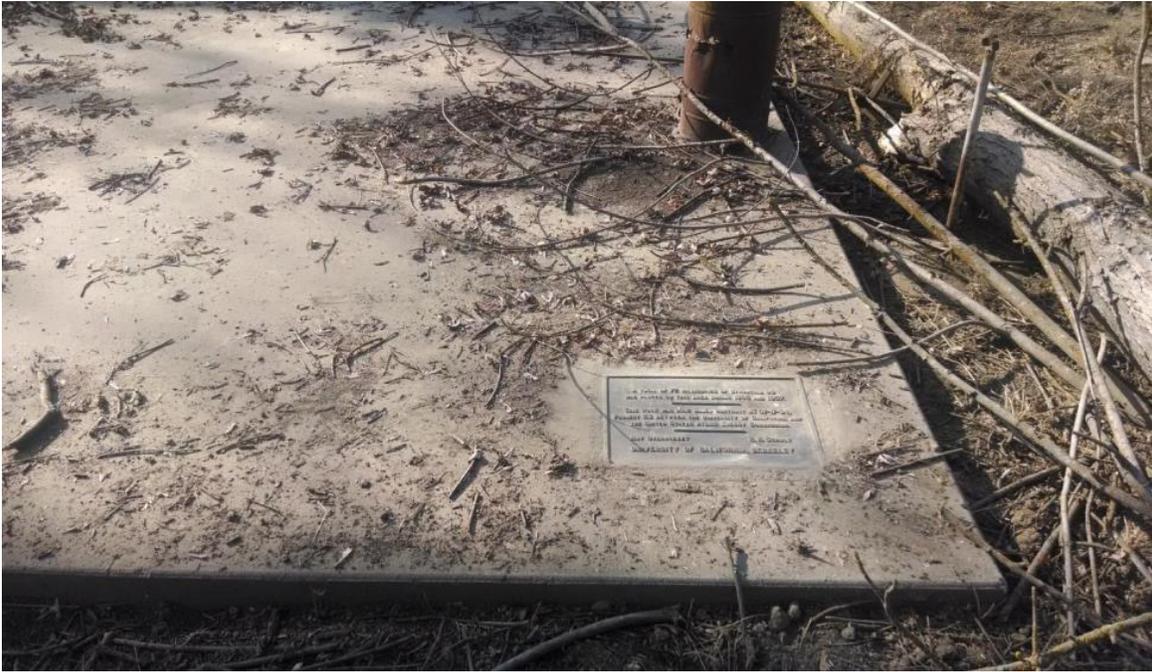
*PL-3. Bronze plaque (before pad was cleaned) looking north*

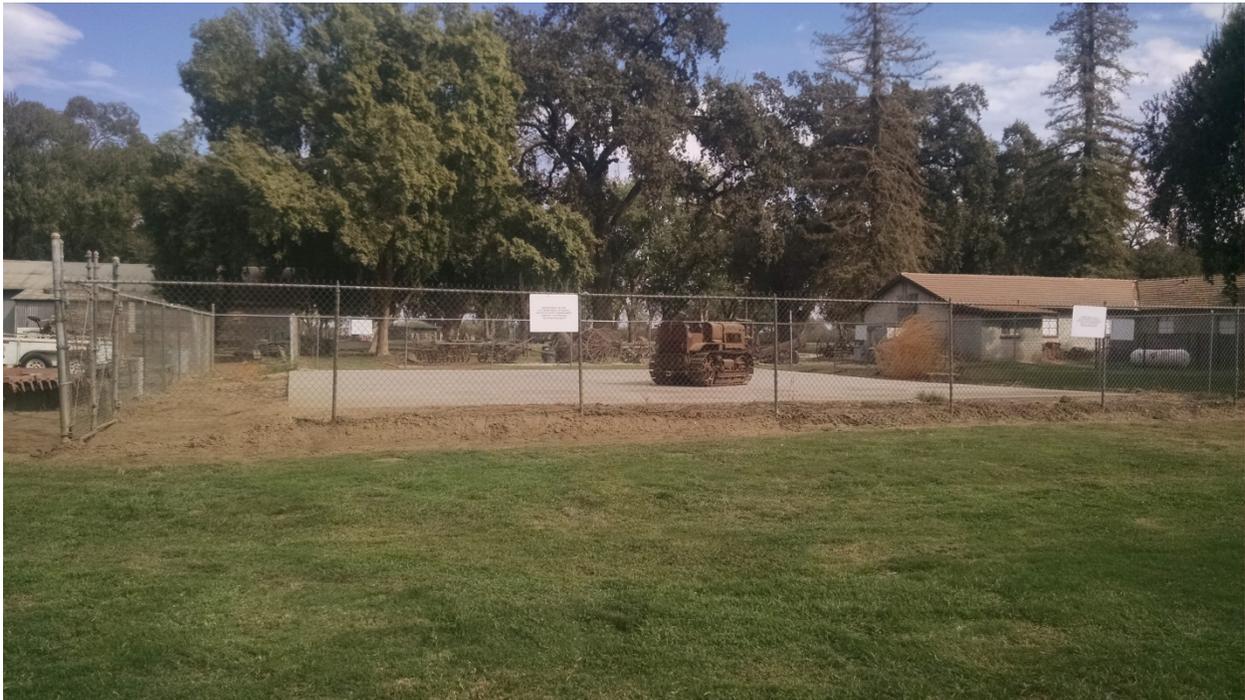
Fence maintenance was completed in March 2015. Barbed wire was removed, metal rails were straightened or replaced, the southeast corner post was replaced, and the entrance gate was adjusted for easier access. PL-4 and PL-5 show the condition of this IC. A few of the wire hooks used to secure the fencing to the posts are missing or broken. Fence hooks will be purchased and sent to the county park custodian, who volunteered to fix the fence. No further maintenance is required for this IC. The expected longevity of the fence is about 25 years. DOE will plan to replace the entire fence and gate in 2040.

*PL-4. Fence looking south*

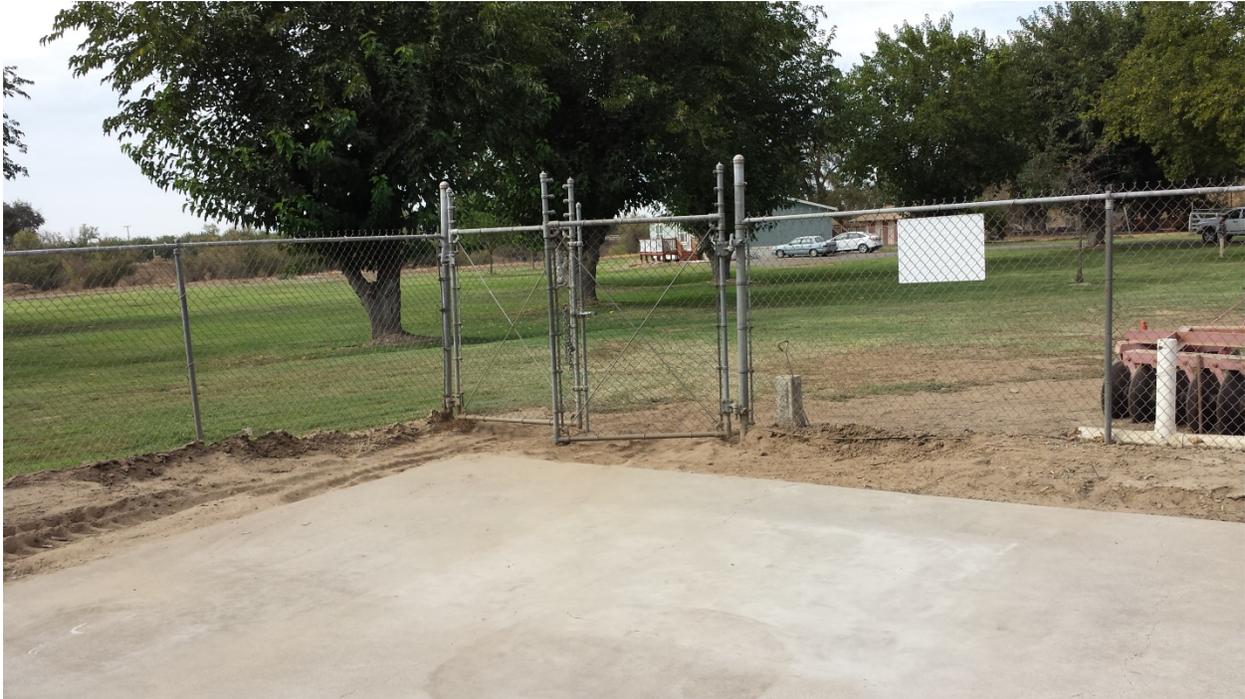
*PL-5. Fence gate looking northeast*

- 1) In the fall of 2018, DOE will conduct work at the site to regrade the area, add fabric and stone cover between the pad and the fence, and reverse the gate so that it opens outward for easier access.
- 2) DOE will replace the entire fence once it reaches the 25-year life expectancy in 2039.

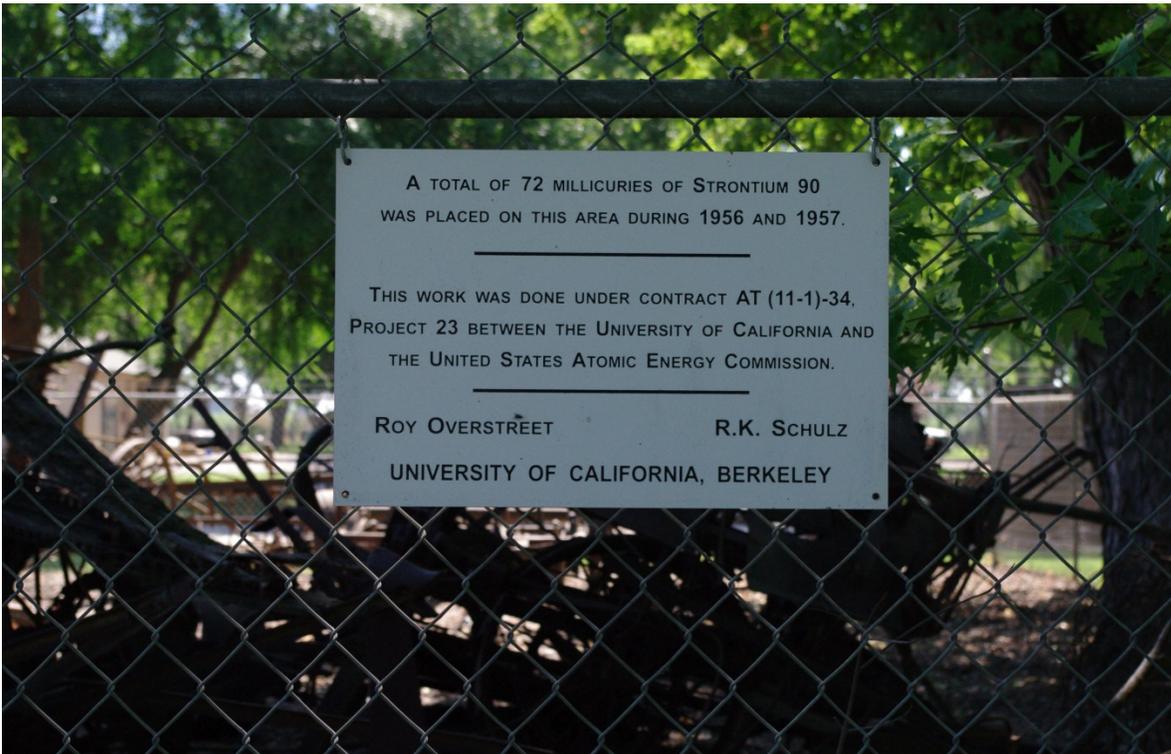
Signs on each side of the fenced area were replaced with signs (two per side) that provide DOE LM as the correct contact for the site. PL-6 shows the old signage, and PL-7 shows the new signage. The county, on behalf of the new Burris Park museum curator and UC Berkeley, requested one of each of the old signs for historical purposes. DOE will ship the two old signs to the Kings County Parks and Grounds Superintendent prior to next scheduled inspection.

*PL-6. Old signage*

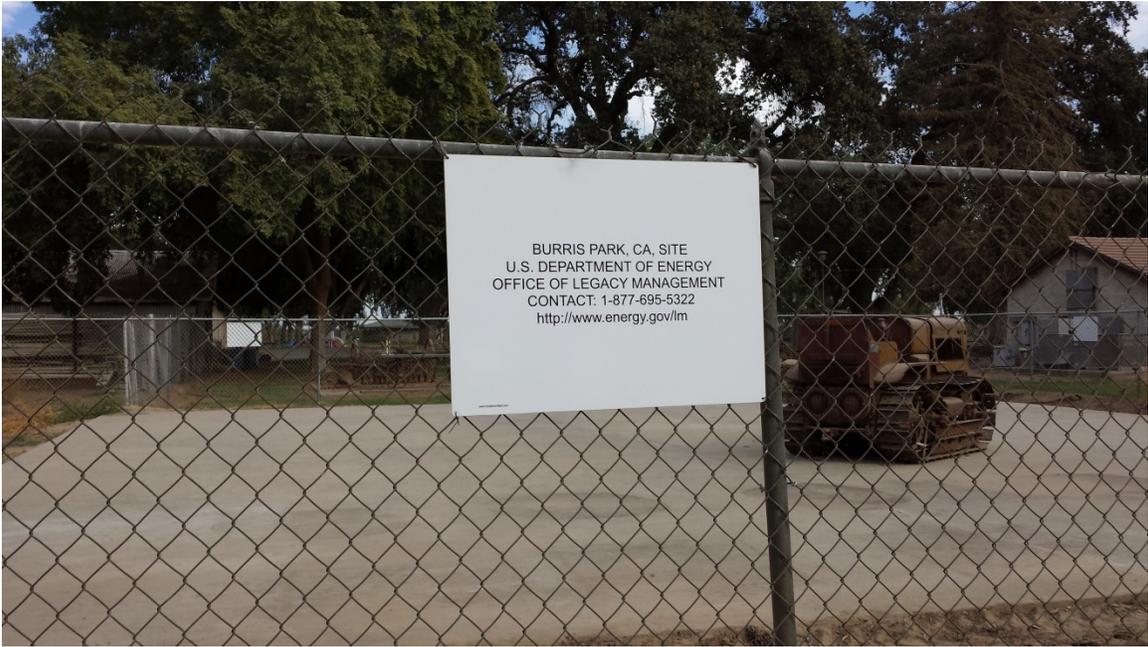
*PL-7. New signage on north fence looking southwest*
