Nevada
Environmental
Restoration
Project

DOE/NV-743

Closure Report for
Corrective Action Unit 417:
Central Nevada Test Area
Surface, Nevada

November 2001

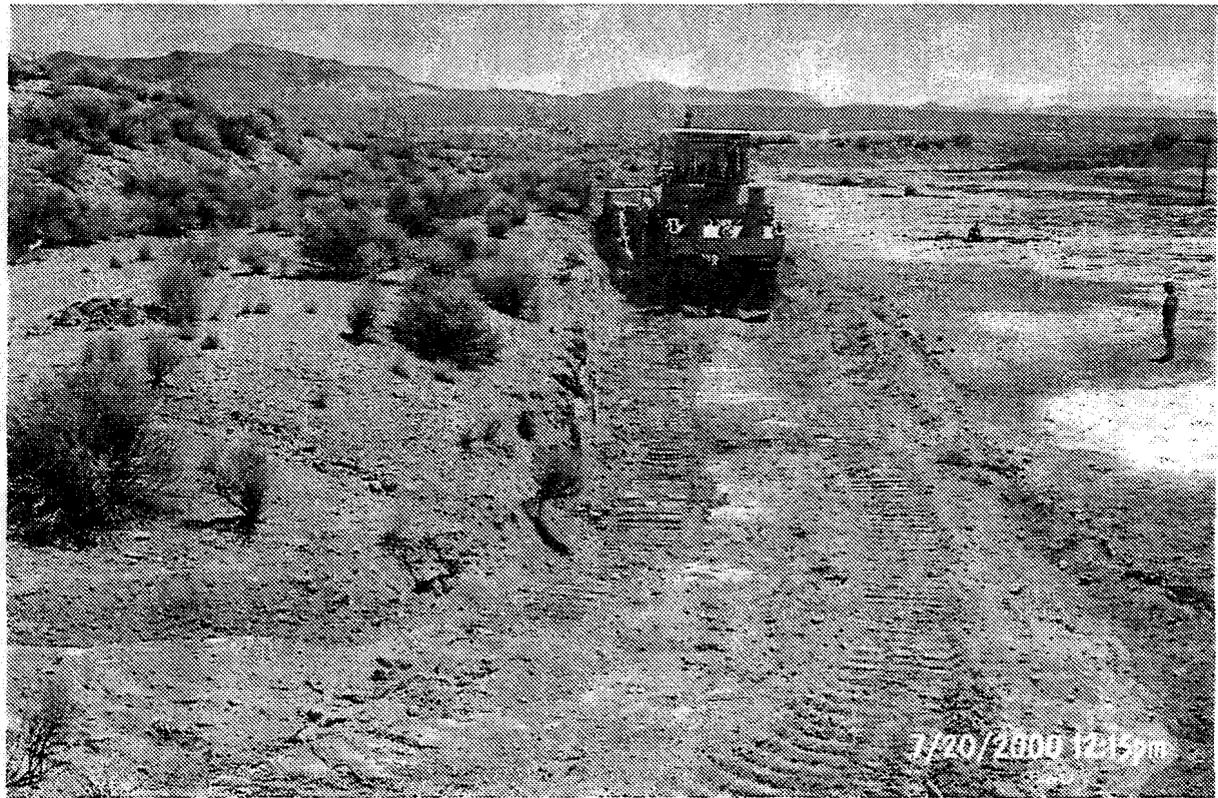
PHOTOGRAPH 1 - Cutting geogrid anchor bench for Central Mud Pit

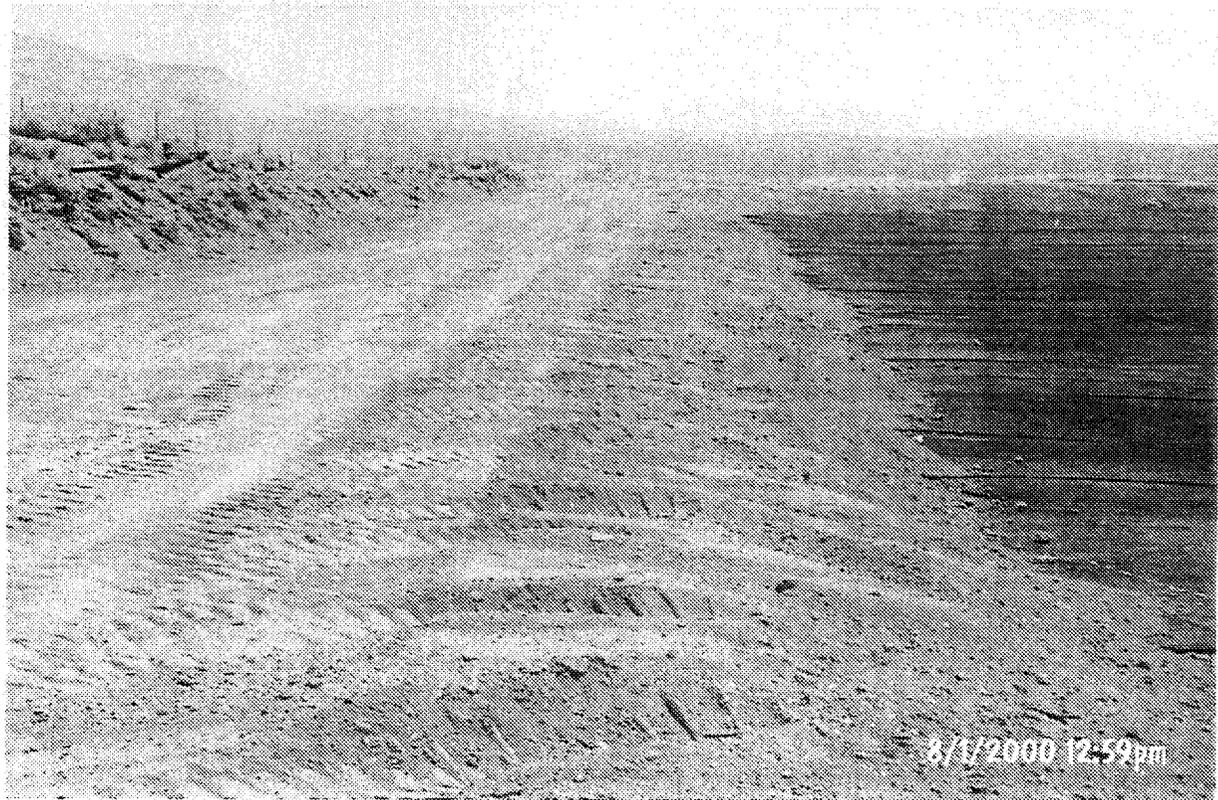
PHOTOGRAPH 3 - Geogrid anchored in place on CMP

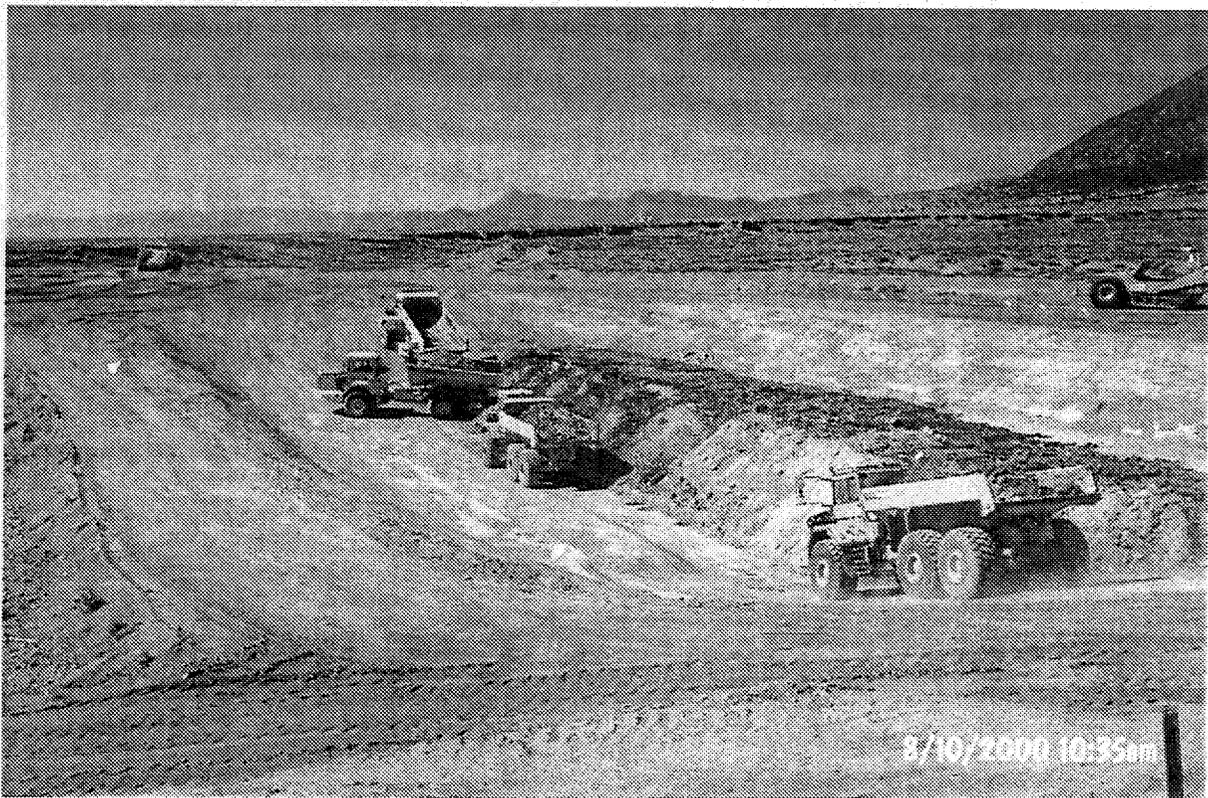
PHOTOGRAPH 8 - Drilling material from UC-4 Area S being placed in Relocation Trench

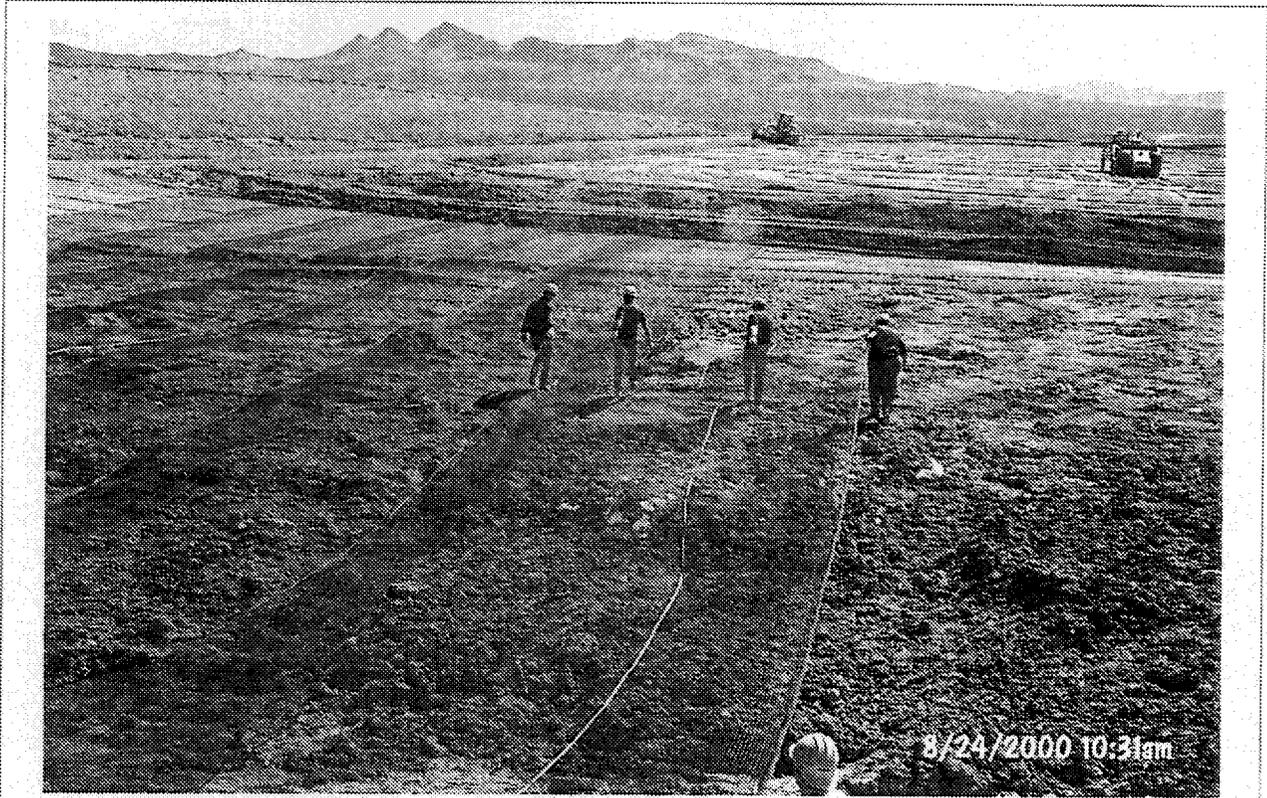
PHOTOGRAPH 13 - Placing geogrid over CMP Mud Relocation Trench

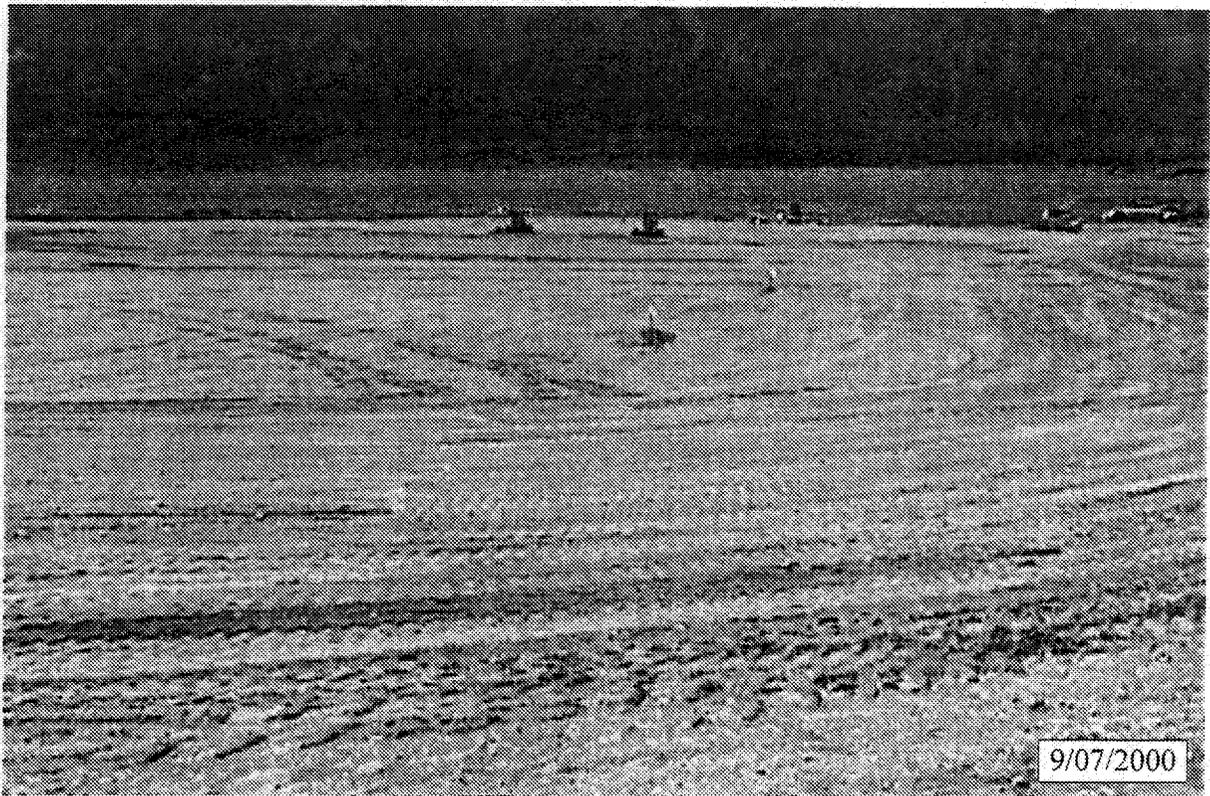
PHOTOGRAPH 14 - Completed 4 foot earthen mono-layer CMP cover

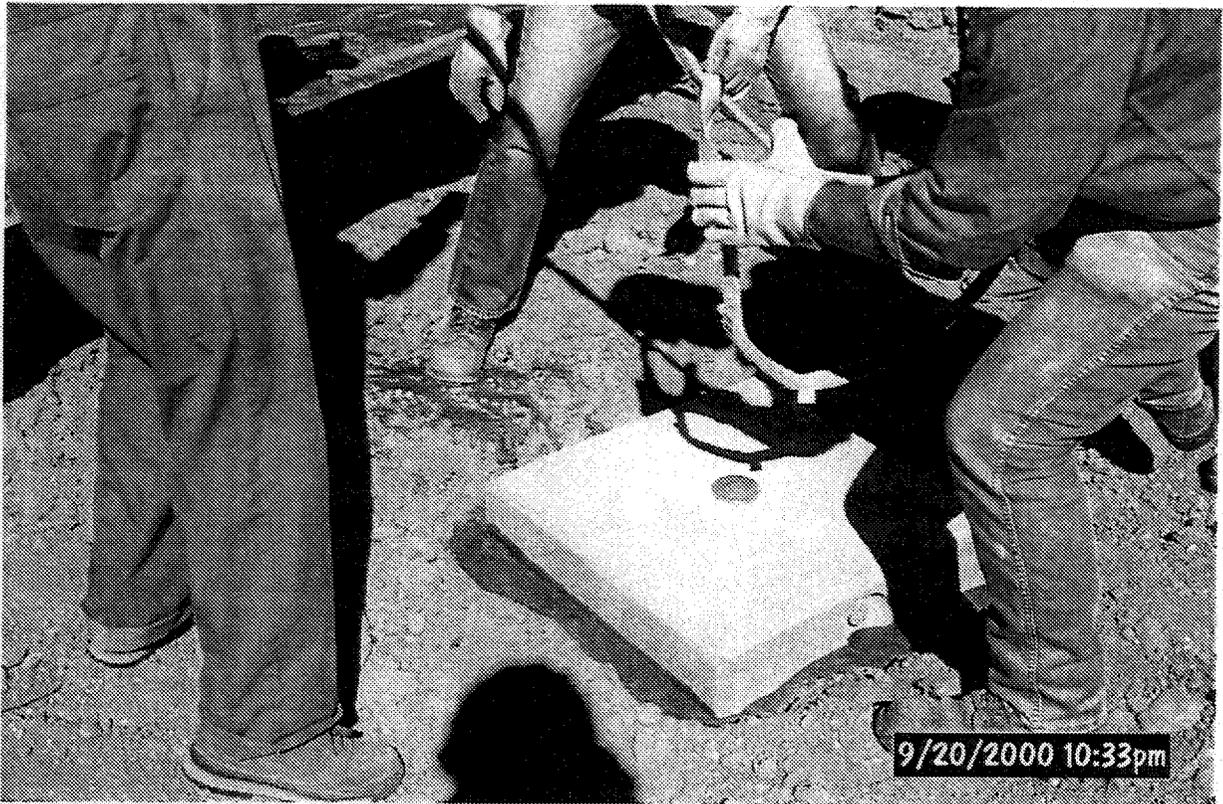
PHOTOGRAPH 20 - Placing subsidence monuments on the CMP cover

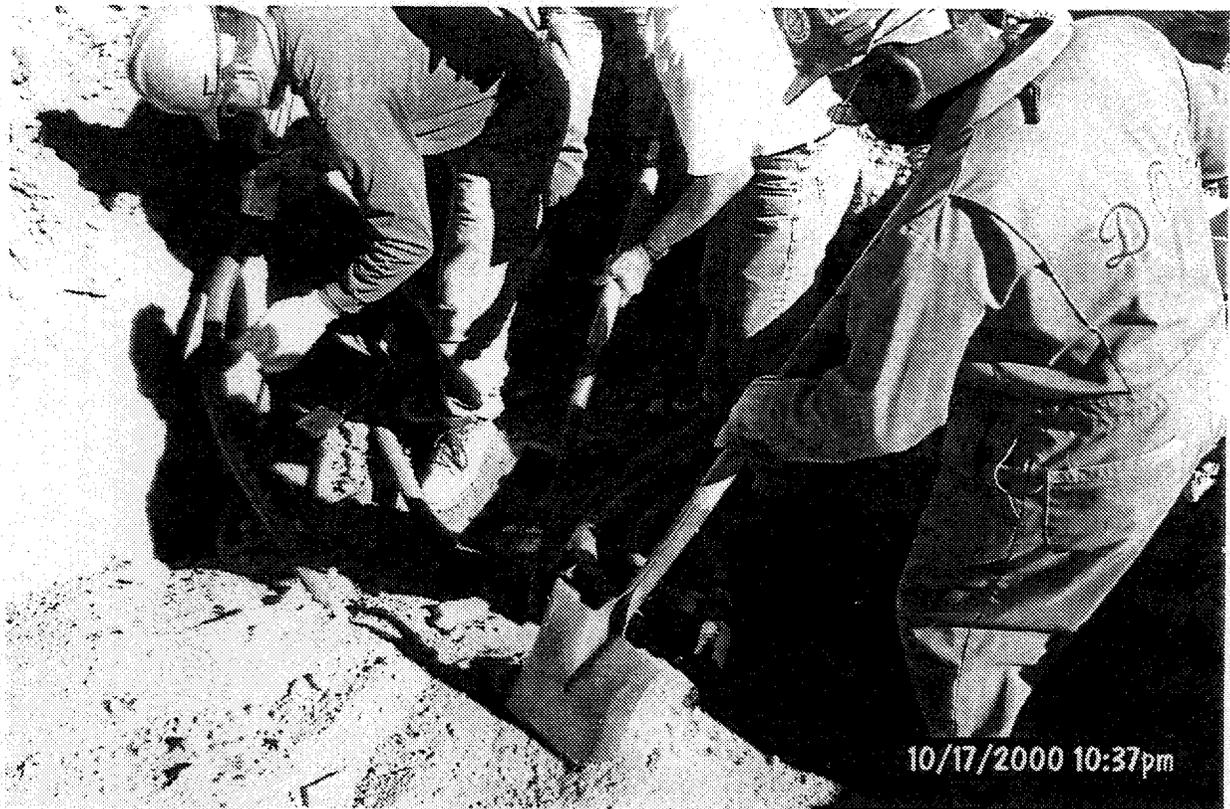
PHOTOGRAPH 22 - Placing and burying TDR sensors in CMP cover

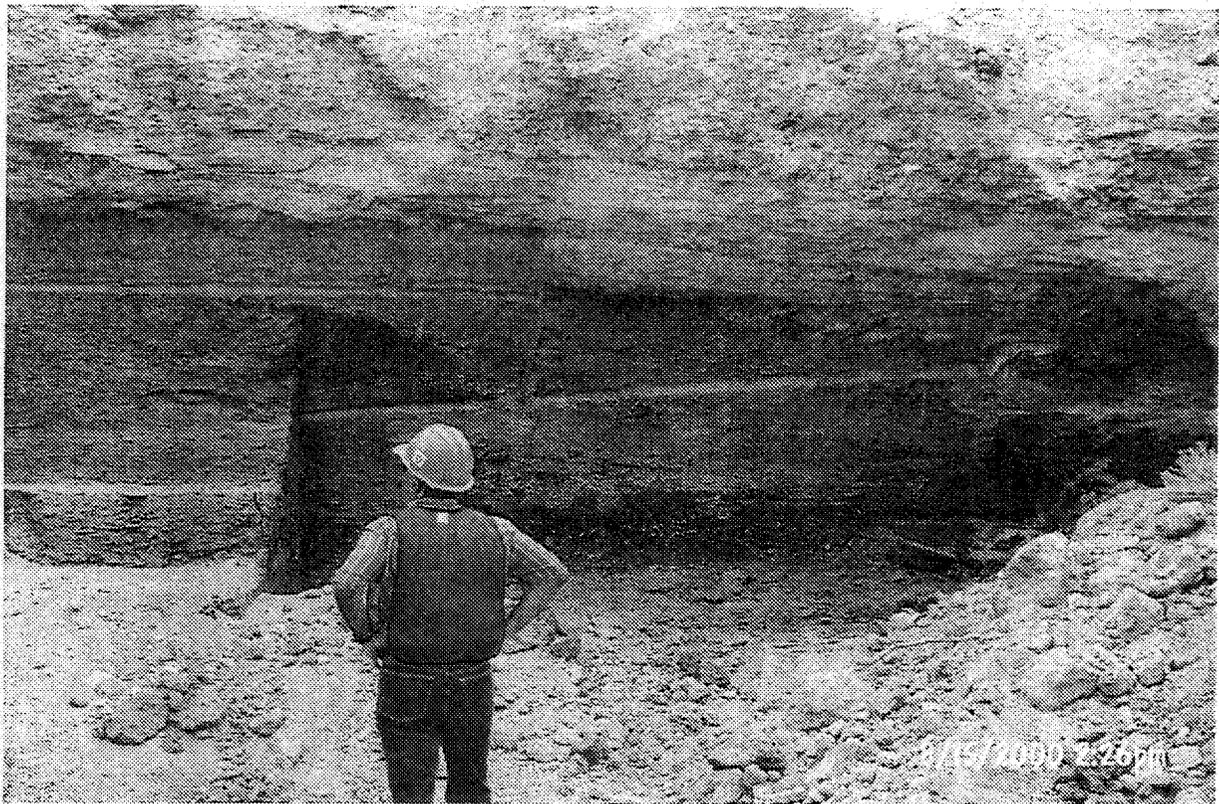
PHOTOGRAPH 30 - Drilling mud/material at UC-4 Area S, CAS 58-10-02

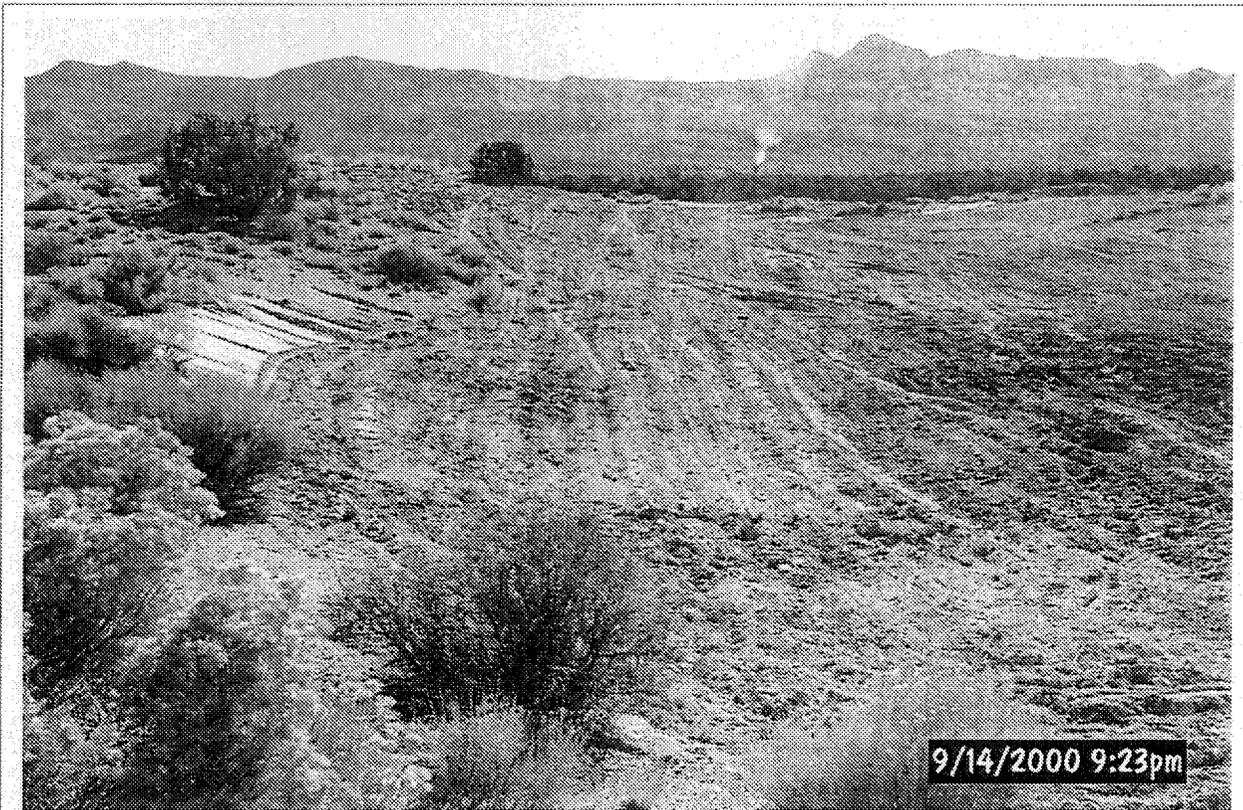
PHOTOGRAPH 31 - Final regraded closed UC-4 Area S, CAS 58-10-02
