2013 Annual Inspection Report for the Grand Junction, Colorado, Site

Summary

The Grand Junction, Colorado, Site was inspected on March 4, 2013, and was in excellent condition. Physical and institutional controls enacted at the site continue to be effective in preventing exposure to contamination remaining on the property. No cause for a follow-up inspection was identified.

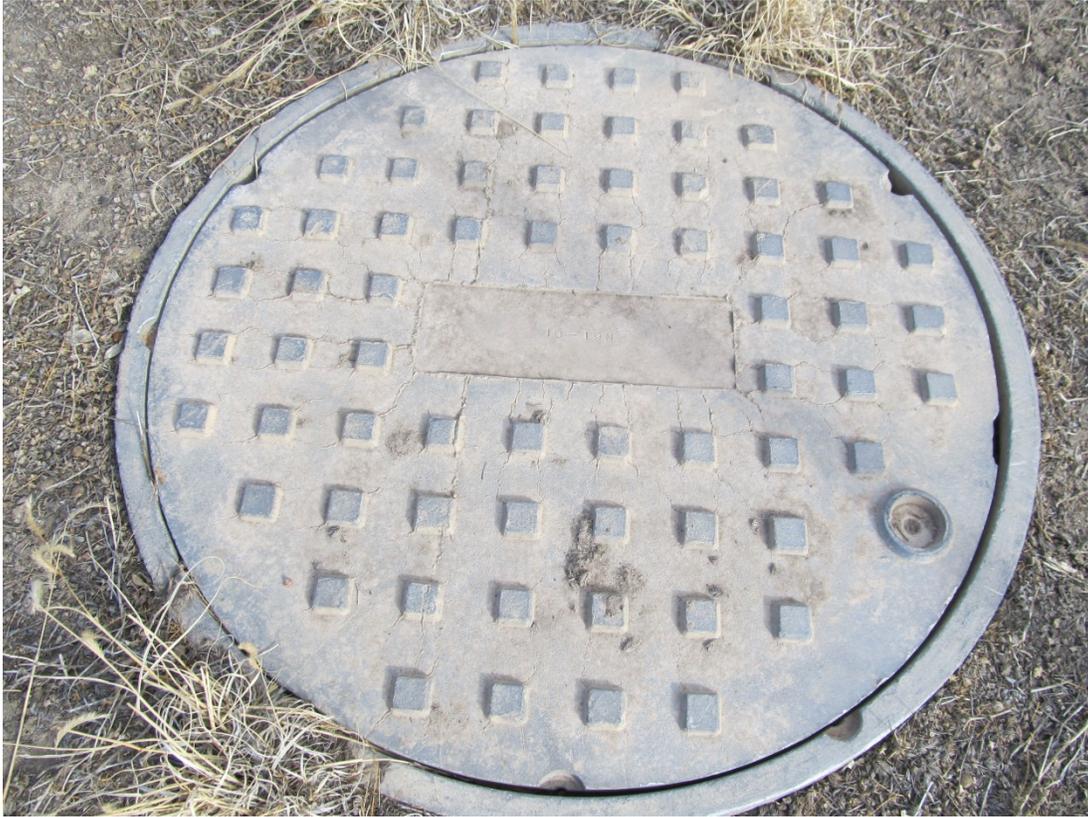
GJO 3/2013. PL-1. Monitoring well 10-19N.

Monitoring Wells—DOE owns eight monitoring wells on the property to monitor the progress of natural flushing of contaminants from the alluvial aquifer. Wells 10–19N, 11–1S, 14–13NA, GJ01–02, and GJ84–04 are flush mounted and protected with standard monitoring well metal caps or manhole covers; well GJ84–04 is also protected by steel bollards (PL–1). Wells 6–2N, 8–4S, and GJ01–01 have above-ground steel well casing protectors; steel bollards are in place as further protection for wells 6–2N and 8–4S (PL–2). The visible portions of all wells were in good condition.

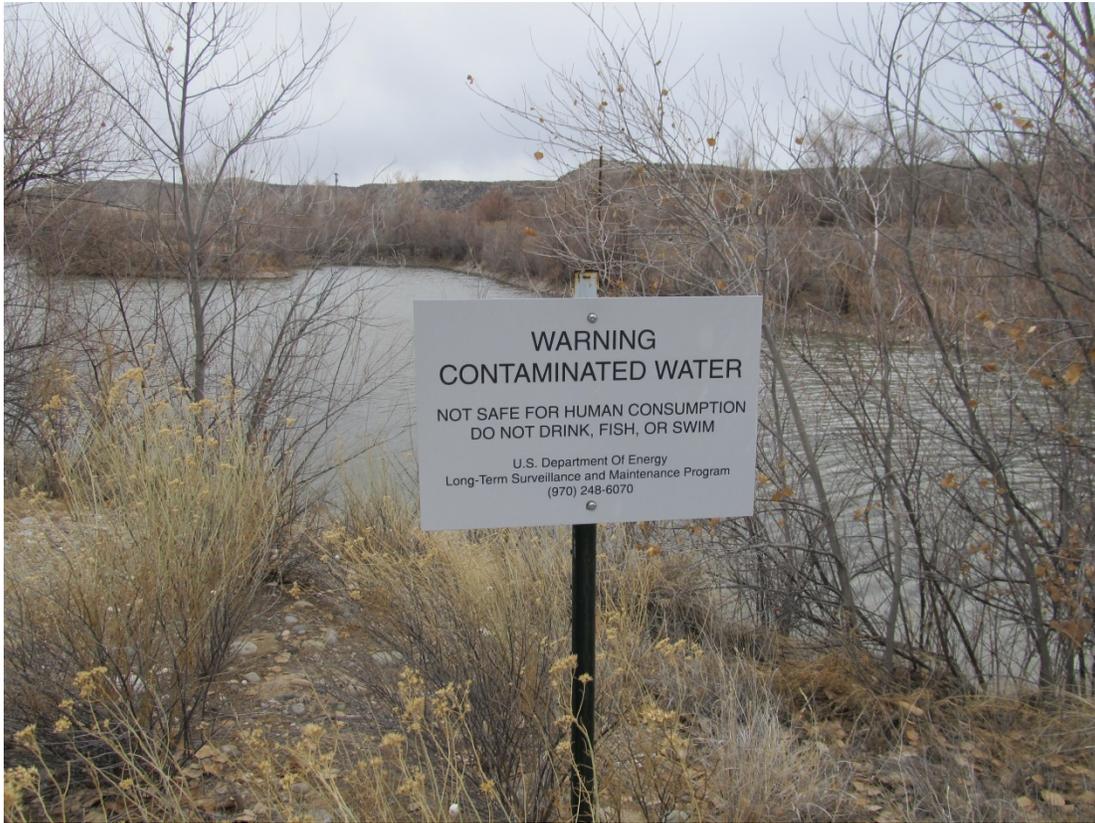
GJO 3/2013. PL-3. South Pond warning sign S5.

Warning Signs—Fifteen warning signs installed on galvanized steel posts are positioned around the surface water areas so the warning will be visible to a person approaching from any direction of reasonable access. All signs were undamaged and legible (PL–3 and PL–4).

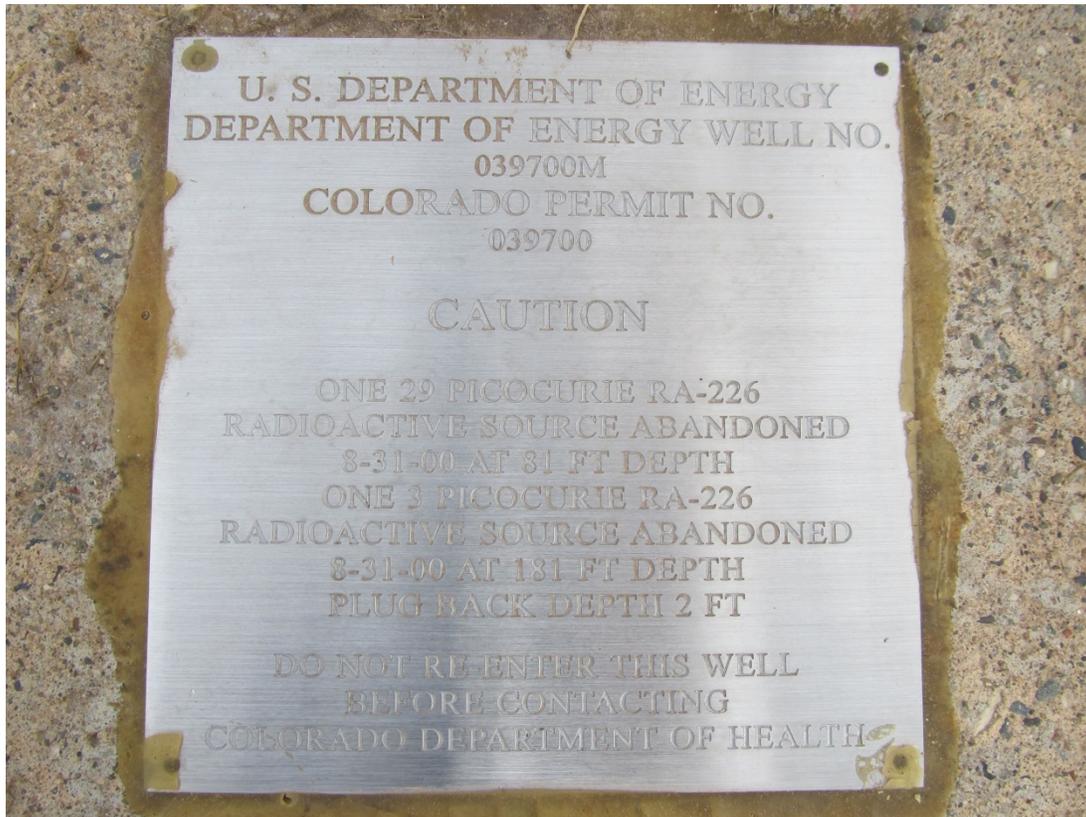
GJO 3/2013. PL-5. Plaque at the decommissioned borehole containing radium foil.

The borehole was decommissioned in place in 2000. DOE perforated the casing above and below each strip of foil and pressure-grouted the annulus with Portland cement to seal the foil in place. The borehole was filled with grout, and a metal plaque was mounted in concrete at ground level over the well. The metal plaque with the borehole information and warning engraved into the metal was in excellent condition (PL-5).

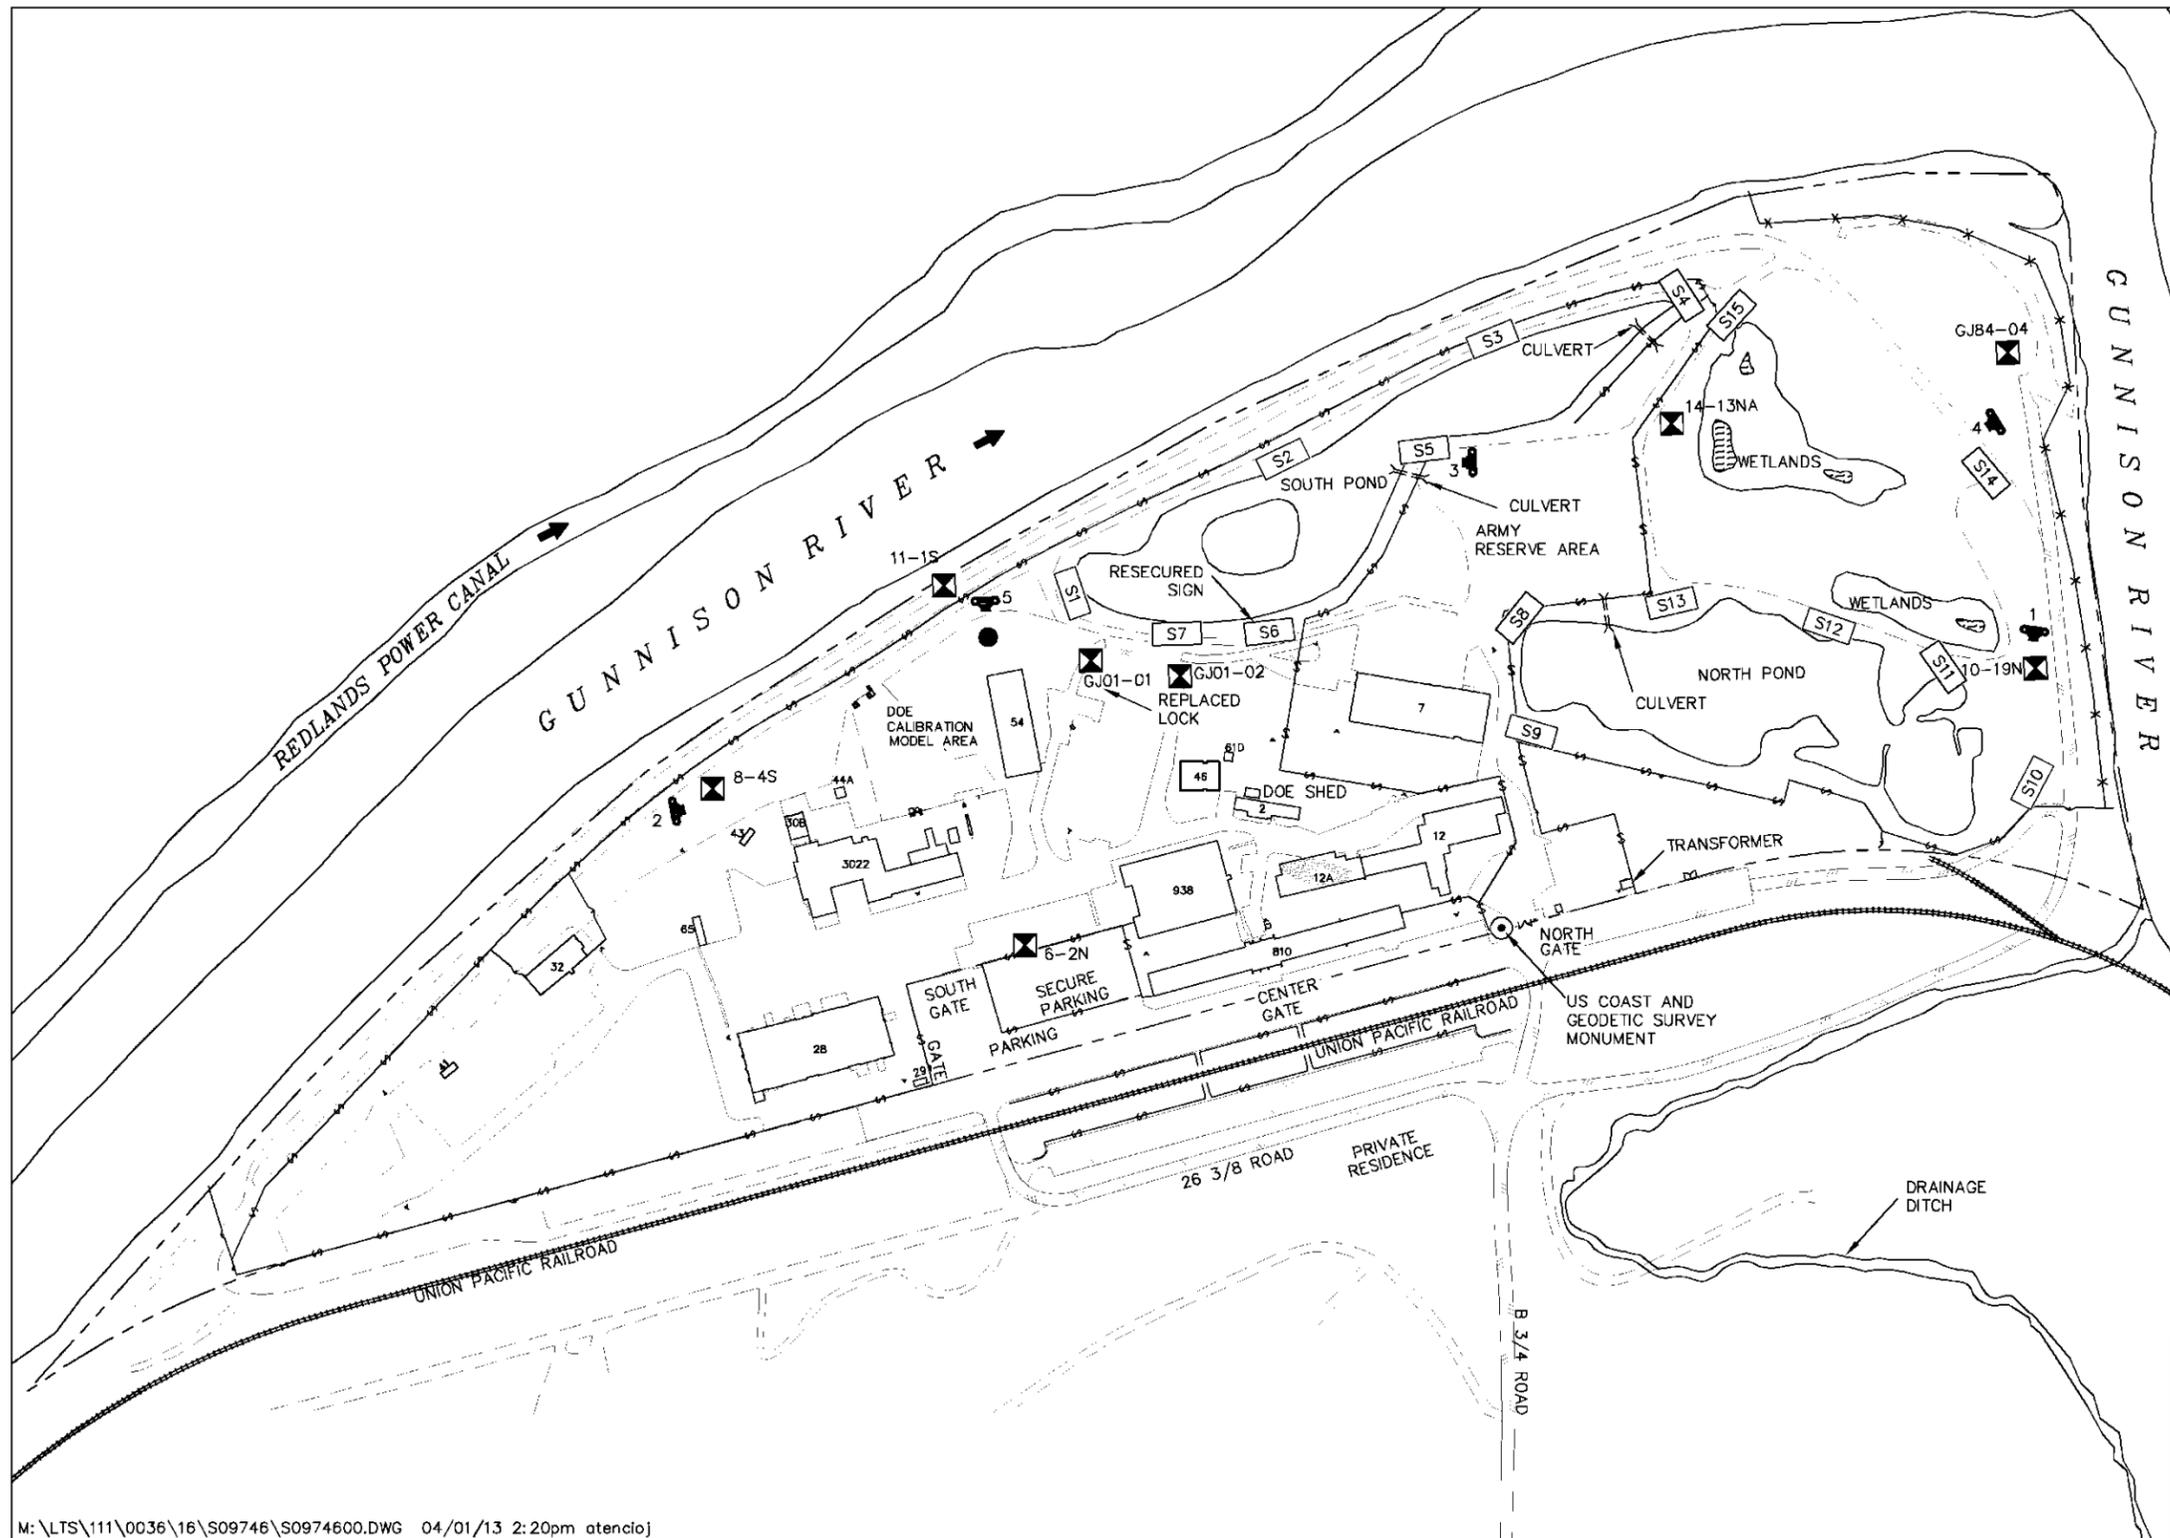
U.S. DEPARTMENT OF ENERGY GRAND JUNCTION, COLORADO	Work Performed by S.M. Staller Corporation Under DOE Contract No. DE-AM01-07LM00060
2013 ANNUAL INSPECTION DRAWING GRAND JUNCTION SITE GRAND JUNCTION, COLORADO	
DATE PREPARED: APRIL 1, 2013	FILENAME: S0974600

The annual inspection addresses only those portions of the site that must be monitored and maintained to ensure continued protection of human health and the environment. Those portions are related to contaminated media that remain at the site. Features discussed in this report are shown on the attached drawing. Photographs to support specific observations are identified in the text and on the drawing by photograph location (PL) numbers.
