Annual Inspection of the Grand Junction, Colorado, Site

1.1 Inspection Summary

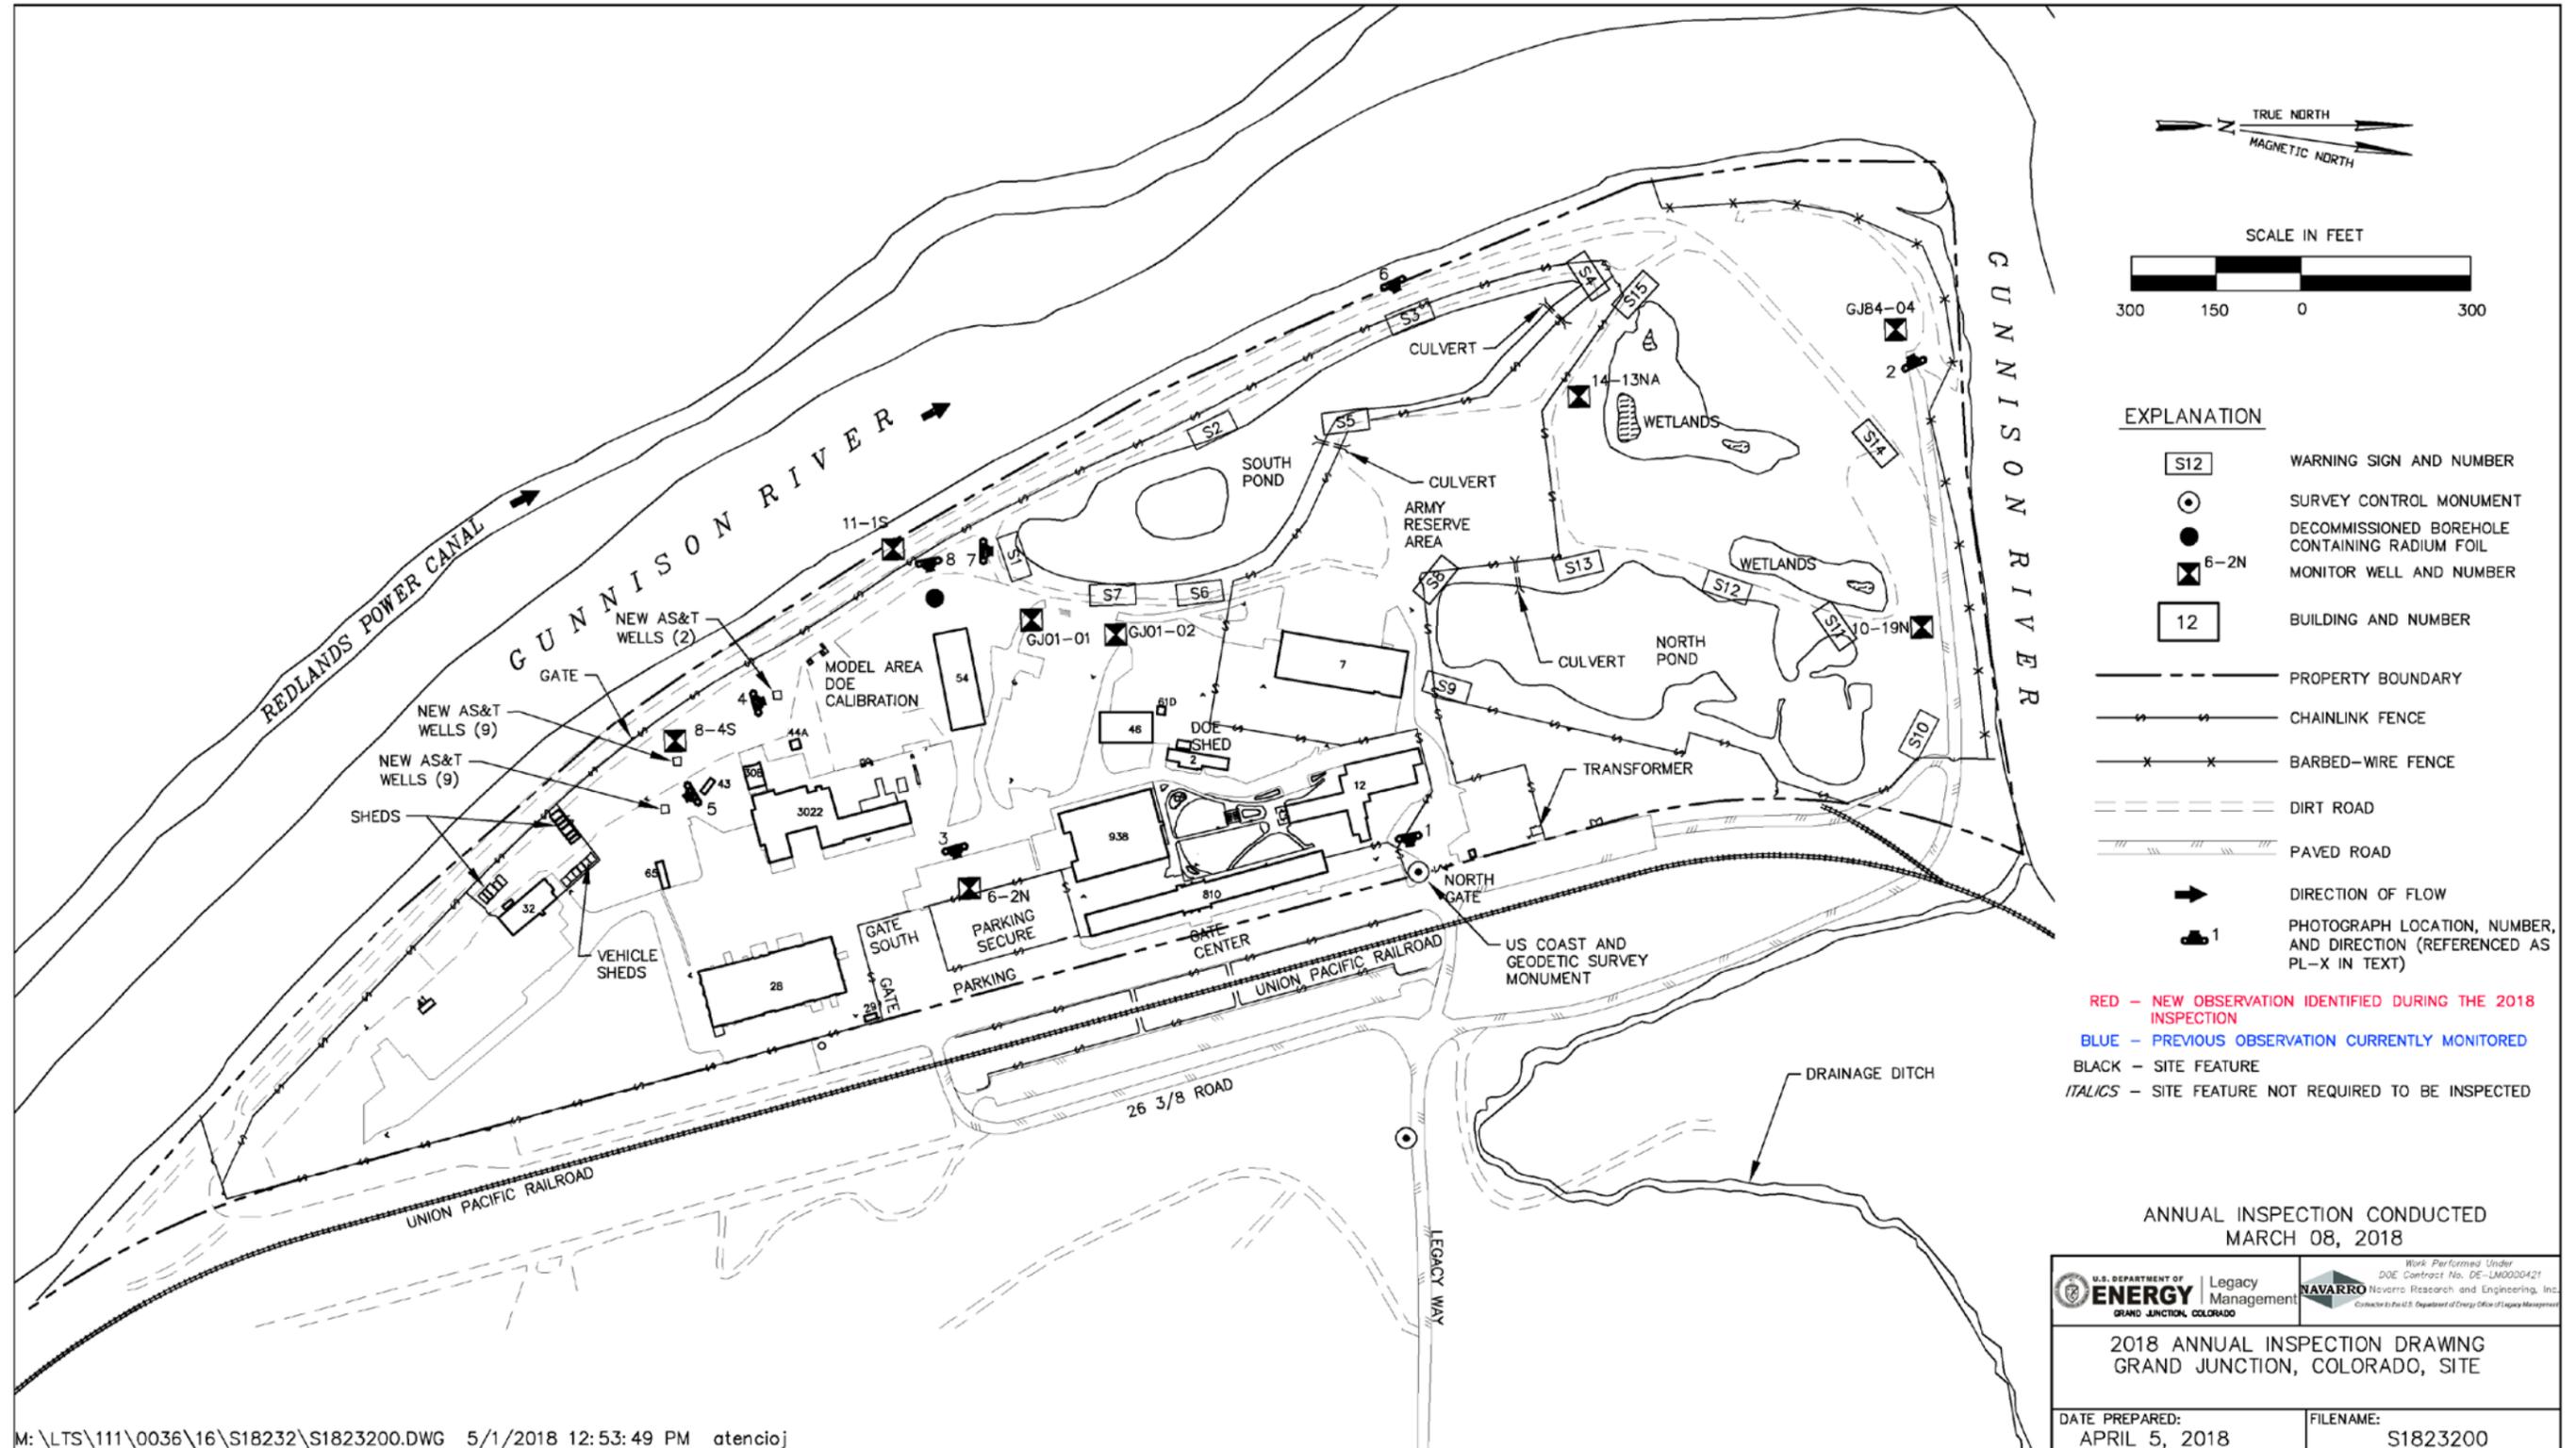
Figure 1. 2018 Annual Inspection Drawing for the Grand Junction, Colorado, Site

Figure 1 shows the locations of site surveillance features. Inspection results and recommended maintenance activities associated with site surveillance features are included in the following subsections.

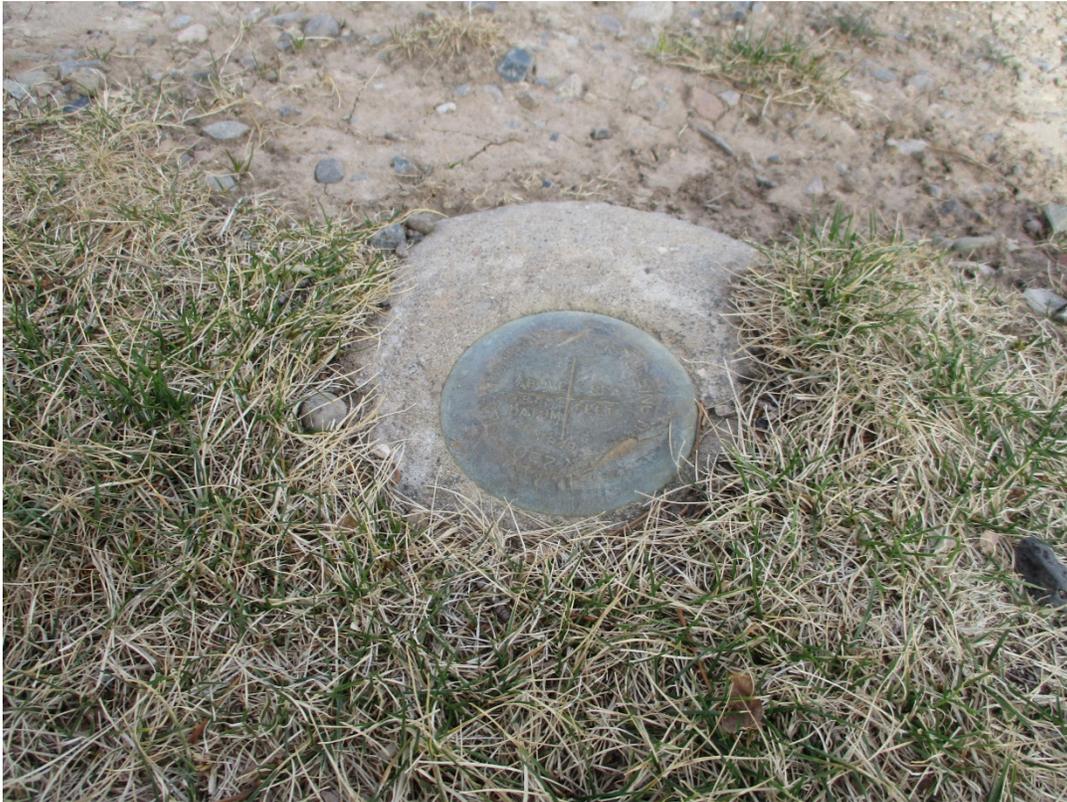
A U.S. Coast and Geodetic Survey monument near the former north gate establishes elevation control for the site (PL-1).

PL-1. U.S. Coast and Geodetic Survey Monument

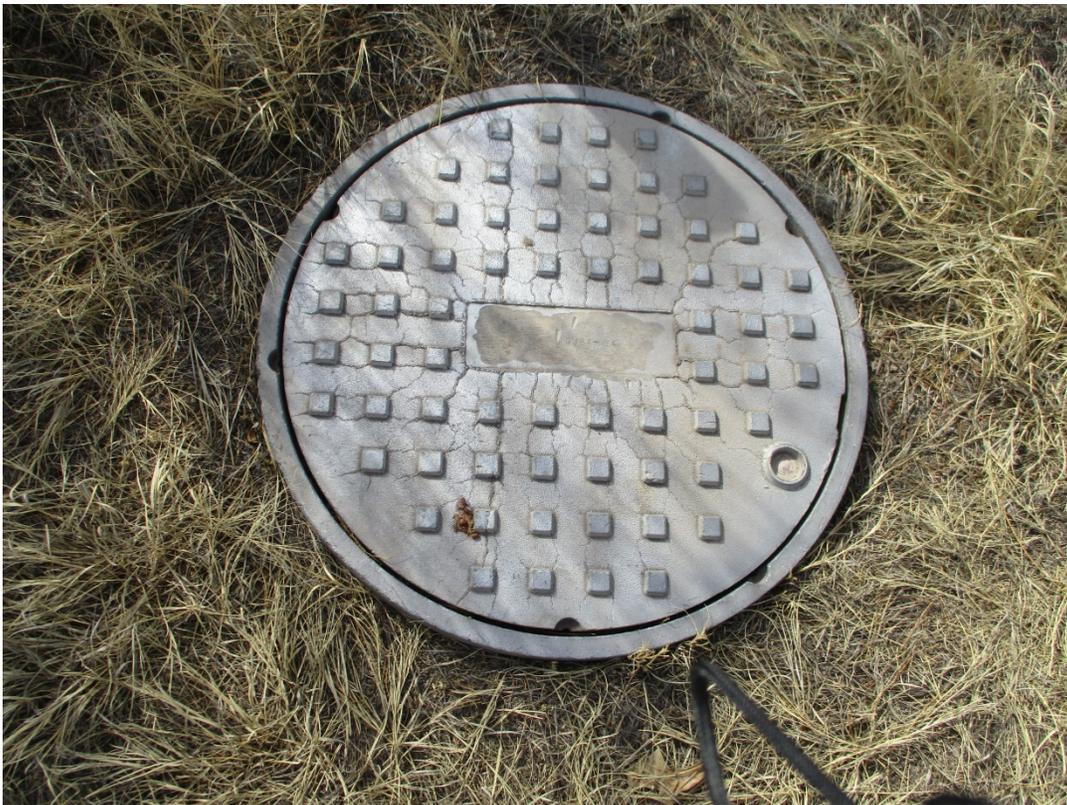
DOE owns eight monitoring wells on the property that are used to monitor the progress of natural flushing of contaminants from the alluvial aquifer. Wells 10-19N, 11-1S, 14-13NA, GJ01-02, and GJ84-04 (PL-2) are flush mounted and protected with standard monitoring well metal caps or manhole covers; well GJ84-04 is also protected by steel bollards. Wells 6-2N (PL-3), 8-4S, and GJ01-01 have aboveground steel well casing protectors; steel bollards are in place as further protection for wells 6-2N and 8-4S. Twenty additional monitoring wells were recently installed as part of a tracer project in association with the Applied Studies and Technology (AS&T) group. These wells were inspected, and no issues were identified (PL-4 and PL-5). No maintenance needs were identified.

PL-2. Monitoring Well GJ84-04

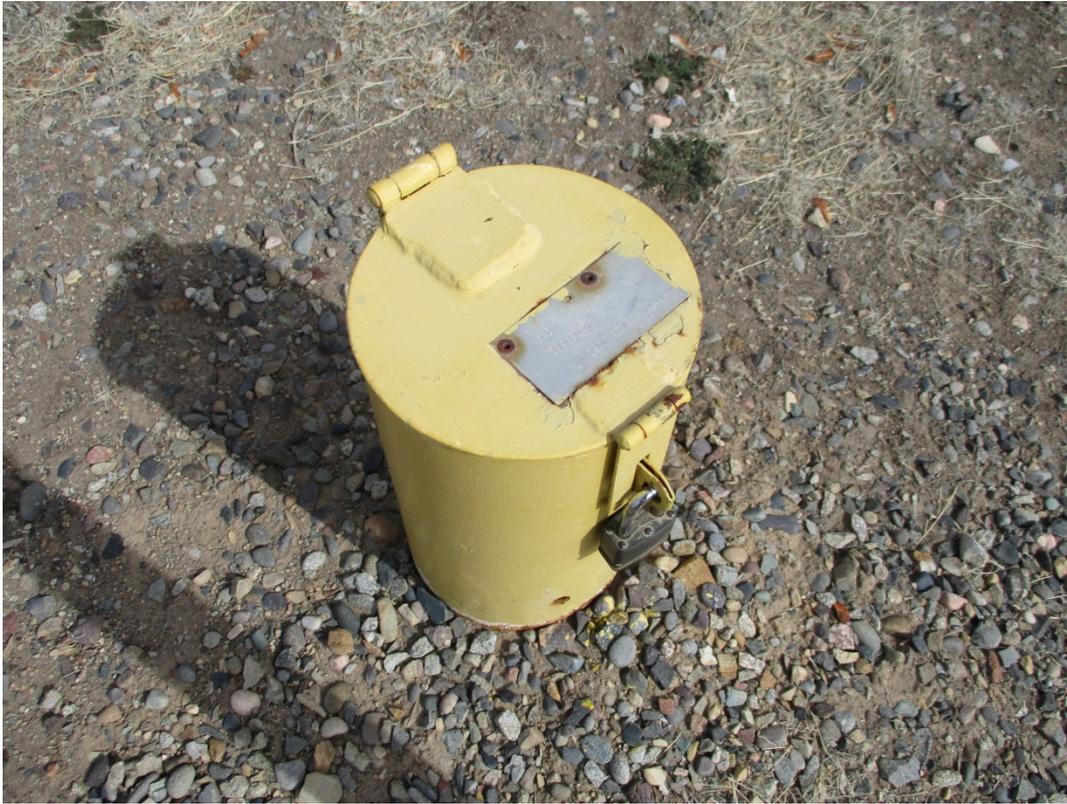
PL-3. Monitoring Well 6-2N

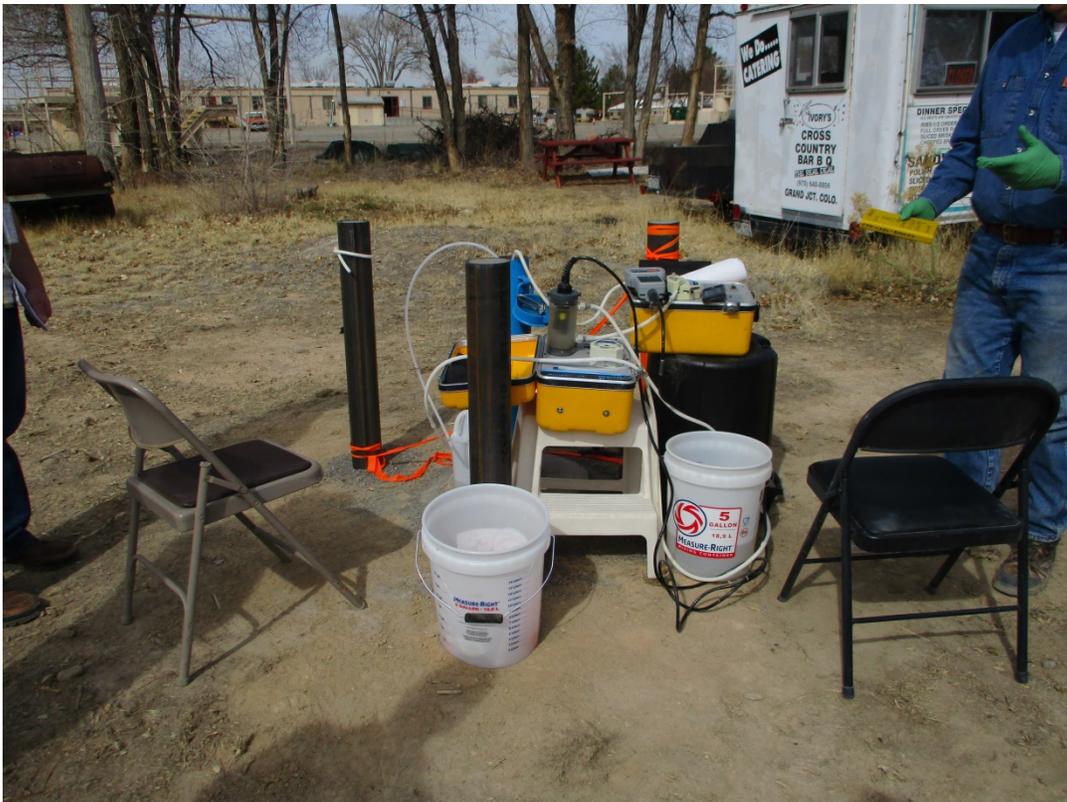
PL-4. Monitoring Wells Associated with AS&T Tracer Project

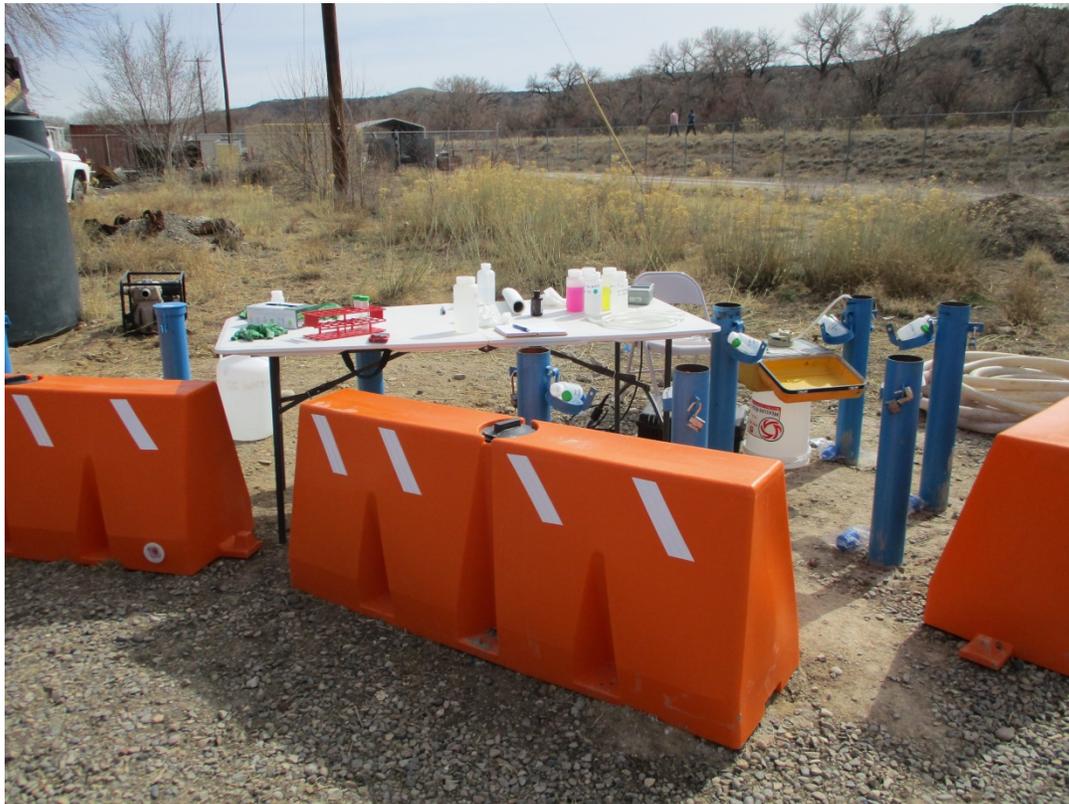
PL-5. Monitoring Wells Associated with AS&T Tracer Project

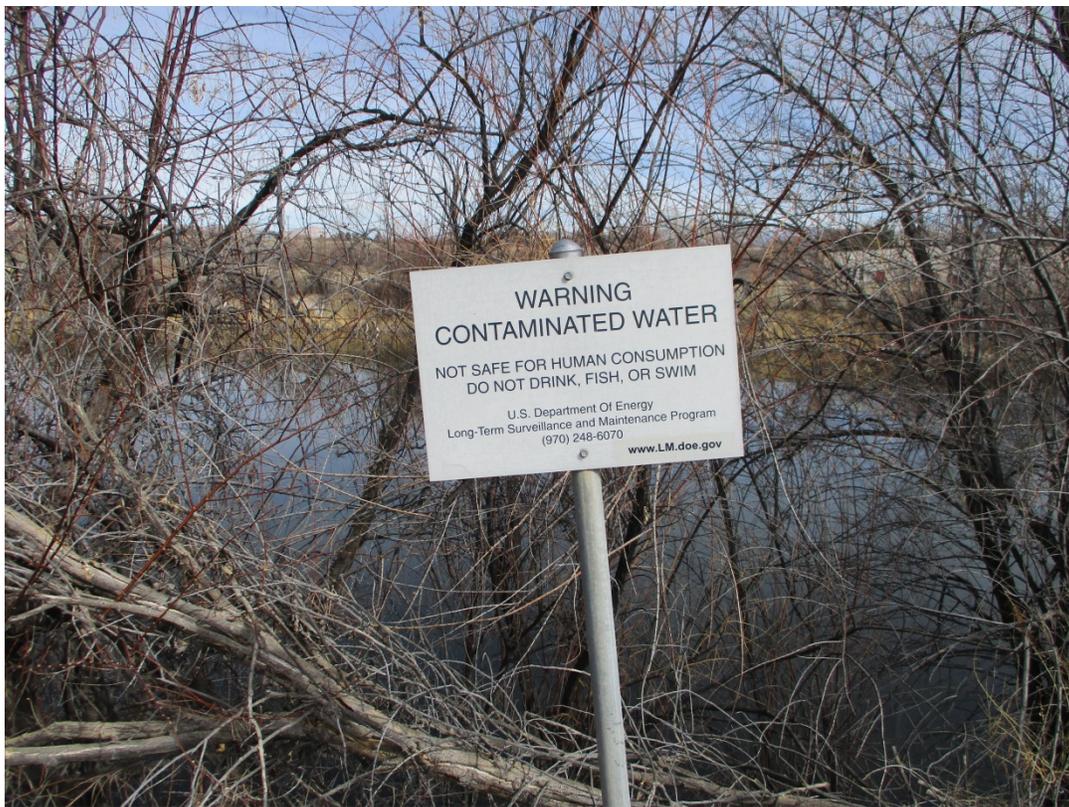
Fifteen warning signs installed on galvanized steel posts are positioned around the surface water areas so the warning will be visible to a person approaching from any direction of reasonable access. All signs were undamaged and legible (PL-6 and PL-7).

PL-6. Warning Sign S3

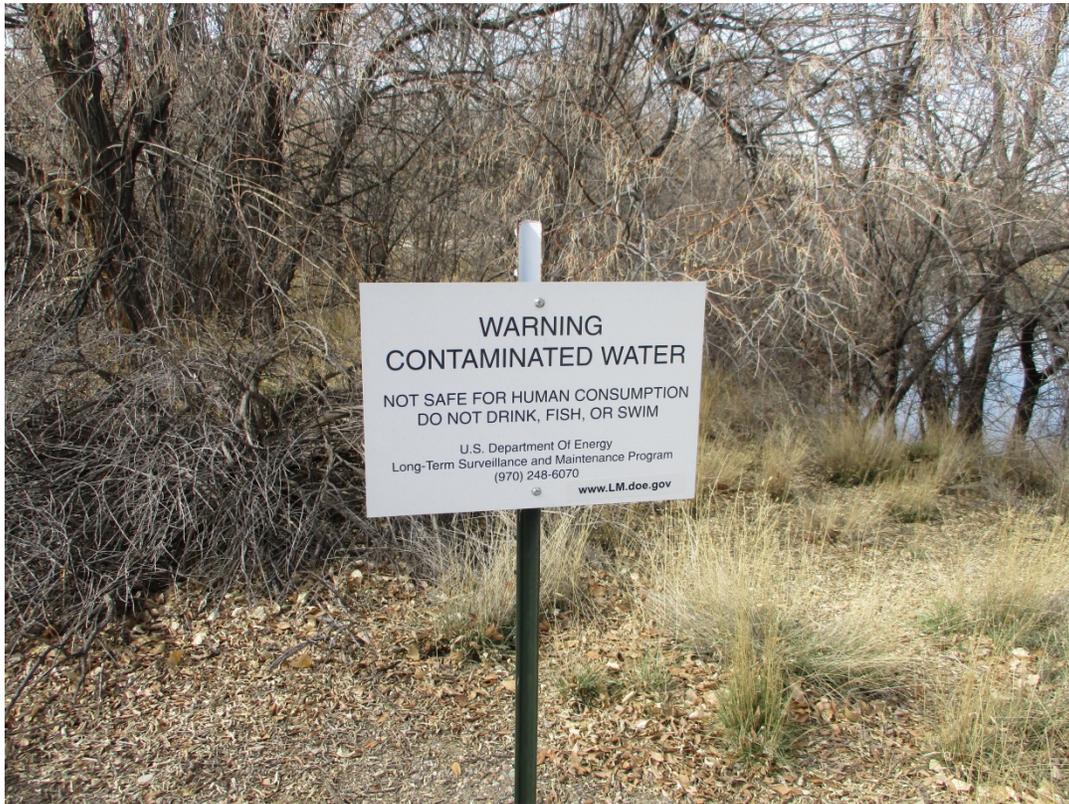
PL-7. Warning Sign S1

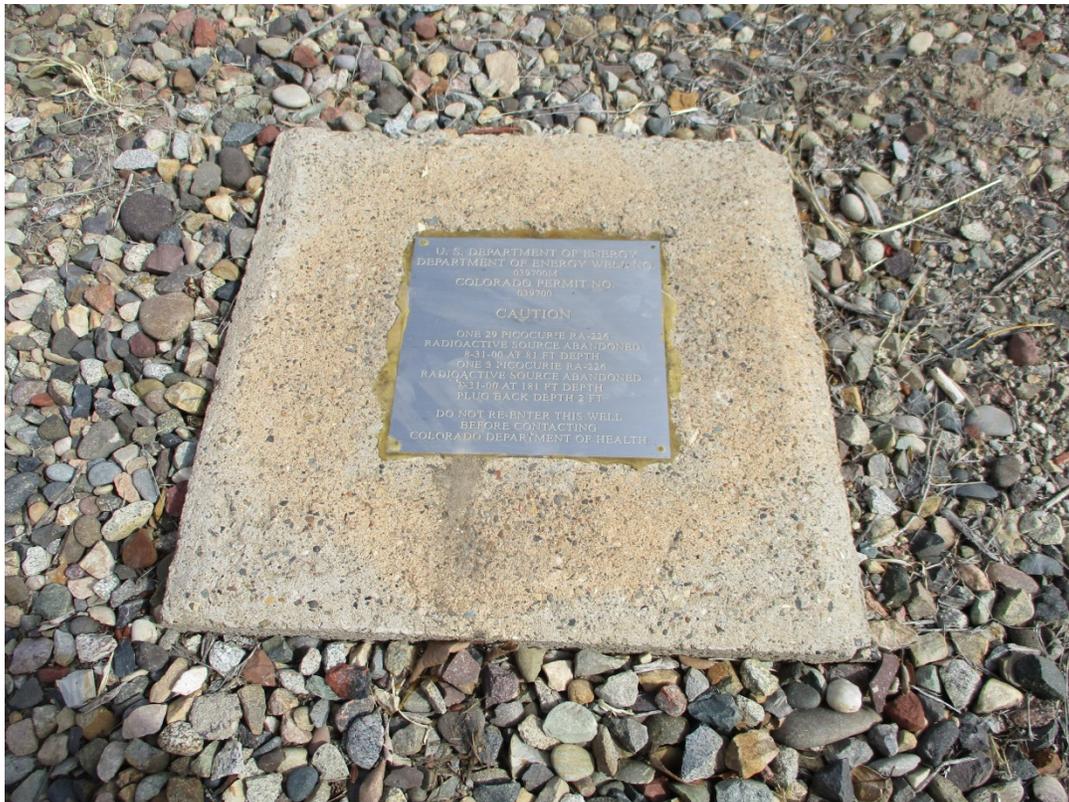
In the 1980s, DOE installed a 300-foot-deep cased borehole to calibrate depth measurement systems on borehole geophysical logging trucks. Two strips of radium-226 foil were placed around the casing at depths of 81 feet (29 picocuries activity) and 181 feet (3 picocuries activity). During calibration, the instruments in the trucks would detect the gamma radiation signal from the radium.

The borehole was decommissioned in place in 2000. DOE perforated the casing above and below each strip of foil and pressure-grouted the annulus with Portland cement to seal the foil in place. The borehole was filled with grout, and a metal plaque was mounted in concrete at ground level over the well. The metal plaque includes the borehole information and an engraved warning (PL-8). No maintenance needs were identified.

PL-8. Plaque at Decommissioned Borehole Containing Radium Foil
