**Annual Assessment of the
Effectiveness of
Site-Wide Institutional Controls
Applied to the Former
DOE Mound Site Property**

June 2010

Legacy
Management

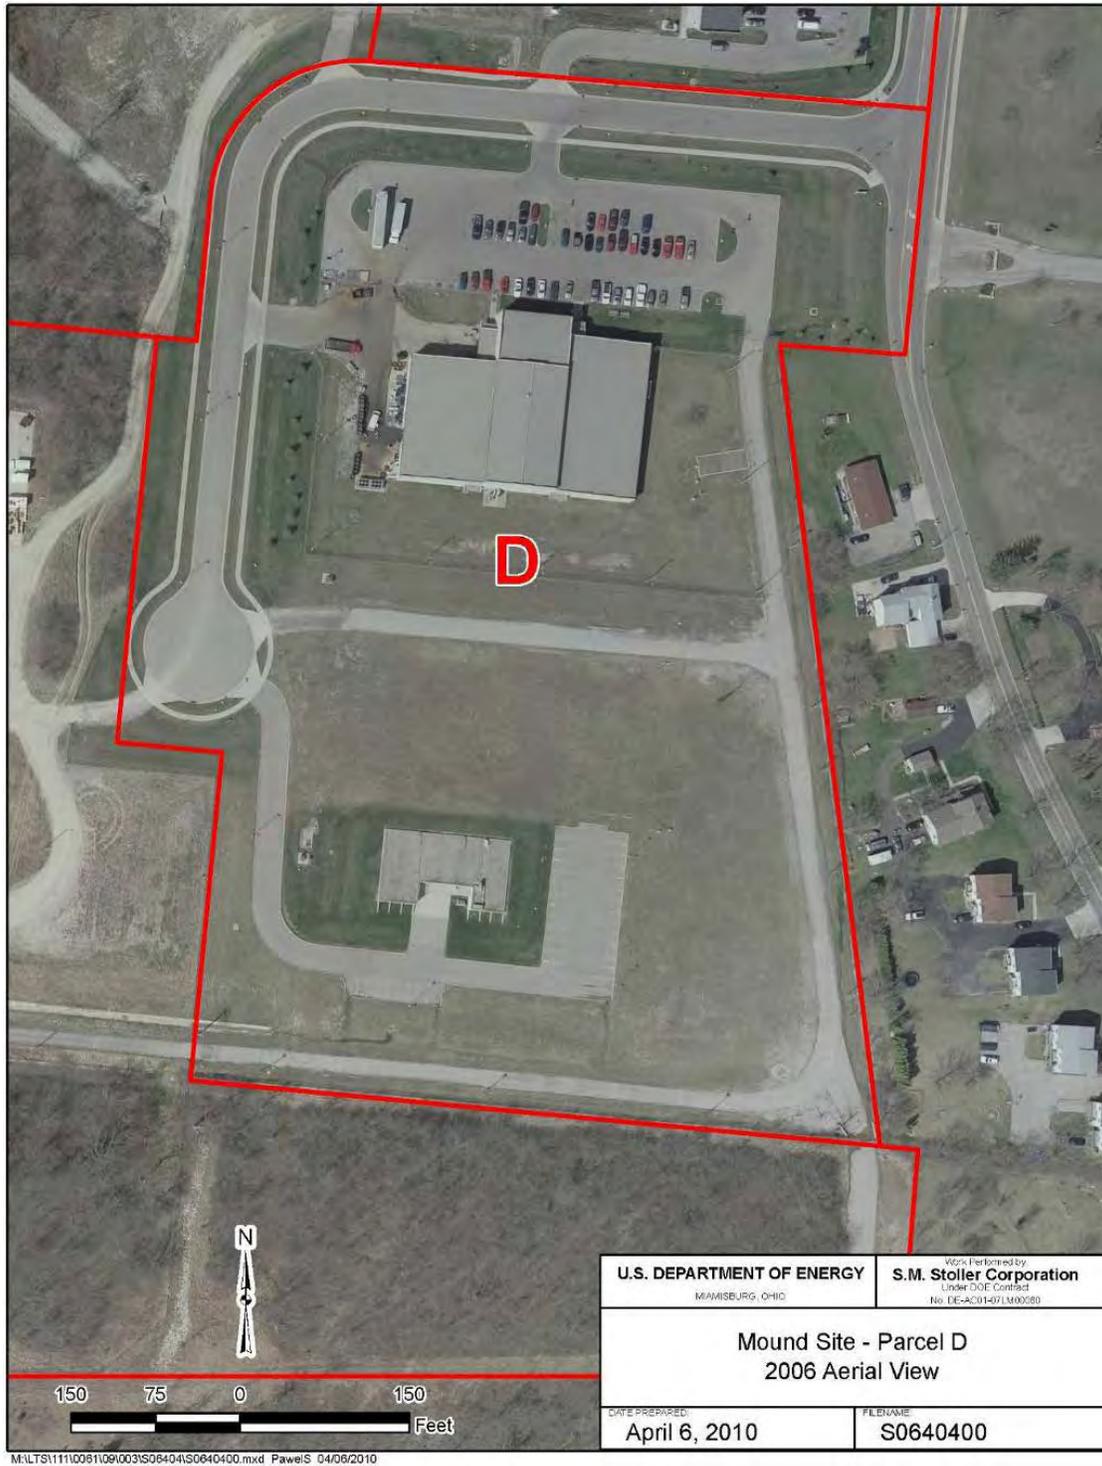
Figure 3. Parcel D 2006 Aerial View

In Parcel D (Figure 3), there were no observations of noncompliance with the ICs. In particular, there was no evidence of unauthorized well installation or soil removal from the original boundaries of the DOE Mound Site Property.

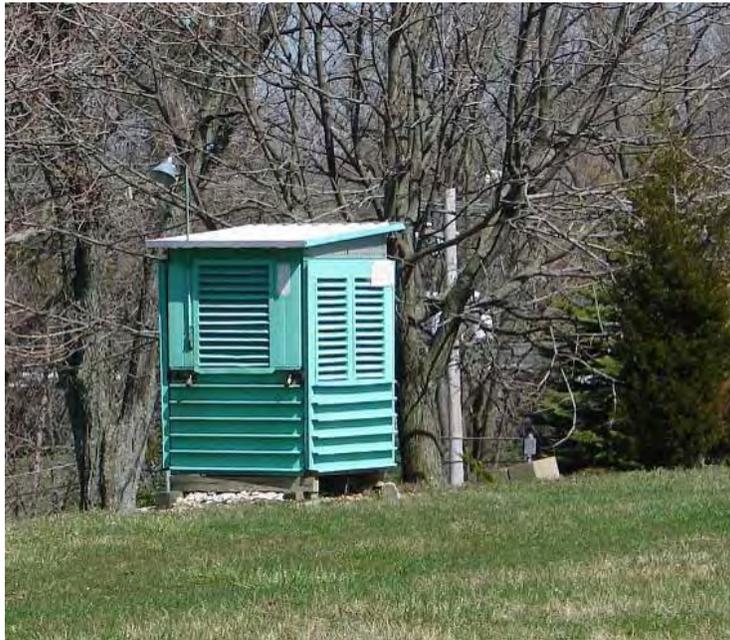
Although air monitoring is not part of the CERCLA remedy for any parcel covered by this assessment, DOE continues to use site air monitoring stations. One station is on the northeast corner of Parcel H (Figure 4). DOE will continue to operate its Mound Site air monitoring stations until the National Emission Standards for Hazardous Air Pollutants (NESHAPs) requirements are met after Operable Unit (OU)-1 work is completed.

Figure 4. Parcel H DOE Air Monitor

Origin	Issue/ Recommendation	Status 2009 Report	Corrected?	Current Status 2010 Report
1	2007 Annual	Determine when OEPA removes air monitoring station in Parcel H.	OEPA was working with EM to dispose of their air monitoring stations on site.	Yes	Removed on May 28, 2009
2	2008 Annual	Landowner or management organization will notify LM when there are changes of address or street names on site. Building permits are filed by street addresses.	No process	No	No process
3	2009 Annual	Confirm that the aRc well was abandoned correctly and removed from the ODNR website.	New	Yes	Obtained written confirmation that the well was properly abandoned, and the <i>Water Well Sealing Report</i> was submitted to ODNR. ODNR keeps wells on its website.
4	2009 Annual	Improve drainage in the area north of Well 0353	New	No	Will revisit this issue when the OU-1 excavation has been completed in the area of the well.

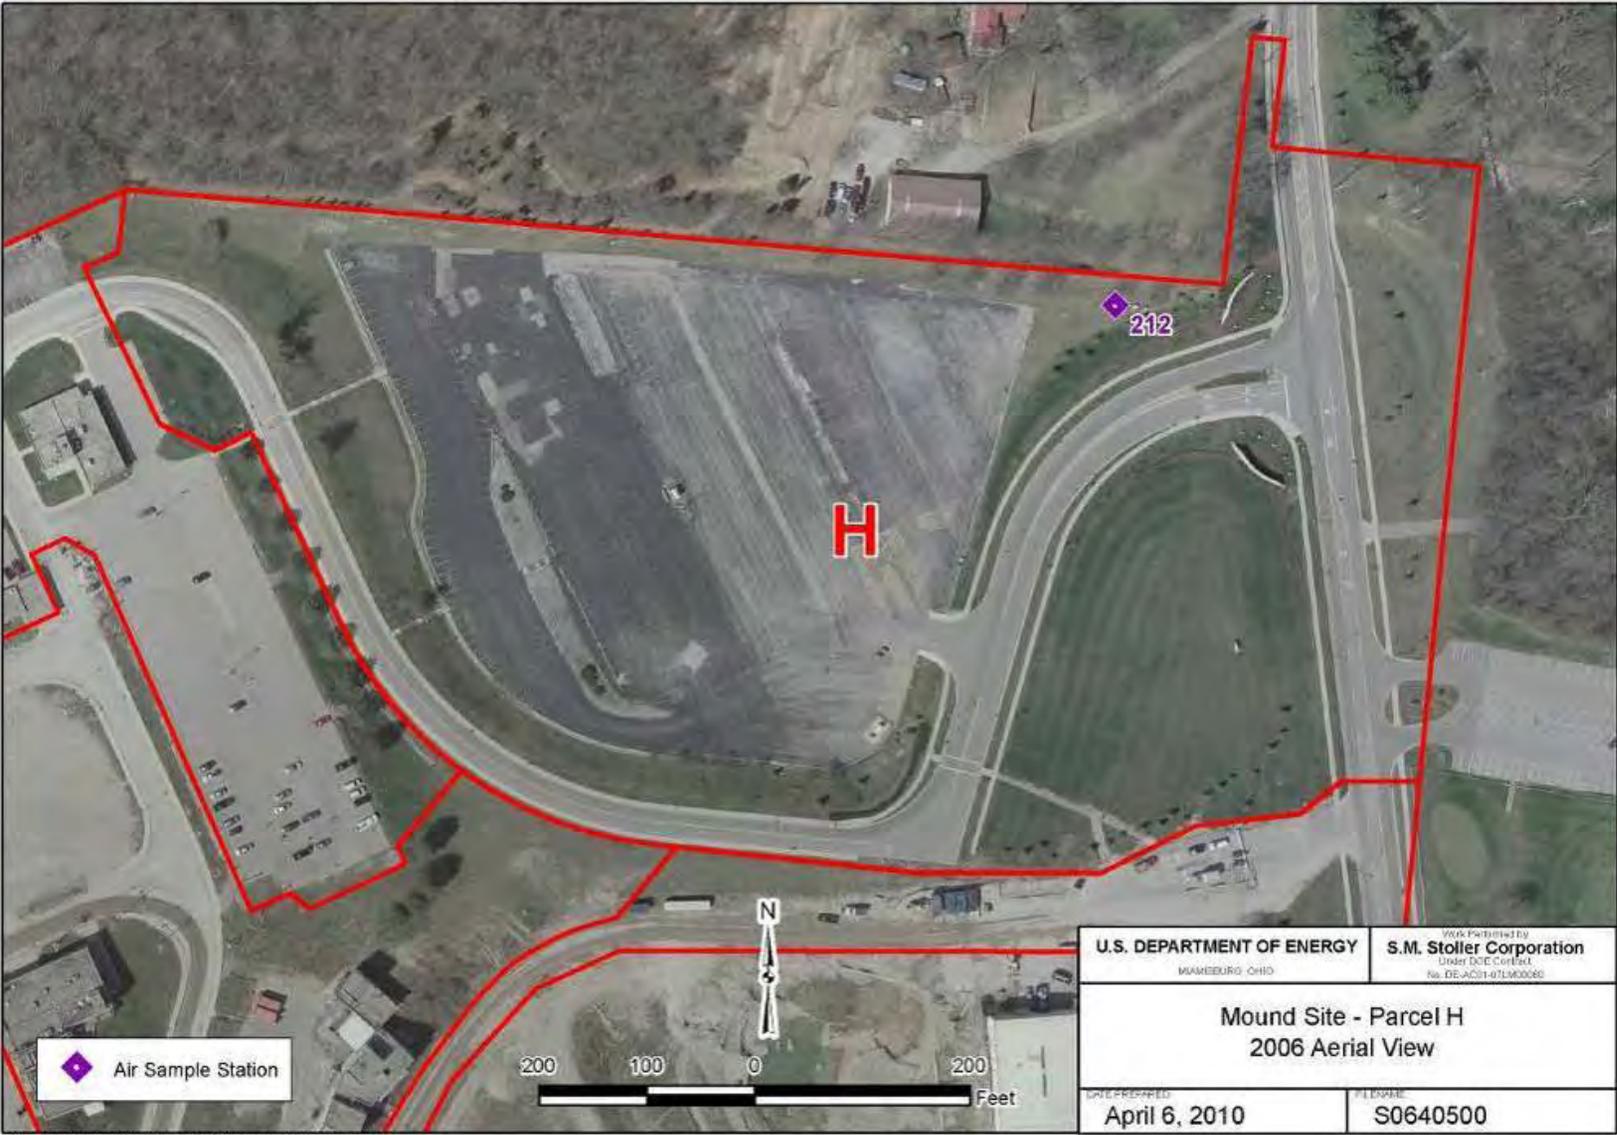
Figure 5. Parcel H 2006 Aerial View

Figure 5 was formerly called Release Block H. There were no observations of noncompliance with the ICs. In particular, there was no evidence of unauthorized well installation or soil removal within the original boundaries of the DOE Mound Site Property.

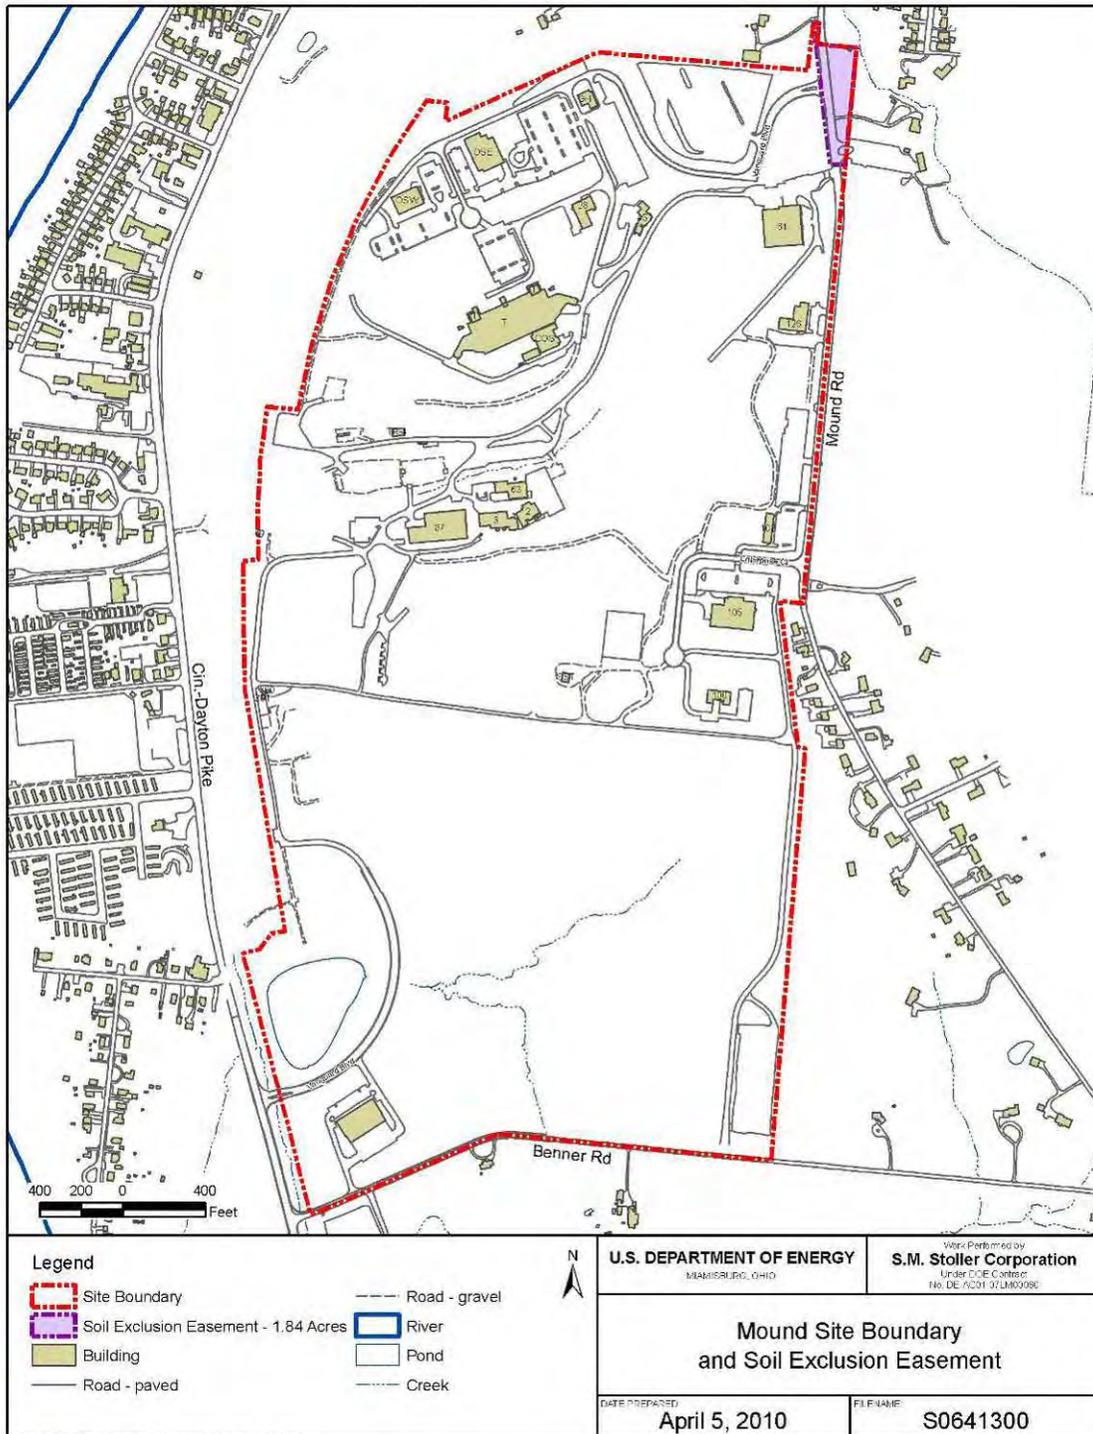
One area of Parcel H is exempt from the soil removal restriction (Figure 6). Modifications to the entry and the rerouting of Mound Road isolated this area from the original Mound property.

Figure 6. Parcel H Soil Removal Exclusion Area

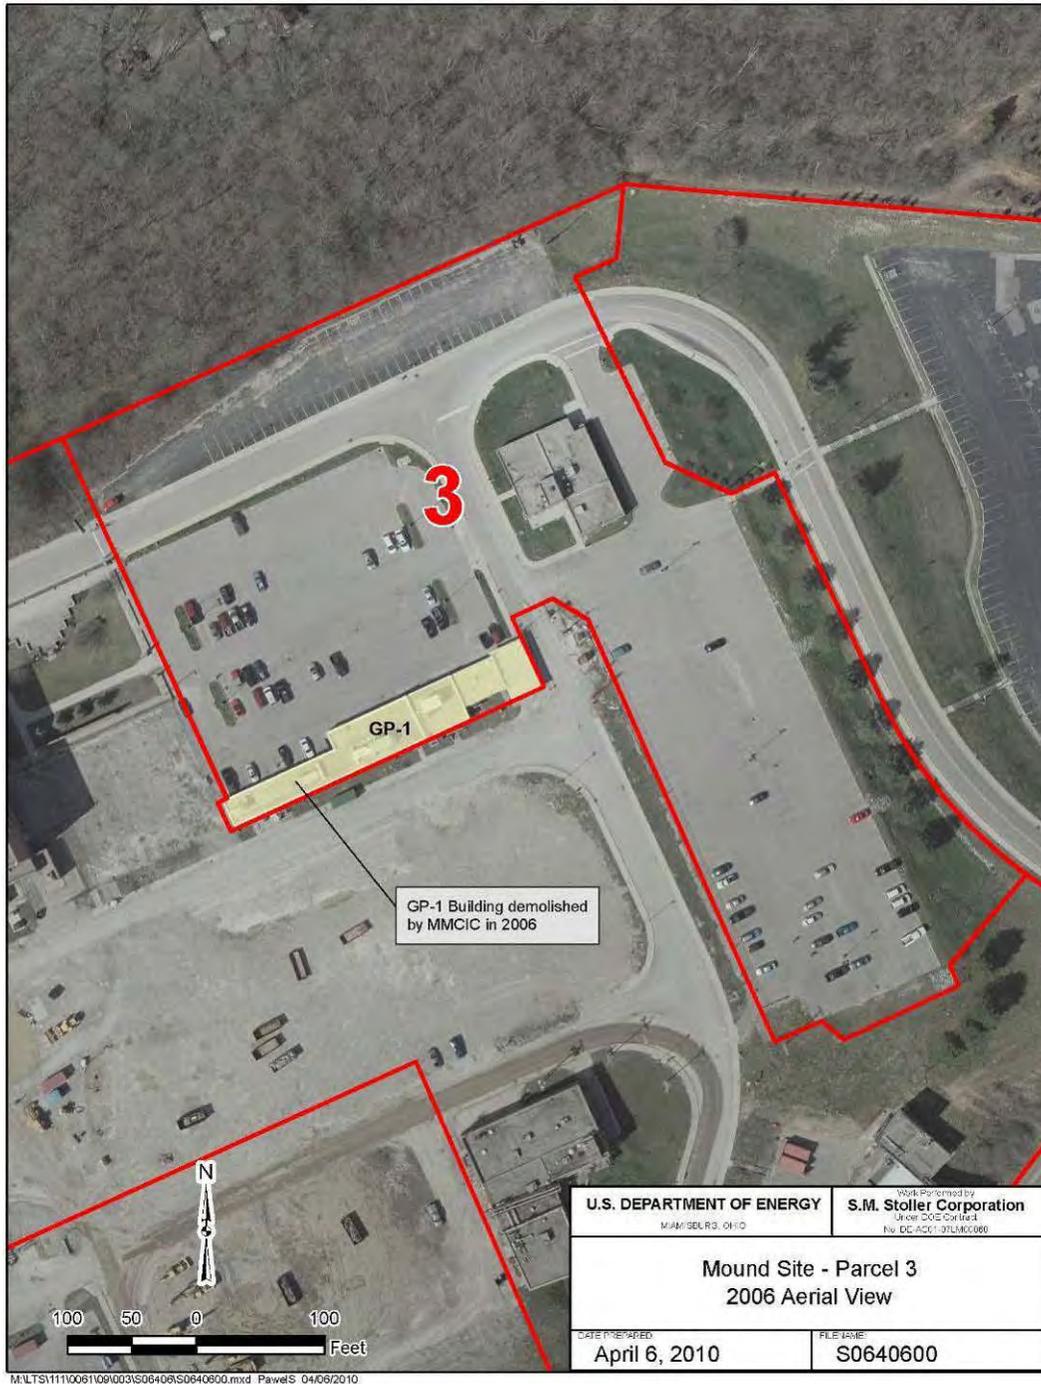
Figure 7. Parcel 3 2006 Aerial View

In Parcel 3 (Figure 7), there were no observations of noncompliance with the ICs. In particular, there was no evidence of unauthorized well installation or soil removal within the original boundaries of the DOE Mound Site Property. There are no groundwater monitoring wells in Parcel 3.

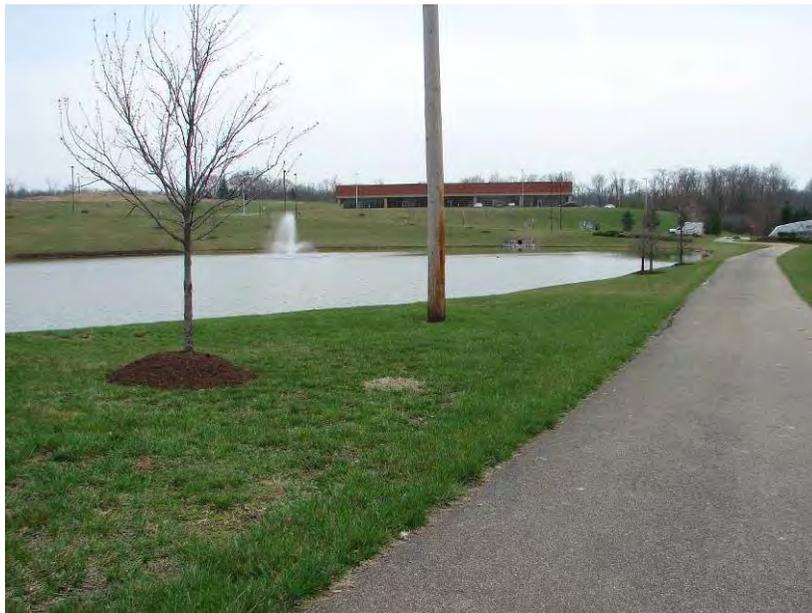
There is a pond for retaining and detaining storm-water runoff in the southwest part of Parcel 4 (Figure 11). One sign, which states, “Recreational Use Prohibited,” was observed. These signs were damaged and replaced before each of the 2008, 2009, and 2010 annual inspections.

Figure 11. Parcel 4 Retention Pond and Flex Building with Bike Path at Right

Number	Issue/Recommendation	Responsible
1	Improve marking labels at seeps.	Stoller
2	Paint Well 0124 in old canal area.	Stoller
3	Remove water sampling station and fencing over Seep 0607, and return area to its original condition.	Stoller
4	Insure that that signs by pond in Parcel 4 are present at all times.	MMCIC

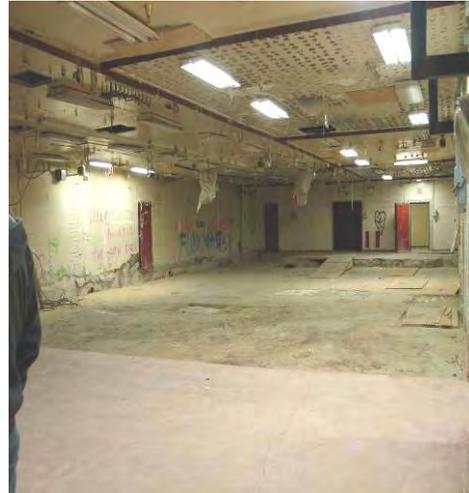
The physical inspection included property and buildings and the areas within T Building with special ICs (Figure 15, Figure 16, and Figure 17). These ICs prohibit penetration in some areas, and removal of concrete flooring in others, without prior approval by the regulators. Figure 18 indicates these areas. Photos of each room are included in Appendix D.

Figure 16. Looking West Toward One of the T Building Areas Where Removal of Concrete Floor is Prohibited without Prior Approval

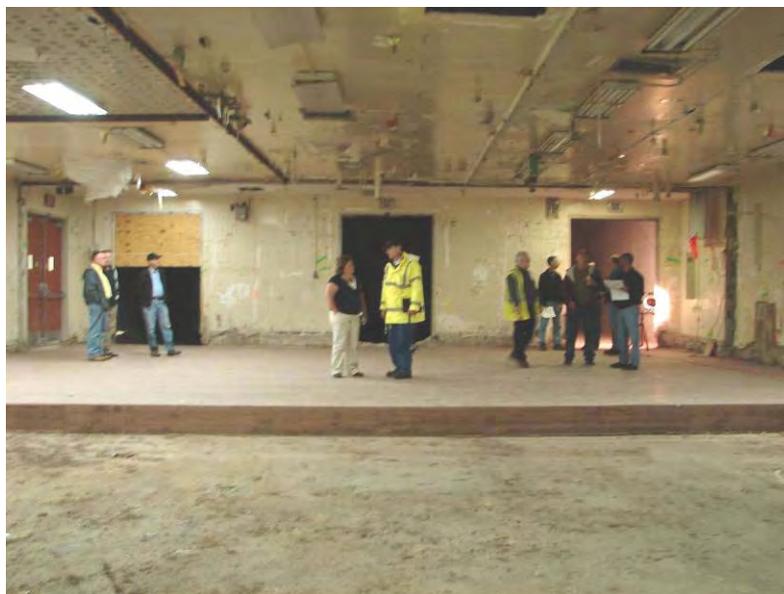
Figure 17. Looking East Toward Inspection Participants Standing on T Building Red Concrete Where Penetration is Prohibited without Prior Approval

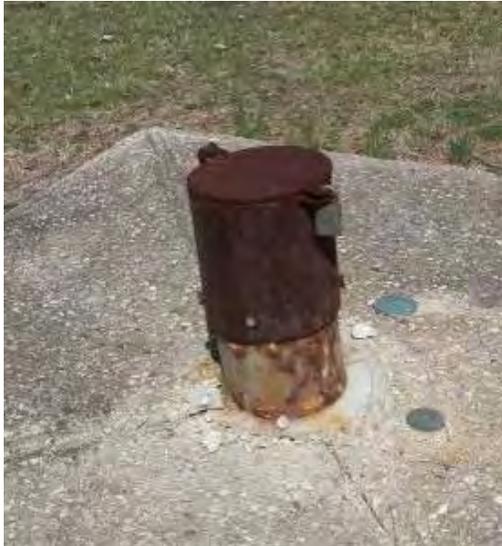
Figure 20. Well 0124

Several things were observed during the physical inspection of Parcel 6, 7, and 8 wells and seeps. First, Well 0124 was rusty and needed painting (Figure 20). Second, the seeps were marked with unsubstantial pink plastic flags with faded numbers (Figure 21). It is recommended that a sturdier marker be used.

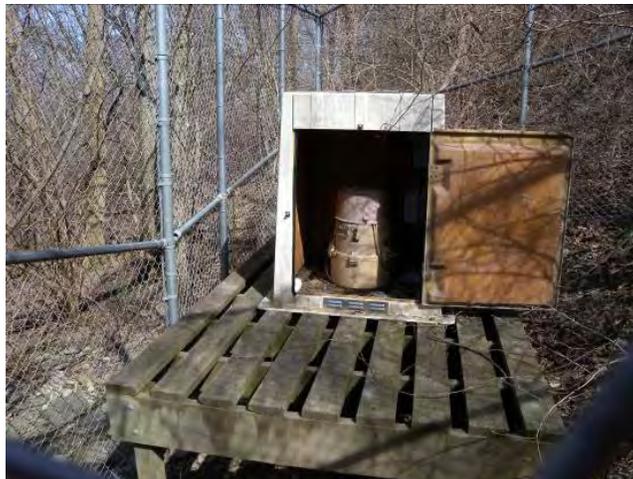
Figure 22. Old Sampler over Seep 0607 (No Longer in Use)

Third, the old sampler over Seep 0607 was no longer functional (Figure 22). It is recommended that the sampler and the surrounding fencing be removed and the area be returned to its original state.

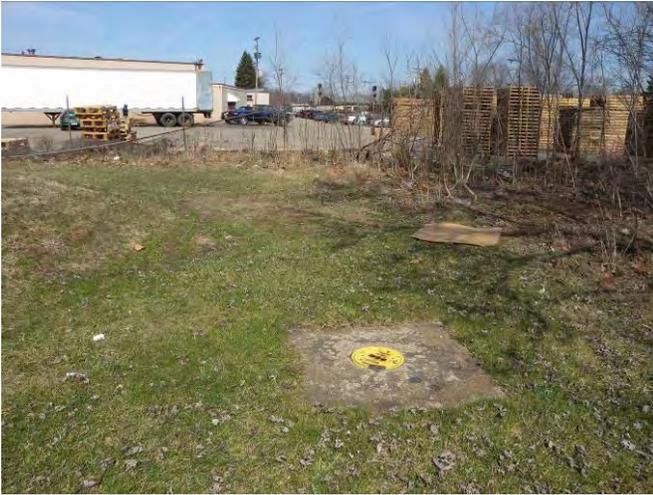
Figure 23. Well 0118, Off Site

Photos of wells and seeps are shown in Figure 23 to Figure 40. All were locked and in good condition.

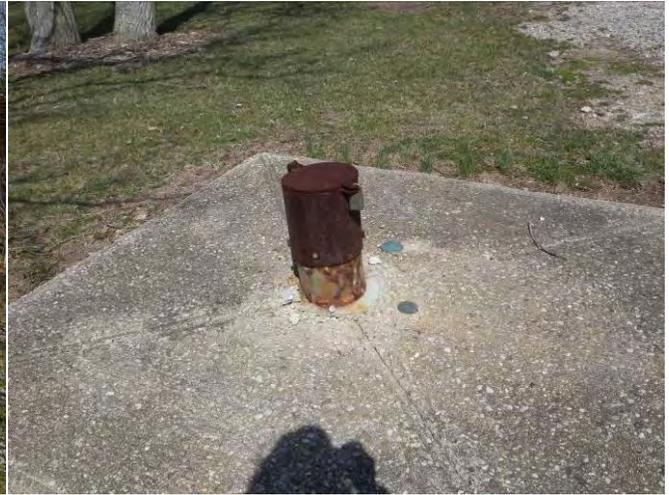
Figure 24. Well 0124, Off Site

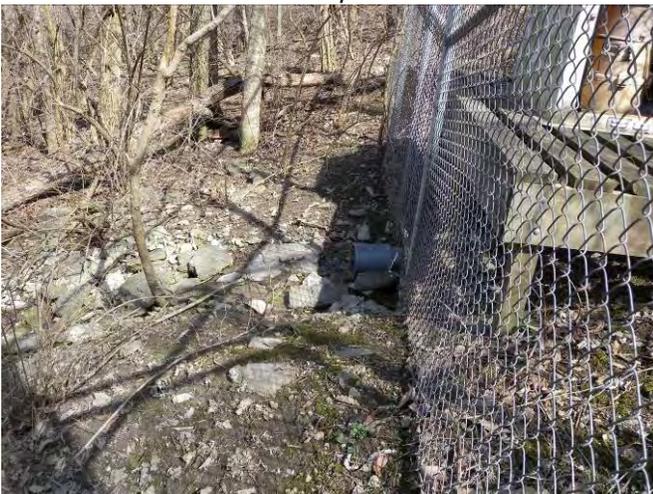
Figure 39. Seep 0607, Off Site

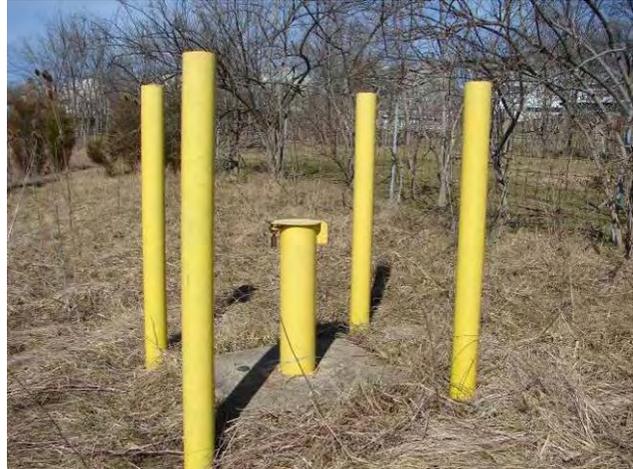
Figure 57. Well 0411

Figure 57 through Figure 67 are photos of the wells and seep. All wells were locked, had permanent markers, and were in good condition.

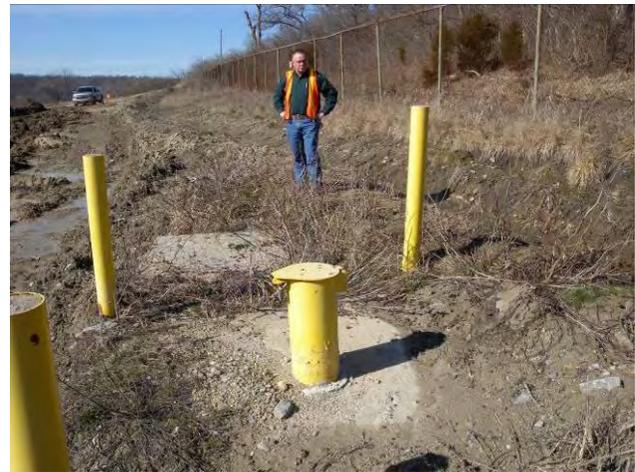
Figure 66. Well 0353, Which Still Has Drainage Problems
