**Annual Assessment of the
Effectiveness of
Sitewide Institutional Controls
Applied to the Former DOE
Mound Site Property
Miamisburg, Ohio**

June 2012

**U.S. DEPARTMENT OF
ENERGY**

Legacy
Management

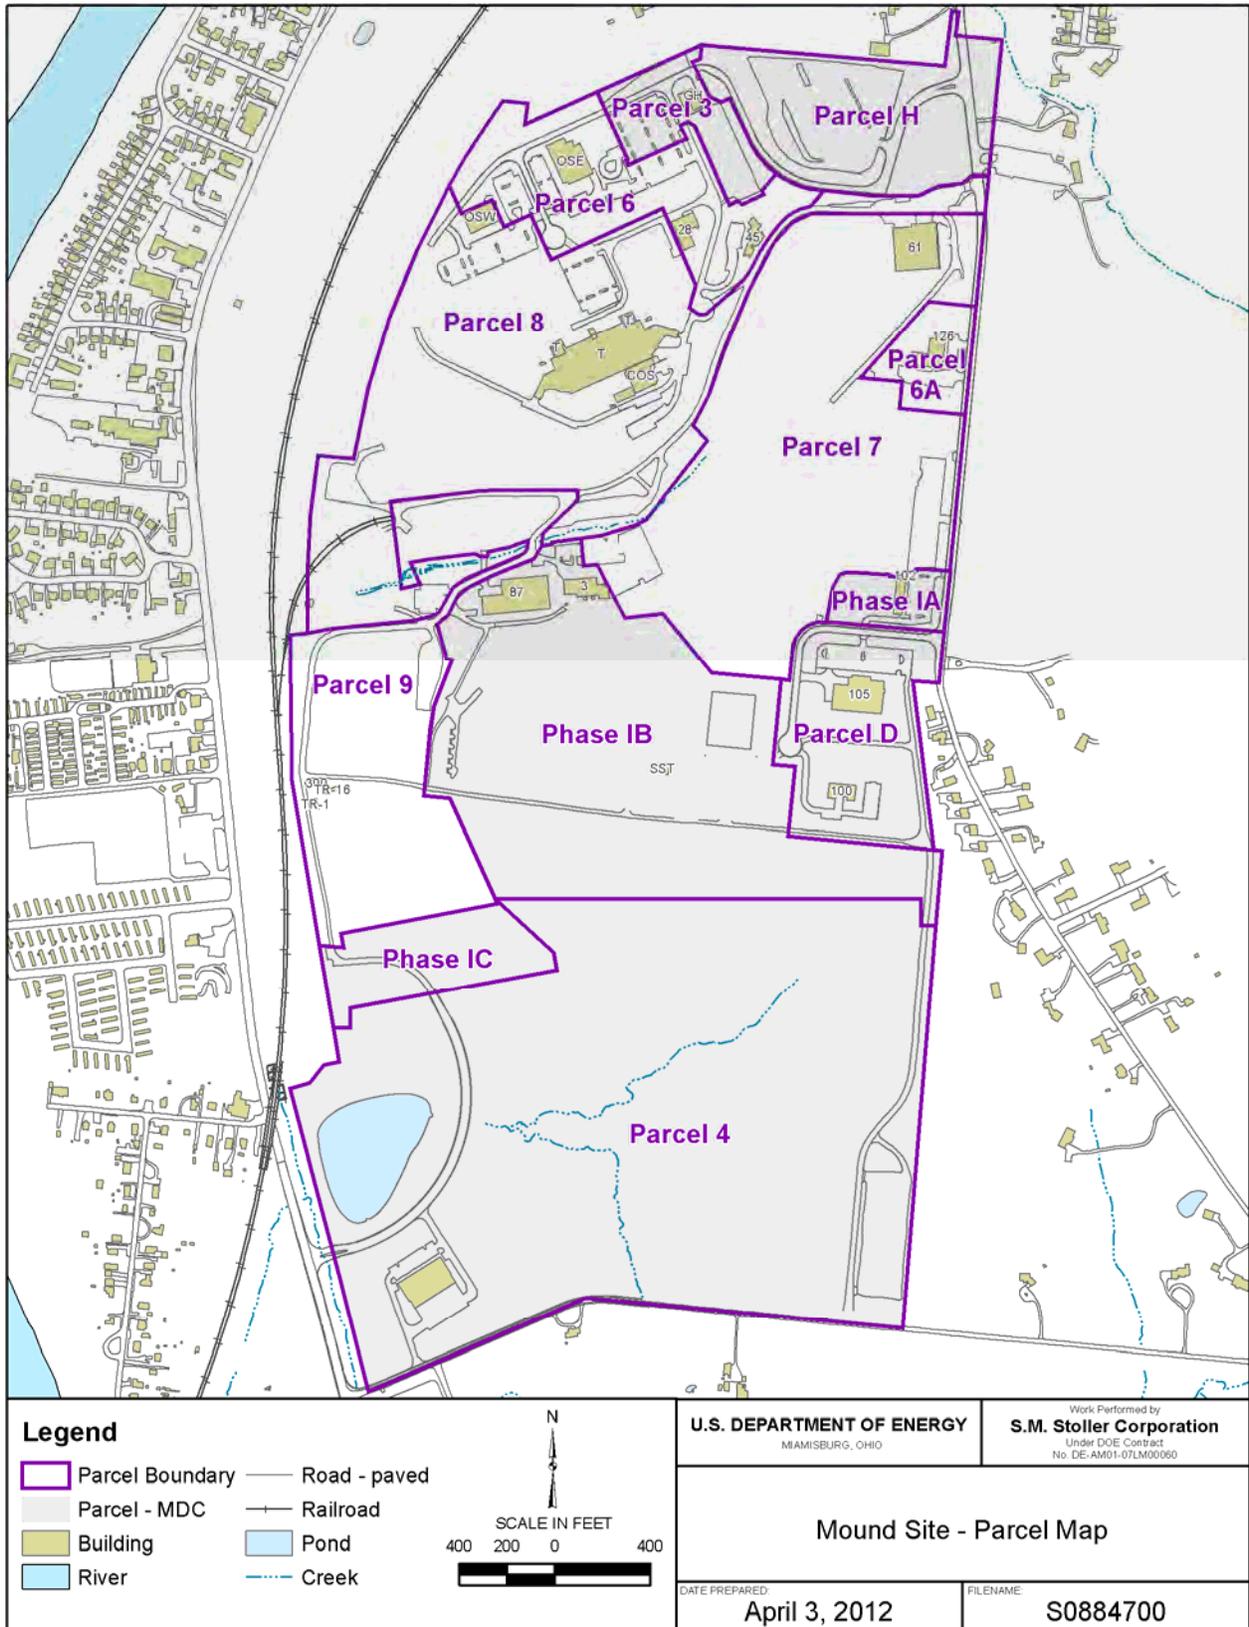
Figure 1. Parcel Map of the DOE Mound Site, Miamisburg, Ohio

At the time of this annual IC assessment, MDC owns Parcels D, H, 3, and 4 and the Phase I parcel (which comprises sub-parcels A, B, and C). The DOE Office of Environmental Management (EM) owns Parcels 6, 6A, 7, 8, and 9. EM amended the Operable Unit 1 (OU-1) ROD in 2011, expanding the footprint and renaming the area “Parcel 9.” Figure 1 shows the original boundaries of the former DOE Mound Site Property divided into parcels. The shaded areas indicate the parcels that have been transferred to MDC.

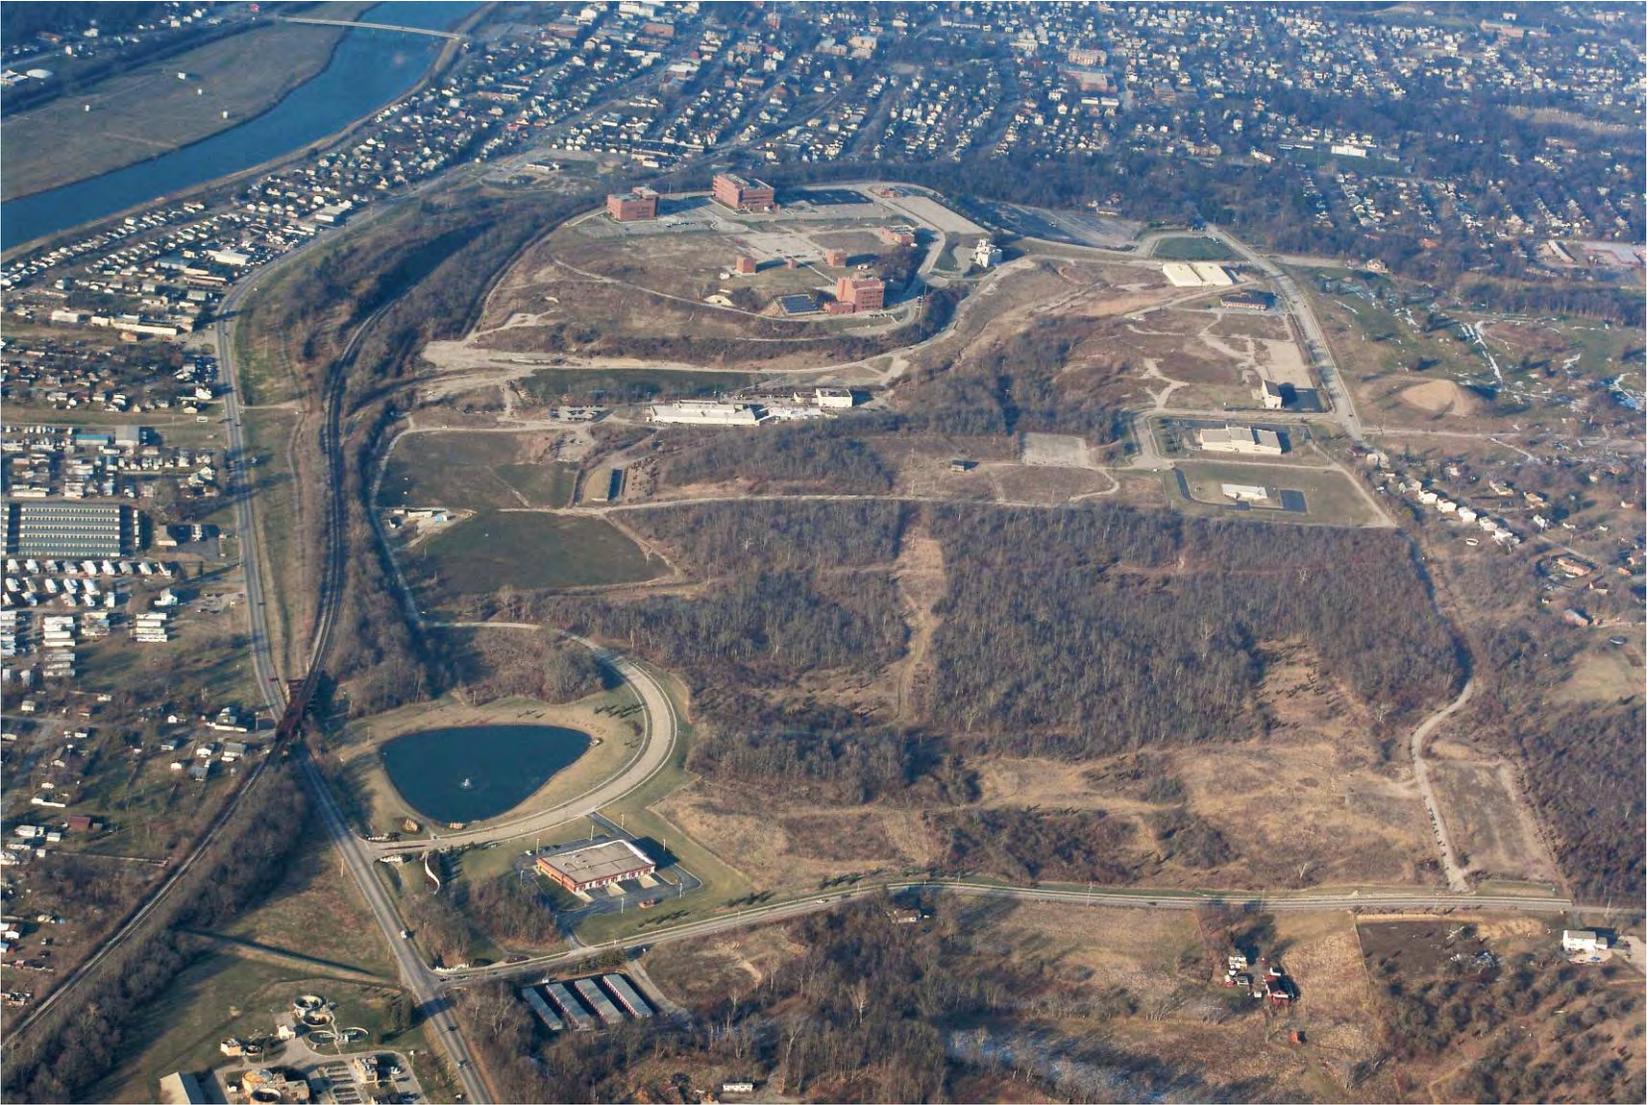
Figure 2. Mound Site Looking North (March 2011)

Figure 2 is an aerial photo, taken in March 2011, that shows the entire site looking north.

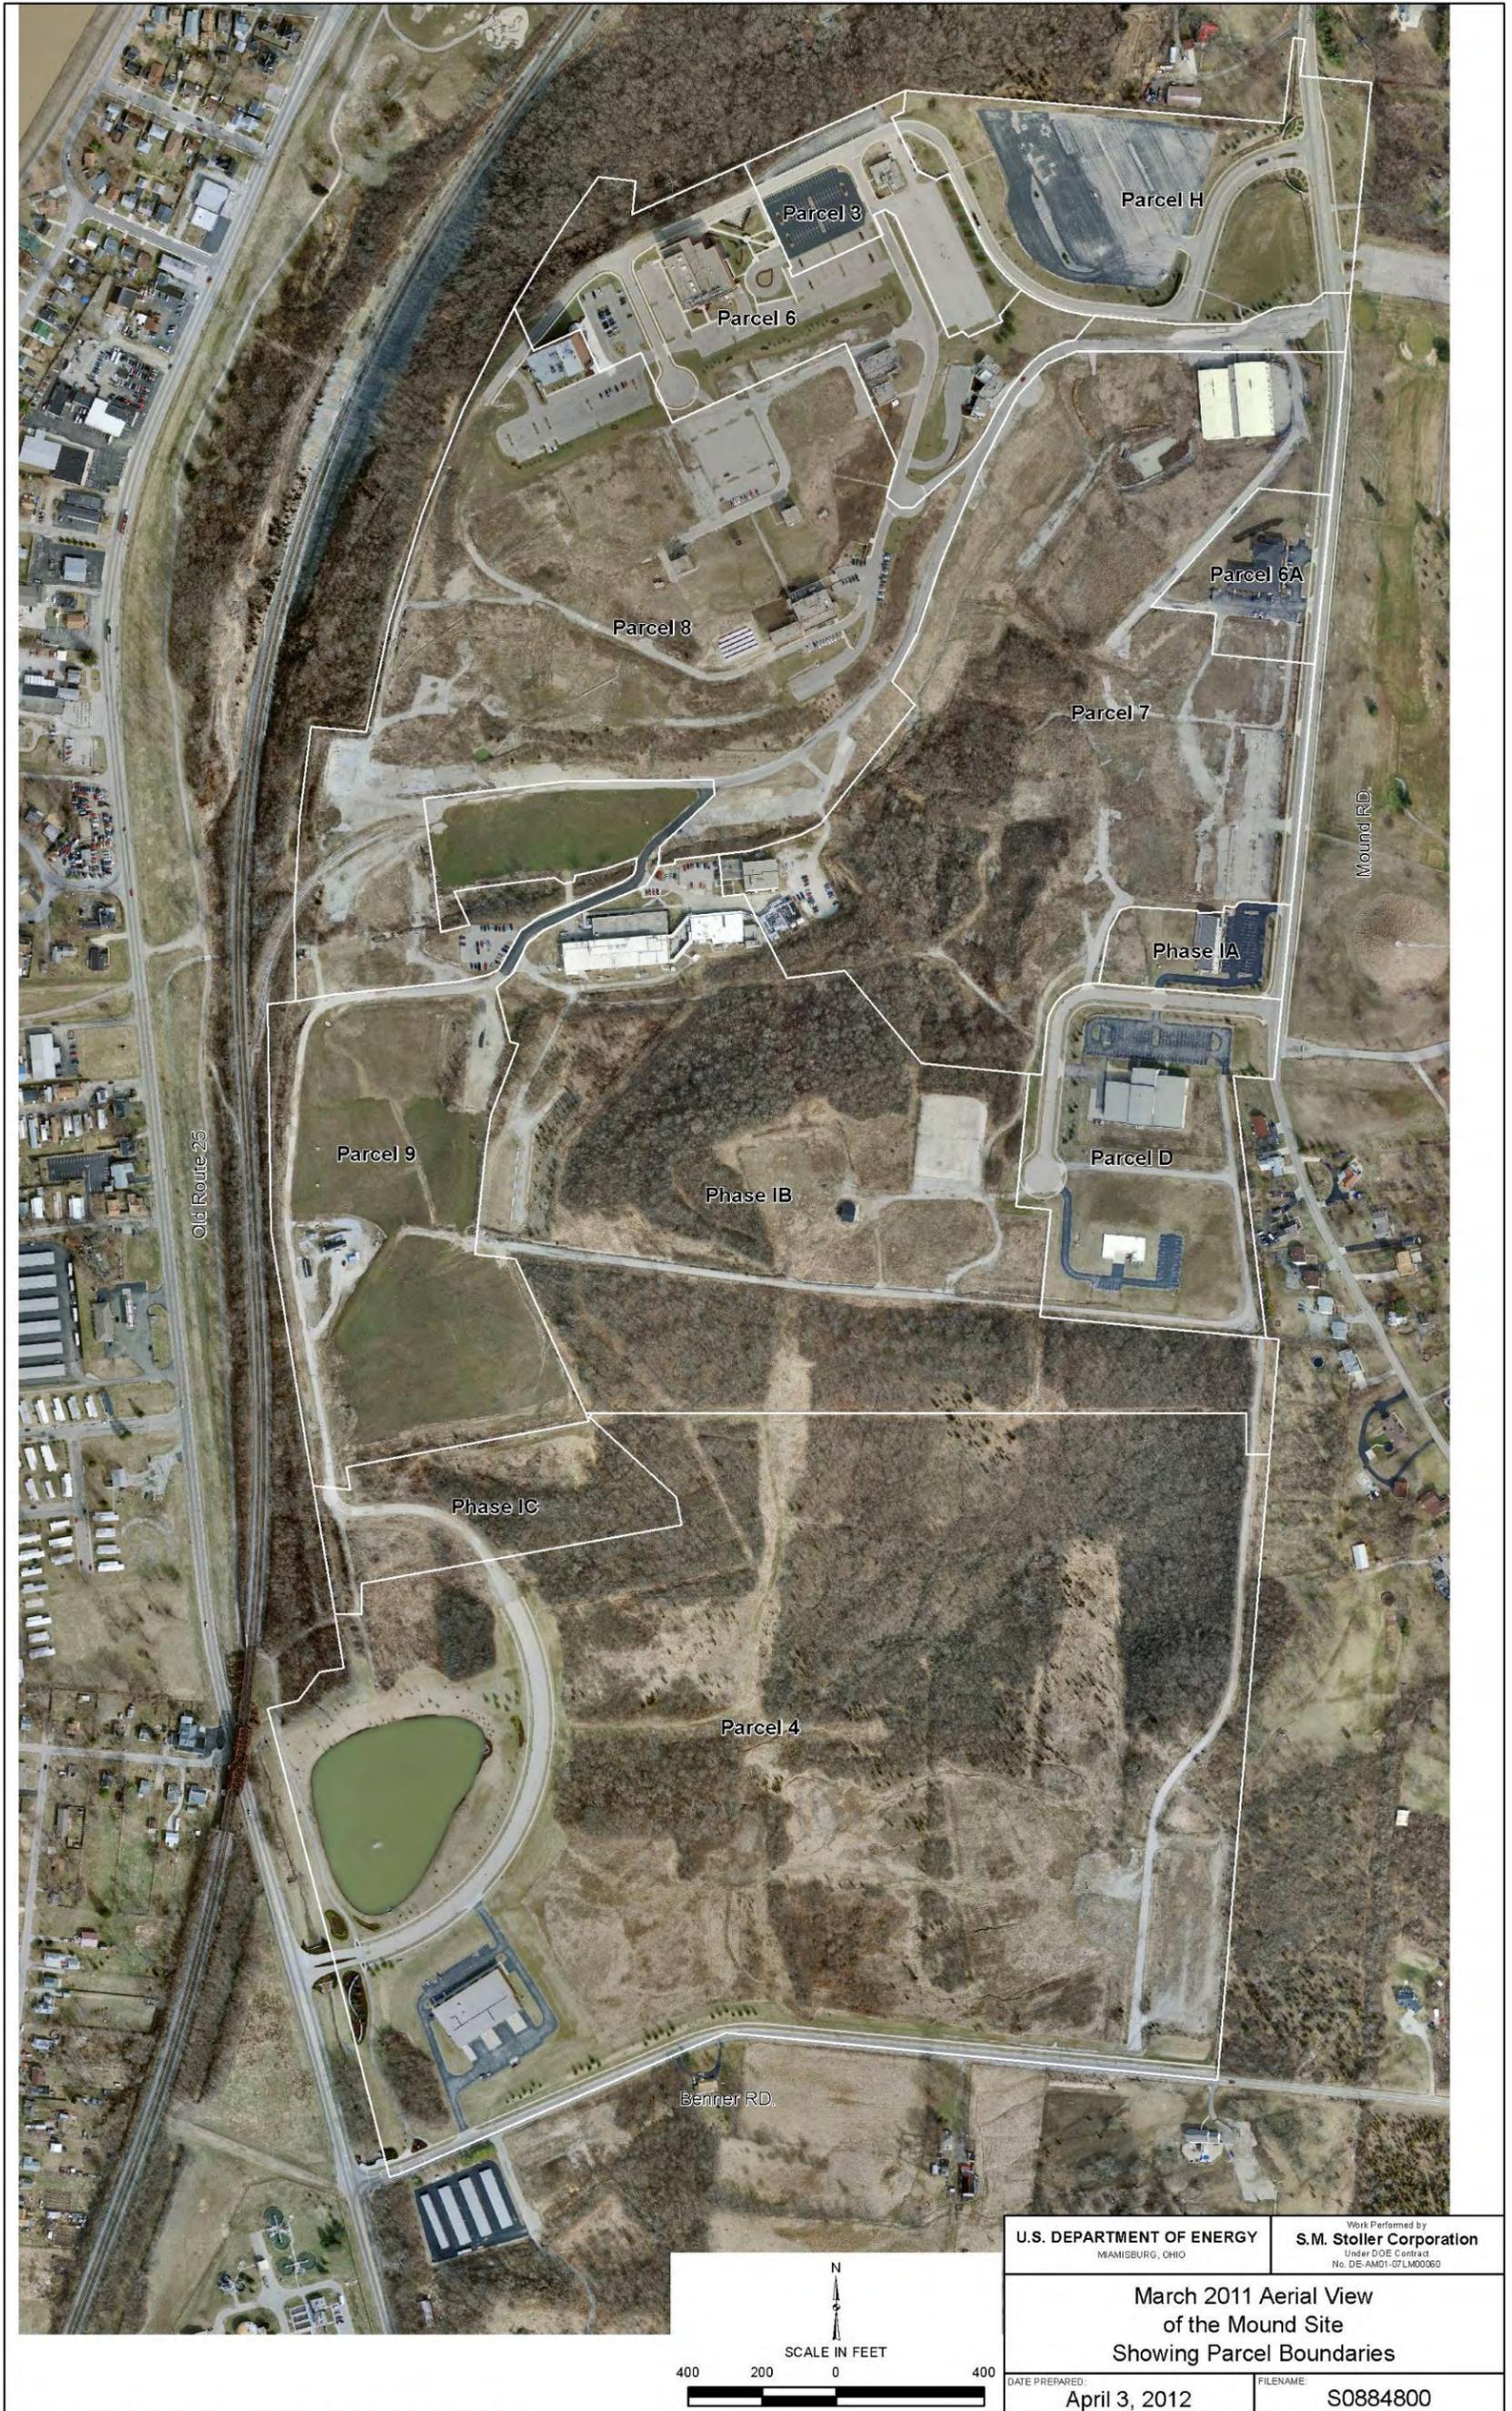
Figure 3. Mound Site, Showing Parcel Boundaries (March 2011)

Figure 3 shows the parcel boundaries laid over a March 2011 aerial photograph of the Mound Site.

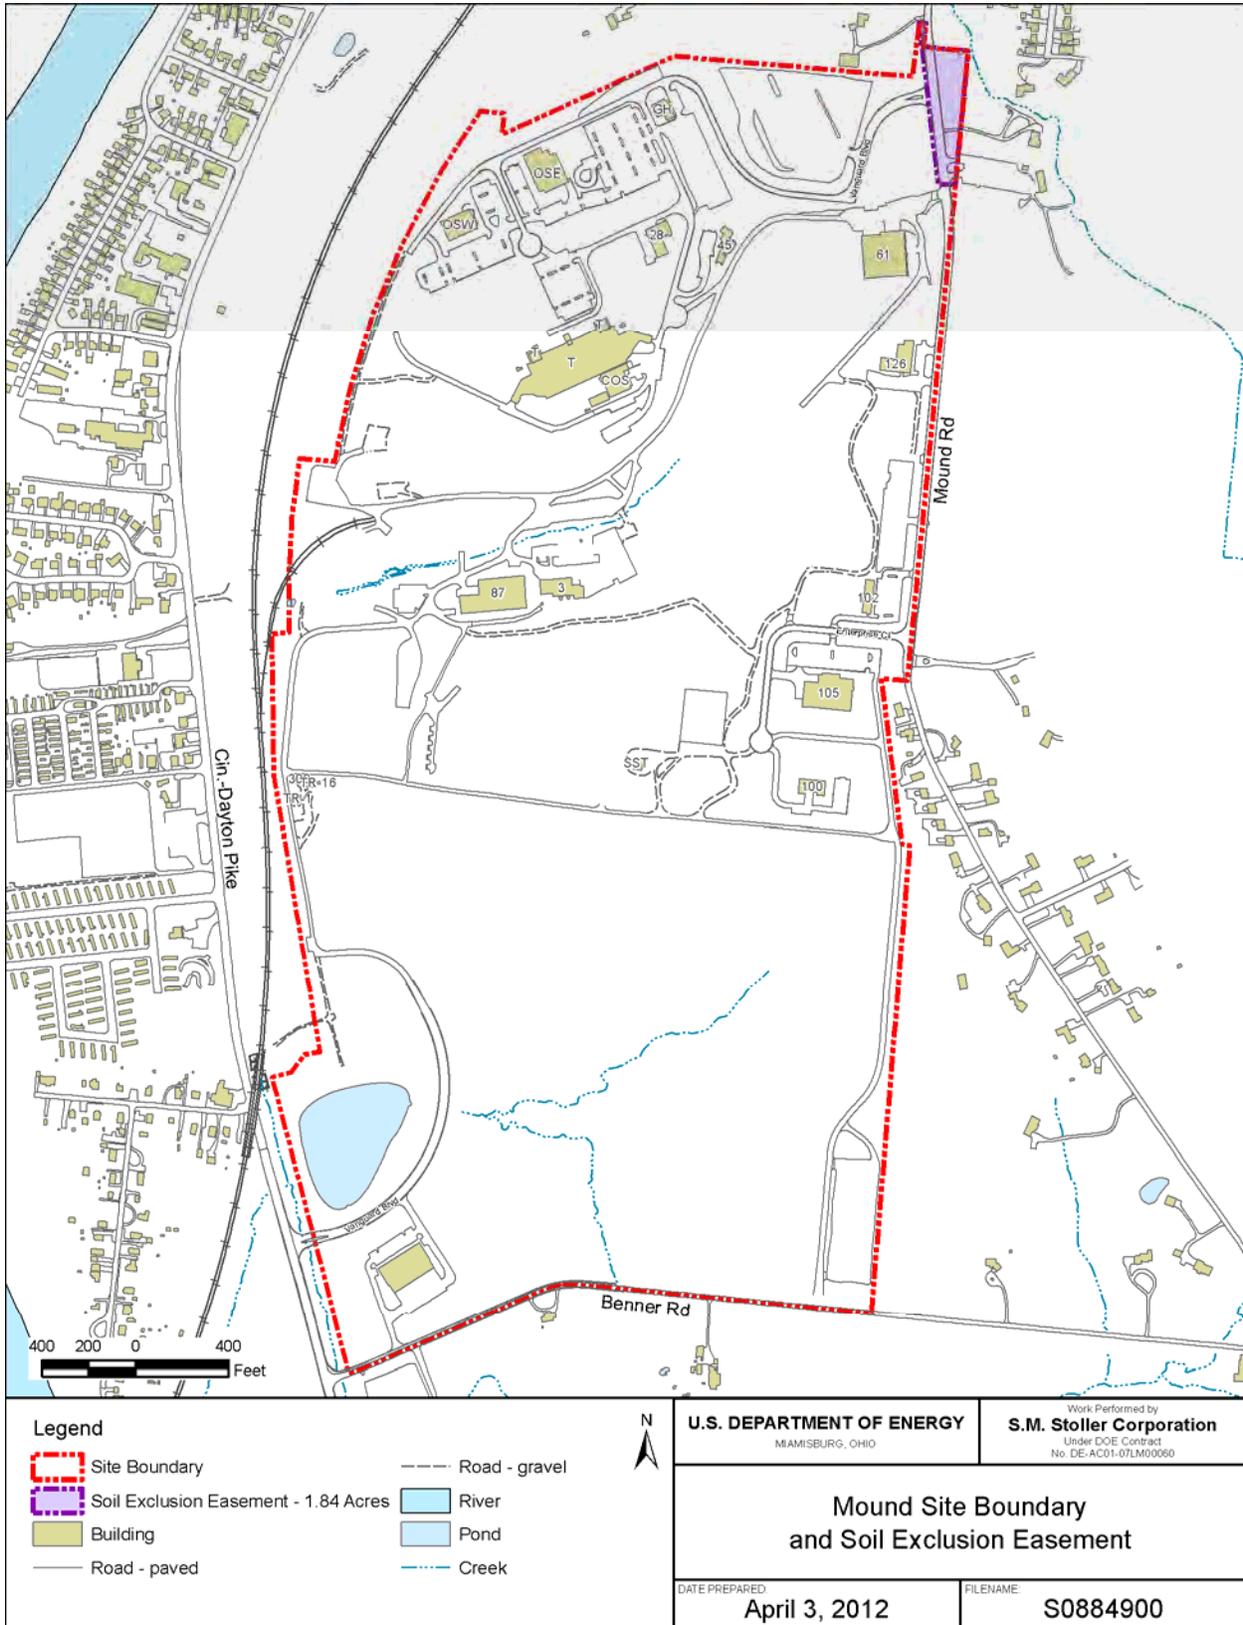
Figure 5. Parcel H Soil-Removal Exclusion Area within the Original Mound Site Boundary

One area of Parcel H, shown in purple in Figure 5, is exempt from the soil-removal restriction. Modifications to the entry and the rerouting of Mound Road isolated this area from the original Mound property.

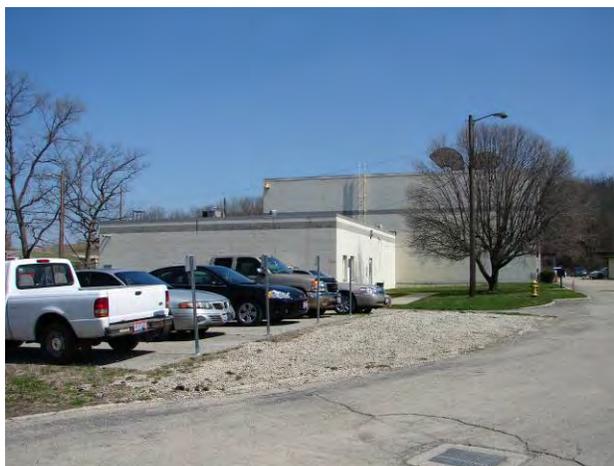
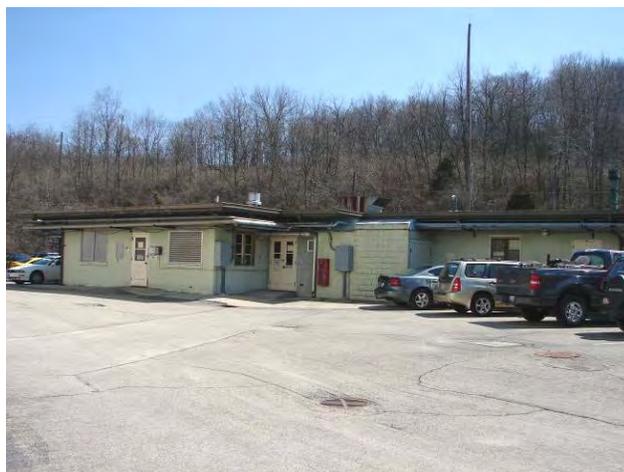
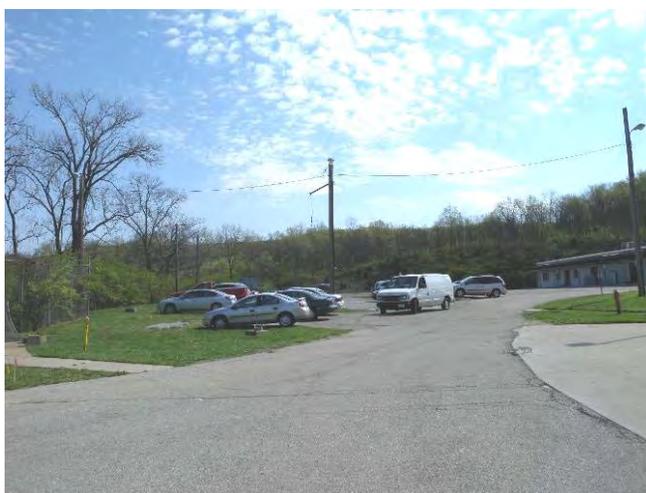
In Parcel 7, MDC removed Buildings 2, 63, and 63W and added parking areas in 2011. These activities were funded by a state grant and overseen by MDC. Figure 6 and Figure 7 show the buildings in 2010, and Figure 8 shows the parking area in March 2012 after the buildings were removed.

Figure 6. Buildings 63 and 63W in 2010

Figure 7. Building 2 in 2010

Figure 8. Parking Area That Replaced Buildings 2, 63, and 63W

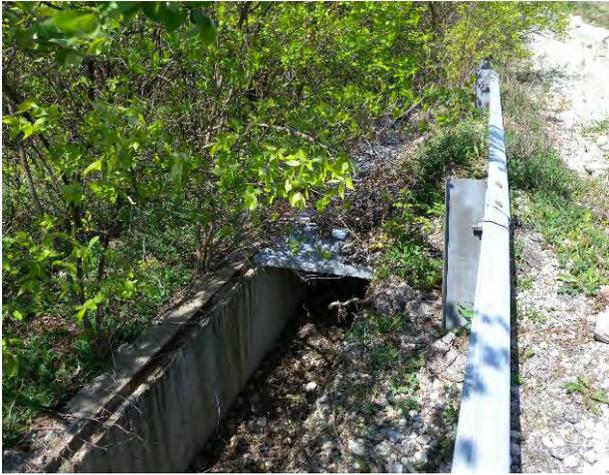
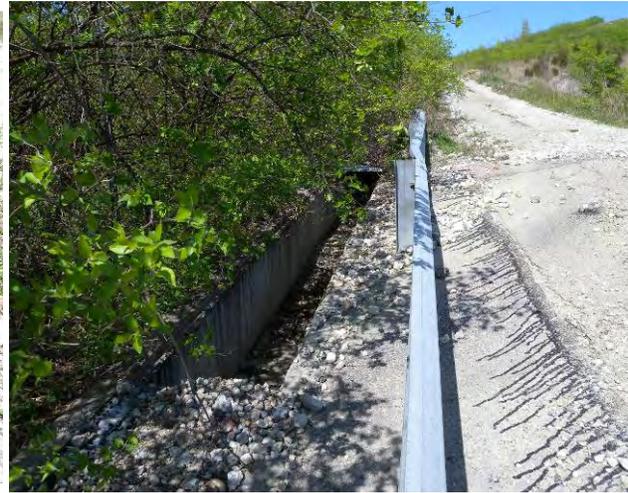
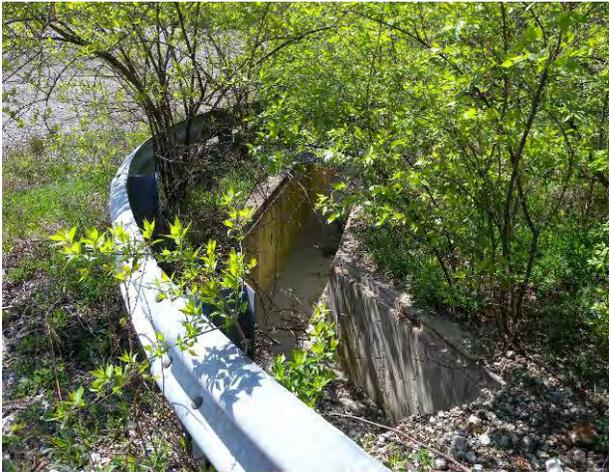
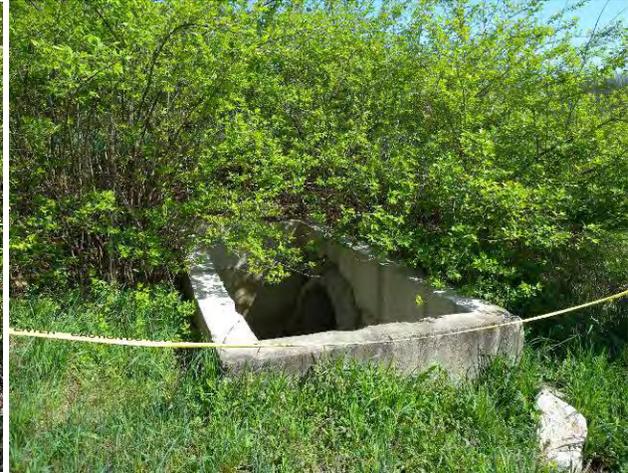
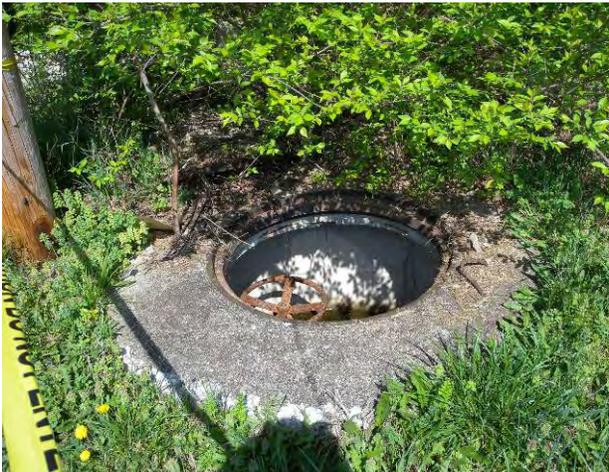
There was a theft of steel grates from over the concrete storm drains along the western site boundary in Parcel 8 during the reporting period. Figure 9 to Figure 13 show the open storm drains. Stoller personnel advised that the thefts were reported to local law enforcement.

Figure 9. Storm Drain from Which a Grate Was Stolen in Parcel 8, Looking North and Uphill Along the Western Site Boundary

Figure 10. Section of Parcel 8's Western Site Boundary from Which Grates Were Stolen, Looking North and Uphill

Figure 11. Storm Drain from Which Grates Were Stolen, Looking Southwest in Parcel 8

Figure 12. Storm Drain from Which Grate Was Stolen in Parcel 8

Figure 13. Manhole from Which Grate Was Stolen in Parcel 8

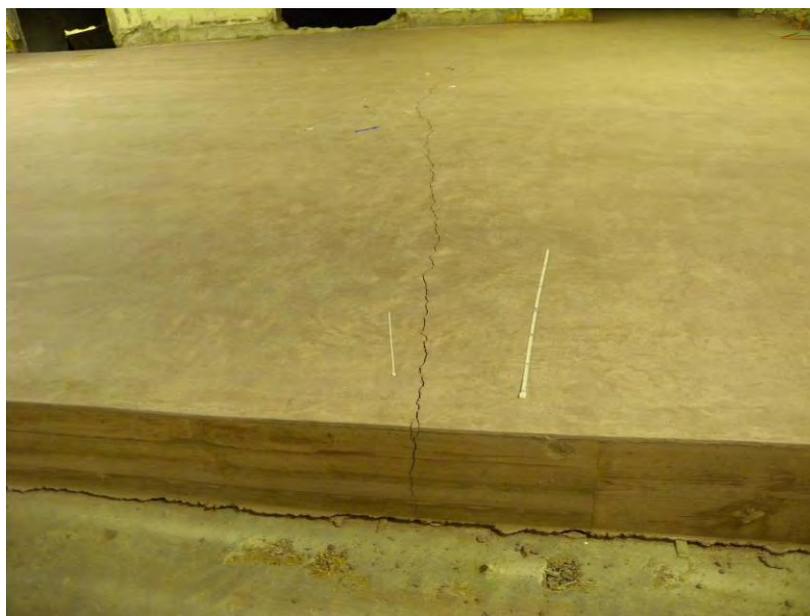
Figure 14. 2012 Photo of Crack in Red Concrete Slab in T Building Areas Where Penetration of Concrete Floor is Prohibited Without Prior Approval

Figure 14 shows the red concrete area; the photo was taken during the April 5, 2012, physical inspection of the building. These cracks were observed and noted in previous annual IC assessments. Appendix E, “Photos of T Building Red Concrete Cracks,” provides more detailed photos of the cracks taken during April 2012. As stated in the 2011 annual IC assessment report, the cracks are not of concern to the Core Team at this time, but DOE will continue to monitor them during future IC assessments.

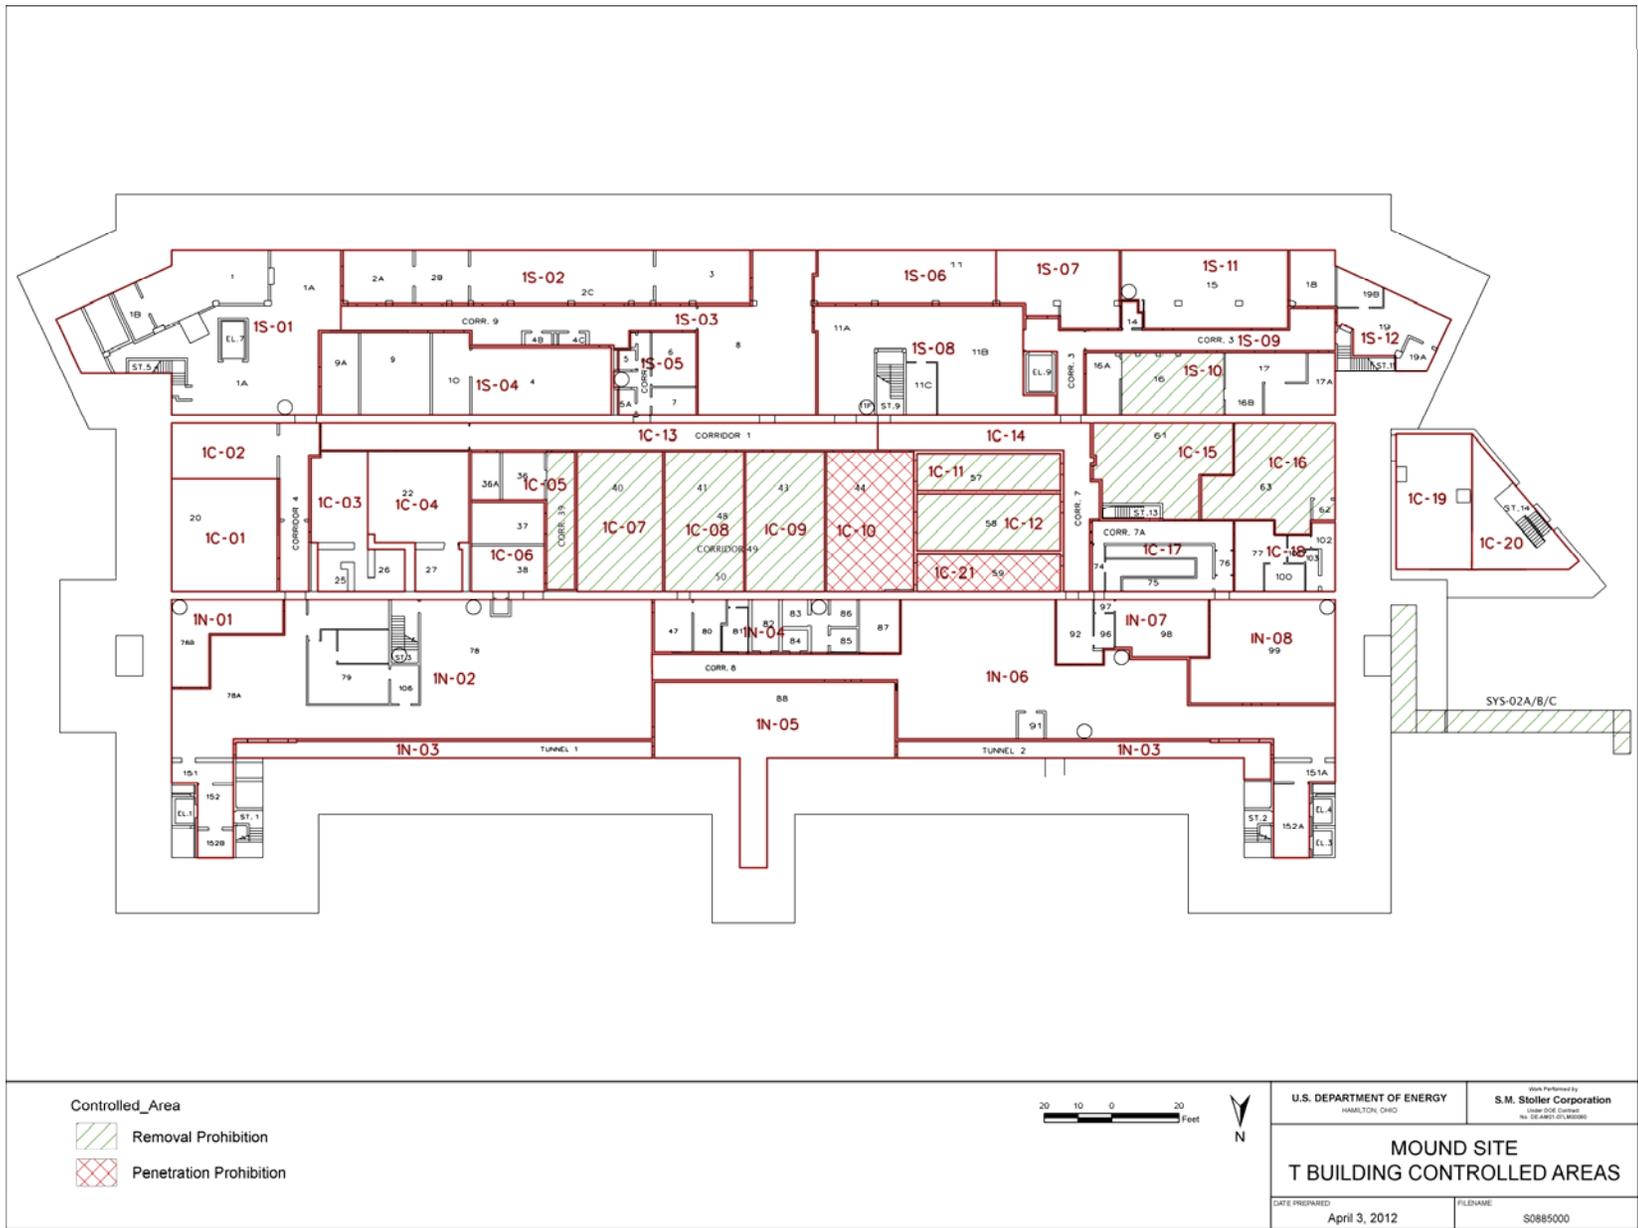
Figure 15. T Building Areas with Additional ICs

5. **Prohibit the penetration of concrete floors** in specified rooms of T Building (Figure 15) without prior approval from EPA, Ohio EPA, and ODH.
6. **Allow site access for federal and state agencies** for sampling and monitoring.

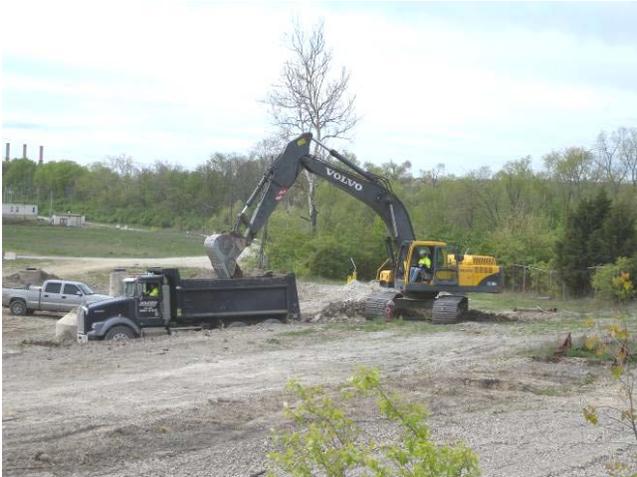
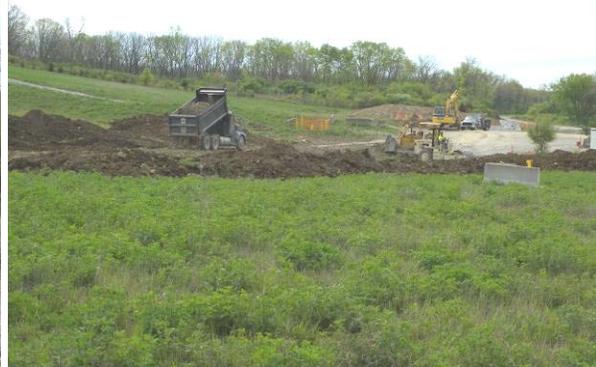
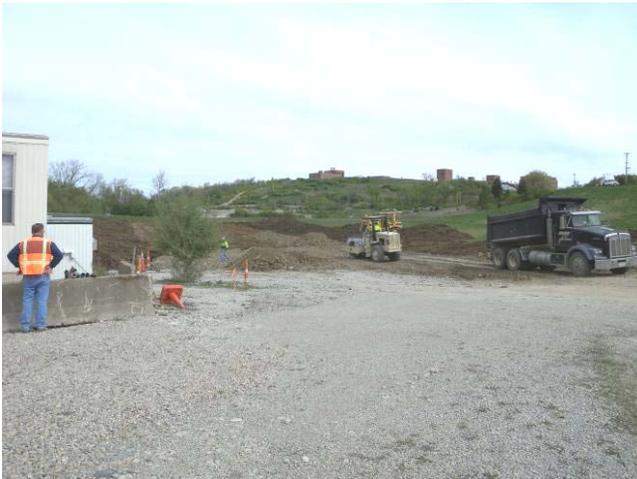
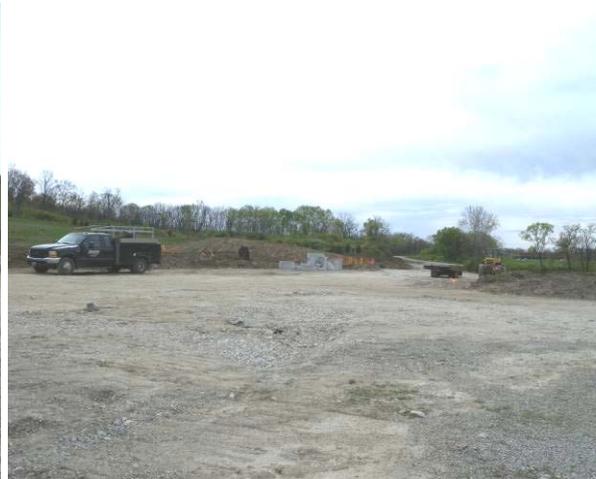
In March 2012, MDC began construction of the spine road to improve Vanguard Boulevard from Parcel 4 to Excelitas. Figure 16 through Figure 19 are photos of roadwork construction taken on April 5, 2012.

Figure 16. Work on Spine Road, Looking South Toward Wells 0315 and 0347

Figure 17. Work on Spine Road in OU-1 Area, Looking Southeast from Roadway. Well P053 is in Center Right of Photo.

Figure 18. Work on Spine Road, Looking North Toward OU-1 Area

Figure 19. Work on Spine Road, Looking Southeast from Trailer 1 in OU-1 Area

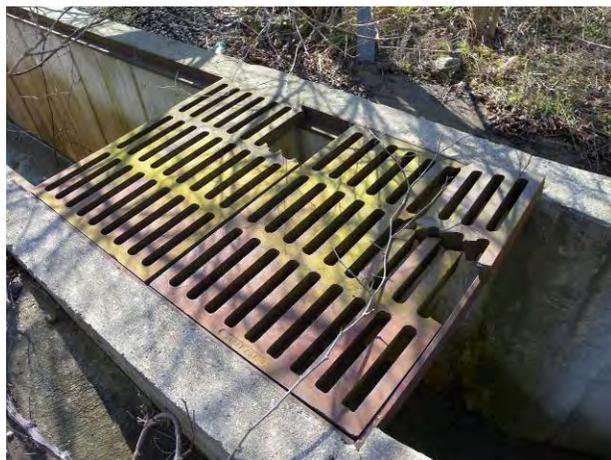
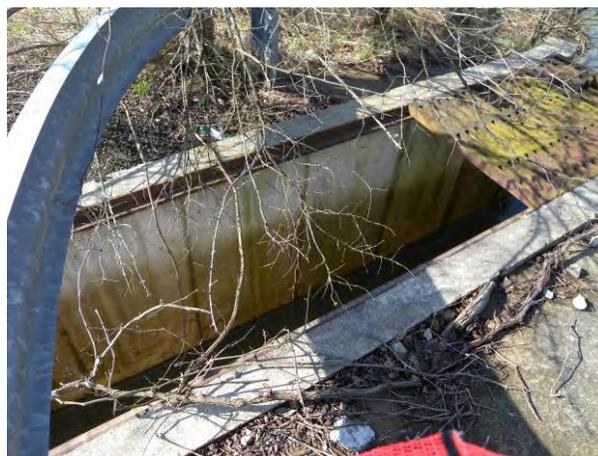
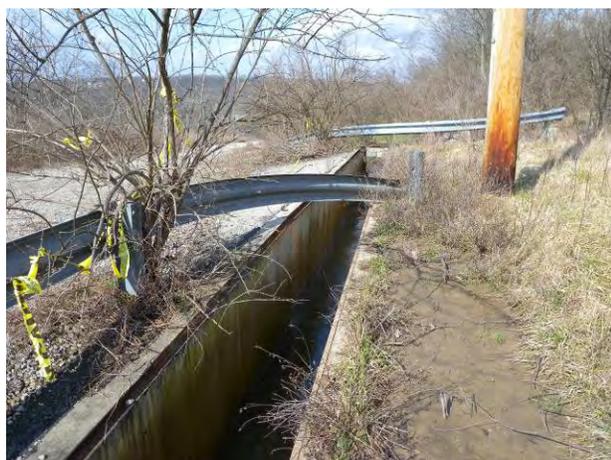
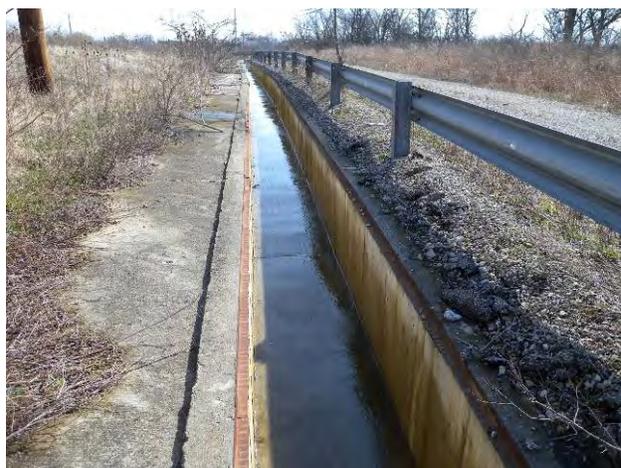
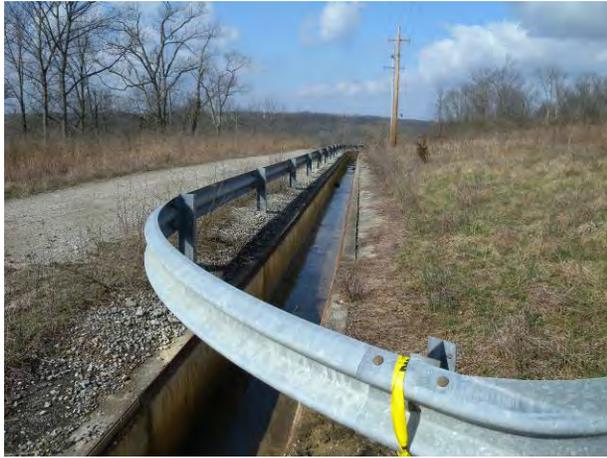
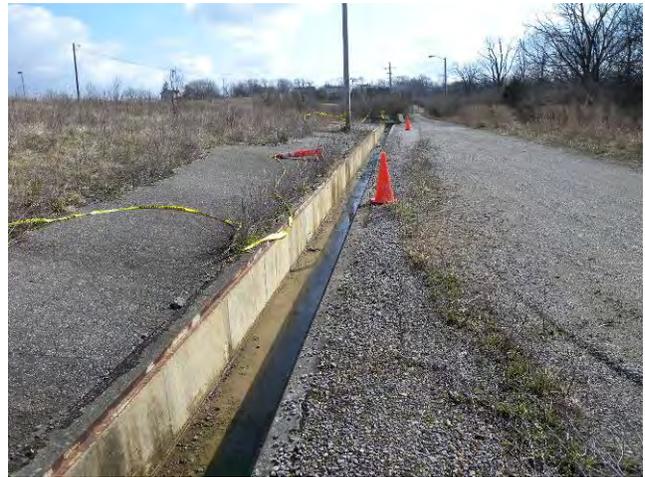
Metal grates that covered the concrete storm drain along the east-west roadway in the Phase IB parcel were stolen. See Figure 20 through Figure 25.

Figure 20. Single Remaining Grate

Figure 21. Single Remaining Grate

Figure 22. Section of Storm Drain from Which Grates Were Stolen

Figure 23. Section of Storm Drain from Which Grates Were Stolen, Looking East

Figure 24. Section of Storm Drain from Which Grates Were Stolen, Looking West from Center Roadway

Figure 25. Section of Storm Drain from Which Grates Were Stolen, Looking East from Center Roadway
