Annual Assessment of the Effectiveness of Institutional Controls at the Mound Site Miamisburg, Ohio

June 2013

Legacy
Management

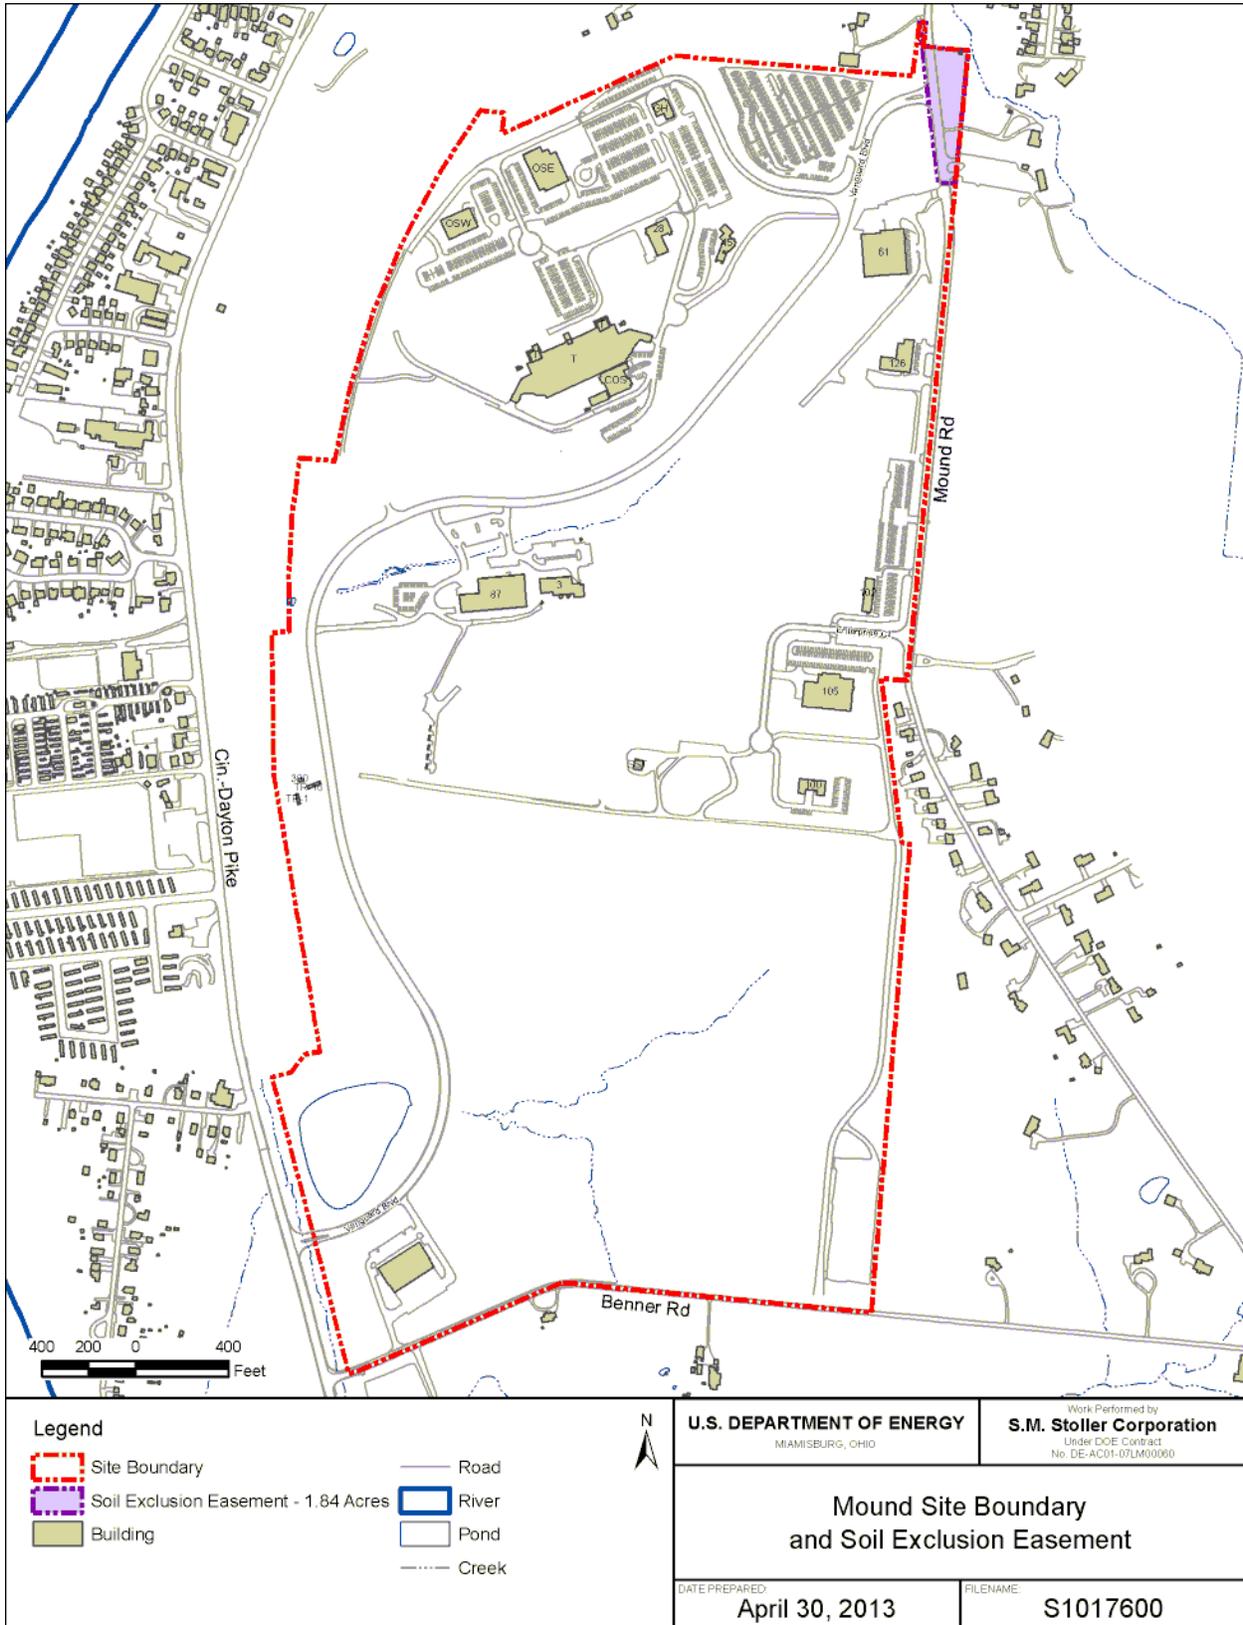
Figure 4. Parcel H Soil-Removal Exclusion Area Within the Original Mound Site Boundary

One area of Parcel H, shown in purple in Figure 4, is exempt from the soil-removal restriction. Modifications to the entry and the rerouting of Mound Road isolated this area from the original Mound property.

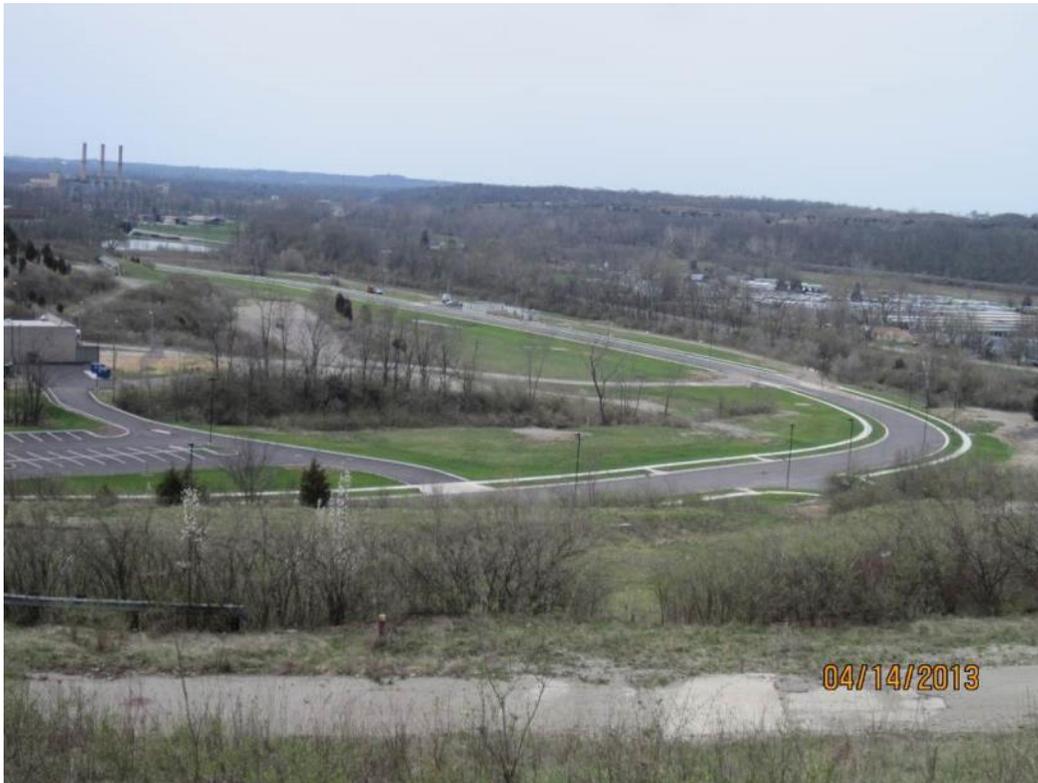
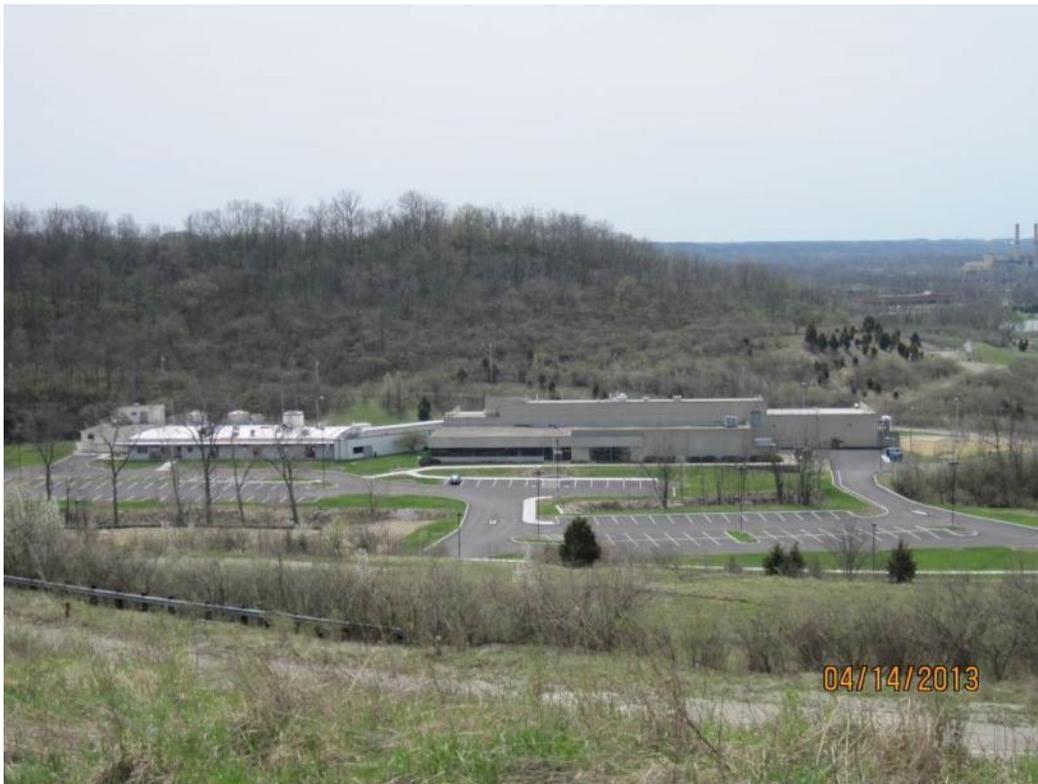
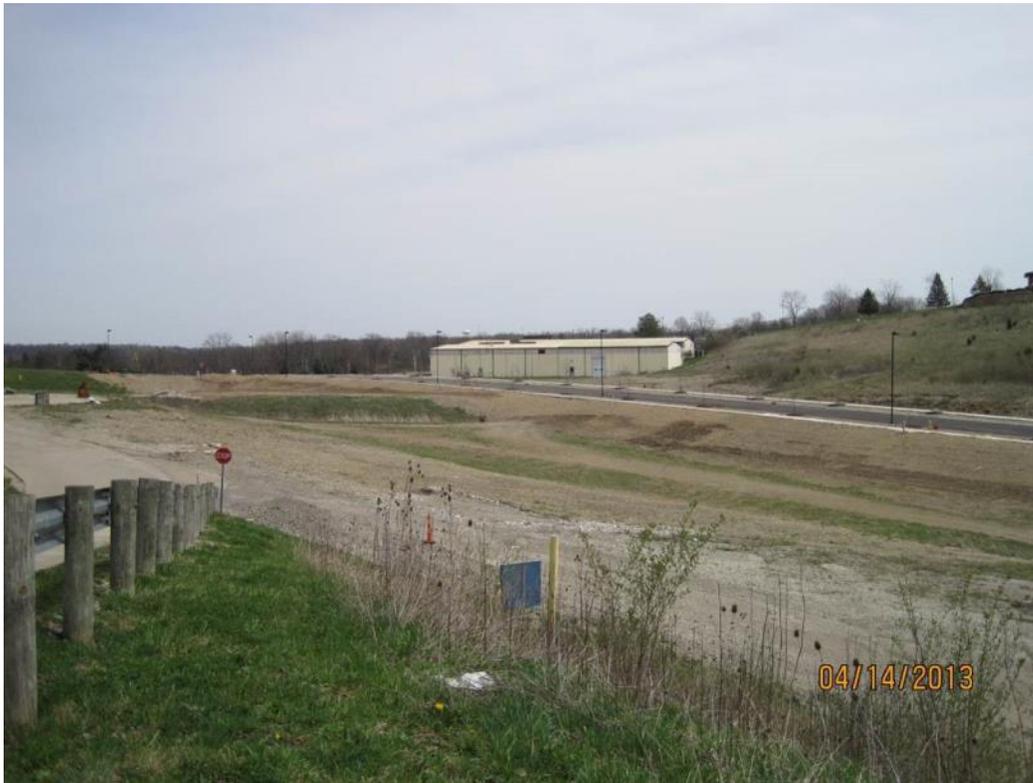
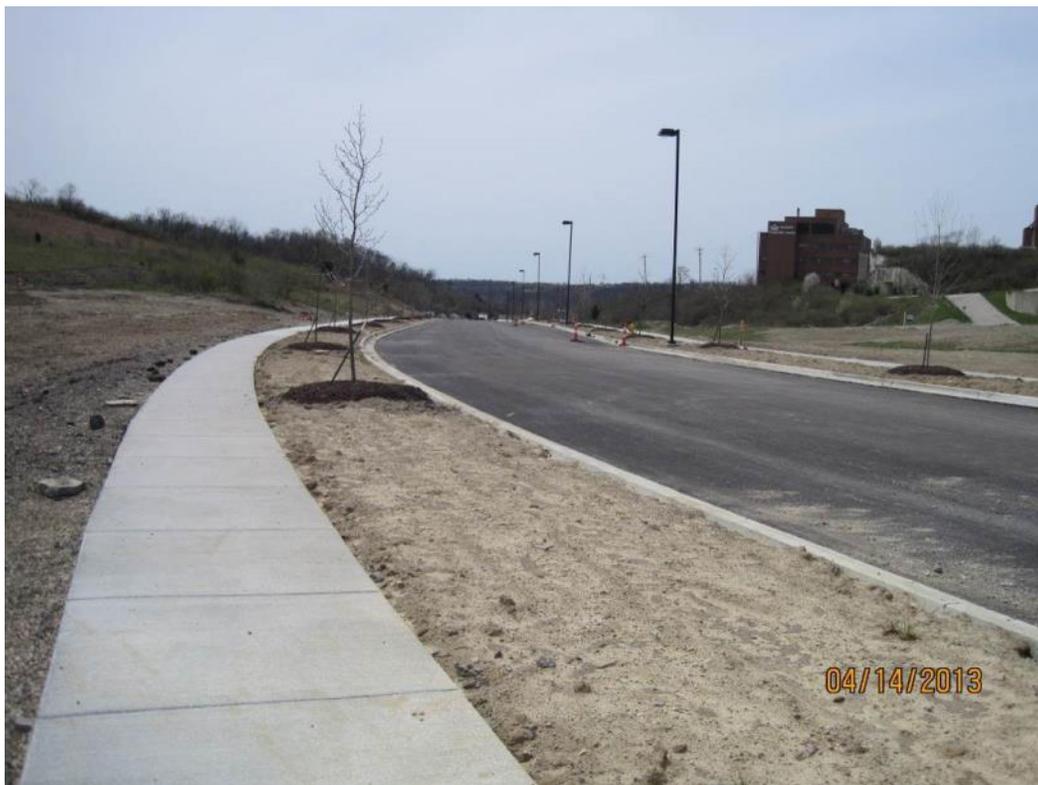
Construction of the Vanguard Boulevard (Blvd.) spine road continued during 2012. The roadway connecting the southwest and northeast site entrances was nearly completed at the time of the walkdown, and the final paving was scheduled for May 2013. The construction included the new roadway, a parking lot, storm and sanitary sewers, curbs and gutters, sidewalks, and street lights. Figure 5 through Figure 14 show the progress of the construction.

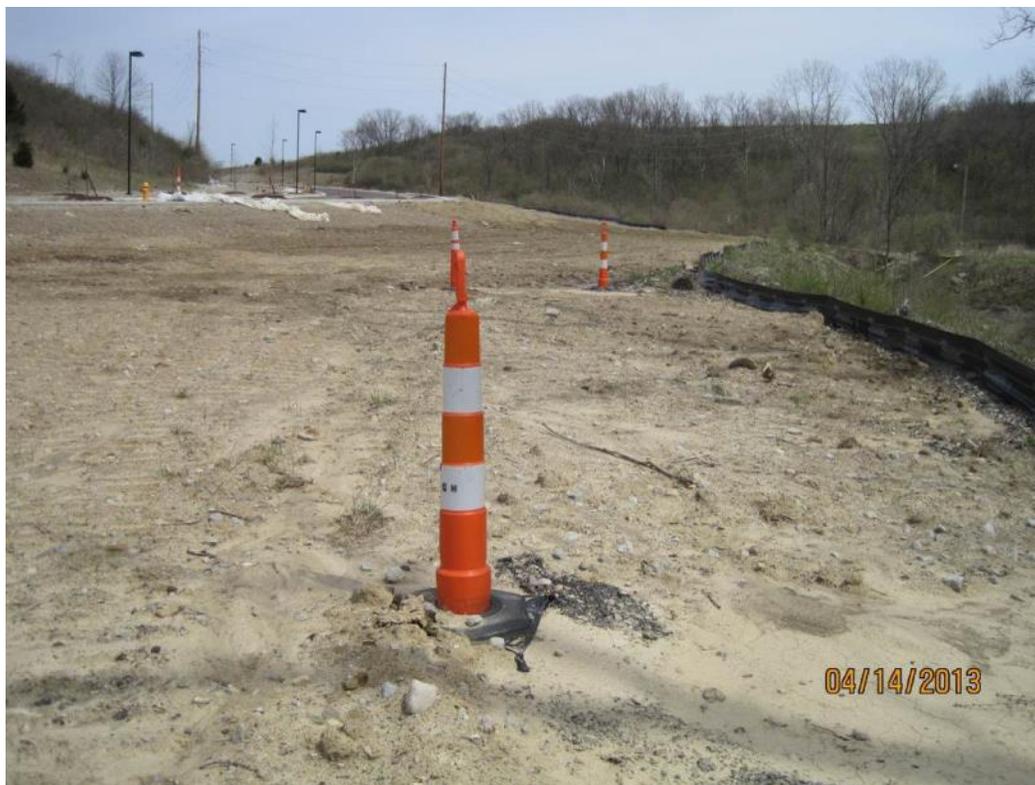
Figure 9. Erosion Problems South of Vanguard Blvd. near Well 0346

EMCBC instructed LM and Stoller to continue to monitor the construction through the DOE-owned parcels. The project followed the MDC soil management plan. No soil was removed from the site. The IC inspectors were told that EM had notified MDC of specific issues relating to soil erosion, drainage around wells, and well access. MDC advised that they were working with their contractor to resolve these issues. Figure 9 shows one of the problems observed.

Erosion problems were observed near the OU-1 area as shown in Figure 9 through Figure 14. Drainage issues can interfere with access to monitoring wells.

MDC and their contractor are correcting the sources of these drainage issues.

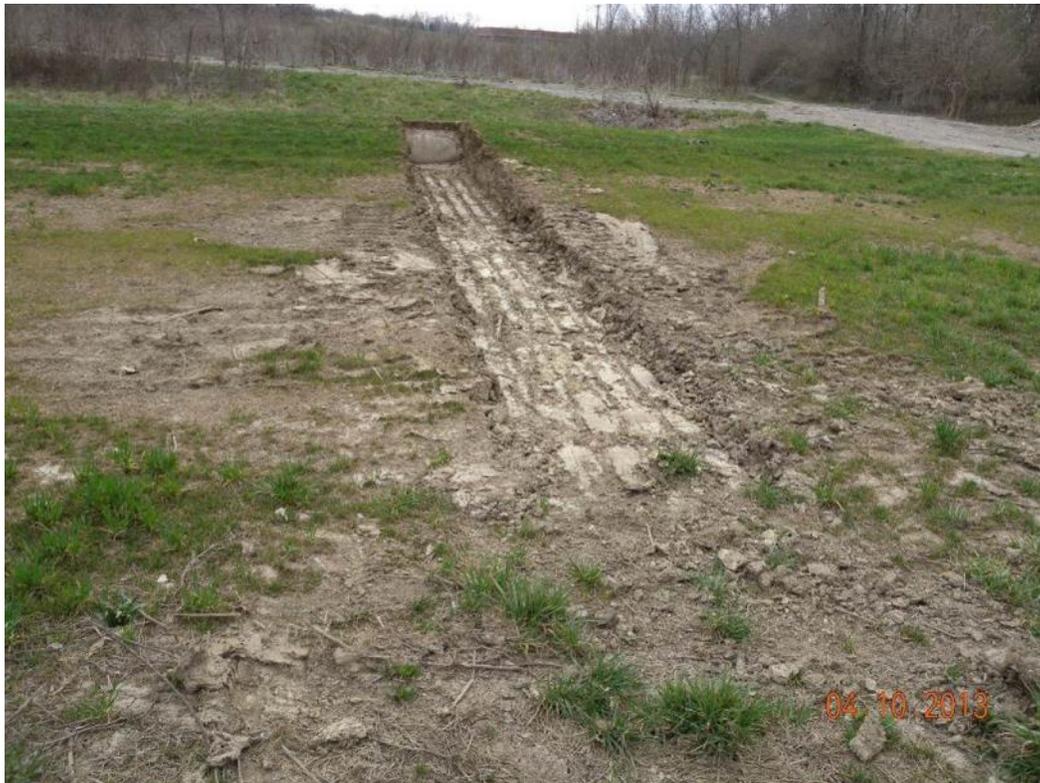
Figure 12. French Drain Installation Southward from Well P046 in OU-1 Area

In Figure 12, the drain connects to the storm-water pipe running west from Vanguard Boulevard.

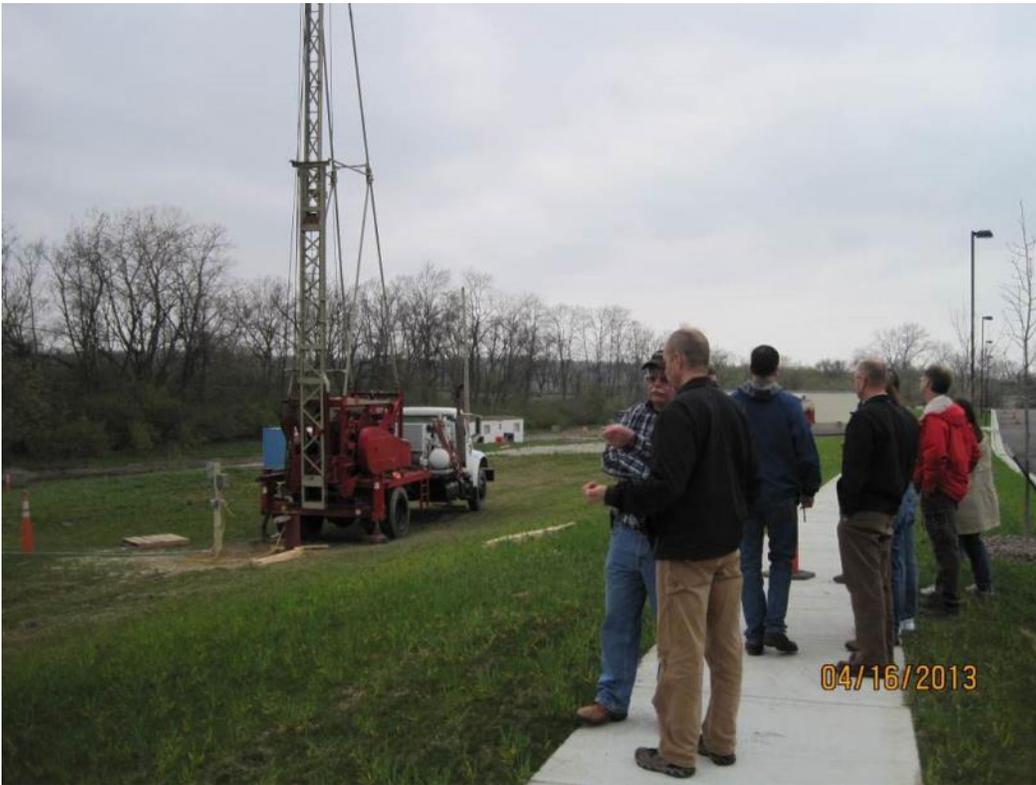
Figure 15. IC Walkdown Participants Observing the Area Around New Monitoring Wells in OU-1

LM had installed one new pumping well and four Geoprobe monitoring wells for an integrated pumping test. The well logs are not yet on the Ohio Department of Natural Resources website.

Figures 15 and 16 were taken during the walkdown of the OU-1 area. Participants observed the new wells and the drainage issues.

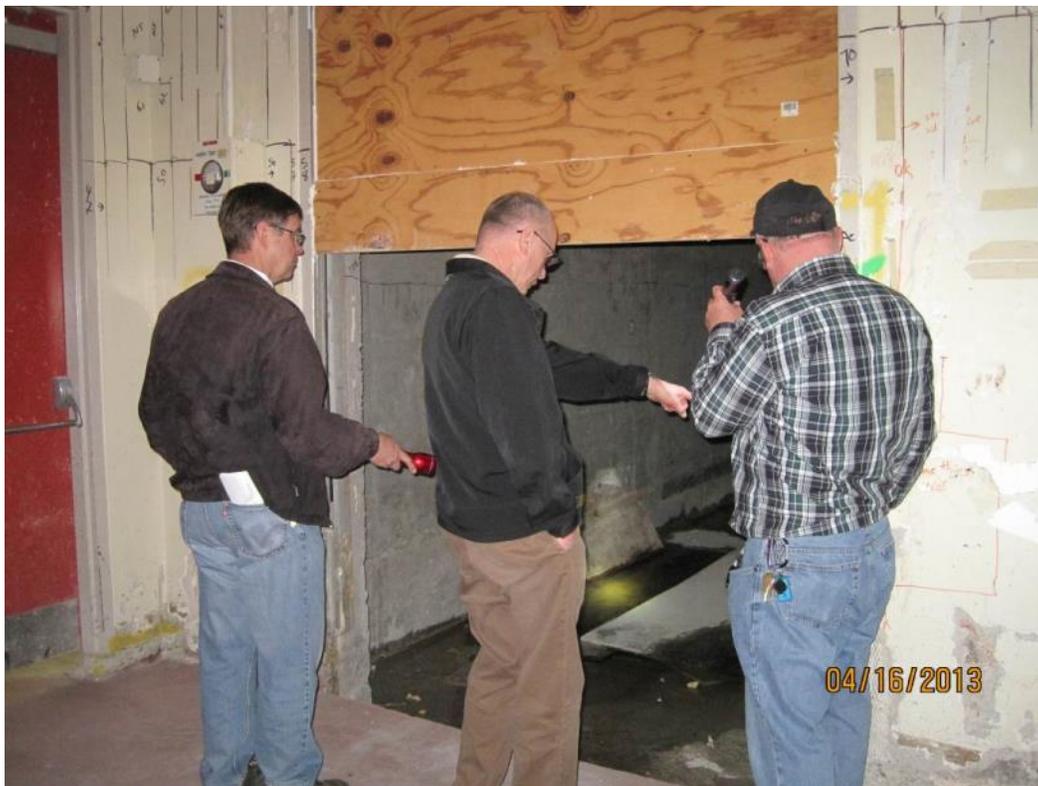
Figure 17. Bob Ransbottom, Bill Hertel, and Gary Weidenbach (Stoller) Observing Water on the Floor of Room 57 in T Building During the IC Walkdown

During the walkdown, standing water was observed in the special IC areas, rooms 57 and 58. The cause was identified as a rusted float valve on the sump pump for those rooms. Frank Bullock contacted his property maintenance contractor, who replaced the float, pumped out the water, and dried the area with fans.

After the walkdown, MDC instructed their property manager, Turner Property, to replace the ball float and to pump the excess water back to the drain. They also dried the area with fans. On April 18, 2013, Stoller verified with MDC that the correction had been made.

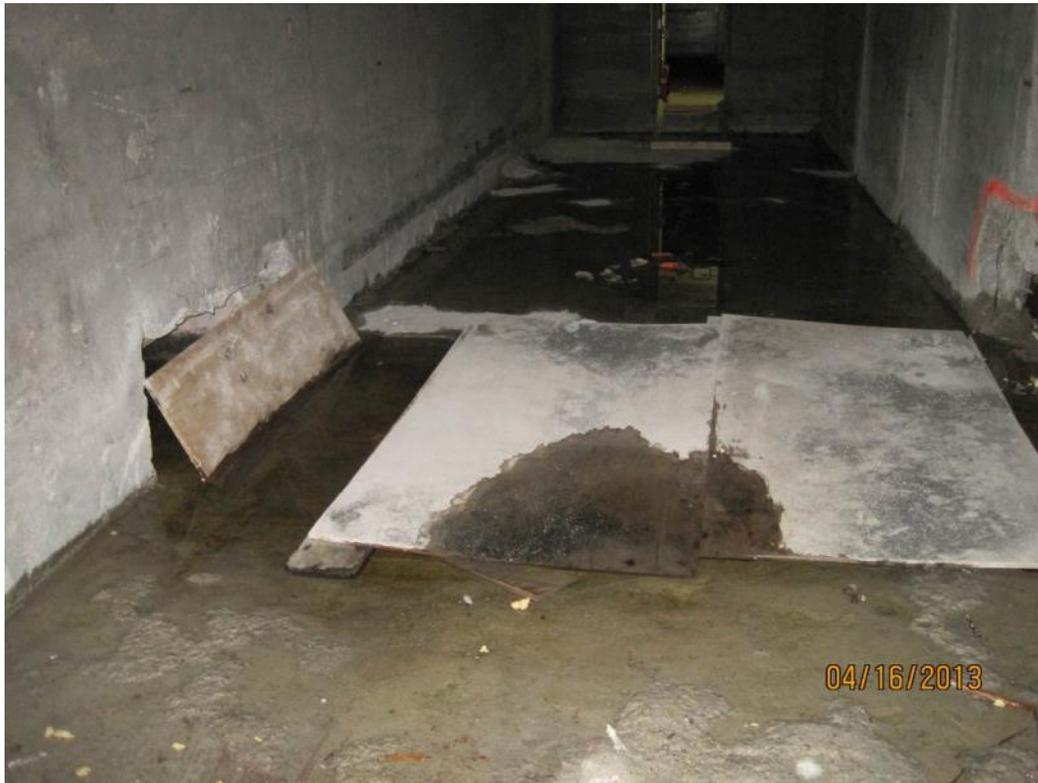
Figure 18. Standing Water Caused by Sump Pump Failure in T Building Room 57, Observed During the IC Walkdown

Standing water was observed during the walkdown in rooms T57 and T58. These are two of the rooms with special ICs. Stoller identified the source of the water, which was from the sump in room 99, whose float ball had rusted off.

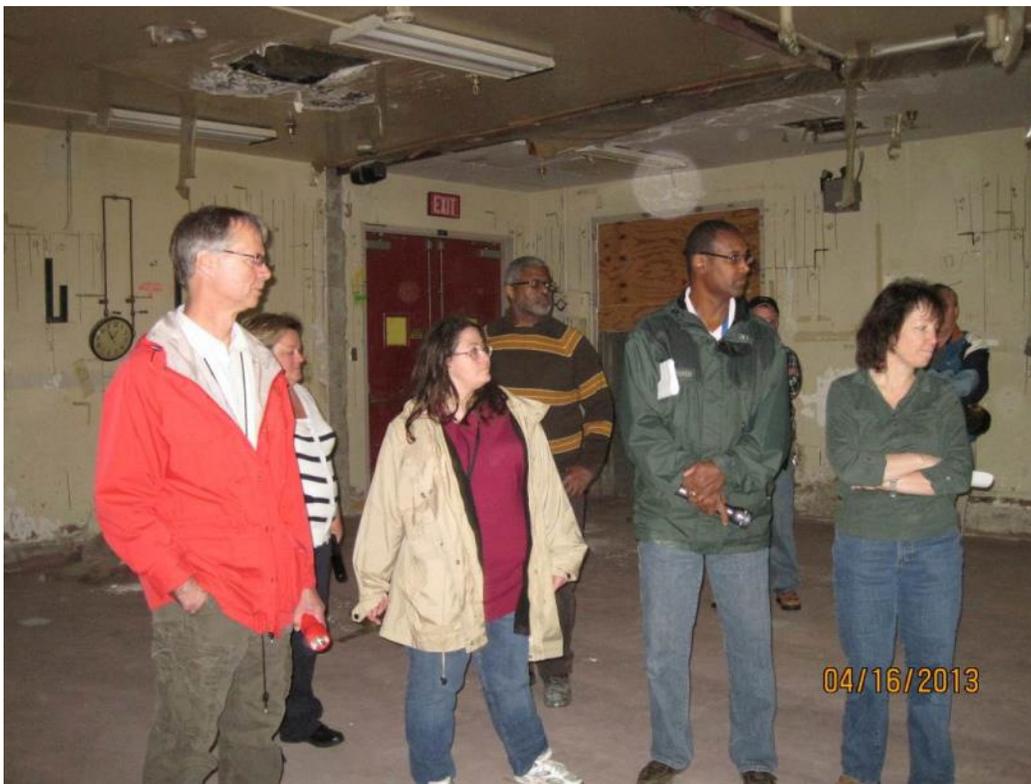
Figure 21. Brian Nickel (Ohio EPA), Ellen Stanifer (City of Miamisburg), Shannon Dettmer (ODH), Larry Kelly (EMCBC), Anthony Campbell (Ohio EPA), and Gwen Hooten (LM) Standing on Red Concrete in T Building Room 44 During the IC Walkdown

The cracks in the red concrete covering Room 44 (survey unit 1C-10) were examined and discussed during the walkdown. A walkdown participant asked what size of crack would become a concern. LM will review the associated T Building documents and discuss the issue with the Core Team.

Cracks in the red concrete were again observed. Ohio EPA asked what crack width would trigger a repair action. LM advised they will review T Building documents to determine the intent of the red concrete and will discuss with the Core Team. LM photographed cracks to document any changes from the 2012 inspection. The photos did not show a significant change.

Number	Issue/Recommendation	Responsible
1	Review the records regarding the purpose of the red concrete. Discuss with Core Team.	LM/EM
2	Repeat the photographs of the cracks in the red concrete in 2014.	LM

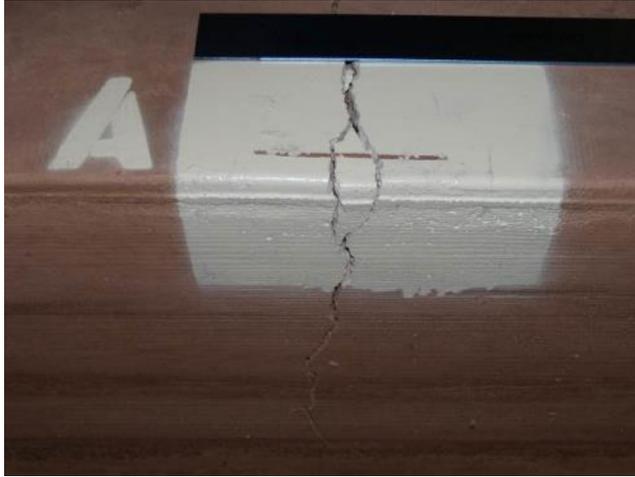
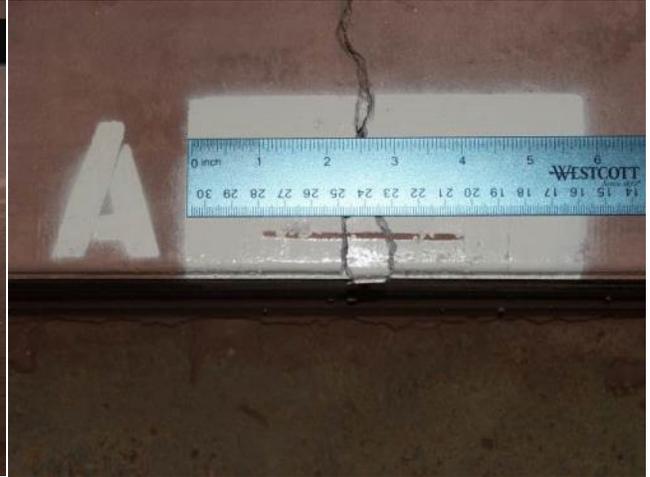
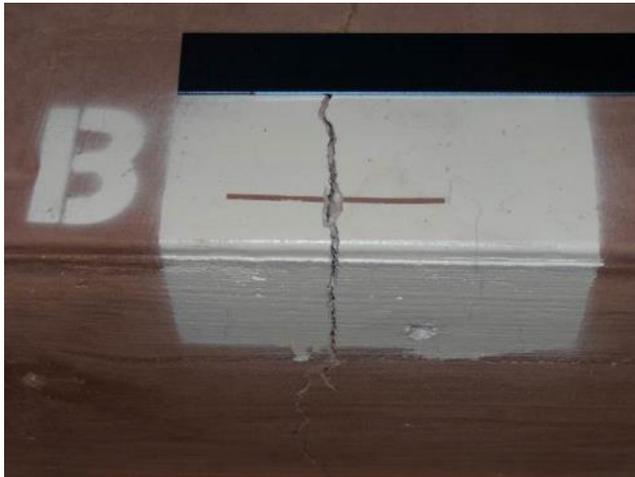
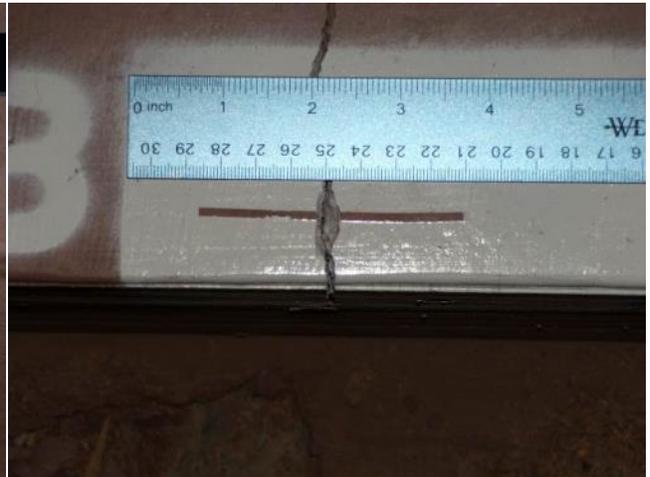
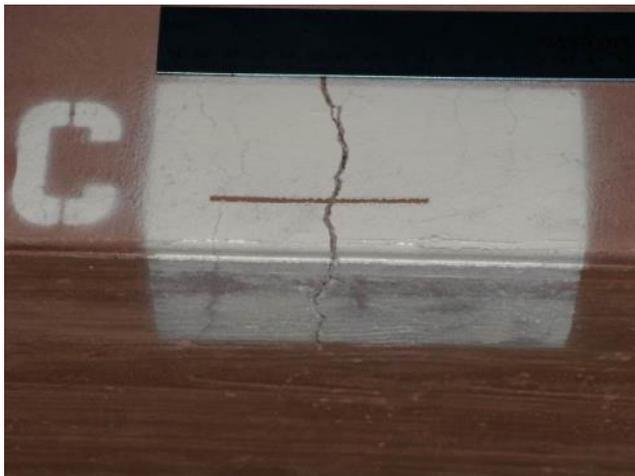
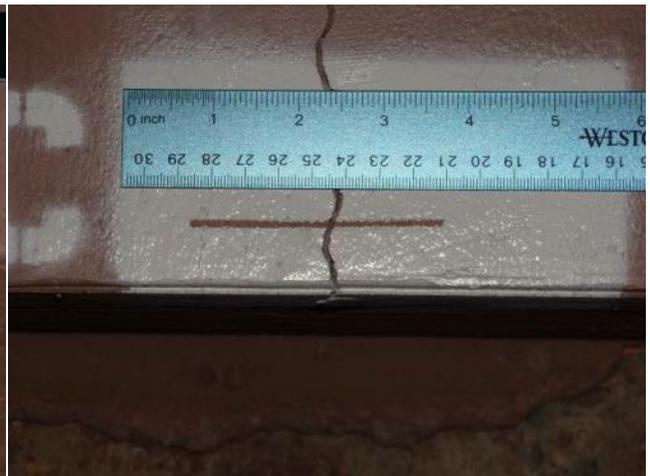
Appendix D contains the updated concrete crack photos taken on April 24, 2013. These photos document the crack locations and current condition. The cracks do not appear to have enlarged since 2012.

The following photographs were taken for the 2013 Mound Site Annual IC Assessment to document the current condition of the cracks in the red concrete in specified rooms in T Building. Figure D-1 room diagram shows the location of the crack monitoring points labeled A through I.
