MOUND PLANT

PRS 76

July 10, 1995

PRS HISTORY:

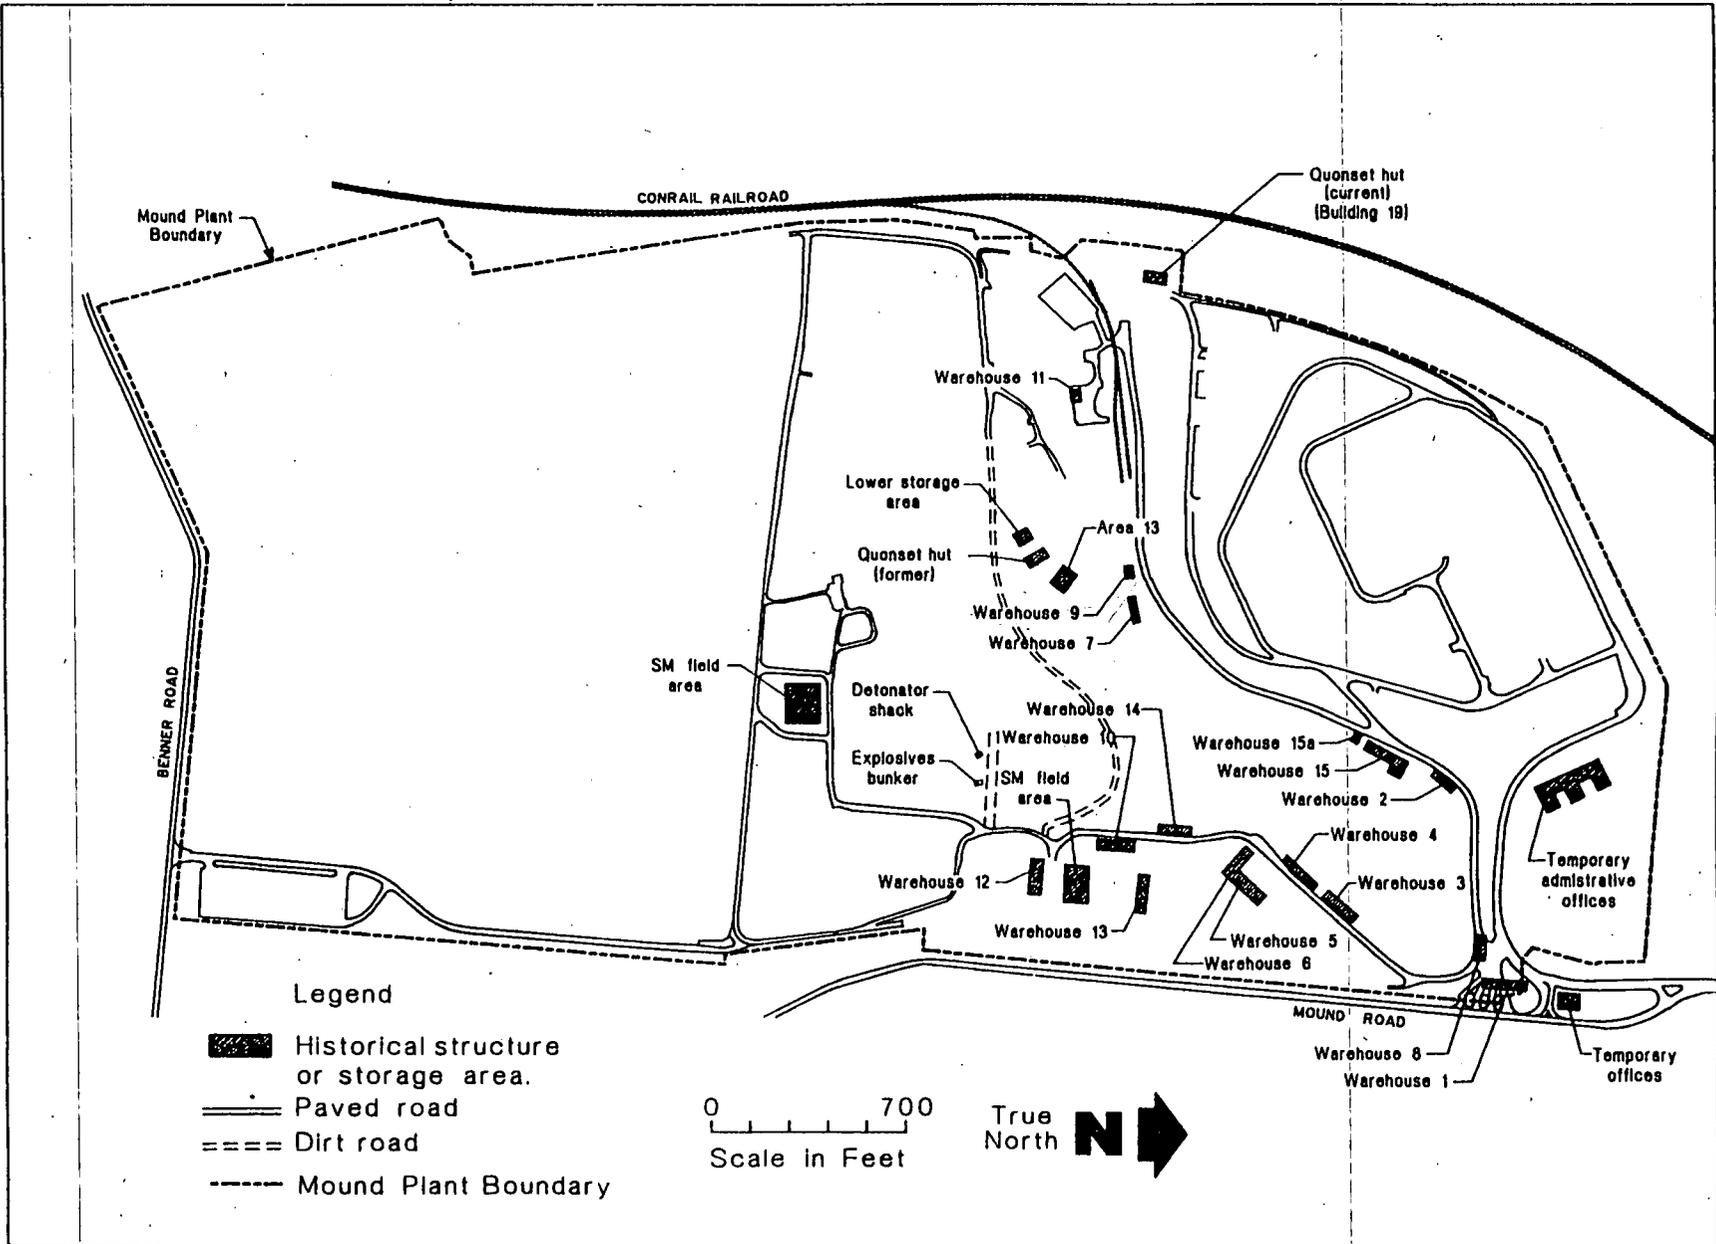
Figure 5.2. Historic buildings, structures, and storage areas.

Two structures for unloading boxcars were located along the south side of the railroad siding south of the present Building 22 (Figure 5.2). The larger of the two was Warehouse 7, located at the far end of the siding; the smaller was Warehouse 9. These were sometimes referred to as the old railroad warehouses. Both buildings were wooden structures with elevated wooden floors and with docks along their north sides. Warehouse 7 is not known to have been used by Mound. Warehouse 9 had a heavy floor structure and was apparently used to ship and receive drummed radioactive materials. Until December 1954, Warehouse 9 served as the central point of waste shipments (MCC 1951-1956). In September 1953, drums of waste from the Purex pilot plant were moved from Warehouse 13, where they had been stored, to Warehouse 9 for shipment to ORNL for burial (MCC 1953-1957). In 1955, Warehouse 9 was used for the unloading of thorium drums for the planned thorium refinery. The drums were moved by truck to other areas of the plant for storage. Neither of the old railroad warehouses was used for unloading of the lead casks used to ship radioactive materials into Mound; the casks were too heavy and required crane unloading along the siding. Warehouse 9 was last used December 7, 1954. Warehouse 15A was used thereafter for waste shipments (MCC 1951-1956). Review of photographs indicates that it was gone by August 1962. It was probably sold for salvage.

and, as with many of the old warehouses, the flooring was too contaminated to remove from the site and may have been burned in place. The site of Warehouse 9 currently lies under a paved parking lot.

Numerous wooden buildings were built by Maxon Construction Company during the initial phase of plant construction in 1947. These temporary buildings included warehouses for shipping and storing construction materials and equipment and supplies, as well as for use as office space (Figure 5.2). Several of the warehouses were retained by Mound after plant construction to provide enclosed storage. Warehouses numbered 1 through 8 and 11 and 12 (Figure 5.2) were apparently demolished in the early 1950s. There are no records that indicate that these 10 structures were ever used by Mound. The temporary office buildings (Figure 5.2) in the north parking lots were also demolished during this time period. Warehouses 9, 10, 13, 14, 15 and 15a were used to stage or store radioactive wastes for shipment offsite. The records of use of these building are sketchy and fragmented.

Warehouse 10 was located on the SM/PP Hill in an area now partially occupied by Building 38 (Figure 5.2). Warehouse 10 was used in the early 1950s to store materials contaminated with polonium-210 from the Dayton units (Bradley 1953e). Over the years much of the radioactivity died away and by August 1956, the materials were either cleaned and sold for salvage or shipped to ORNL for burial (Meyer 1956b). The building itself was sold for salvage, but the flooring was too contaminated and was burned in place during the fall of 1956 (Meyer 1956e, 1957a).

Warehouse 13 was located on the SM/PP Hill in the area now occupied by the SM Building (Figure 5.2). It was a wooden structure and probably had a concrete floor. During the mid-1950s, Warehouse 13 was used to store waste materials from the radium/actinium program and the Purex pilot plant (Bradley 1953f). In 1952, materials contaminated with low levels of radioactivity from the radium/actinium program were placed in Warehouse 13 until they were moved to the Quonset hut for shipment offsite (Bradley 1952f). These were probably solid wastes of some sort, as all liquids were processed in an evaporator (see project descriptions in this report). In March 1953, eight 55-gallon drums of sludge with high gamma radiation (1.5 rem), along with miscellaneous tanks, pipes, and valves from the Purex pilot plant, were moved to Warehouse 13 for storage (MCC 1952-1957). By September 1953, the sludge drums were moved from Warehouse 13 to Warehouse 9 for shipment offsite. One of the drums apparently leaked and the contents were redrummed in Warehouse 13. The floors of Warehouse 13 were scrubbed (MCC 1953-1957). No record was found of the decommissioning of Warehouse 13, but it is noted during a review of photographs that the building was gone by August 1956. The floor remained and was used as a pad for storage of thorium drums in 1959.

Warehouse 14 was located on the SM/PP Hill, on the west side of the access road just south of the present Building 30 (Figure 5.2). It was a wooden structure and probably also had a concrete floor. Very little is actually known about this structure. A logbook entry on August 30, 1958, indicates equipment destined for disposal was stored in Warehouse 14 (MCC 1951-1961). No other data were given. Another log book entry, dated January 18, 1966, indicates that WD sludge was moved to the Warehouse 14 area, behind the SM Building (MRC 1961-1968). In January 1966, drums of apparently recoverable plutonium-238 and contaminated trash were to be moved from Warehouse 14 to the new storage Building 31. Contaminated trash was apparently stored since May 1965 (McMannon 1963-1966). There are no records of the decommissioning of Warehouse 14, but it is noted during a review of photographs that the building was gone by March 1968. The floor is still present.

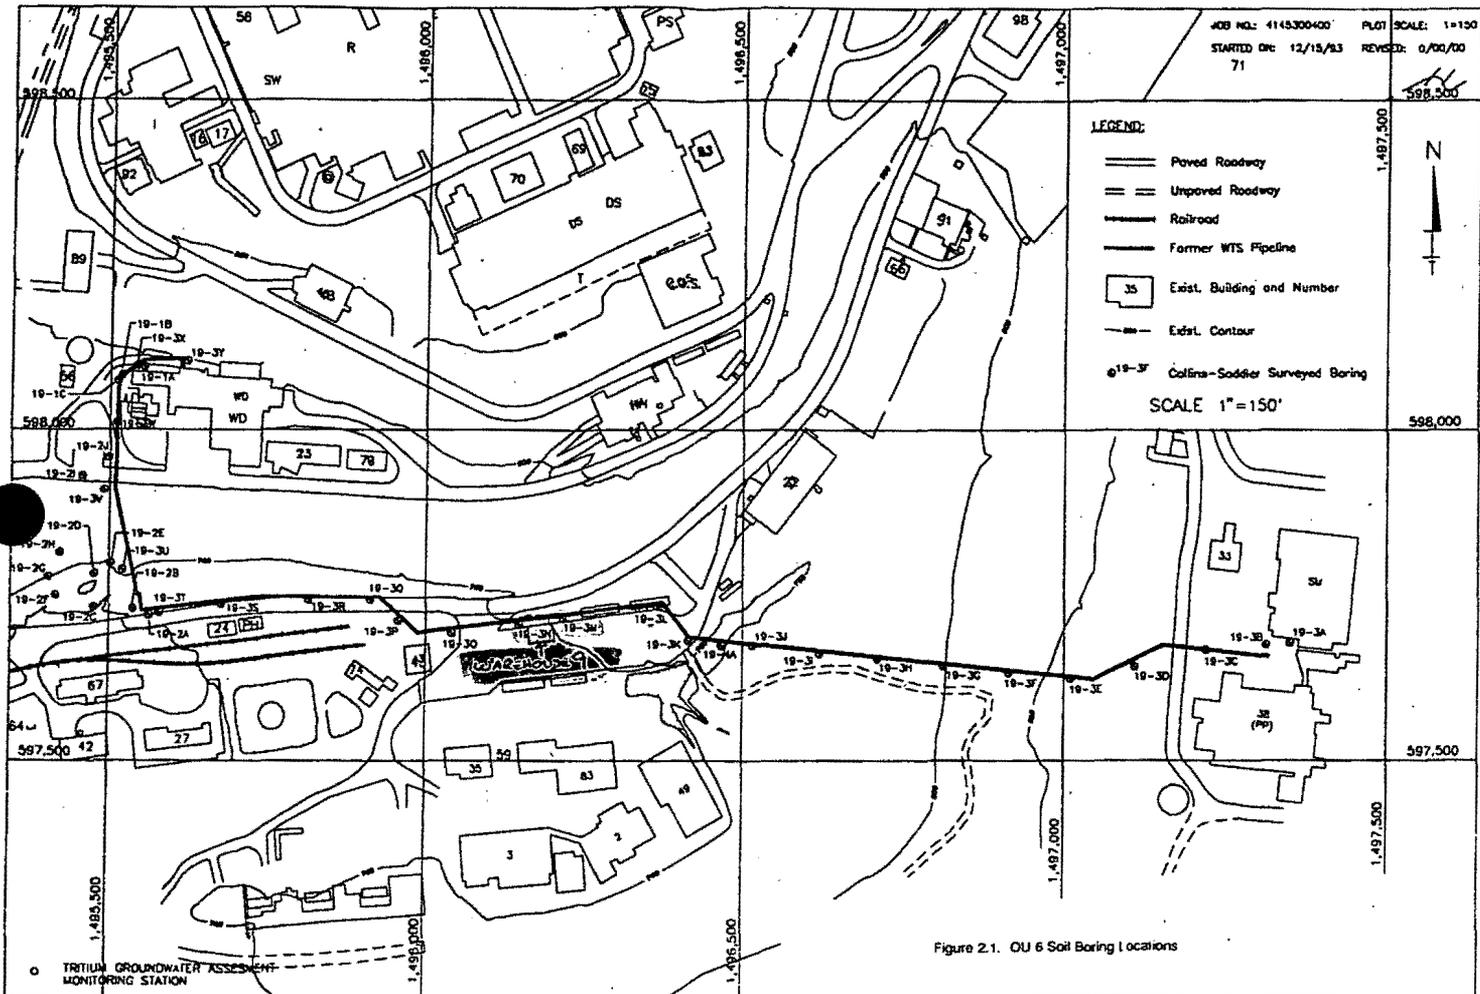
Figure 2.1. OU 6 Soil Boring Locations

A soil sampling verification investigation at Mound's OU 6 Area 19 and Area 14 was performed. Based on extensive testing, a review of all the analytical data for both radiological and non-radiological parameters and a statistical analysis of the analytical data, a conclusion was reached that the mean value of the analytical results for Pu-238 and Thorium isotopes have attained the cleanup criteria.

The results of the subsurface soil samples in Area 19-1 and Area 19-2 indicate that the cleanup criteria for Plutonium and Thorium isotopes was attained. However, one sample, 19-1B did exceed the ALARA value of 25 pCi/gram for Plutonium. The results of the subsurface investigation in Area 19-3 indicate that the cleanup criteria for Thorium isotopes was attained.

The results of the soil samples for Pu-238 indicate that some contamination still exists. Levels of Pu-238 of 132.05 and 100.92 pCi/gram were found at the Area 3 locations, 19-3A and 19-3B, respectively. In addition, a Pu-238 value of 82.57 pCi/gram was obtained from a sample collected at the Area 1 location, 19-1B. However, the mean and upper 95 percent confidence value for Pu-238 in Area 3 location indicates that the cleanup was successful.

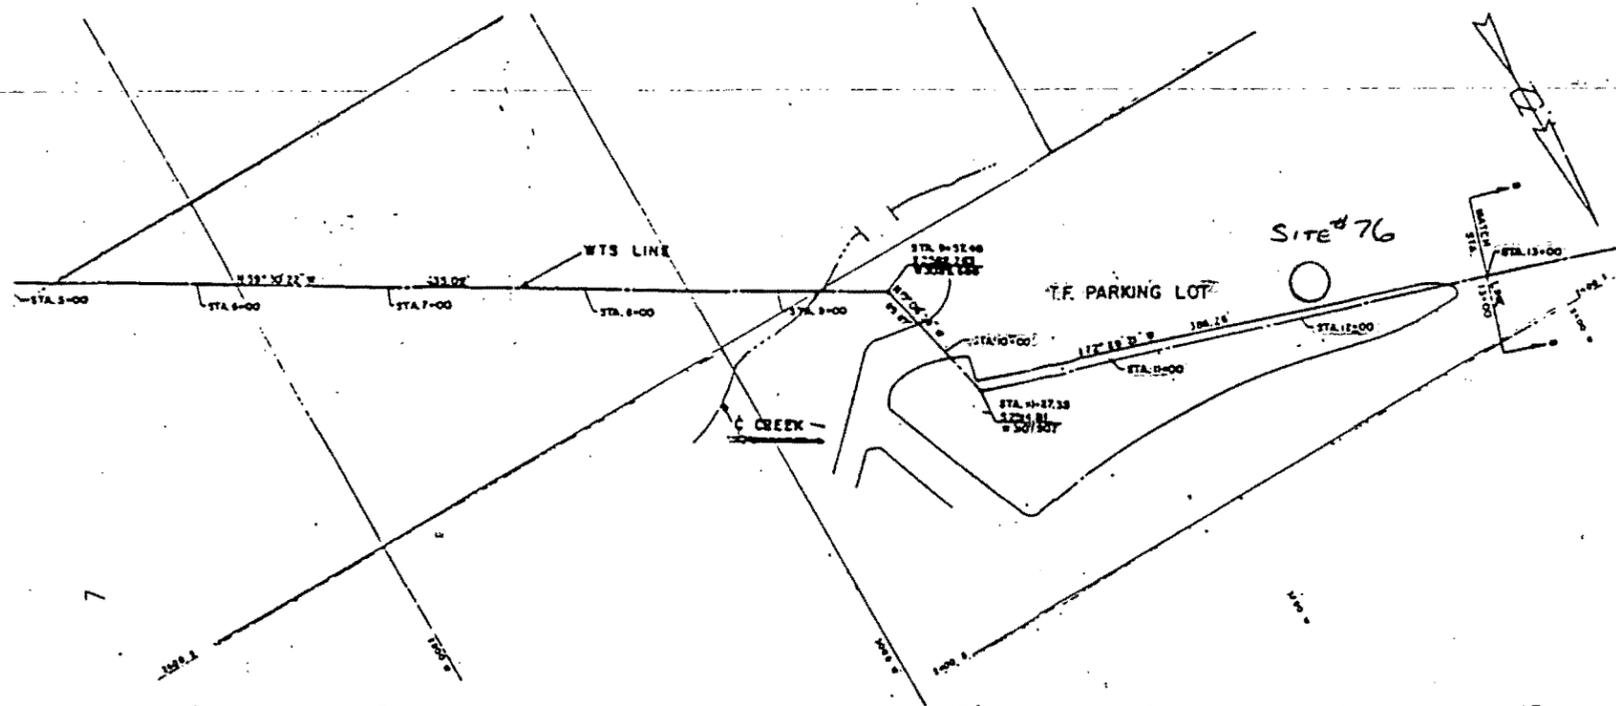
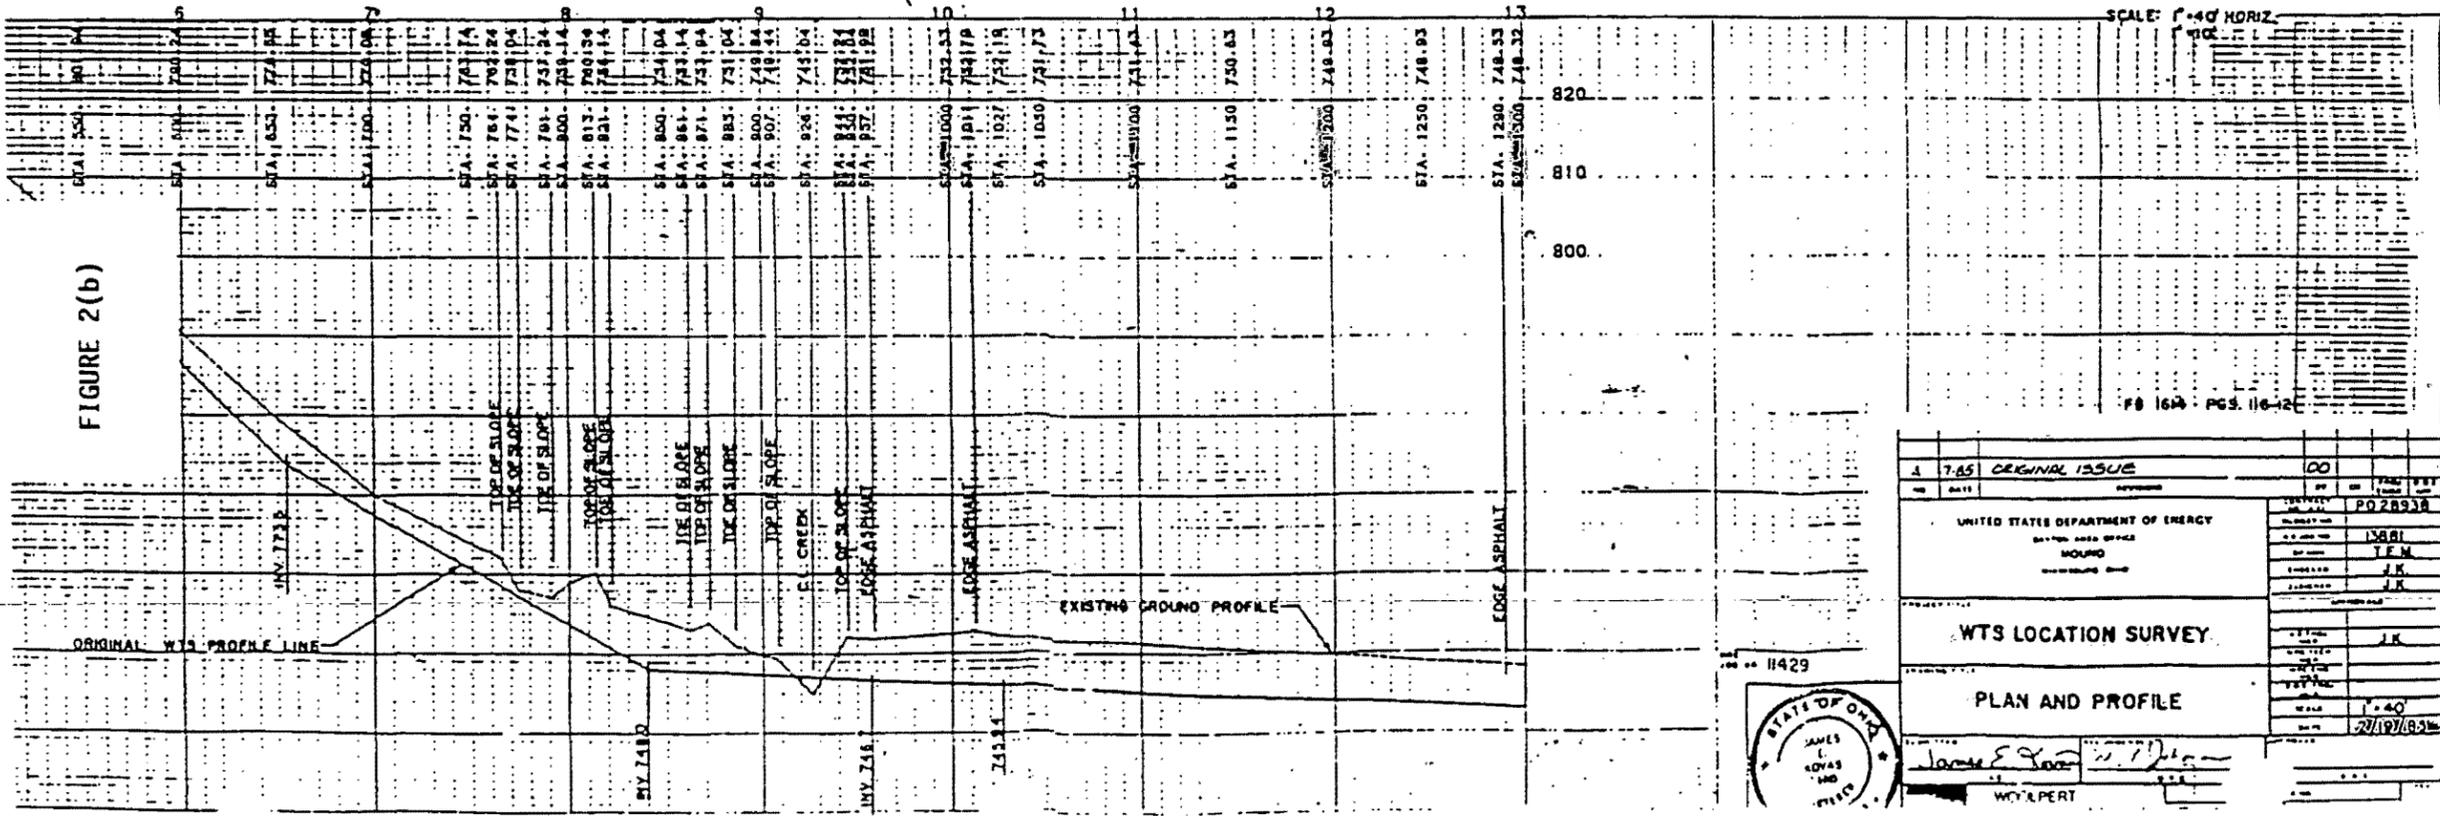
DATE	7-85	DESCRIPTION	ORIGINAL ISSUE	BY	JK	CHKD	JK
UNITED STATES DEPARTMENT OF ENERGY				PROJECT NO. PD2893A			
MOUND				DATE 1981			
WTS LOCATION SURVEY				DRAWN BY J.K.			
PLAN AND PROFILE				SCALE 1" = 40'			
DRAWN BY James E. ...				DATE 2/19/83

NOTE: 1 THE COORDINATES, BEARINGS, AND DISTANCES BETWEEN ANGLE POINTS ON THE WTS LINE WERE OBTAINED FROM MOUND LAB DRAWING NO. FSE19801 SHEETS 2, 3, AND 4.
 2 THE ORIGINAL WTS PROFILE WAS OBTAINED FROM MOUND LAB DRAWING "RADIOACTIVE WASTE PROCESSING FACILITY" SHEET NO. 8-6.
