MOUND PLANT

Potential Release Site Package

PRS # 345

**MOUND PLANT
PRS 345
FORMER EQUIPMENT STORAGE SITE
NEAR AREA C**

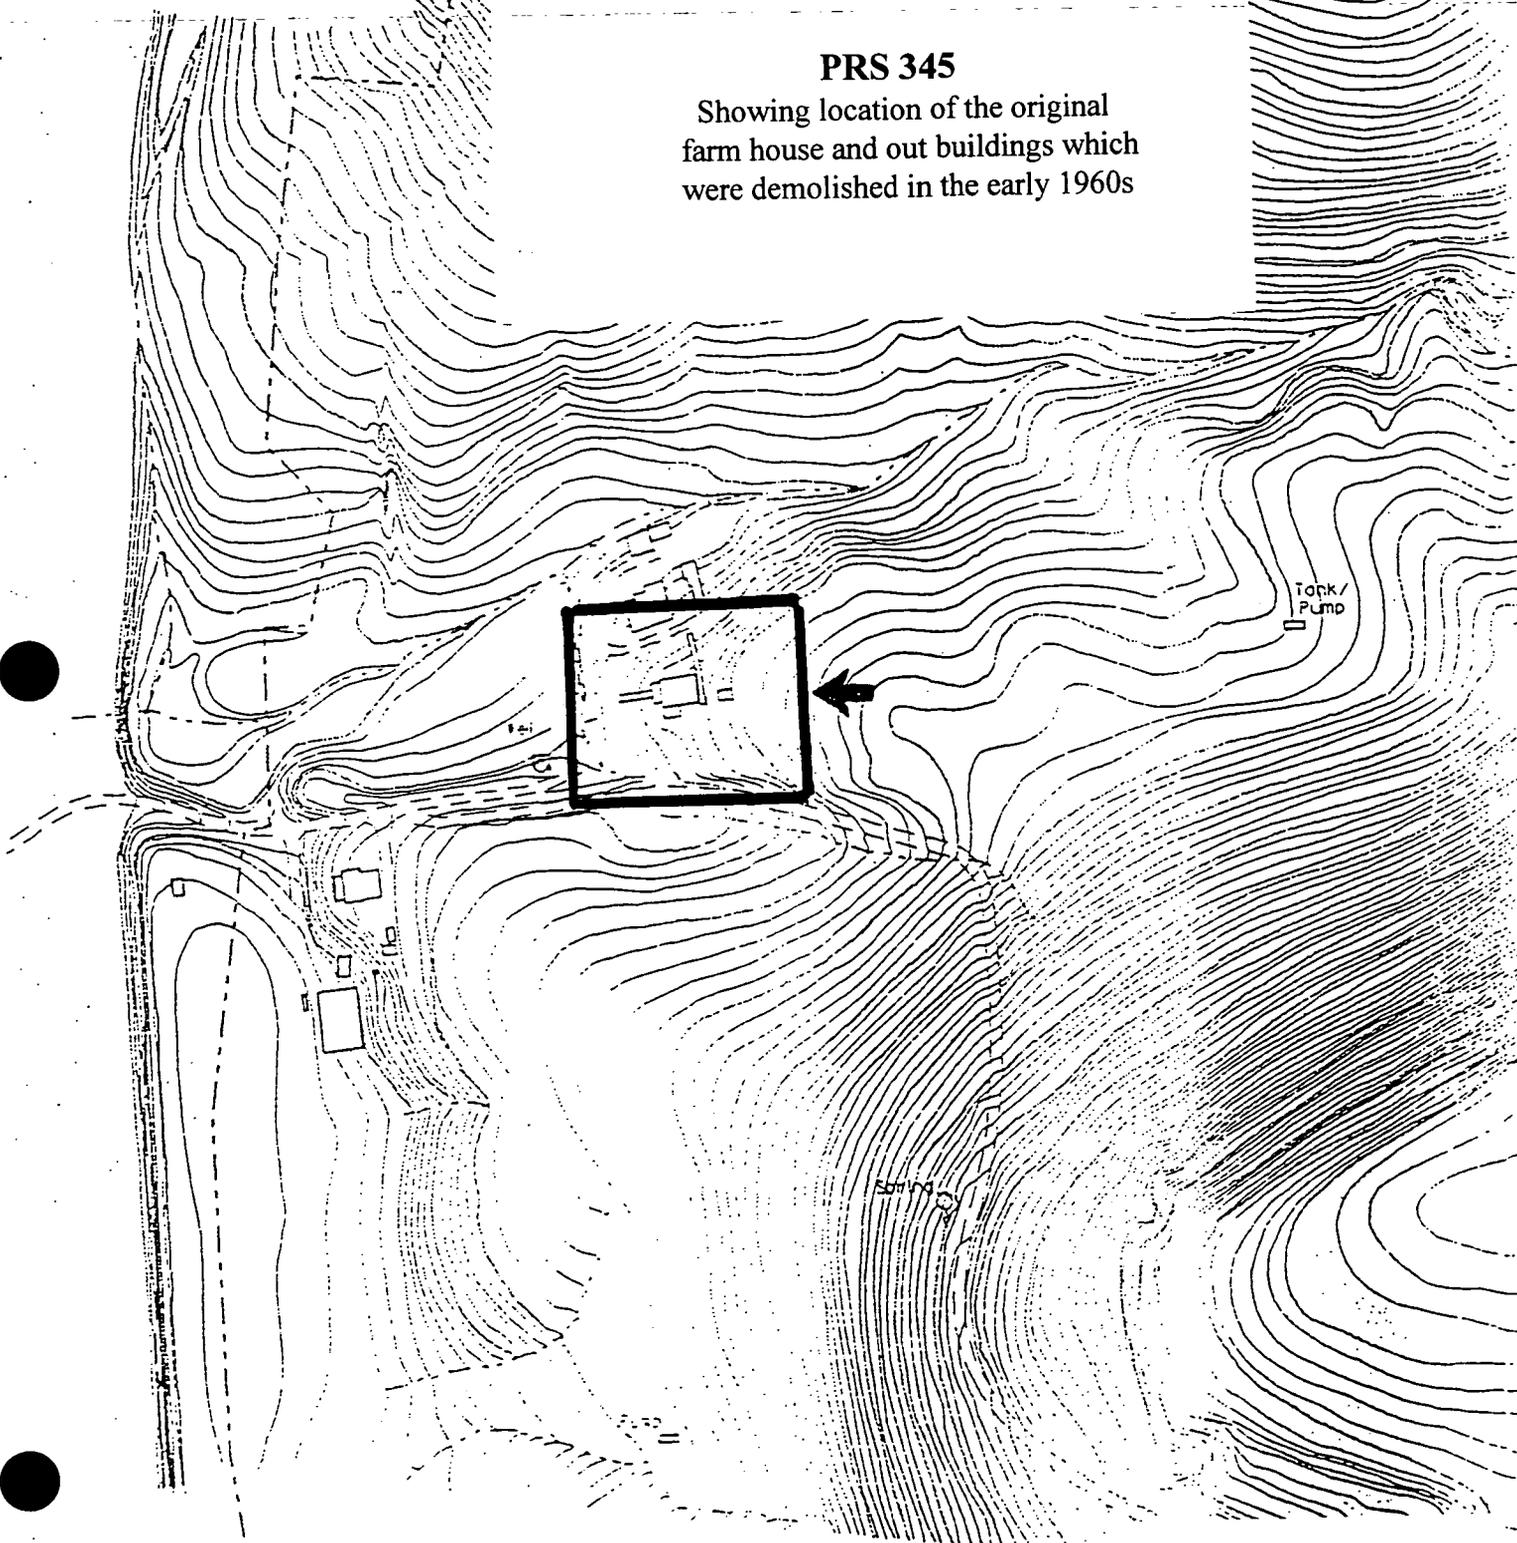
PLATE 3

Historic Topographic Map
of Main Hill, 1946

Showing location of the original
farm house and out buildings which
were demolished in the early 1960s

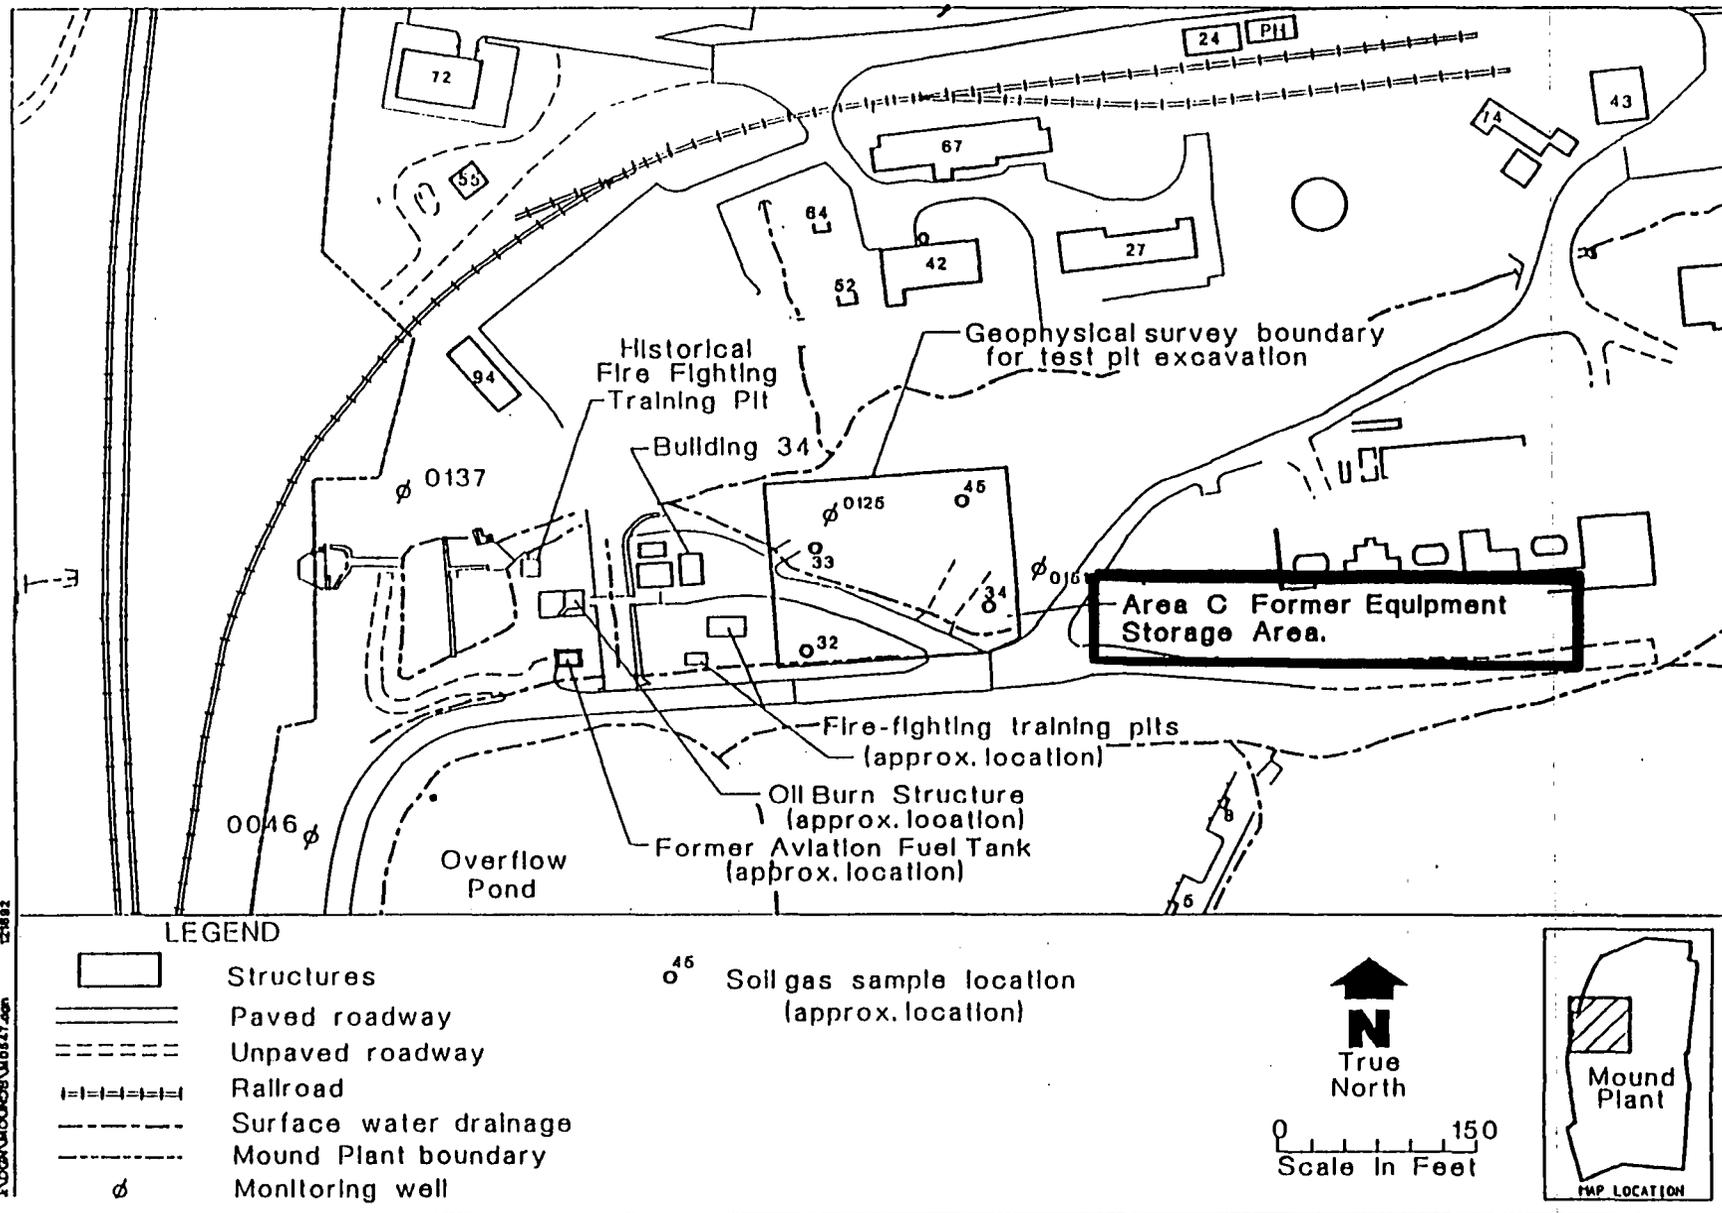
Figure 2.16(a). Area C Former Equipment Storage area.

Area C is located in the Mound Plant lower central valley (Figure 2.16(a)). "Area C" is the name given to a site where lithium carbonate containers were treated and disposed of. From its identification by the CEARP Program in 1986 through mid 1991, this area was believed to be in the location described in the OU 3 Work Plan, east of Building 34, as shown in Figure 2.16(a). However, in 1991 it was determined that the disposal area was more nearly centered around the current location of Building 34. In this subsection, the investigation of the erroneously located "Area C" is described. This area was investigated despite new information about its correct location, because geophysical surveys had identified subsurface anomalies in the area.

Located within Area C is monitor well 0125. Located to the east of Area C and southwest of the former location of Old Building 72 is monitor well 0151 as shown in Figure 2.16(a).

In the 1980s, Area C was a grassy field that was used as a contractors' equipment yard and staging area for nonhazardous material, such as semi-trailers and rebar. Storage of contractors' equipment was discontinued in the area in the 1990s and the area currently is an undeveloped grassy field. Structures west of Area C include Building 34, a drop tank, a submergence tank, and a test burn facility. The Building 34 Oil Burn Structure, Former Aviation Fuel Tank, Fire-Fighting Training Pits, and retention basins are also located to the west of Area C.

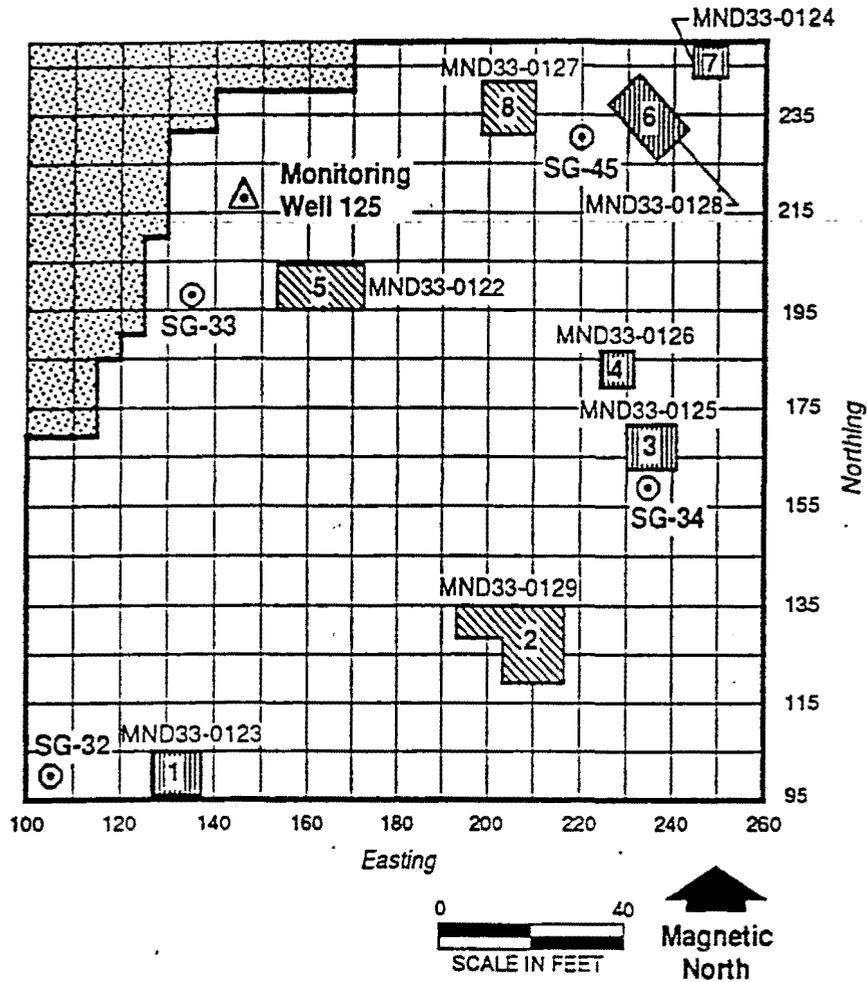
Figure 2.16(b). Area C Former Equipment Storage Area test pit locati

A geophysical investigation was performed in Area C using two techniques, ground penetrating radar (GPR) and magnetic measurement. The objective of the geophysical investigation was to identify locations in Area C where ferrous metal objects were buried. Magnetic anomalies were detected at eight locations in Area C as shown in Figure 2.16(b). Only three of the anomalies were associated with the objects detected on the GPR records. Five of the magnetic anomalies presented in Figure 2.16(b) were located in close proximity to the four soil gas sample stations.

excavations using a backhoe. The test pit areas were marked according to coordinates as stipulated in the Work Plan and are shown on Figure 2.16(b). Excavation work was conducted by WESTON representatives from 31 January to 4 February 1992. Test pit excavations were performed according to Work Plan guidelines. Three of the test pits (nos. 2, 5, and 8) were associated with anomalies found using GPR techniques. The remaining test pits (nos. 1, 3, 4, 6, and 7) were associated with the anomalies found during the magnetic survey.

Excavation work was performed while wearing Level C personal protection equipment. Readings with direct-reading instruments were taken at each 2.0-ft-depth interval from soil collected from the backhoe bucket as specified in the OU3 Work Plan and Sampling and Analysis Plan. The soil was collected using stainless steel scoops and bowls. Photoionization detector and flame ionization detector instrument readings were not greater than 1.0 unit above background for all samples and therefore, as specified in the OU3 Work Plan, no samples were retained for laboratory analysis.

Debris and any other objects found during the excavation activities were described and were returned to their original locations. Each test pit was backfilled during the same day of excavation. The following subsections describe the materials encountered in each individual test pit. The only deviation from approved protocol was that plastic sheeting was only used for the first excavation (no. 5) for soil placement. The other test pits had soil directly placed onto the native surface soils. This deviation from standard protocol was implemented when problems arose as a result of the saturated condition of the soil. Each test pit was backfilled with excavated soils immediately following completion of excavation and screening activities.

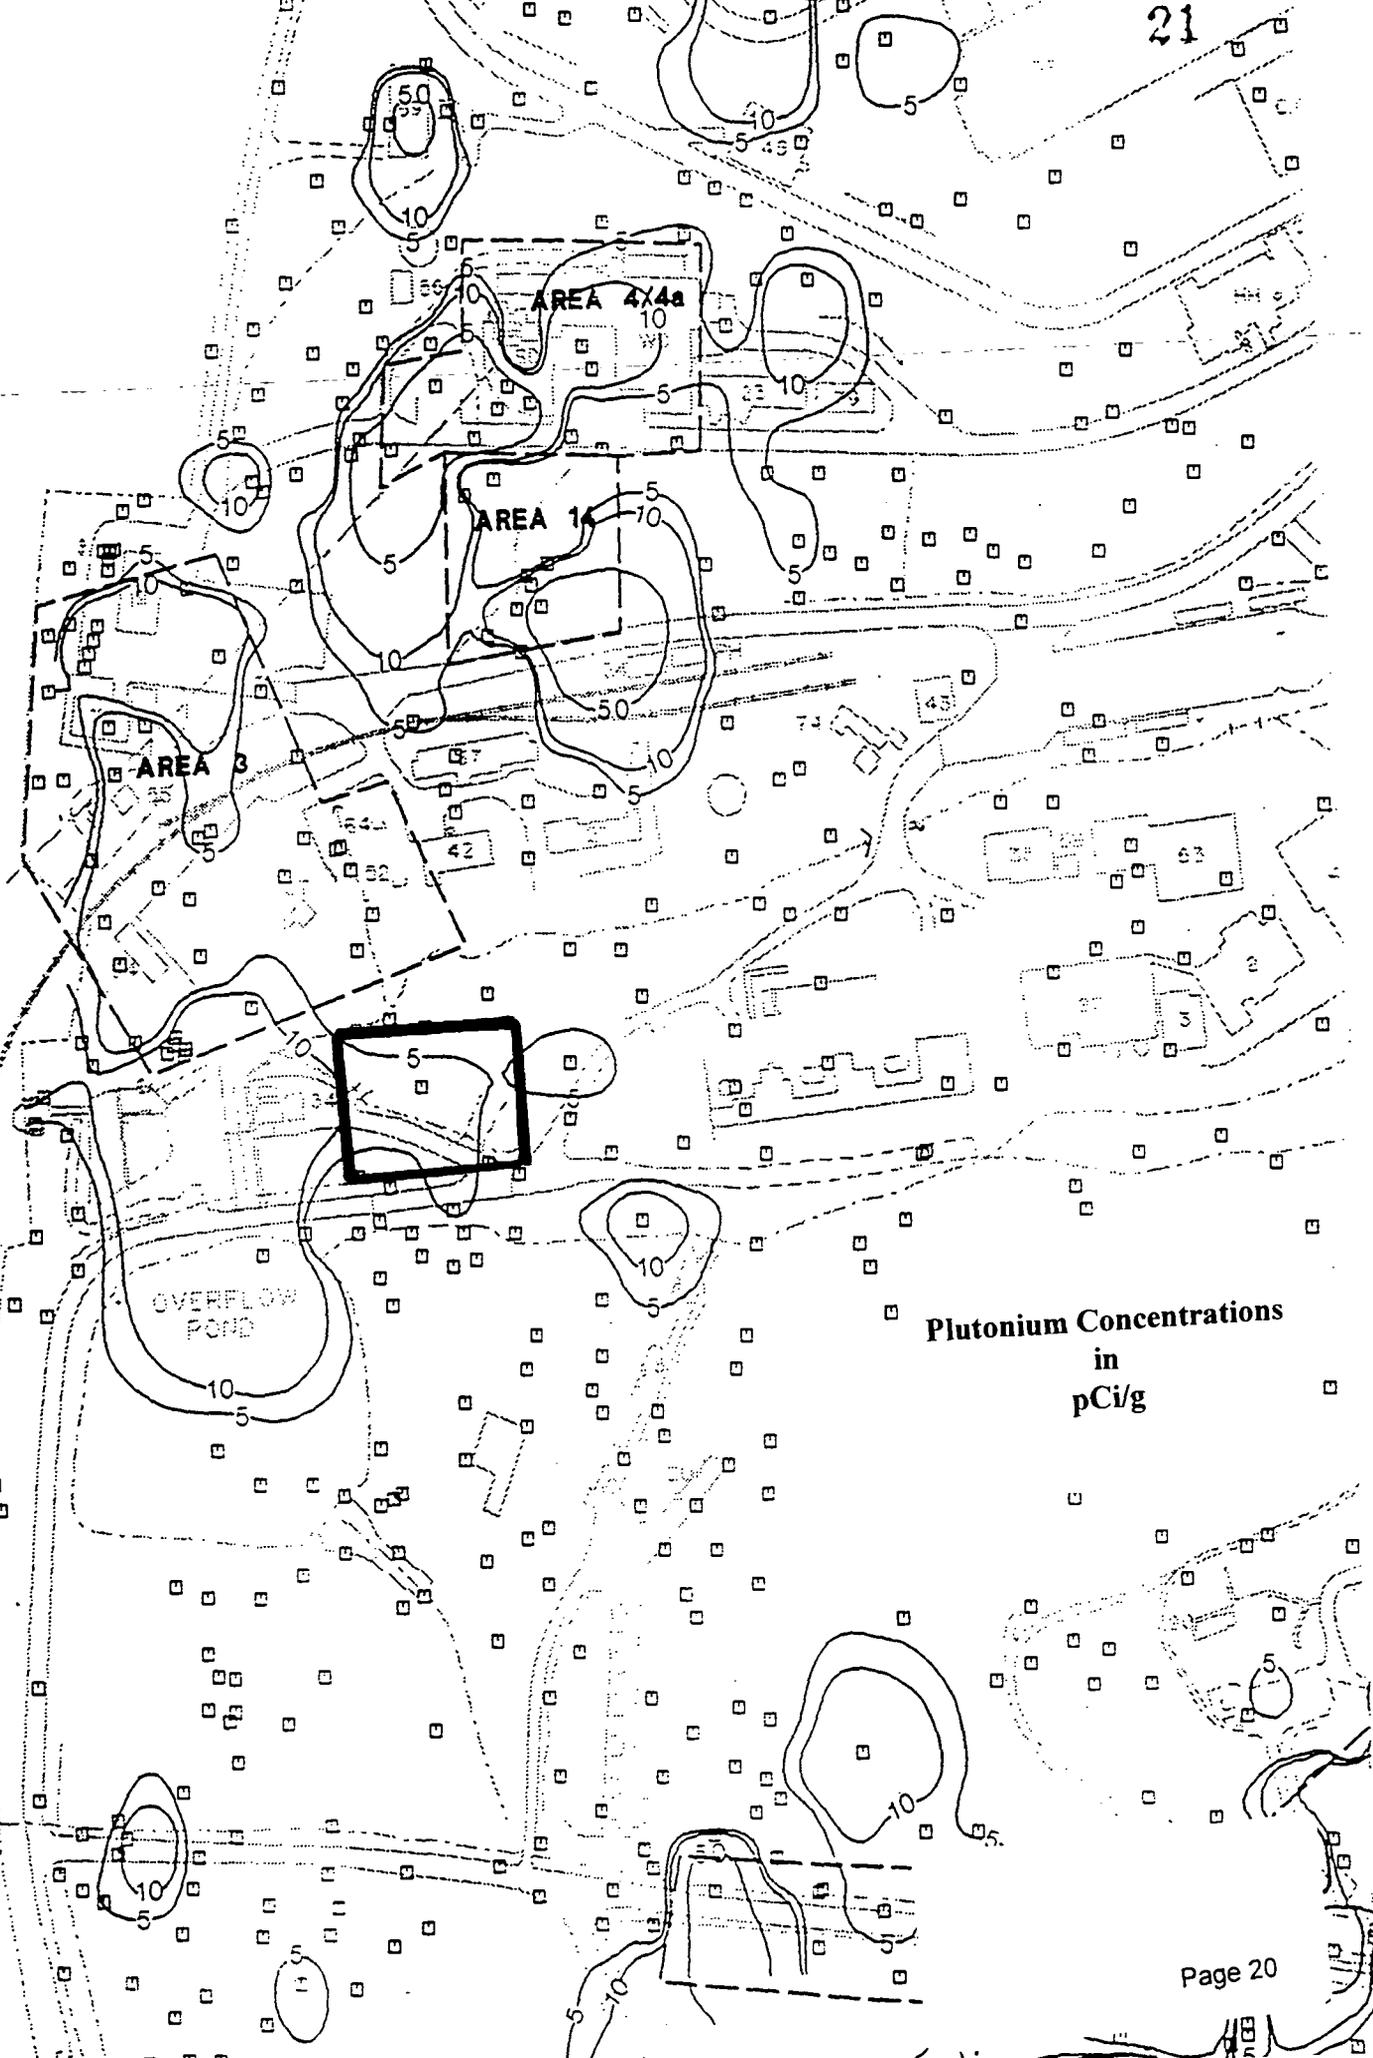
PLATE 4
Site Survey Project
Plutonium Concentrations

Plutonium Concentrations
in
pCi/g

Analyses for VOCs (Volatile Organic Compounds) from well 125 in the northwest downgradient corner of the area have shown no detectable contamination. Field screening of the soil during the OU3 Limited Field Investigation in the area resulted in detector readings not greater than 1.0 unit above background for all samples and therefore, as specified in the OU3 Work Plan, no samples were retained for laboratory analysis.³ Prior to the construction of the Bioremediation Facility native soil samples were taken to determine the existing condition of the area. The samples were analyzed for benzene, toluene, ethylbenzene, and xylene (BETX) and the results were below the detection limit of the instrument. The Radiological Site Survey indicated no Plutonium or Thorium concentrations above Mound action levels of 25 pCi/g for plutonium and 5 pCi/g for thorium.⁴

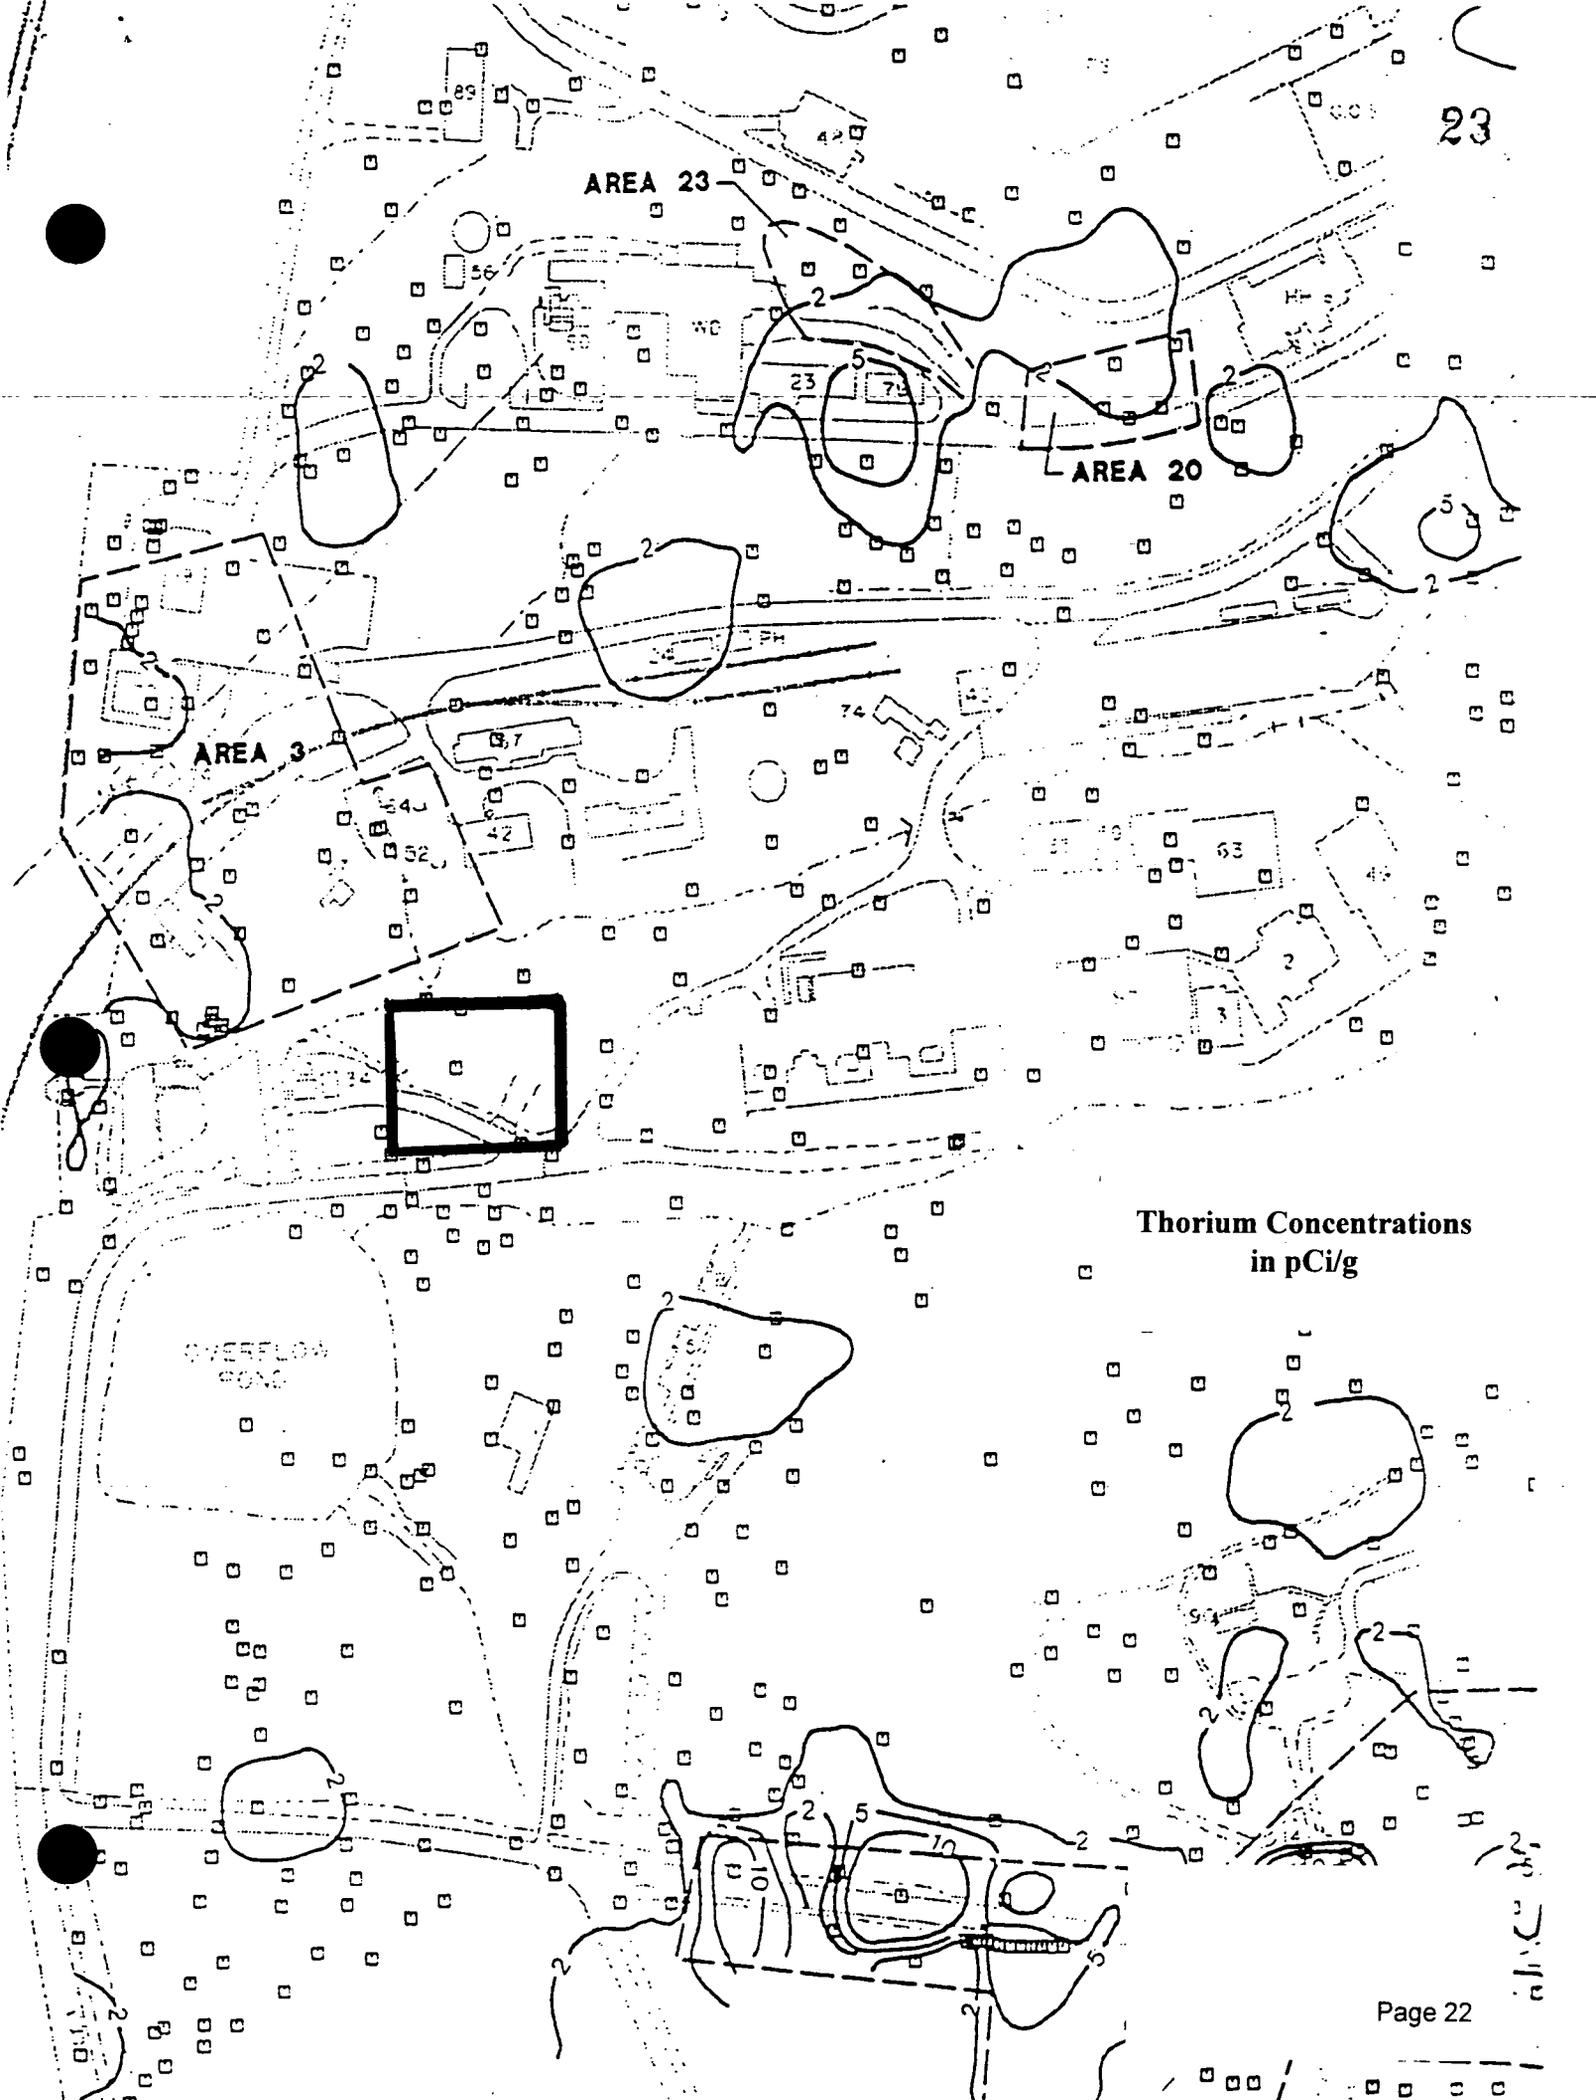
PLATE 5

Site Survey Project
Thorium Concentrations

Thorium Concentrations
in pCi/g
