SW BUILDING STRUCTURE REMOVAL ACTION

OSC REPORT

February 2006

Final

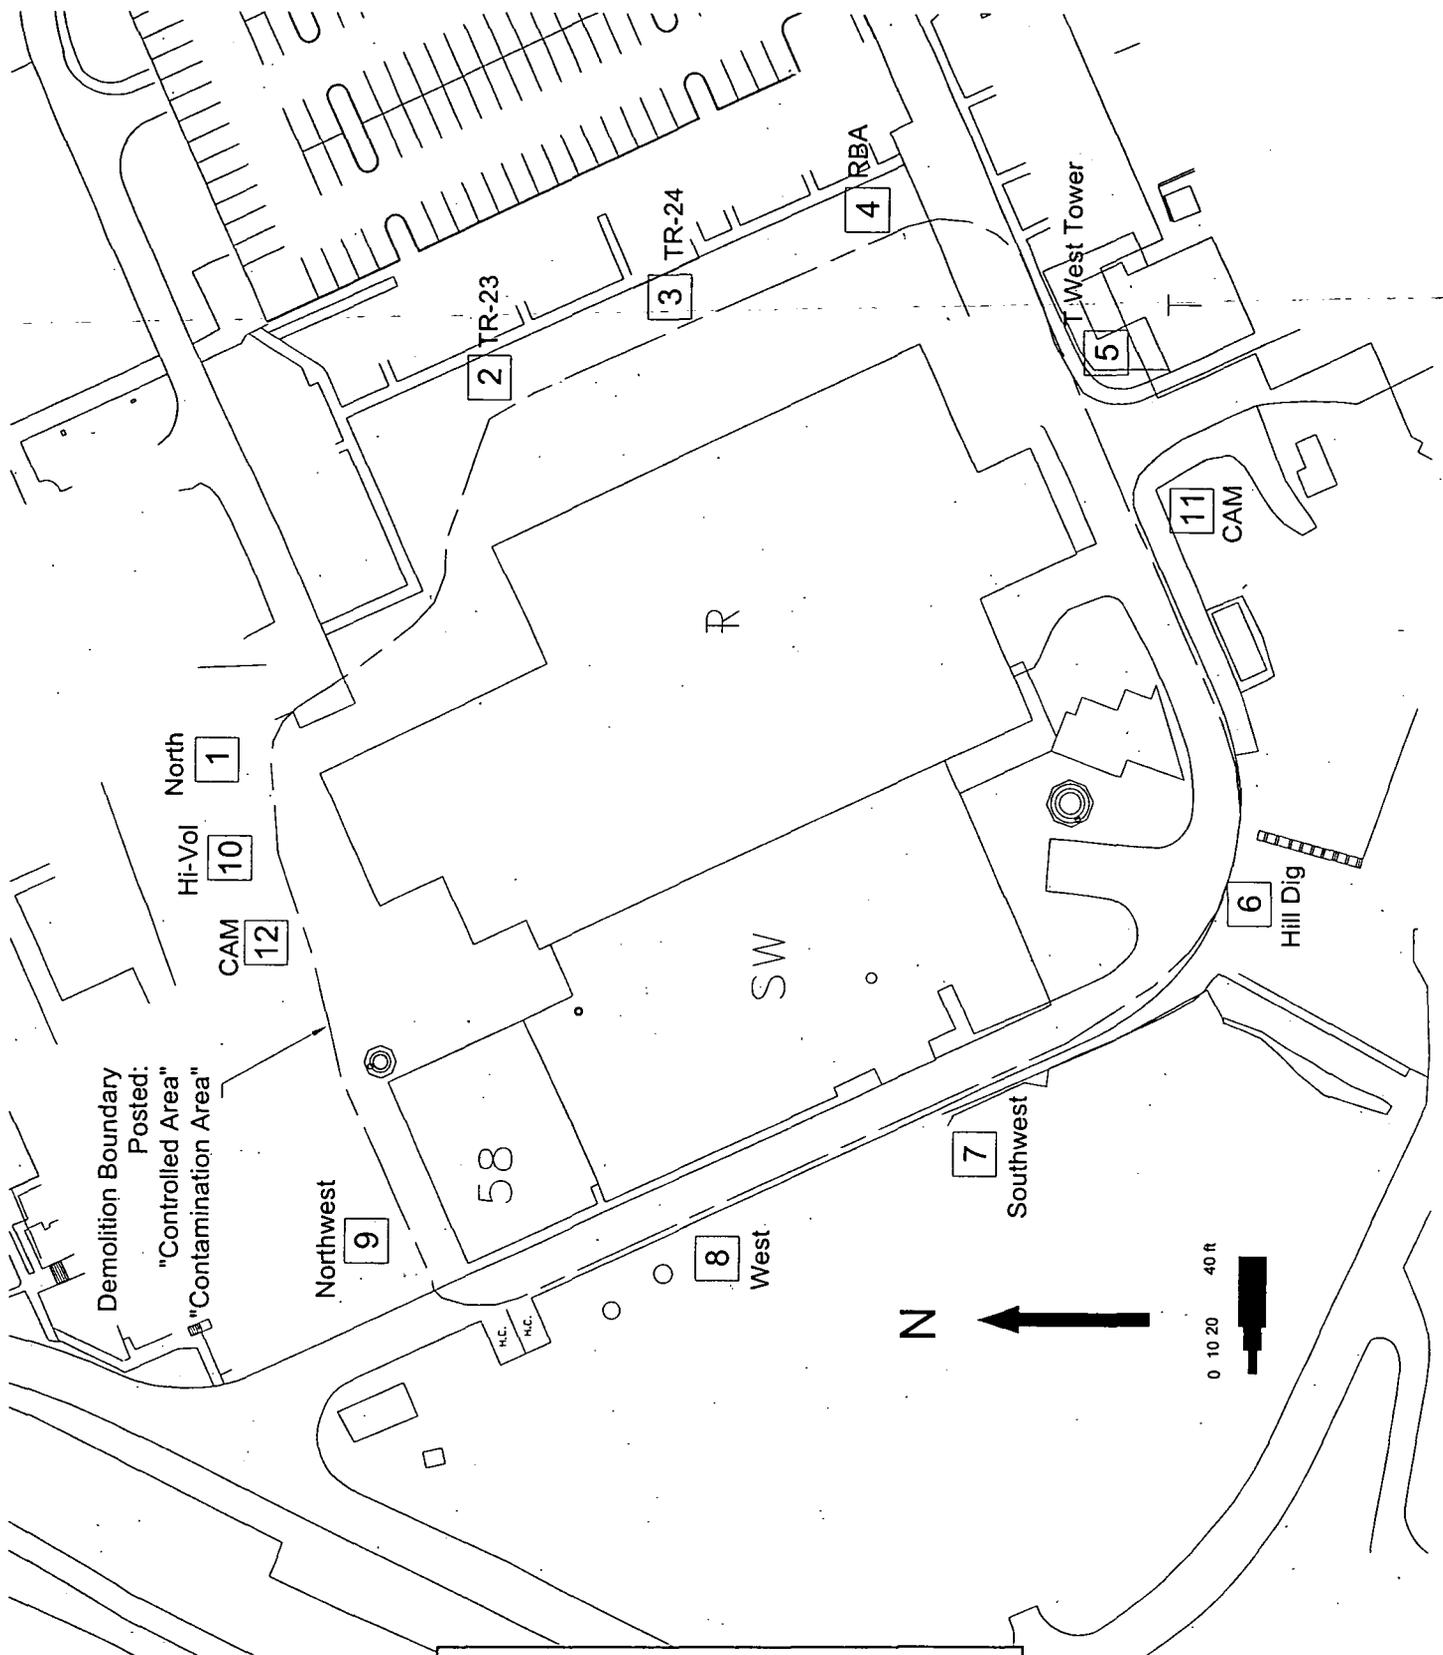
**R, SW, 58, T Stacks Demo
Air Monitor Locations
Fig. 2**

During demolition activities, the Mound Radiological Control organization performed air monitoring to confirm a safe work environment, in accordance with 10 CFR 835. Air monitoring results from the building demolition are provided in Appendix E. The locations of the air monitor stations are shown on Figure 2 in Appendix A. On each day that demolition activities were performed, at least two air monitors were used at any given time (one upwind of the work area and the other downwind of the work area). The monitors were repositioned in response to changes in wind direction.

*Figure 2 (Appendix A) shows the locations of the air monitoring stations.

The average of the air monitoring results at the demolition boundary was below 0.02 derived air concentration (DAC), which means that worker exposure was less than the Mound Administrative Control level of 100 mrem/year, based on 10 CFR 835. The air monitoring results from the Mound site perimeter monitors were all below the 0.3 DAC Mound posting criteria. No MCP worker or environmental exposure limits were exceeded, thus the demolition activities did not pose any additional risk to human health or the environment. (Appendix E).

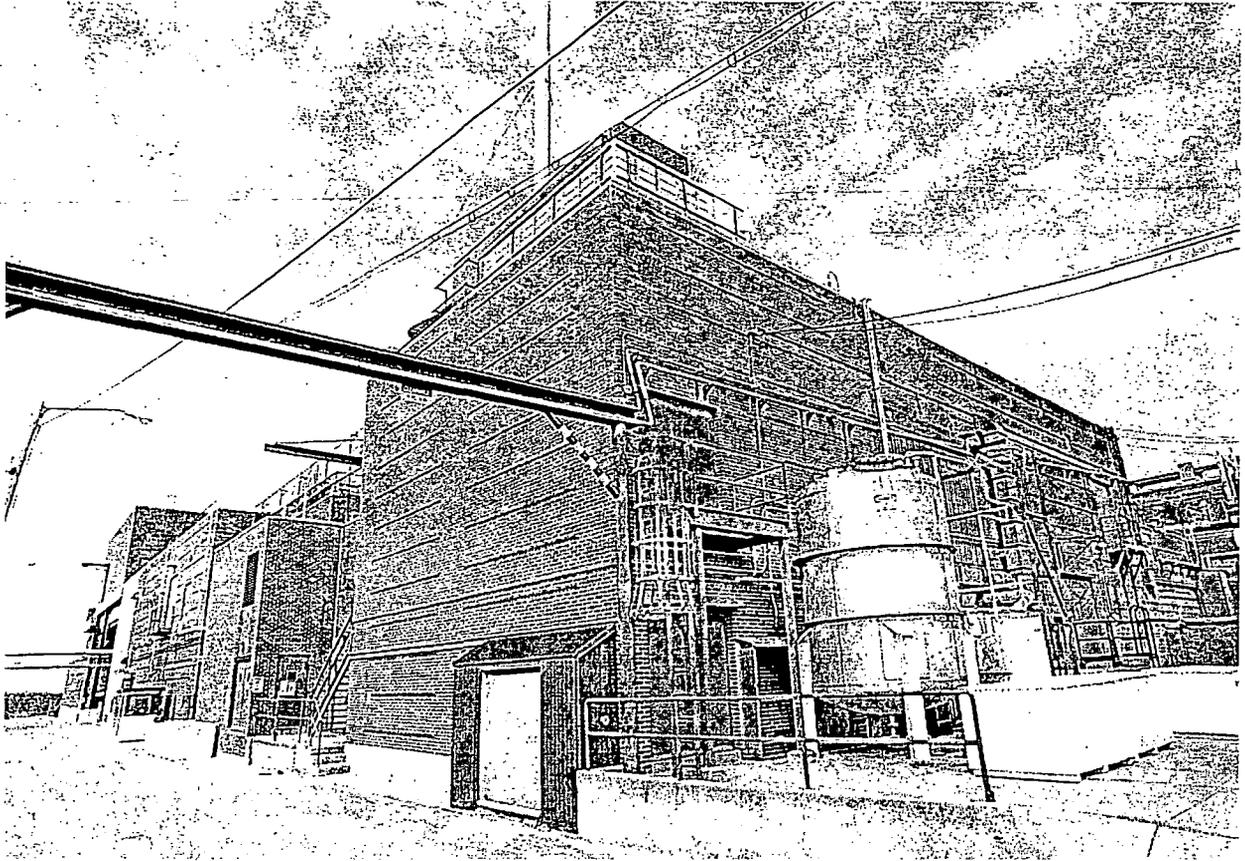
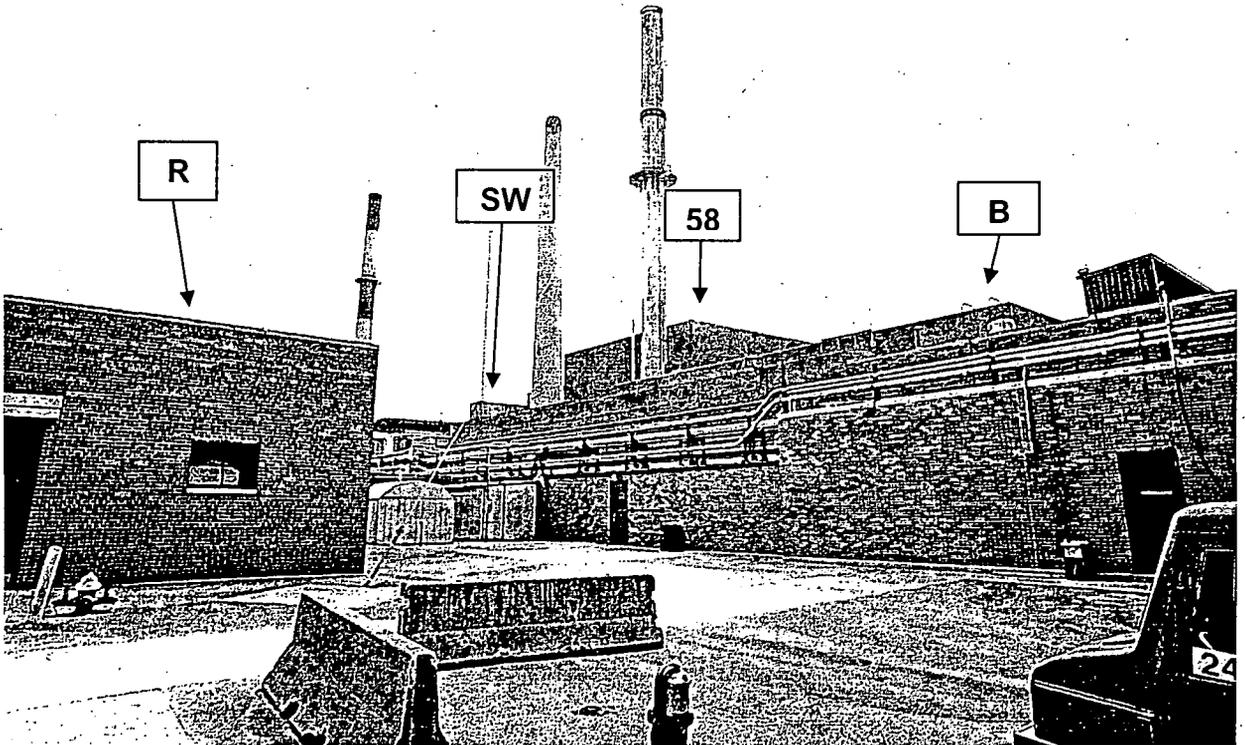
SW Building Before Demo
Top - SW Looking Northeast
Bottom - SW Looking Southwest

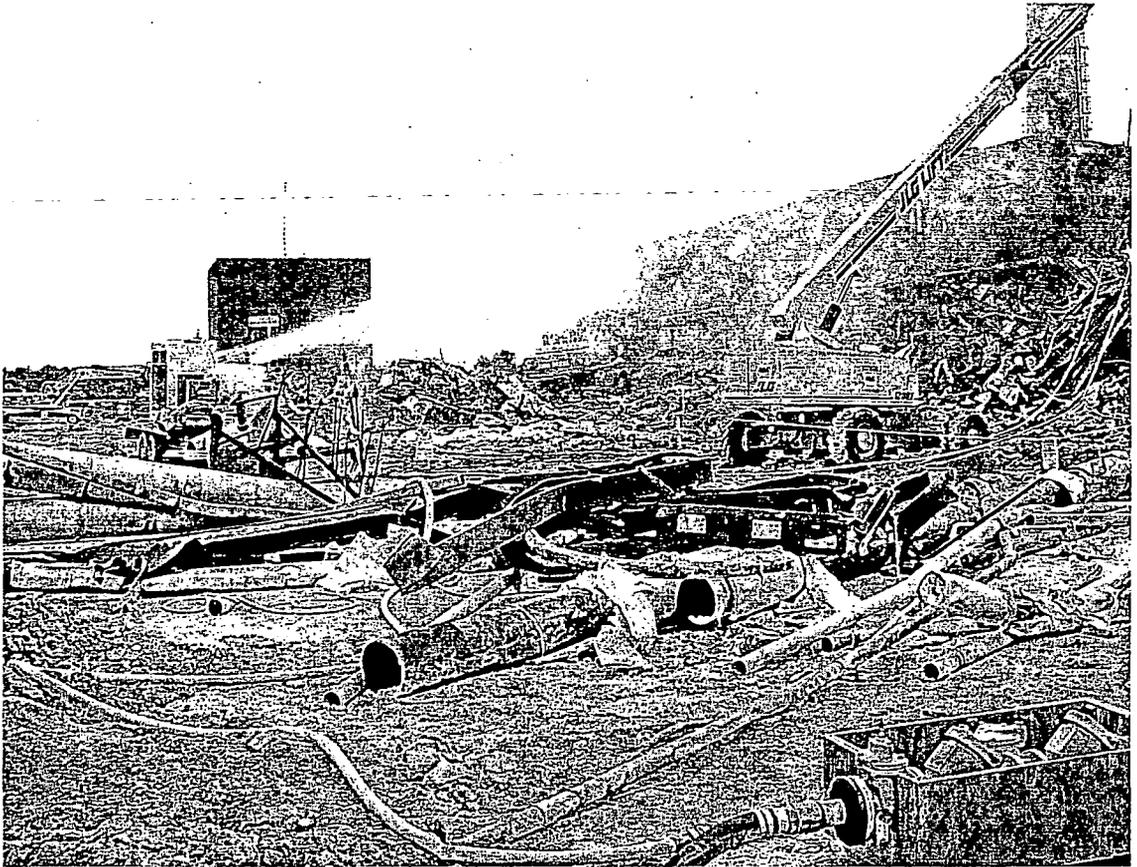
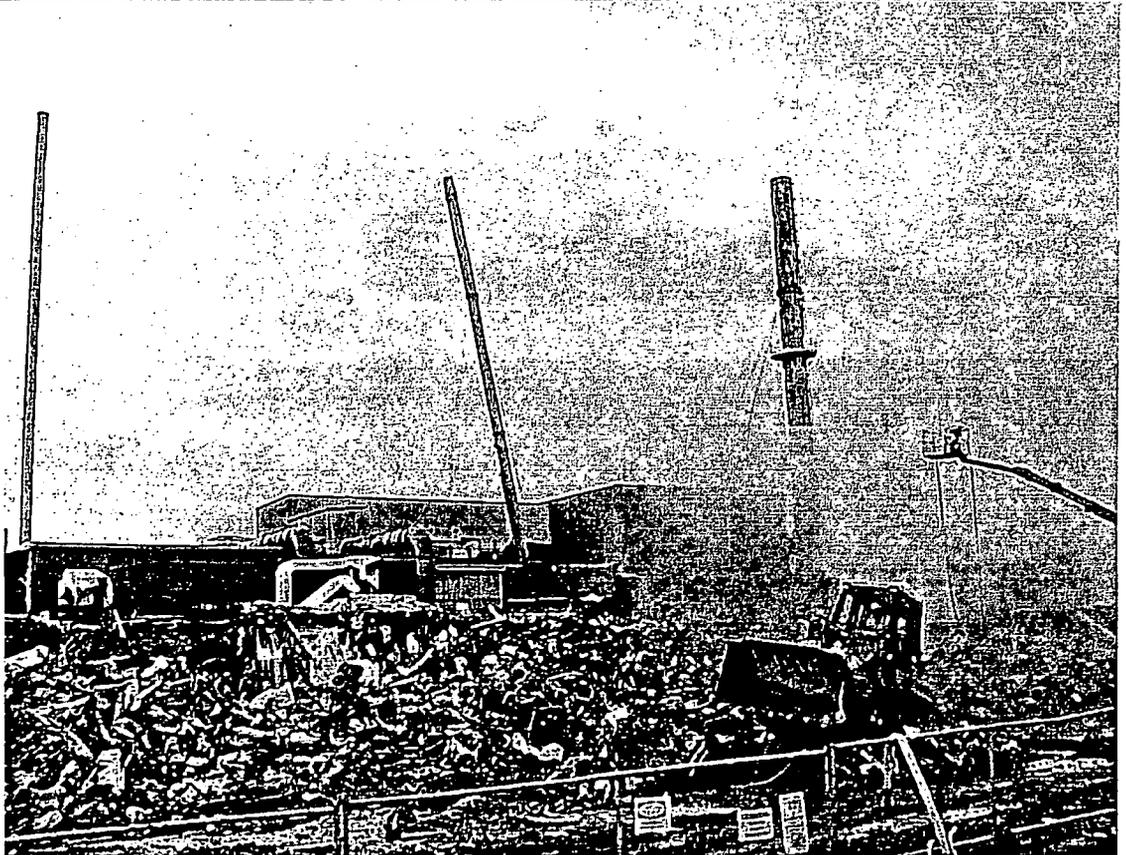
SW Building During Demo
Top - Looking Southwest
Bottom - Looking West

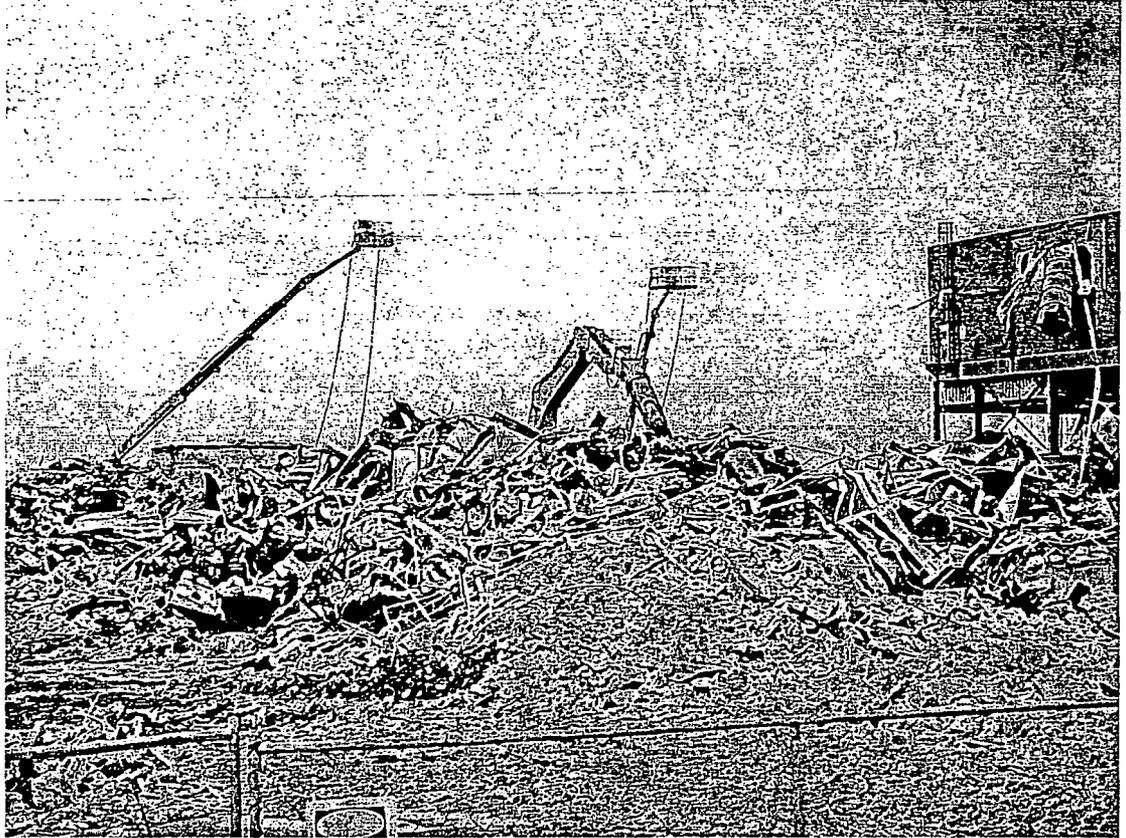
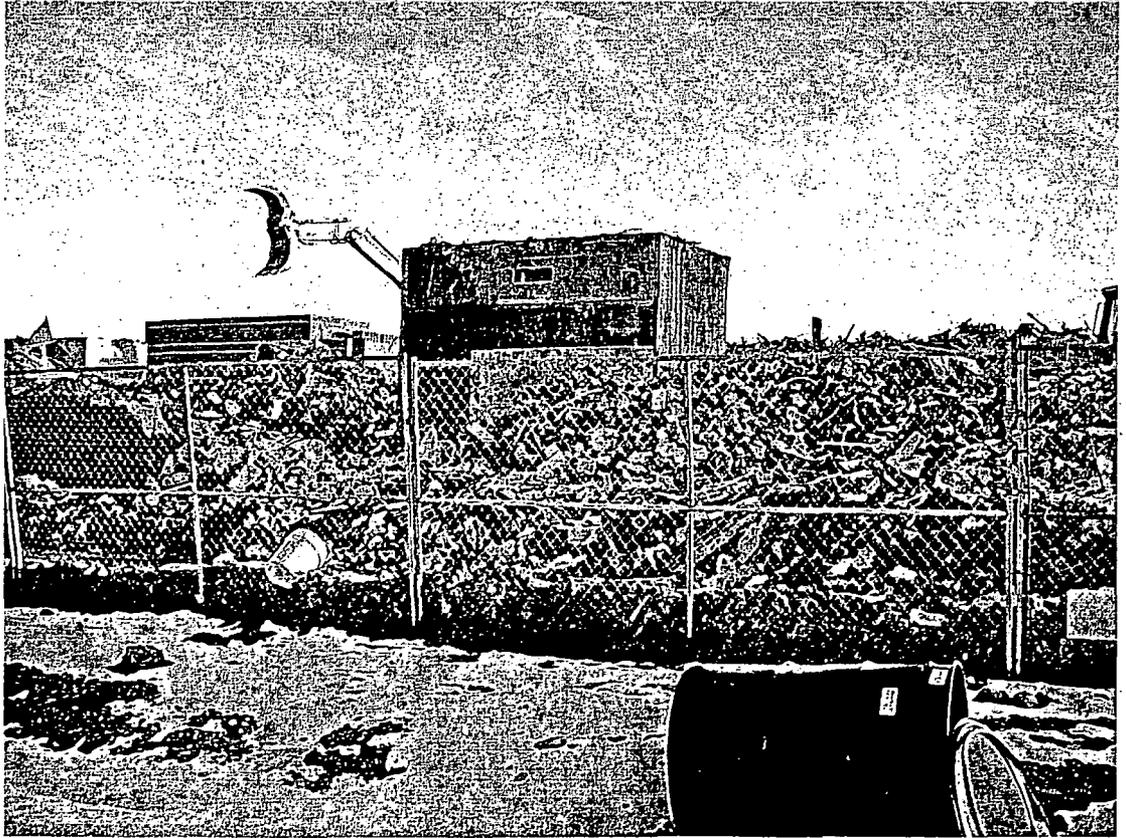
Top - SW Building Water Misting
Bottom - SW Building New Cave

To prevent the generation of airborne radioactive contamination during demolition activities, engineering controls were employed. These controls included (but were not limited to) fixing contamination using liquid fixatives and/or foam, and using water misting to prevent fugitive dust emissions.

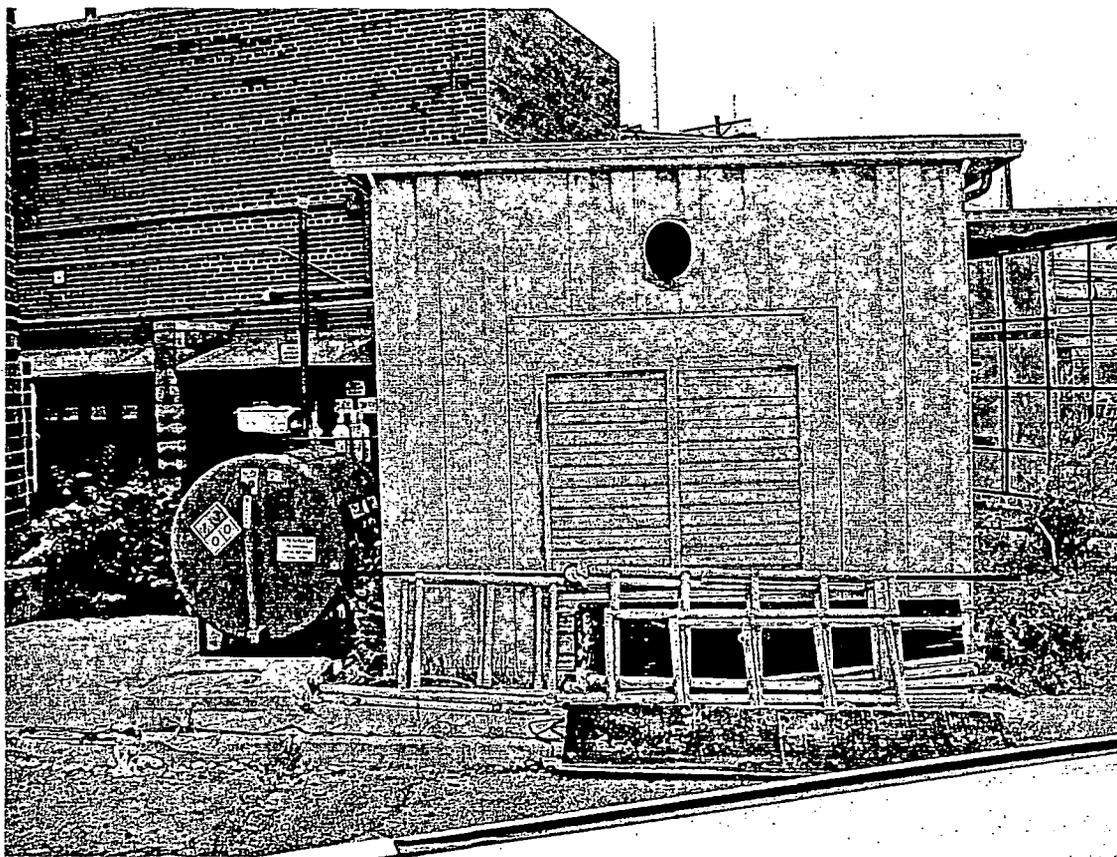
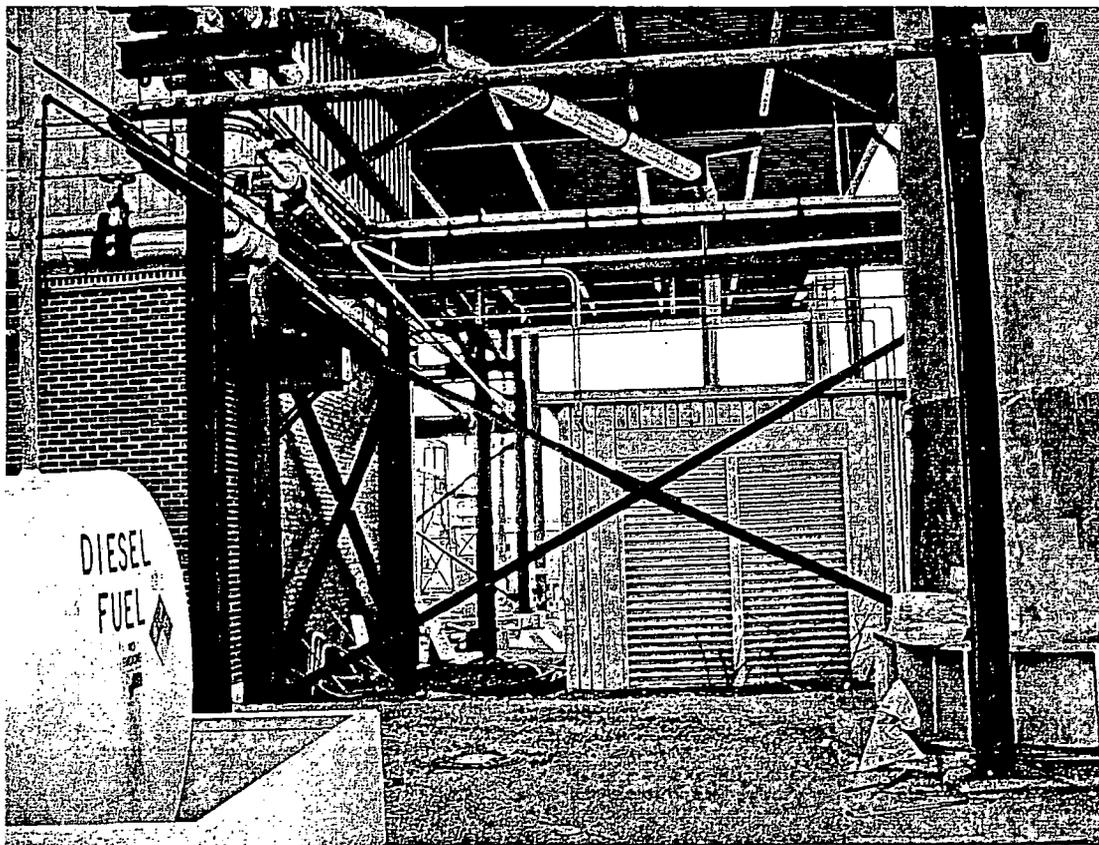
**Before Demo
EG-1 – Top
EG-6 - Bottom**

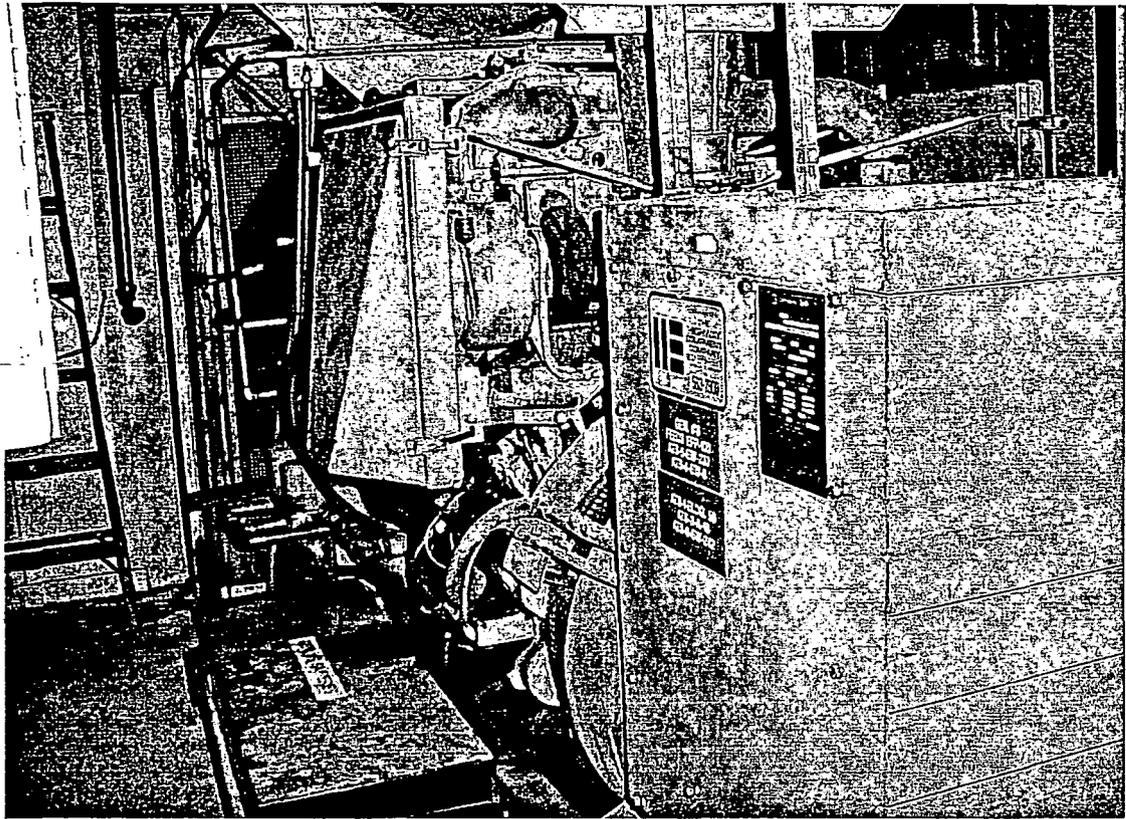
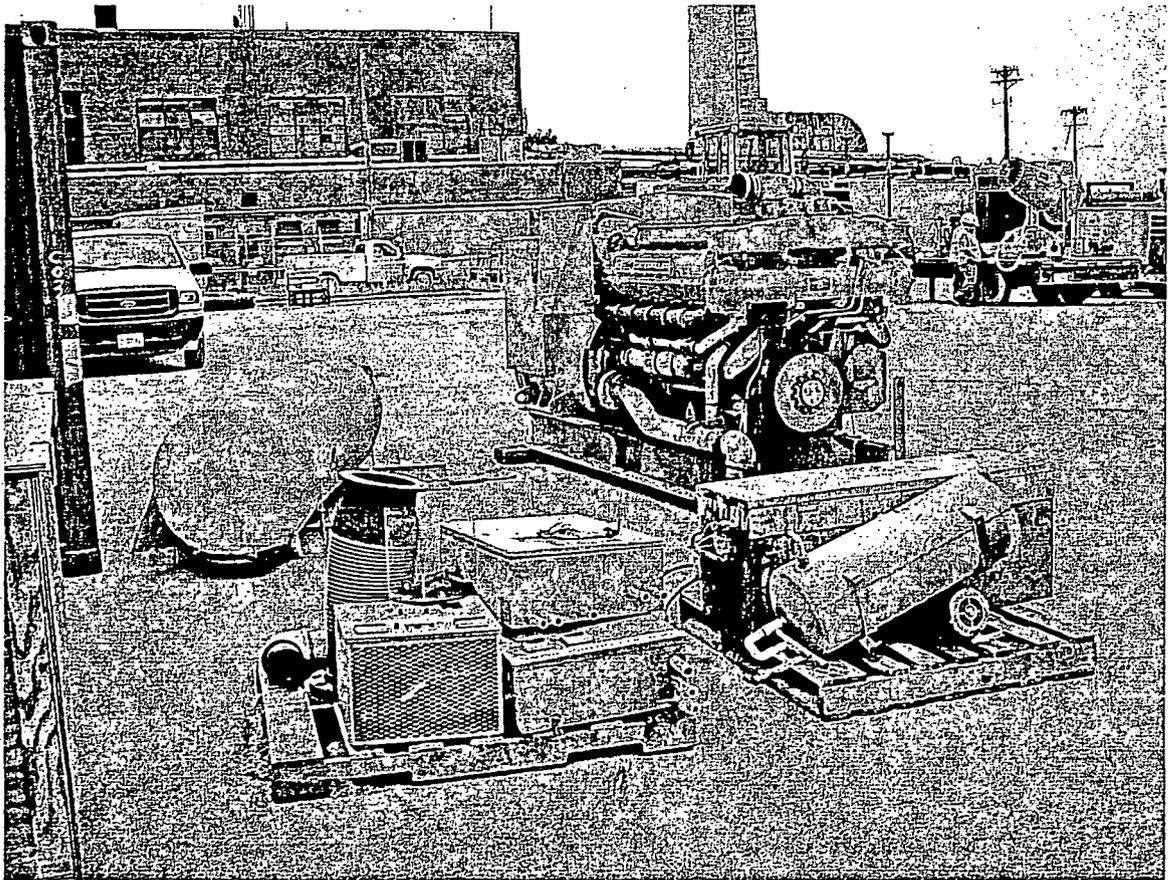
EG-6 Generator In-Situ - Top
EG-1 Generator Removed - Bottom

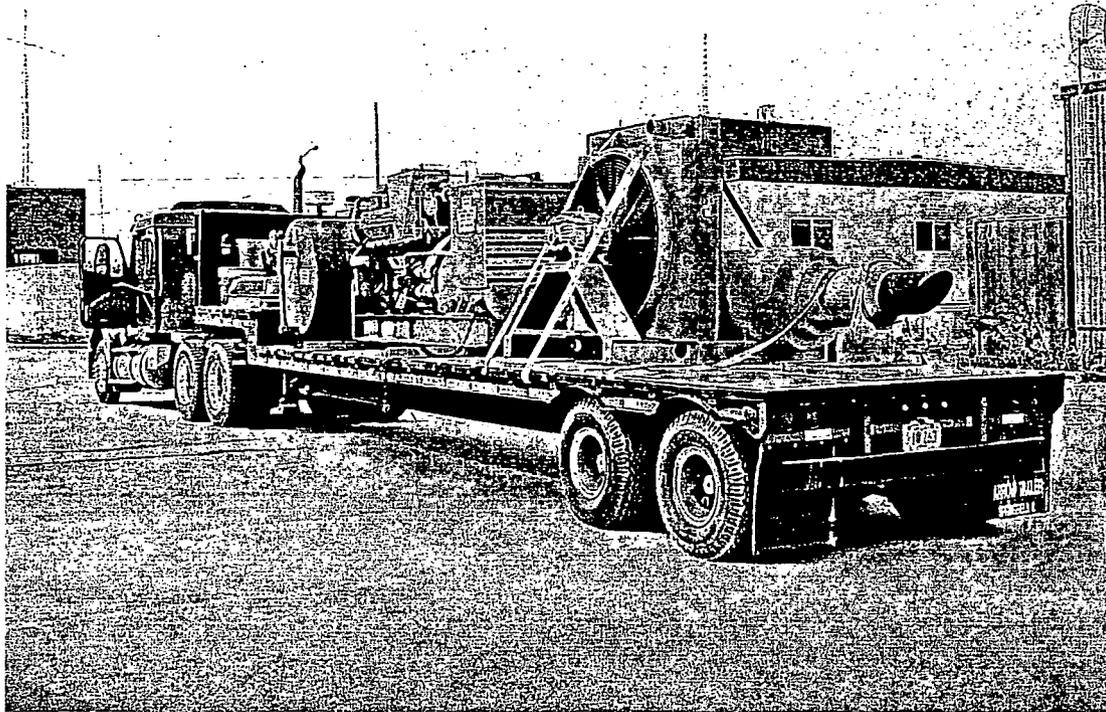
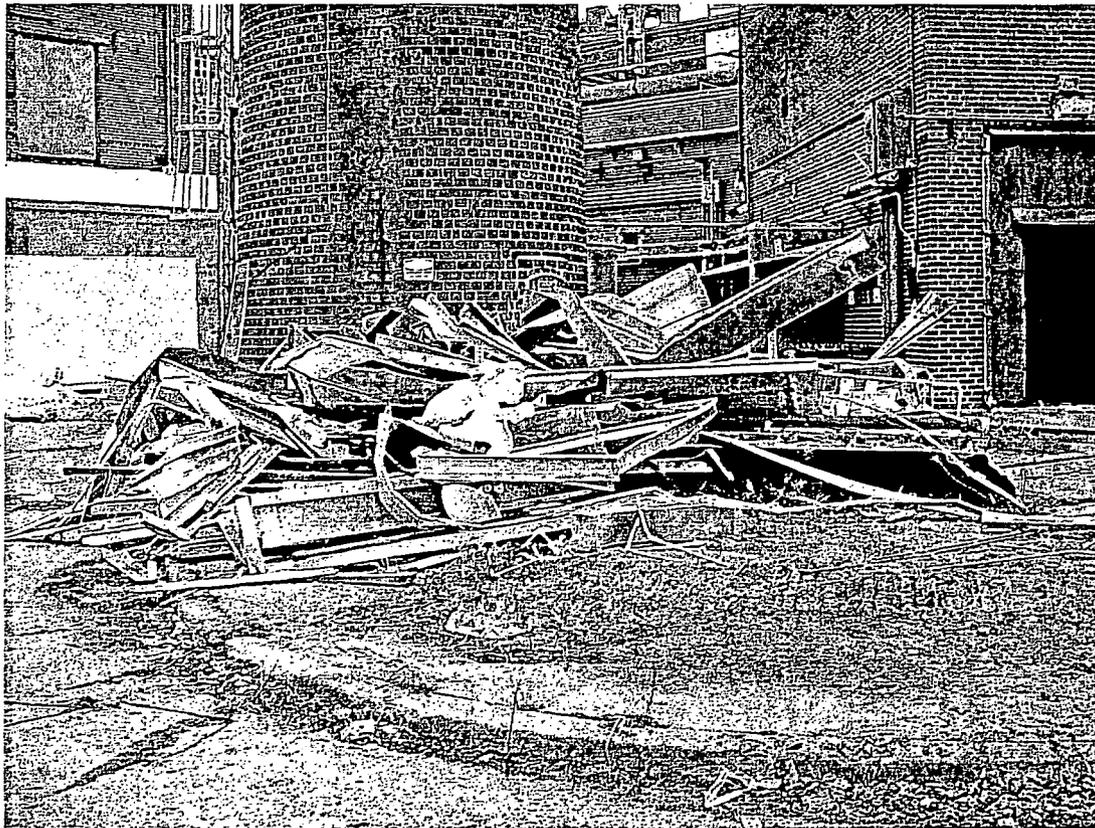
**EG-1 Generator Being Taken by Recipient – Top
EG-1 Structure Demolished – Bottom
(Note: No demolition photo available for EG-6)**

The EG-6 structure was sold, and the EG-1 structure was demolished. The EG-1 and EG-6 USTs had been previously removed per BUSTR. The soil below both former USTs will be evaluated via the R/SW/58/68 Post-Excavation Survey Unit Design (SUD), and closed via Buildings R, SW, 58, and 68 Slab and Soil OSC Report.

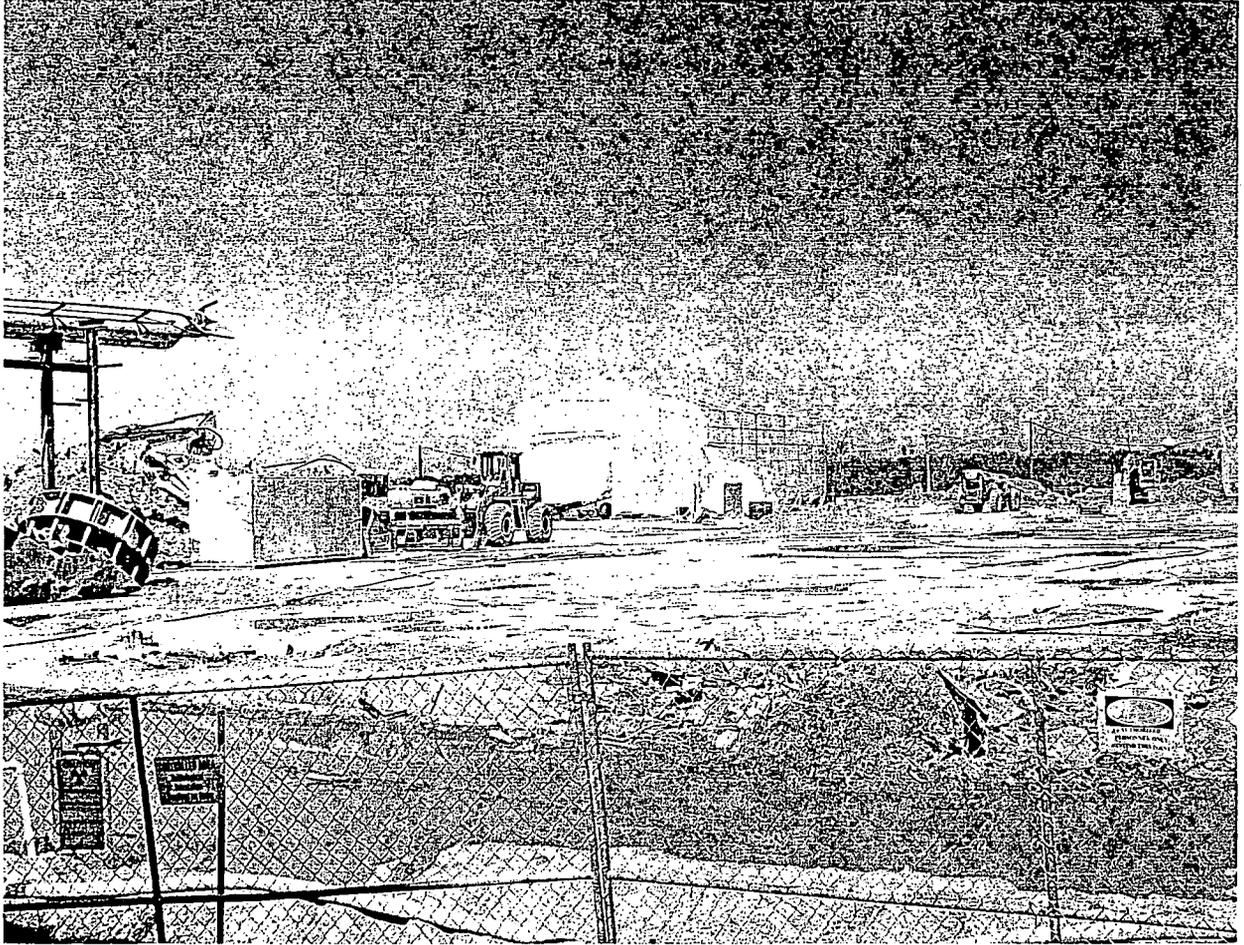
**SW Building Slab After SW, EG-1, and EG-6
Structure Demo
Looking Northwest
(Slab and Underground Line Removal Underway)**
