SUBJECT: Contract No. DE-AC24-97OH20044
FINAL REPORT FOR C-BUILDING DEMOLITION PROJECT

FINAL REPORT
FOR
C BUILDING DEMOLITION PROJECT

Final
May 11, 1998

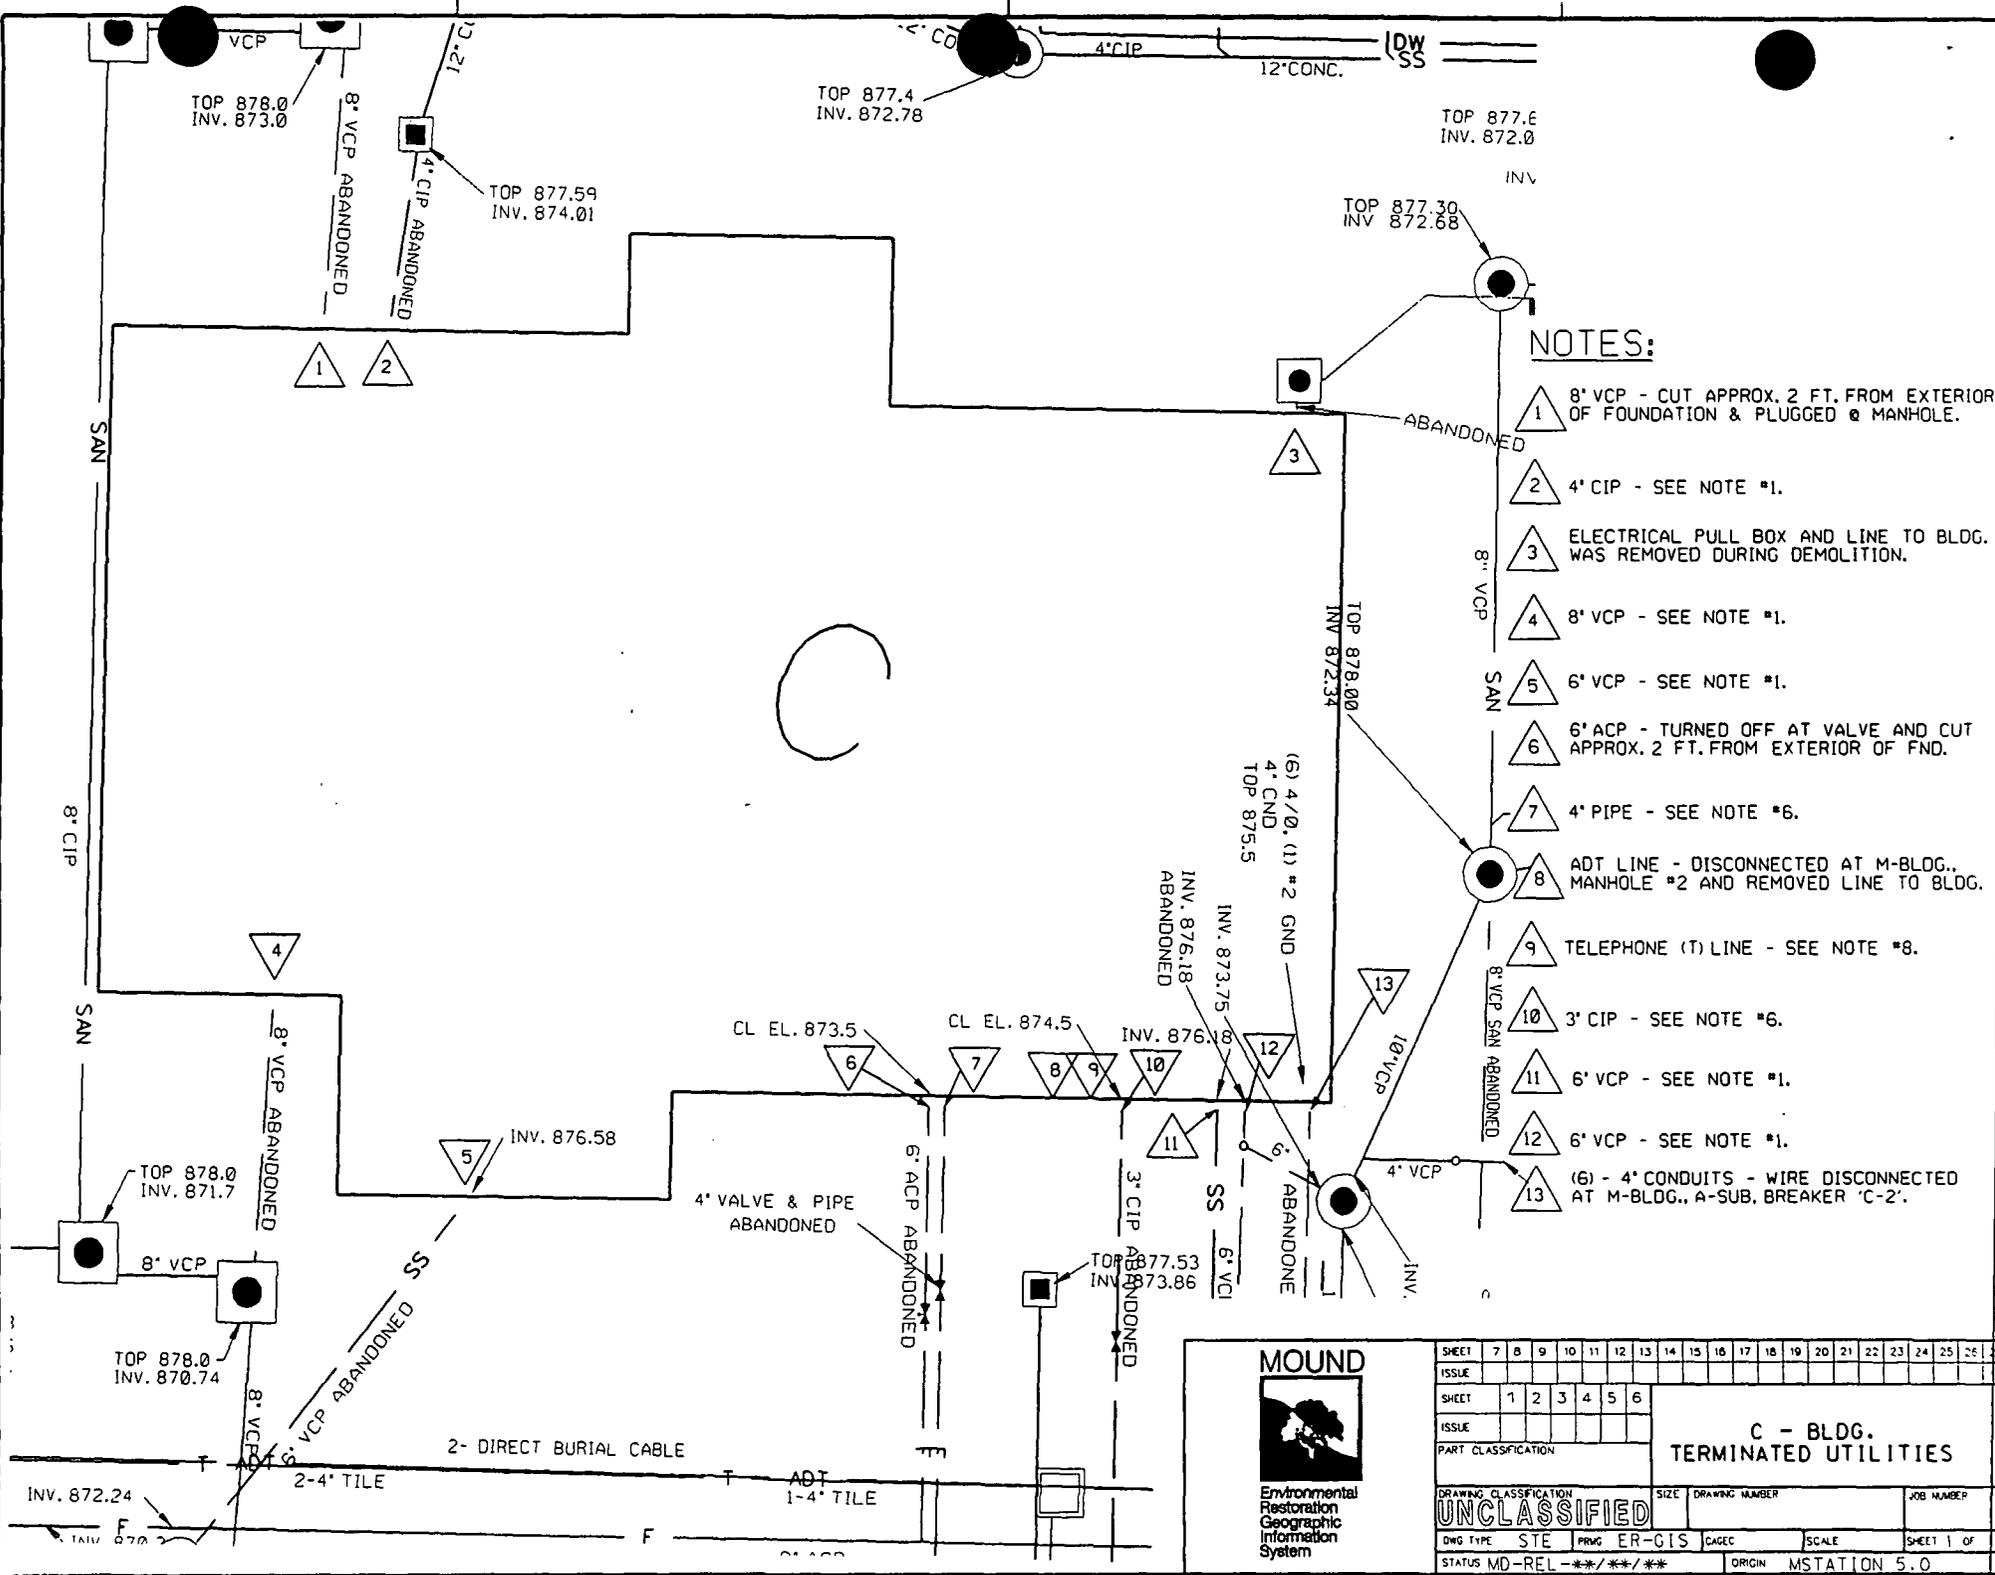
- 1 8" VCP - CUT APPROX. 2 FT. FROM EXTERIOR OF FOUNDATION & PLUGGED @ MANHOLE.
- 2 4" CIP - SEE NOTE #1.
- 3 ELECTRICAL PULL BOX AND LINE TO BLDG. WAS REMOVED DURING DEMOLITION.
- 4 8" VCP - SEE NOTE #1.
- 5 6" VCP - SEE NOTE #1.
- 6 6" ACP - TURNED OFF AT VALVE AND CUT APPROX. 2 FT. FROM EXTERIOR OF FND.
- 7 4" PIPE - SEE NOTE #6.
- 8 ADT LINE - DISCONNECTED AT M-BLDG., MANHOLE #2 AND REMOVED LINE TO BLDG.
- 9 TELEPHONE (T) LINE - SEE NOTE #8.
- 10 3" CIP - SEE NOTE #6.
- 11 6" VCP - SEE NOTE #1.
- 12 6" VCP - SEE NOTE #1.
- 13 (6) - 4" CONDUITS - WIRE DISCONNECTED AT M-BLDG., A-SUB. BREAKER 'C-2'.

The objective of the project was to clean C Building of hazardous waste, isolate utilities and demolish the structure in order to provide adequate laydown and work space for the future demolition of SW & R buildings. Asbestos Containing Material (ACM) was present in the plaster of the first floor ceiling, the piping insulation on numerous pipes in the basement, and the soil inside the crawl space. Seneca Asbestos Removal and Controls Inc., a licensed asbestos abatement contractor, removed all ACM from the building prior to demolition. The molan system located on the roof of the building was rerouted and the electrical, ADT and telephone lines to the building were disconnected and cut. Domestic water and fire water lines were shut off at the valve and cut at least 2 feet from the exterior foundation of the building. All other utilities to the building were also cut at least 2 feet from the exterior foundation of the building, then capped. The basement walls were removed three feet below grade. The remaining wall

sections of the basement were left in place. C Building contained a sump that was located in the basement. The sump along with the entire basement floor was left in place. Holes were punched in the floor to allow for drainage and all storm sewers were plugged, at their respective manholes, to prevent back flow into the basement area.

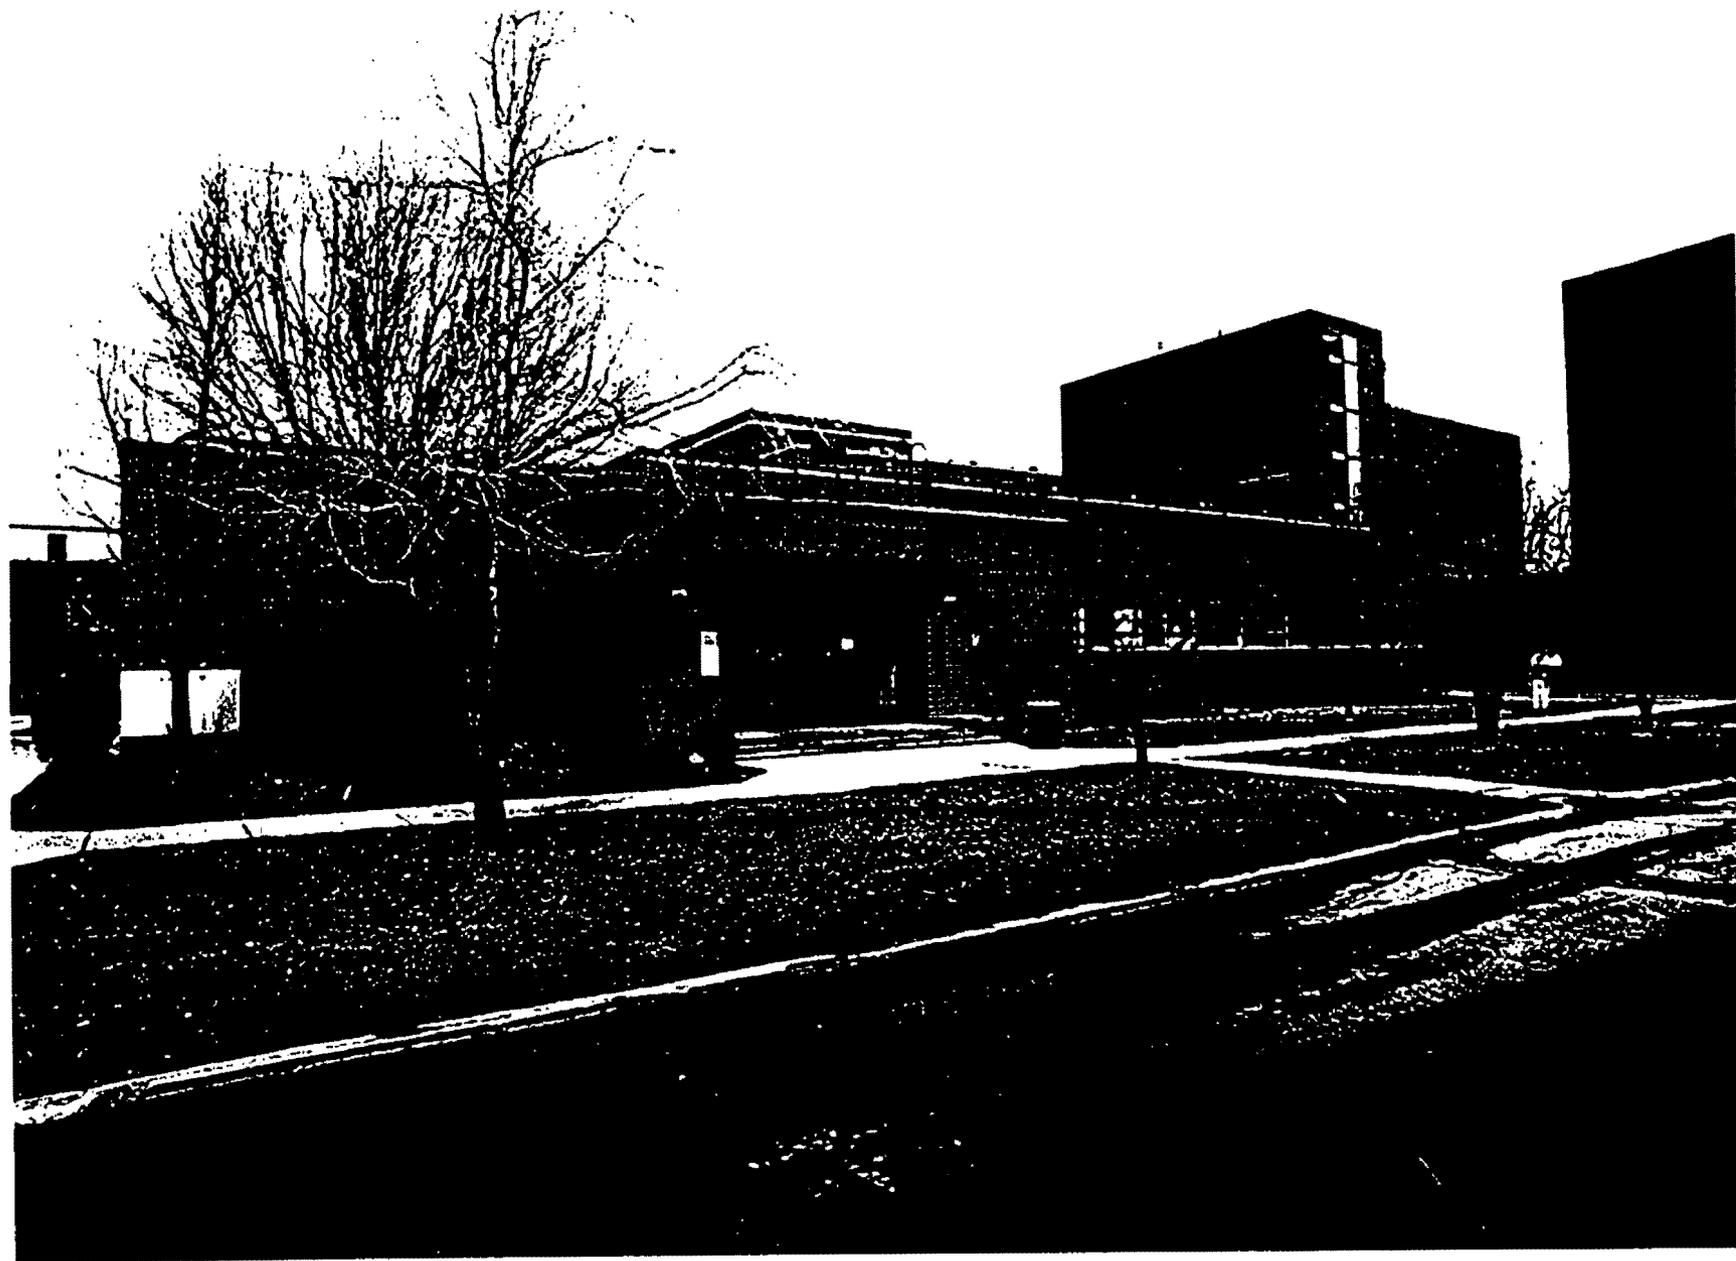
C Bldg., south side 02/28/96

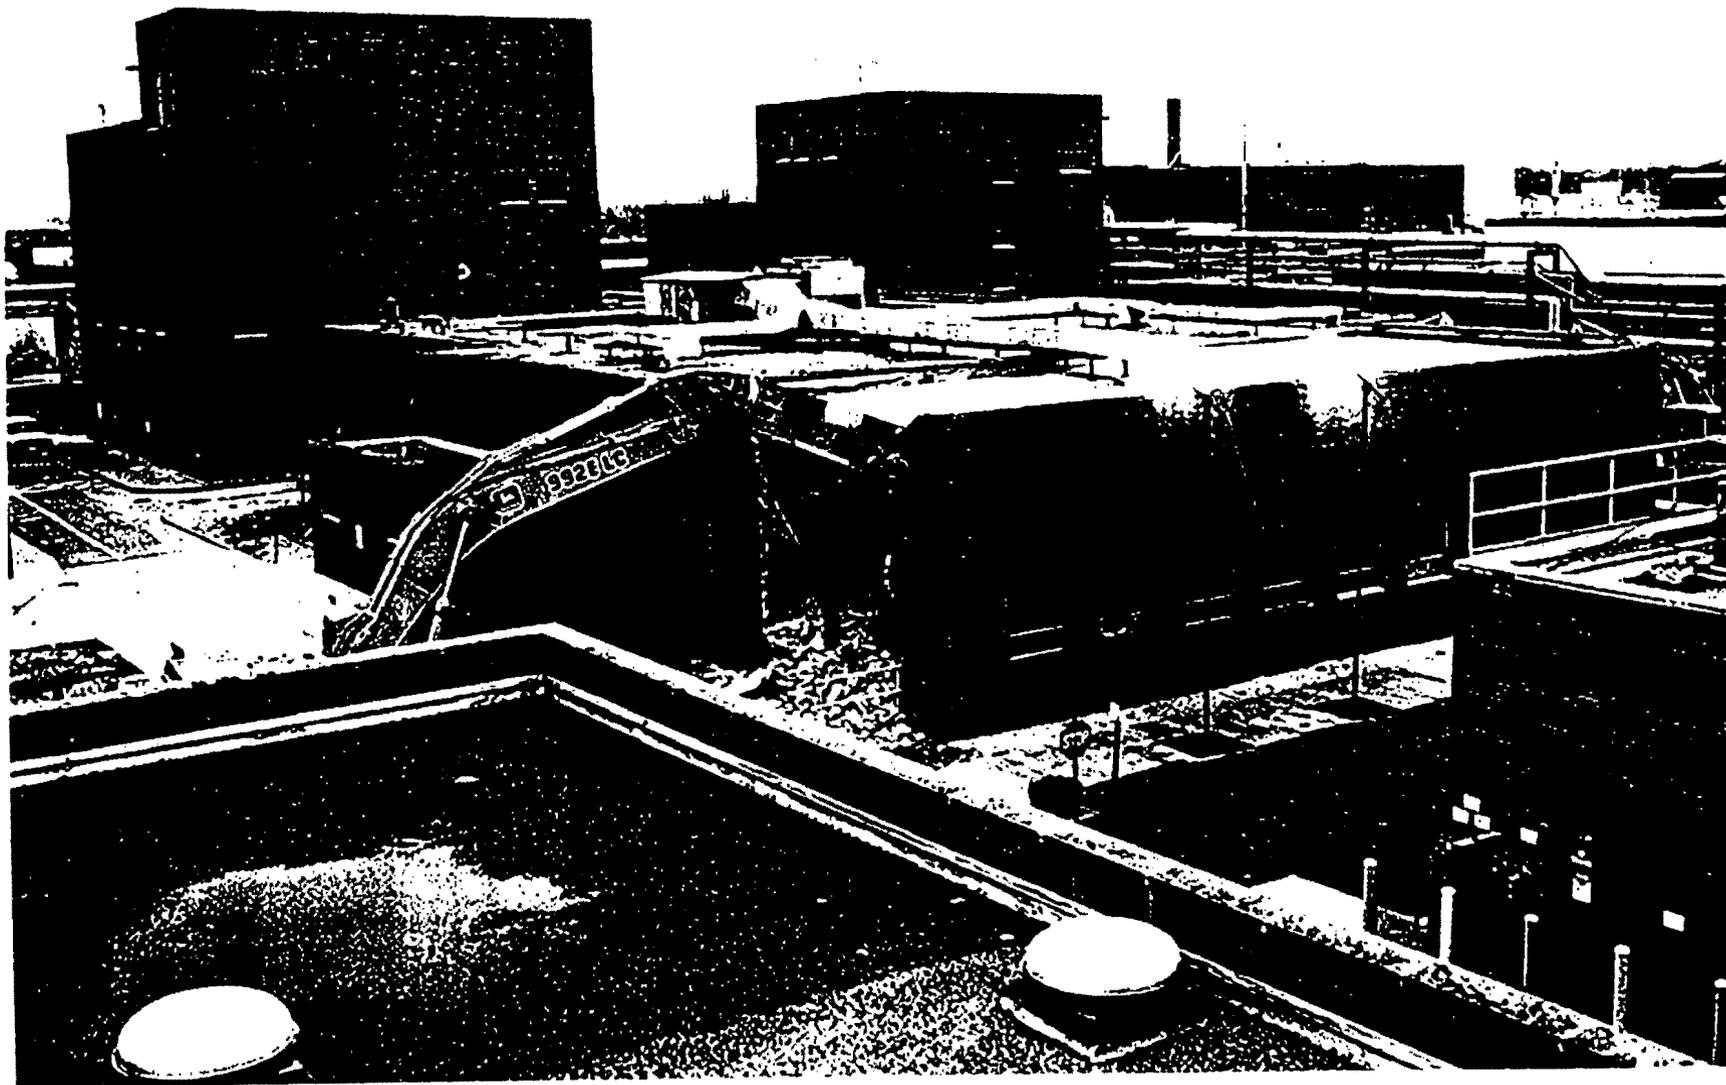
02/26/98 C Bldg. demolition *980433

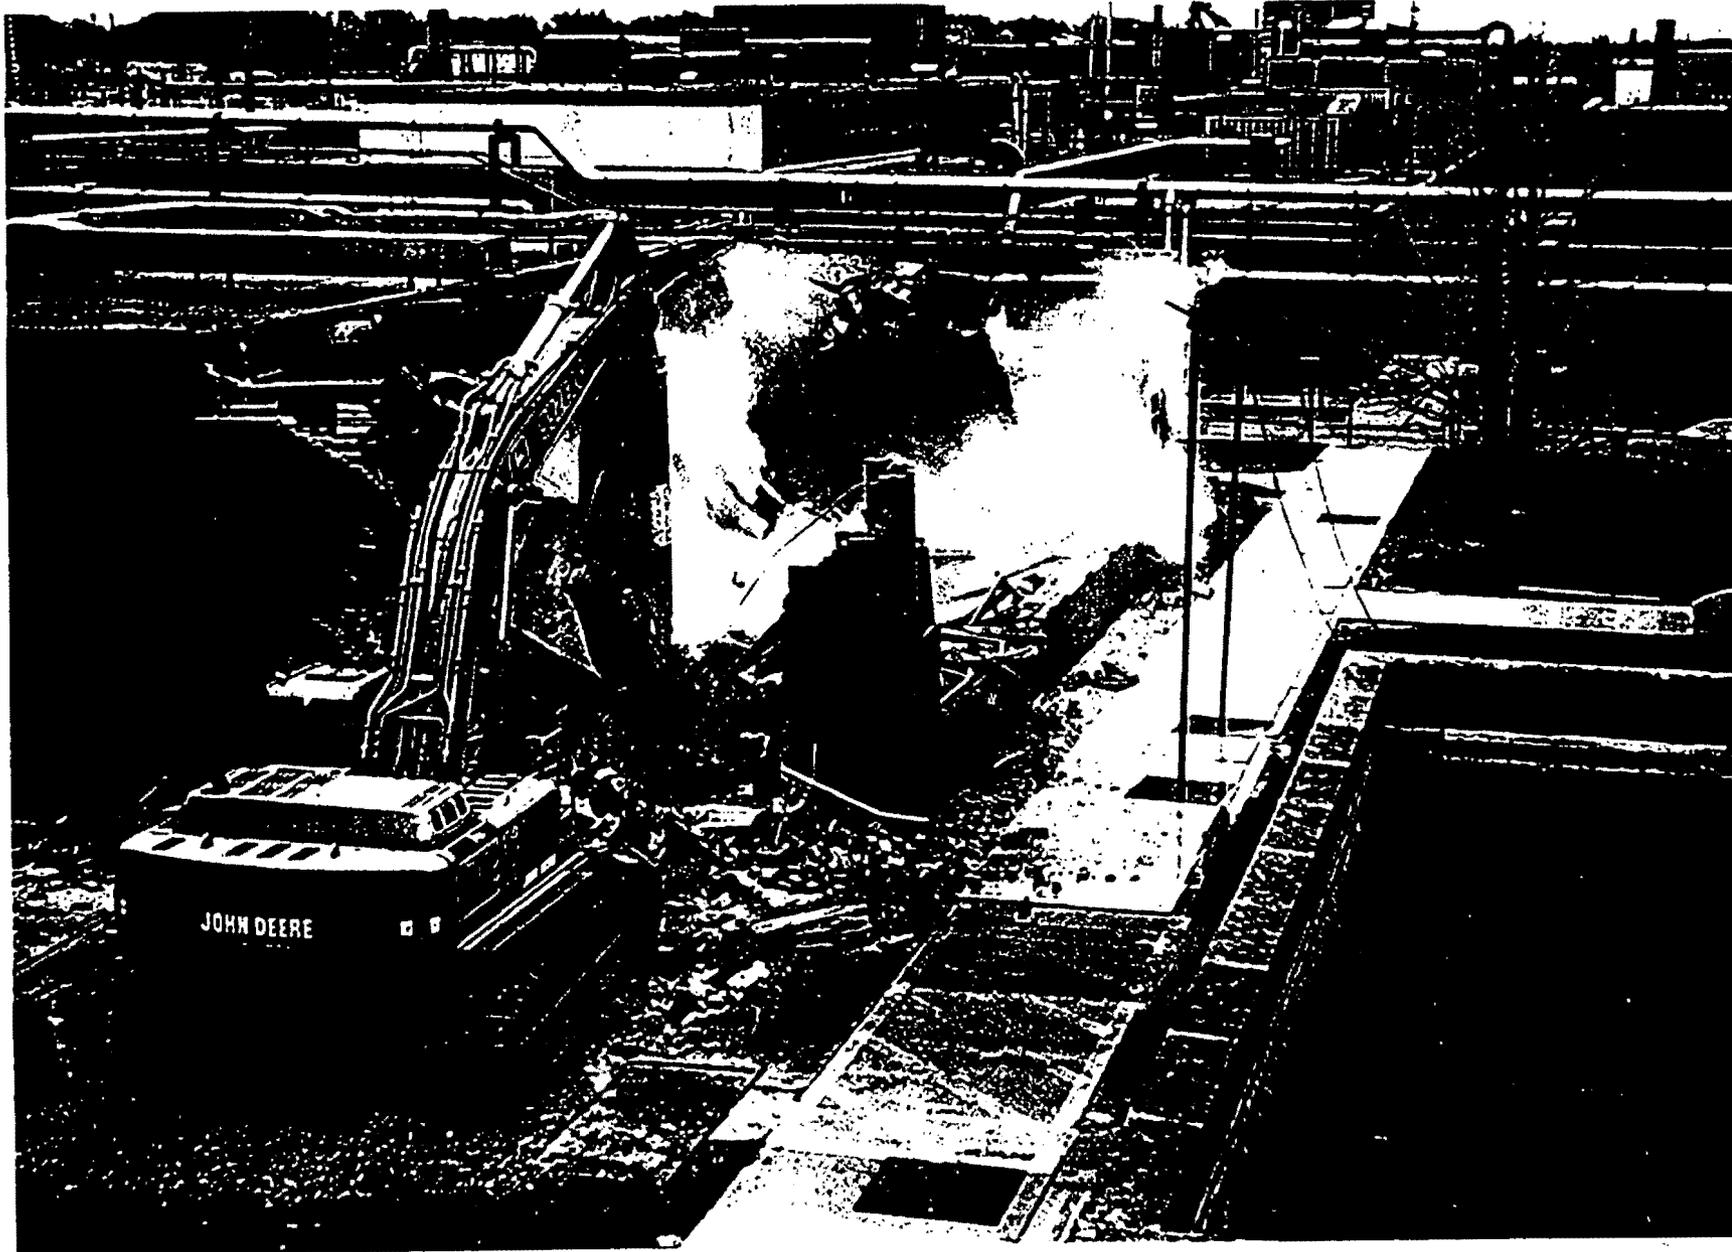
02/26/98 C Bldg. demolition *980444

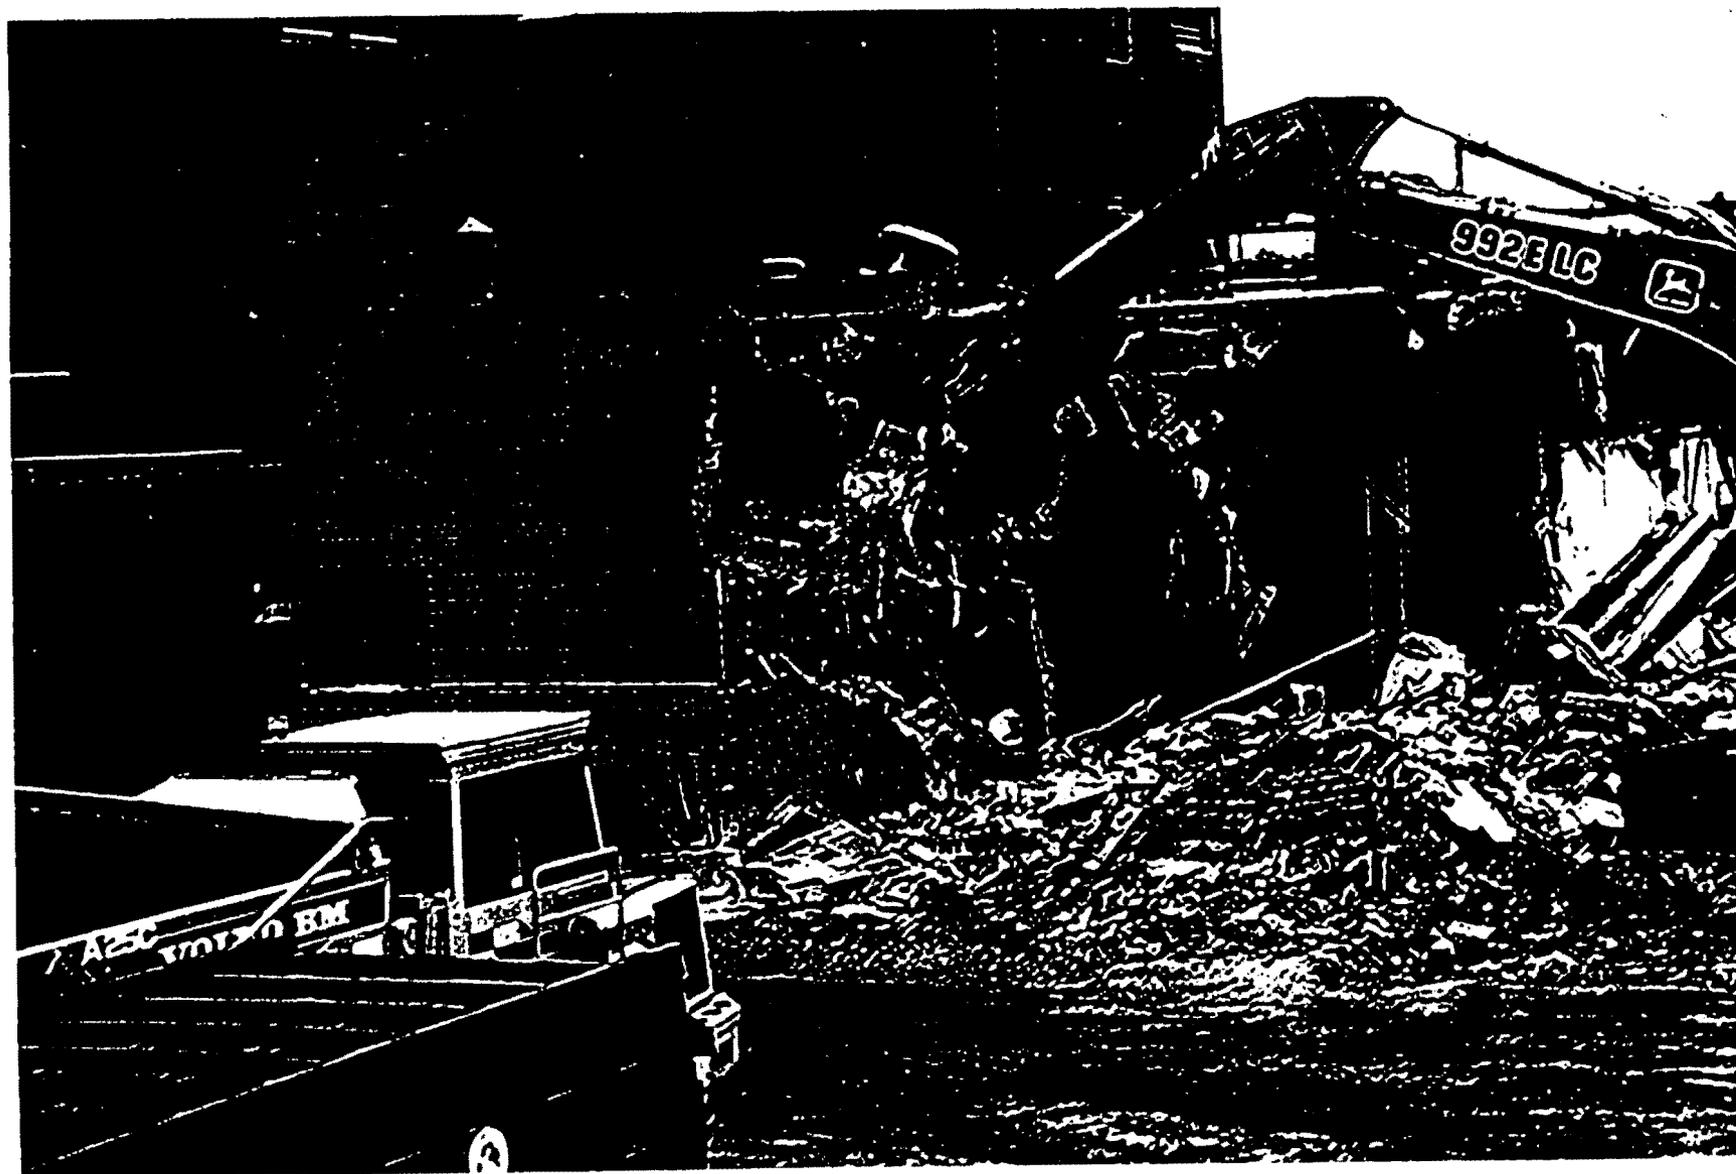
03/09/98 C Bldg. demolition *980504

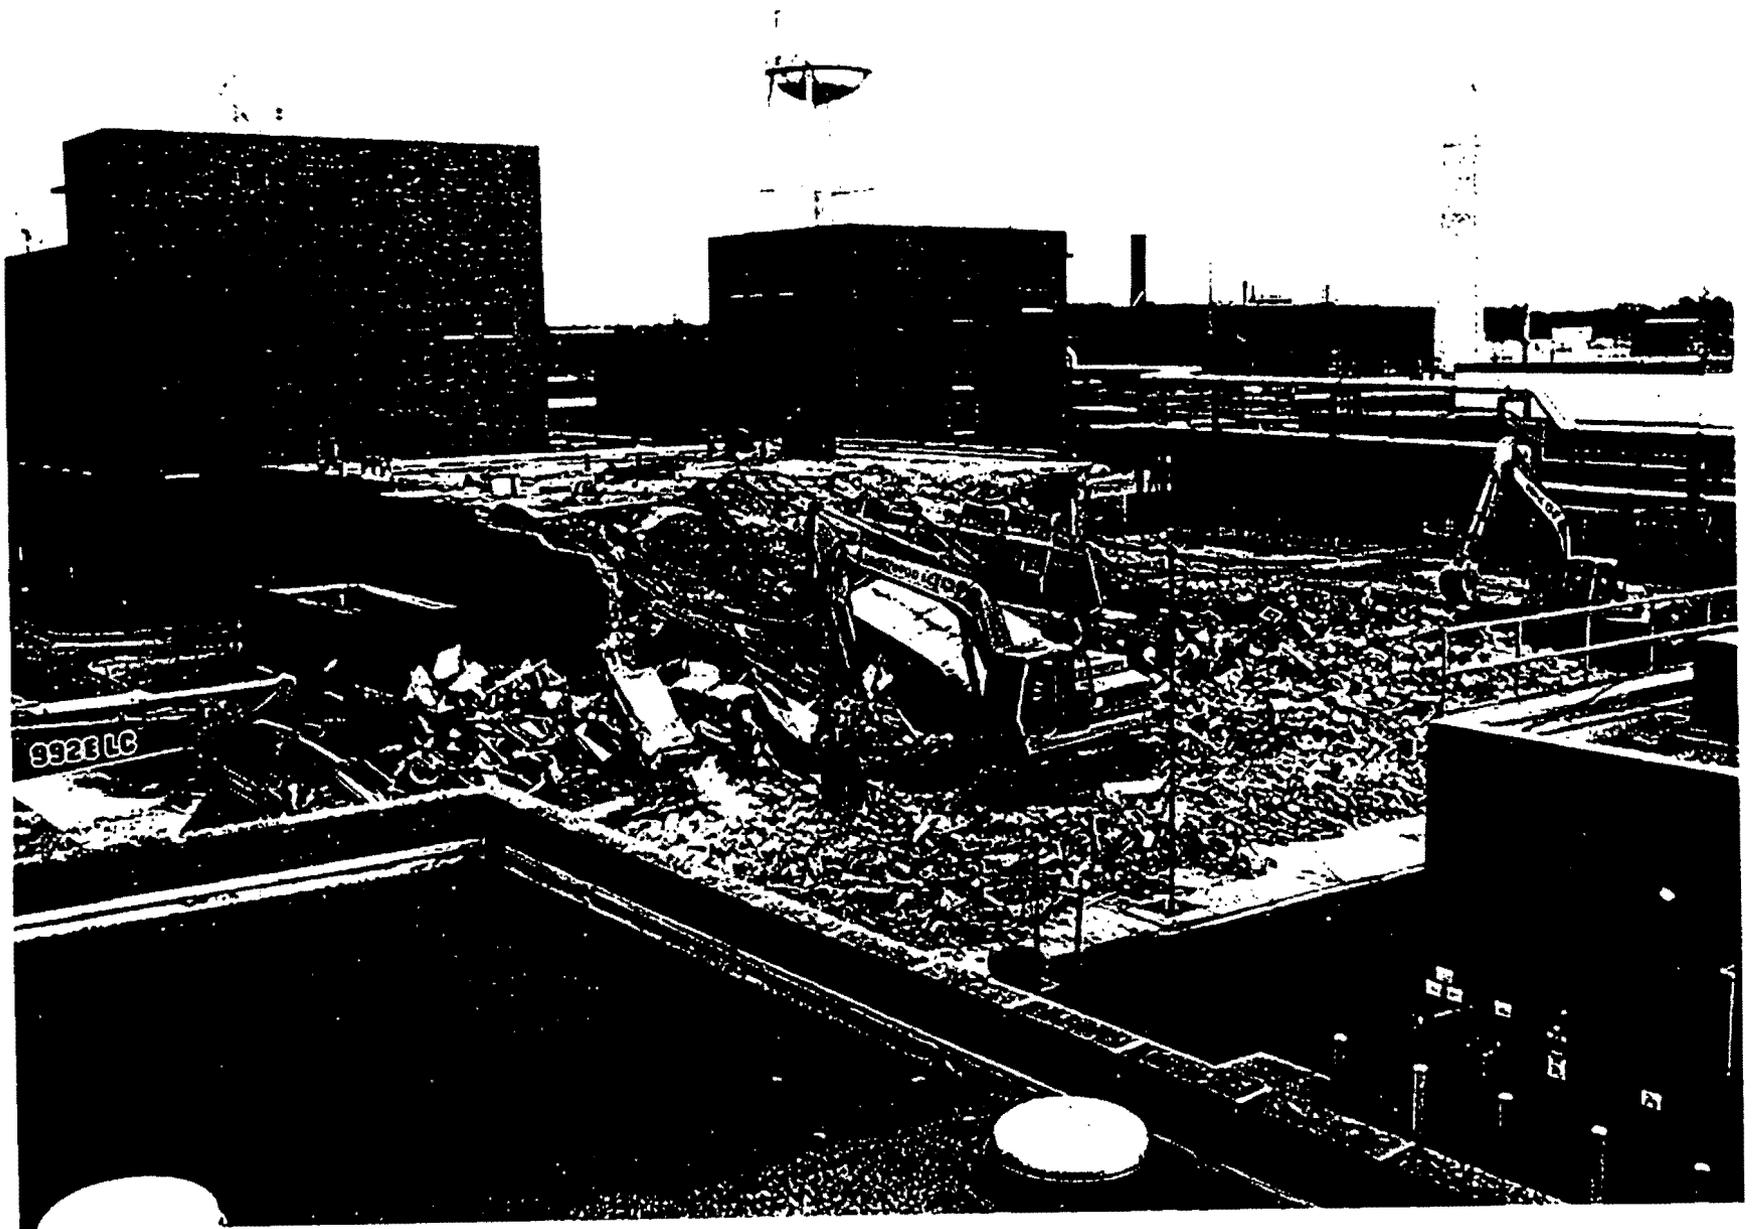
03/02/98 C Bldg. demolition *980475

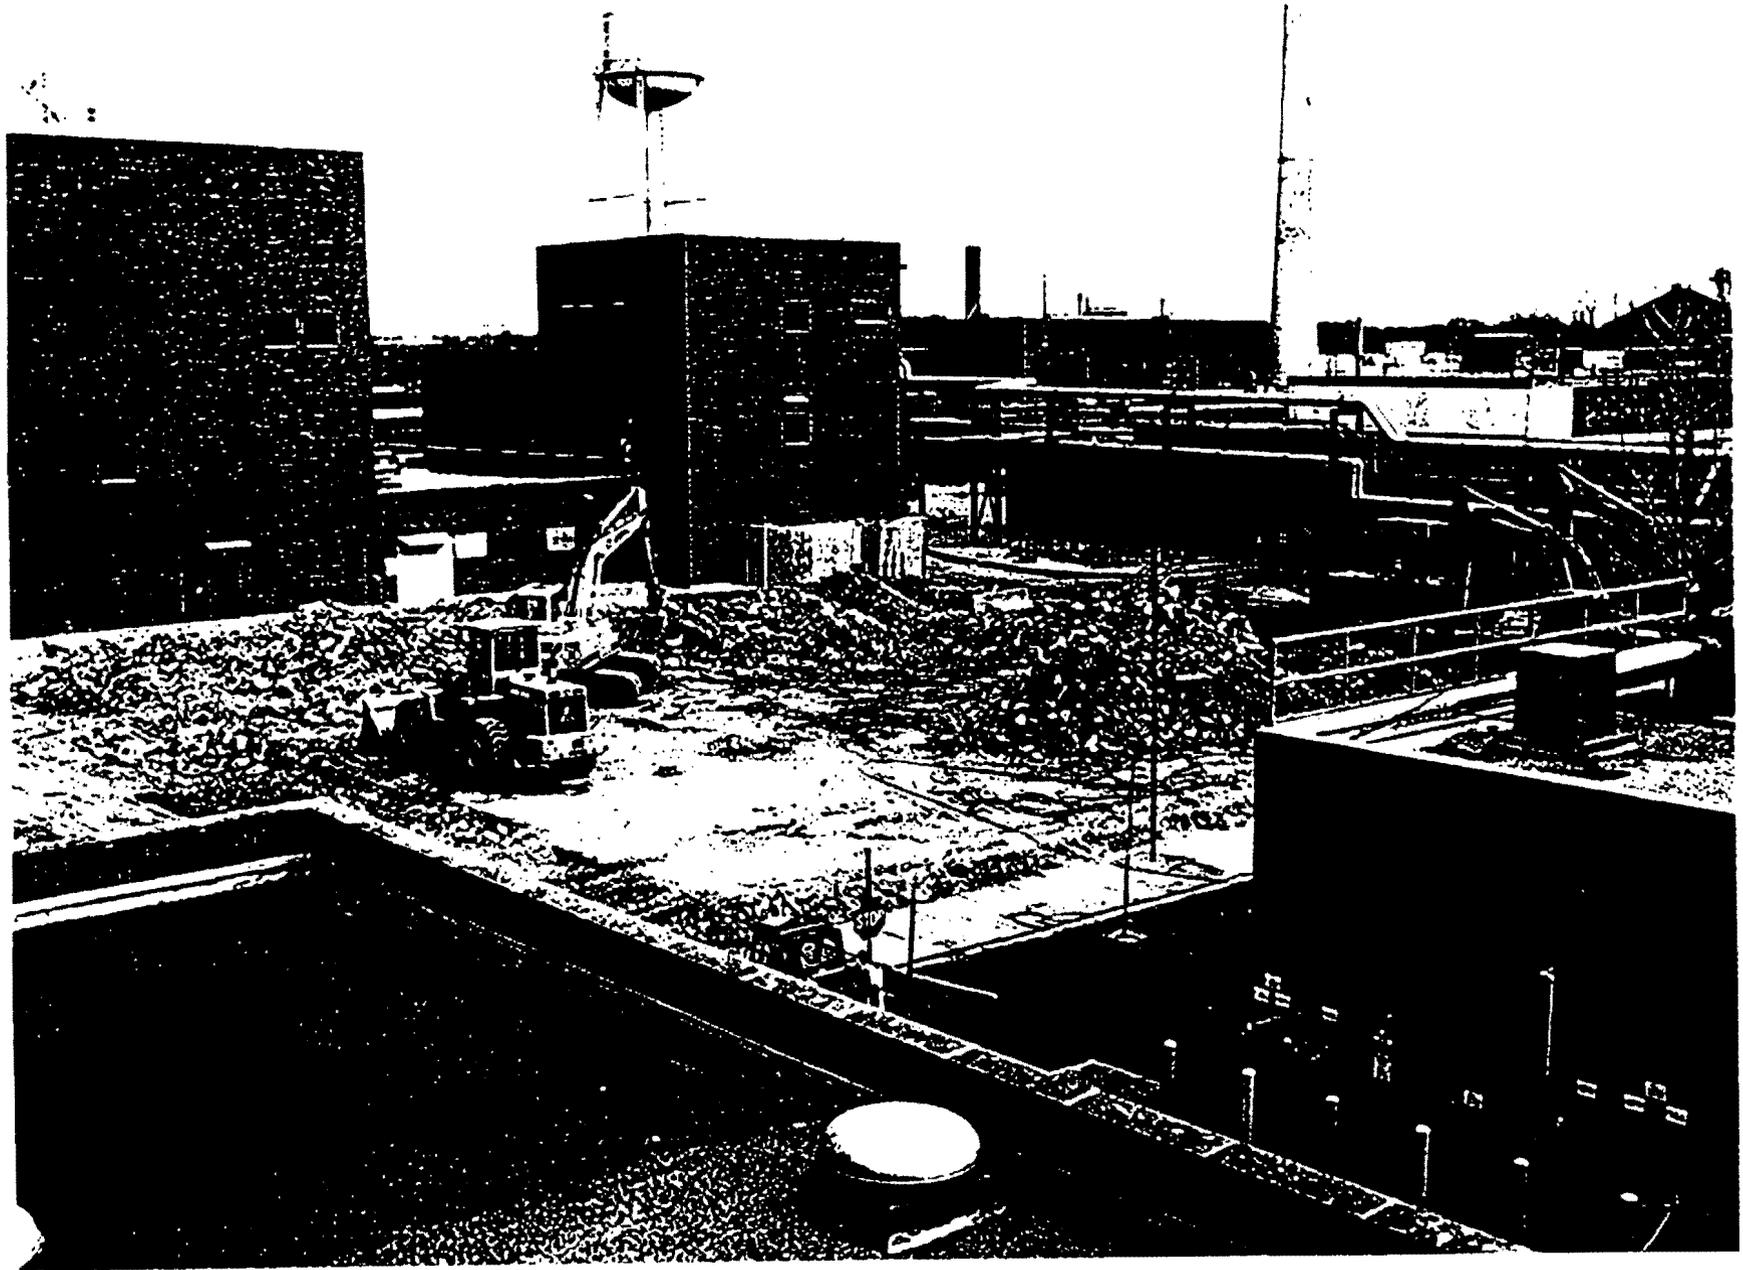
03/16/98 C Bldg. demolition *980592

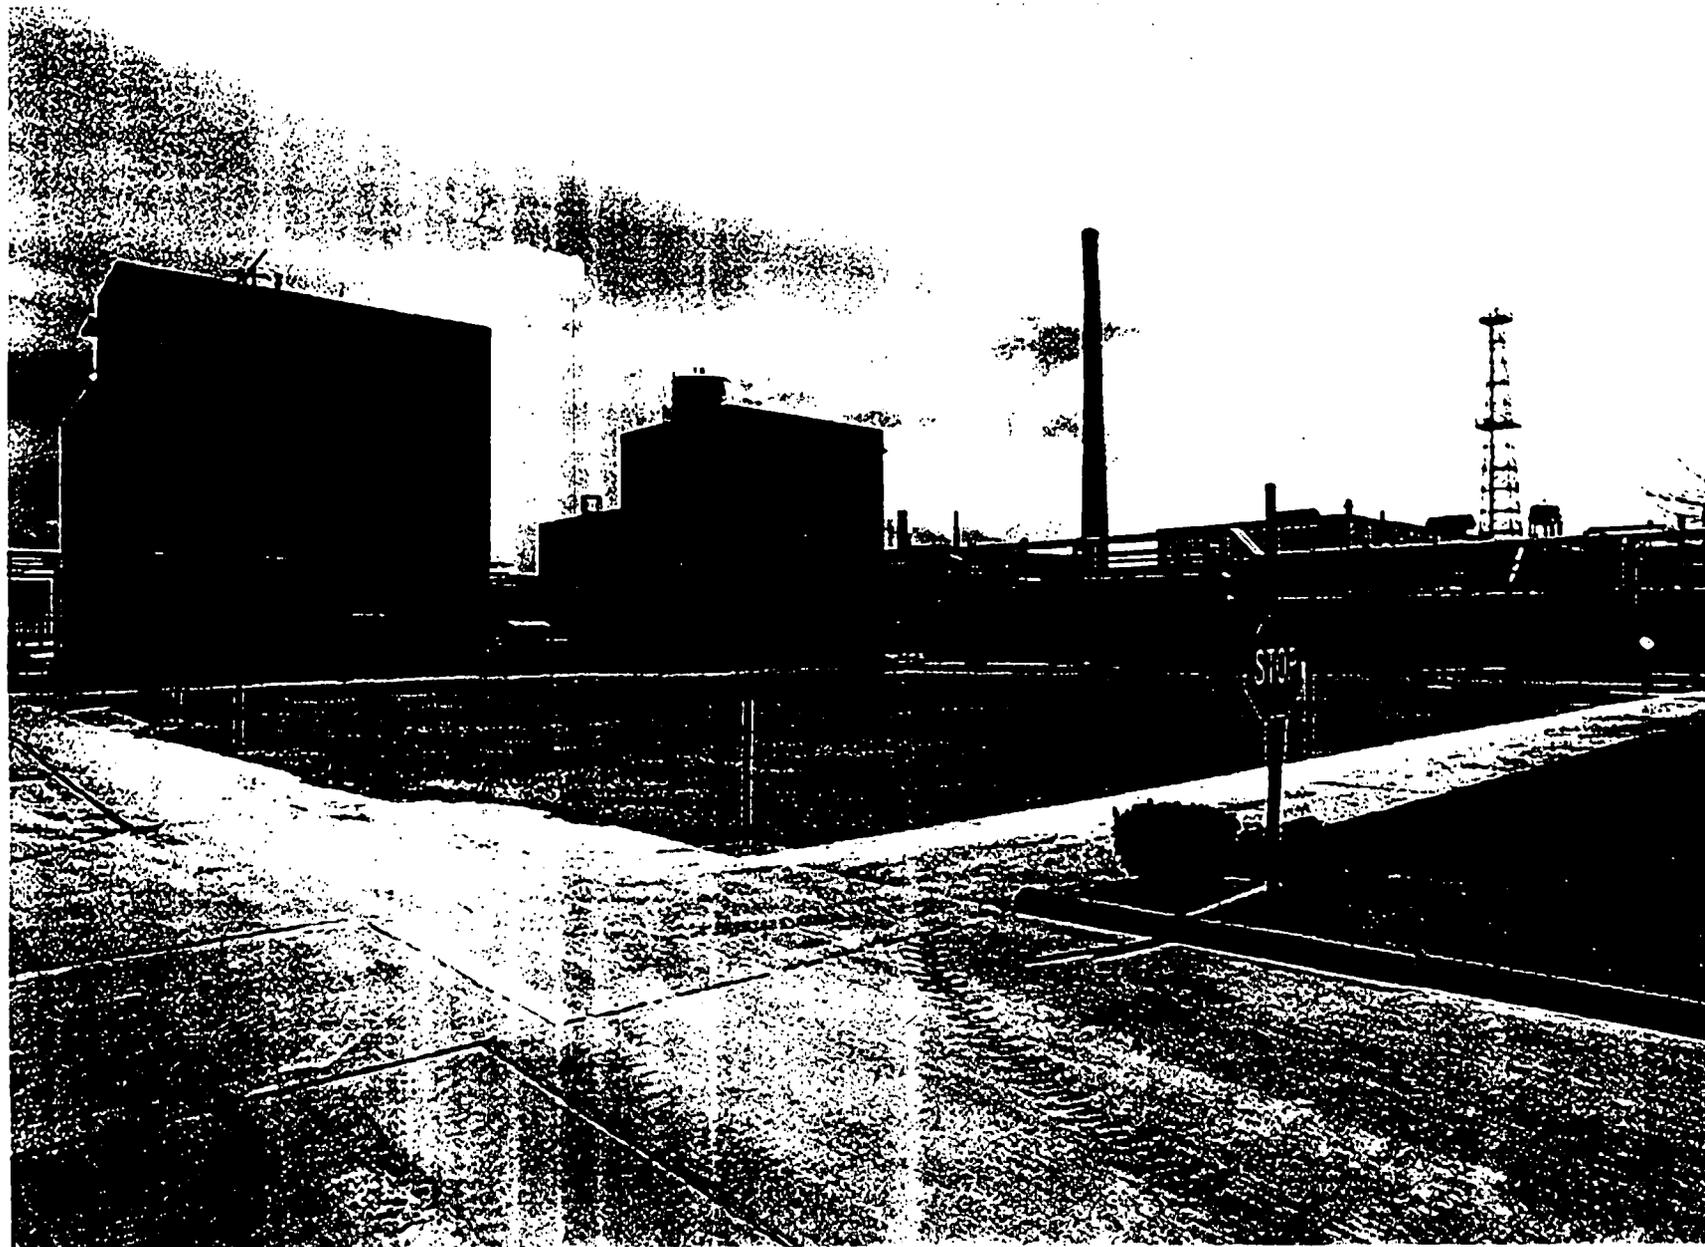
04/08/98 C Bldg. site restoration, looking southeast *980746

All construction debris was separated into three different waste streams. The steel was segregated from the building debris and shipped off site to be recycled. Brick and concrete debris with rebar less than $\frac{3}{4}$ inch thick was sorted from the debris and sent to the staging area to later be recycled on site. Some of the remaining debris was used to backfill the basement and the rest was shipped offsite to an industrial landfill. The area was backfilled with 304 stone, compacted and graded according to the final grading plan. This area will be used for a staging area for future projects.
