MOUND PLANT
Building Data Package
Building GP-5
Located within Release Block L

BDP GP-5

BUILDING GP-5

BUILDING DATA PACKAGE (BDP)

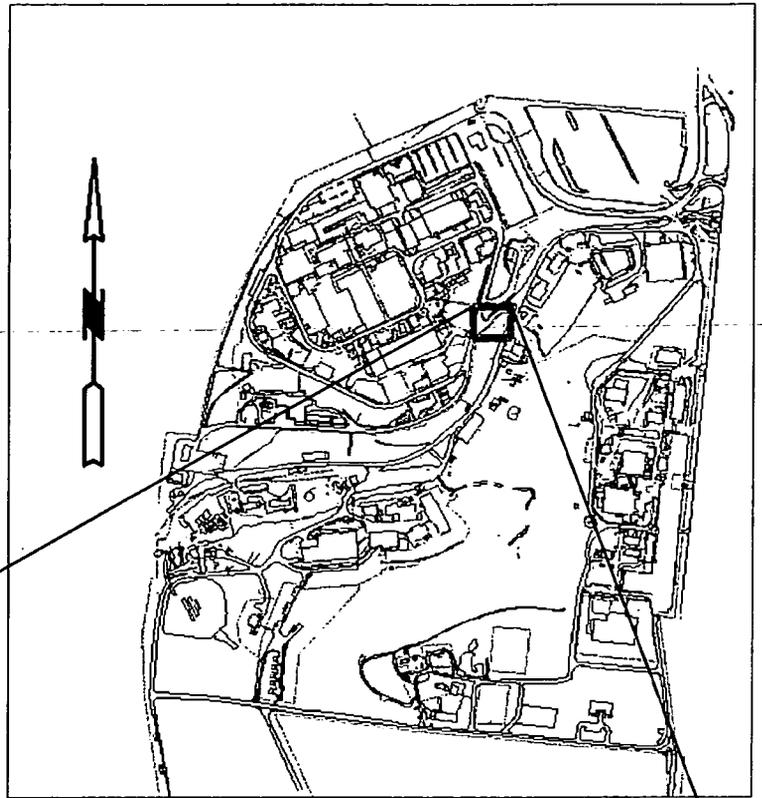
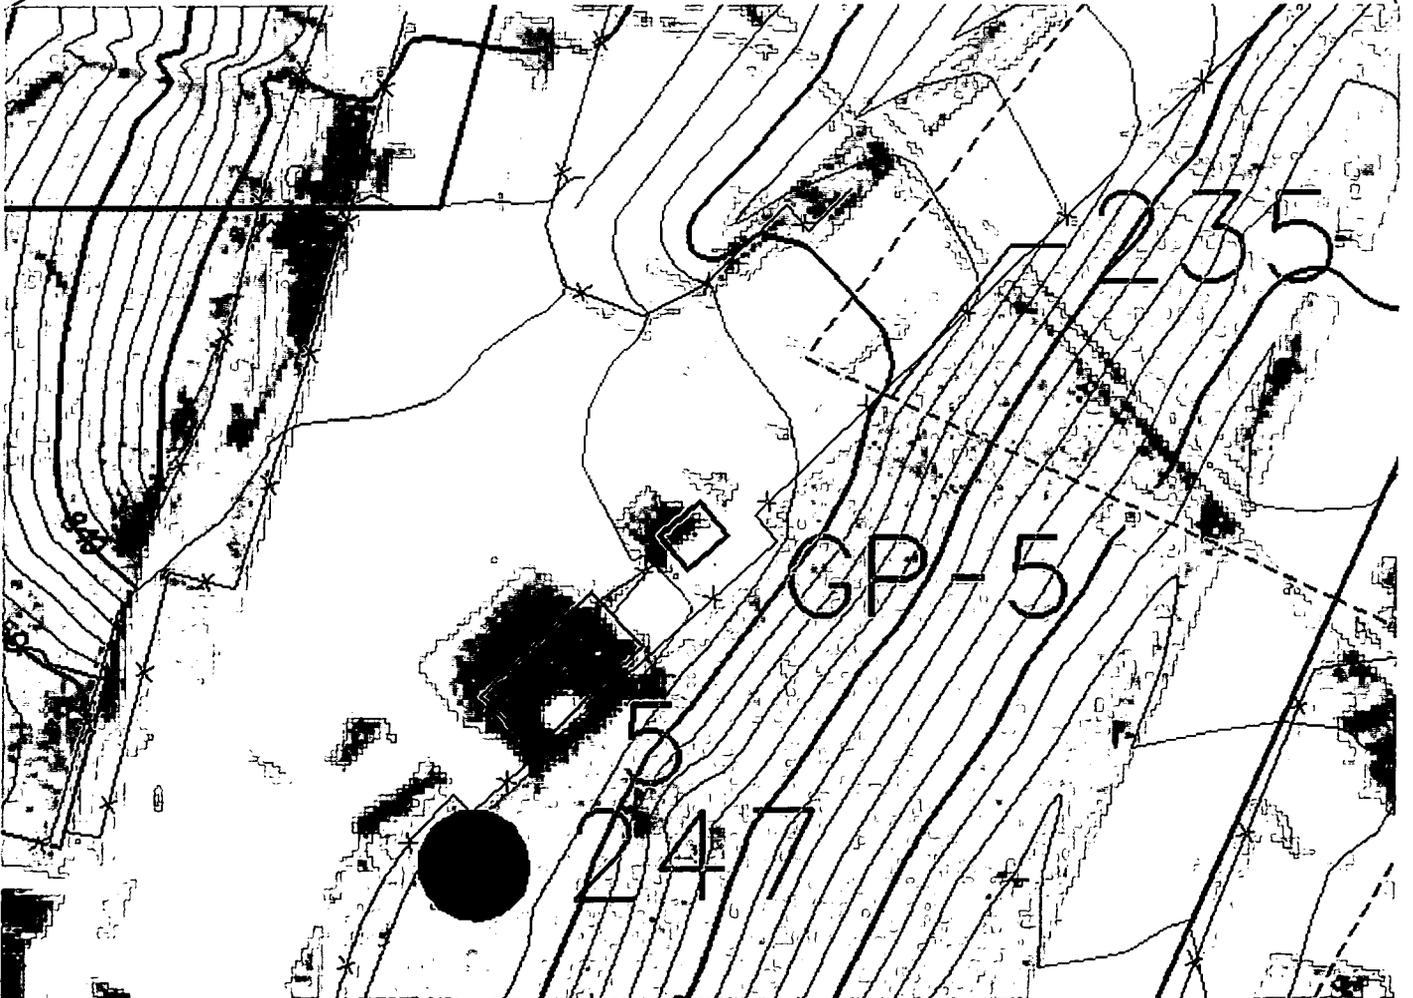
On the map below:

- Building number and location shown in black
- PRS locations and numbers shown in blue
- Surrounding buildings shown in green
- Fencing shown in red
- Elevation contours shown in brown

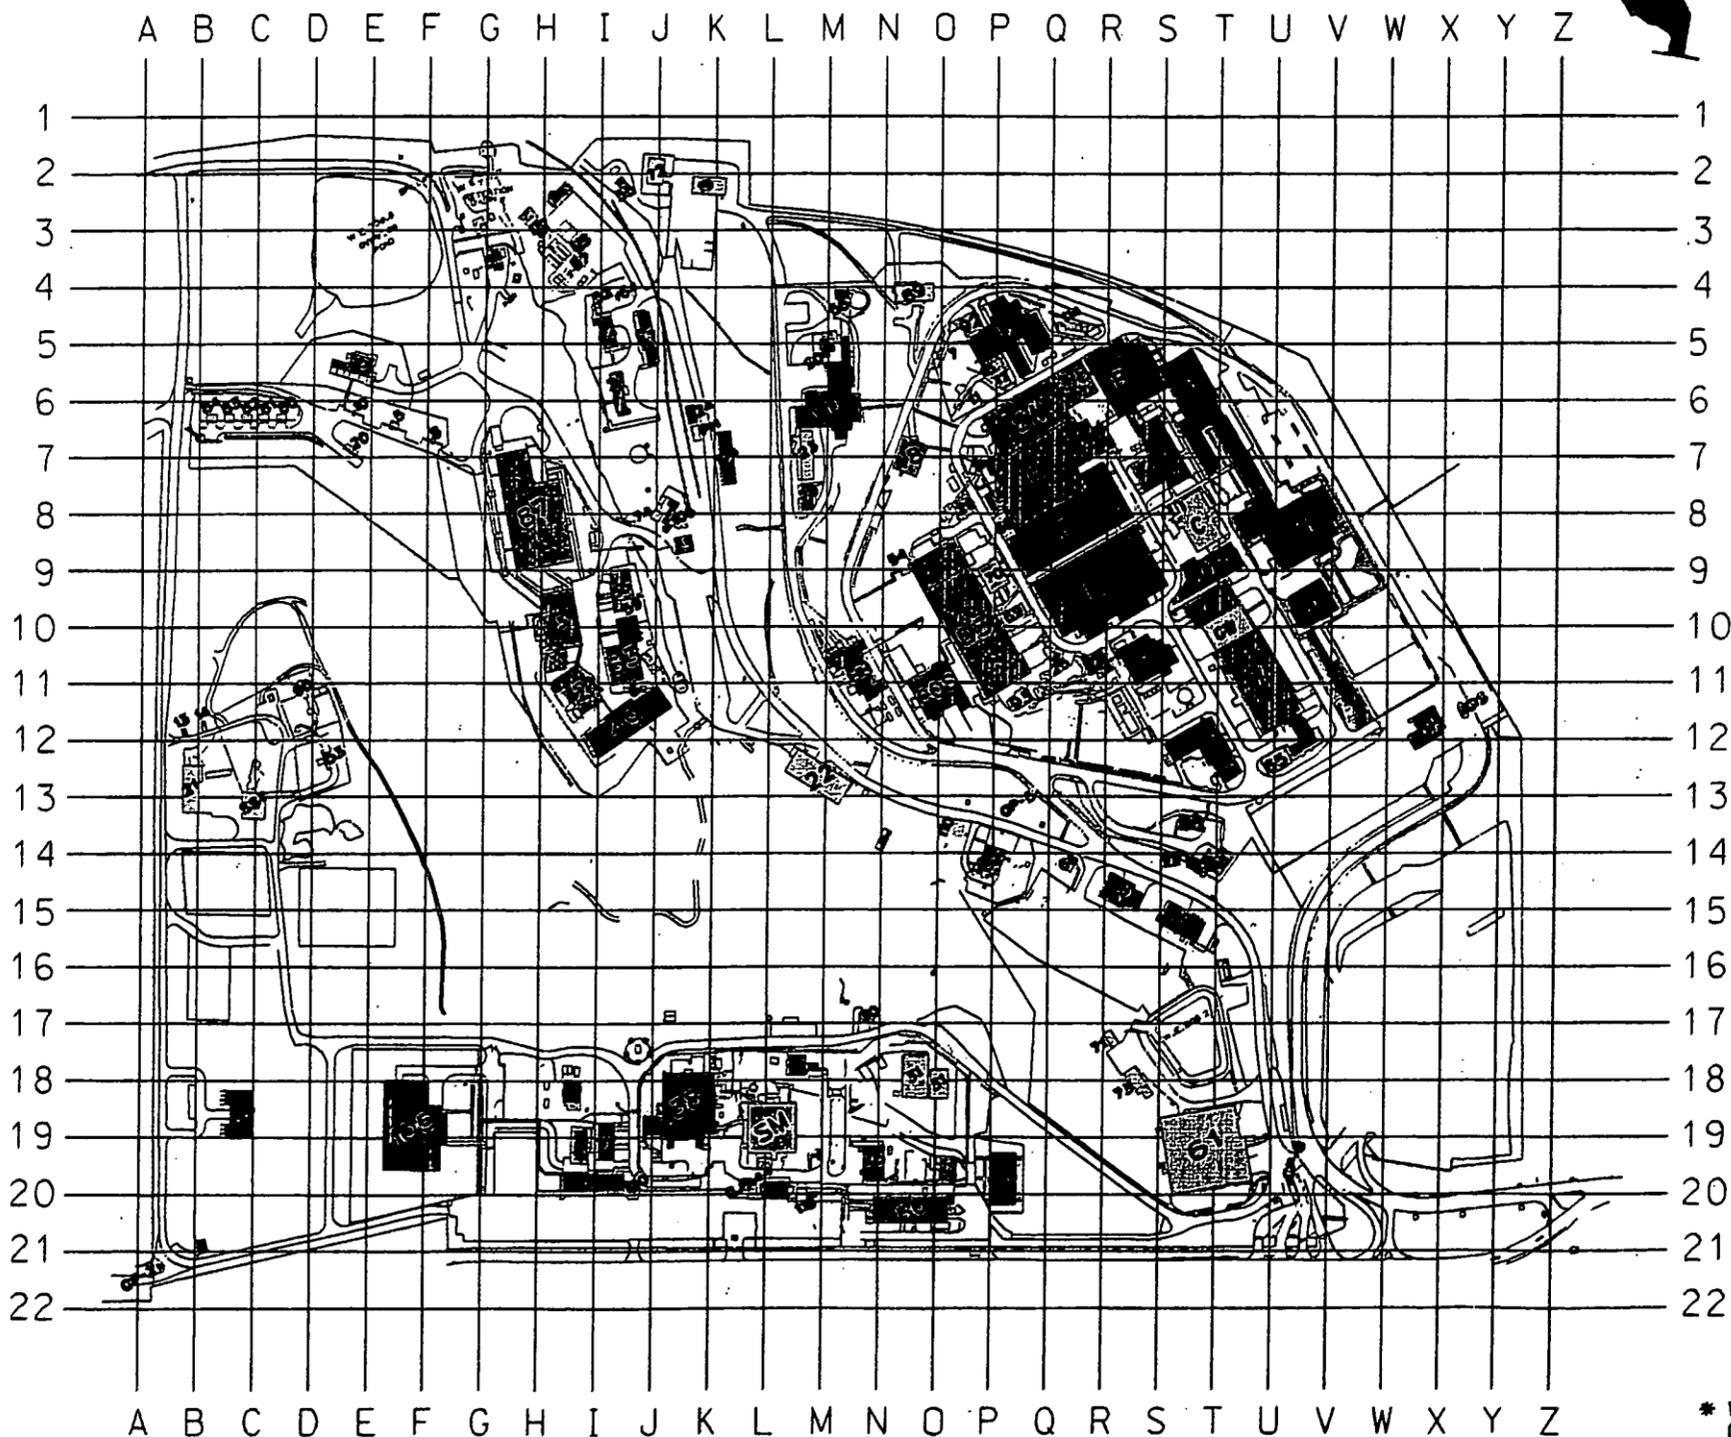
MOUND BUILDING LOCATIONS

BUILDING	LOCATION
A	T/7
B	R,S/5,6
C	S,T/8,9
CDS	O/11
DS	P/10
E	O/8
G	S,T/9,10
GH	W,X/11,12
GIS	X,Y/11,12
GP1	V,W/11,12
GP2	A,B/21,22
GP5	P,Q/12,13
GP8	U,V/19,20
GP44	K,L/19,20
GW	T/10
H	S/7
HH	M,N/10,11
I	P/5
M	R/9
DSE	U,V/8,9
OSW	S,T/5,6
P	R,S/10,11
PH	J,K/6,7
PS	O,R/10,11
R	Q/7
SD	M/5
SST	C/13
SW	Q/6
T	P/10
W	U/11
WD	M/6
WH1	*
WH2	*
WH3	*
1	J,K/8,9
2	H,I/11,12
3	H,I/10,11
4	B/21
5	E,F/6,7
6	J/11
7	O/5
8	F,G/6,7
10	D,E/6,7
11	O,P/5,6
19	J,K/2,3
20	D,E/6,7
21	A,B/12,13
22	L,M/12,13
23	L,M/6,7
24	J,K/6,7
25	Q,R/10,11
27	I,J/5,6
28	T/12
29	S,T/15,16
30	M,N/16,17
31	O/18
33	L,M/17,18
34	G,H/3,4
35	I,J/9,10
36	M,N/19,20

MOUND SITE PLANNING INFORMATION	
BUILDING LOCATIONS	
No. 6-6	REVISION DATE 09/16/96
