MOUND PLANT
Building Data Package
Magazines 5, 6, 7, 10, 11, 20, 53, 54
Located within Release Block C, E, R, Q

BDP Magazines 5, 6, 7, 10, 11, 20, 53, 54

**Building Data Package
BDP 5,6,7,10,11,20,53,54
Release Block C,E,R,Q**

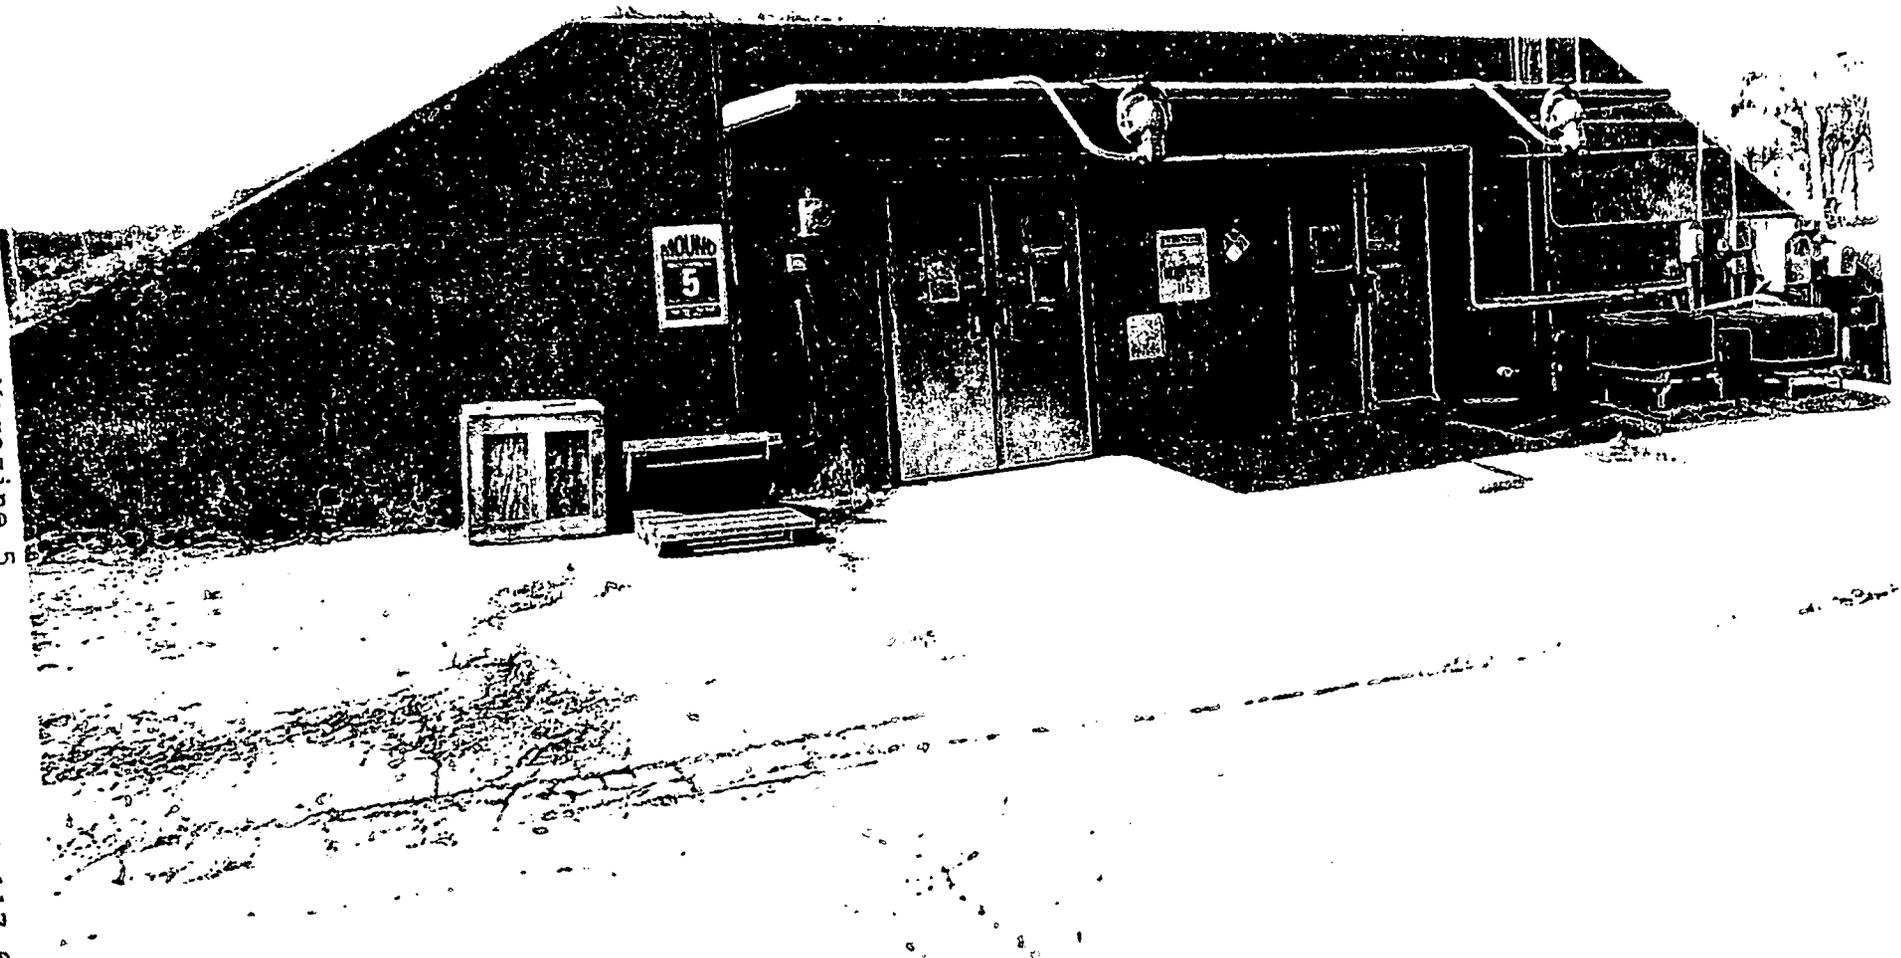
Mound Plant Magazine 5

Magazine 5 consists of two storage cells. A continuous concrete canopy protects the entrance to the cells. The roadway ends at the edge of the foundation. This building was constructed as a slab on grade building, with reinforced concrete walls and roof that was covered with about two feet of earth. Materials were removed by September 9, 1995. This magazine has a central cooling system.

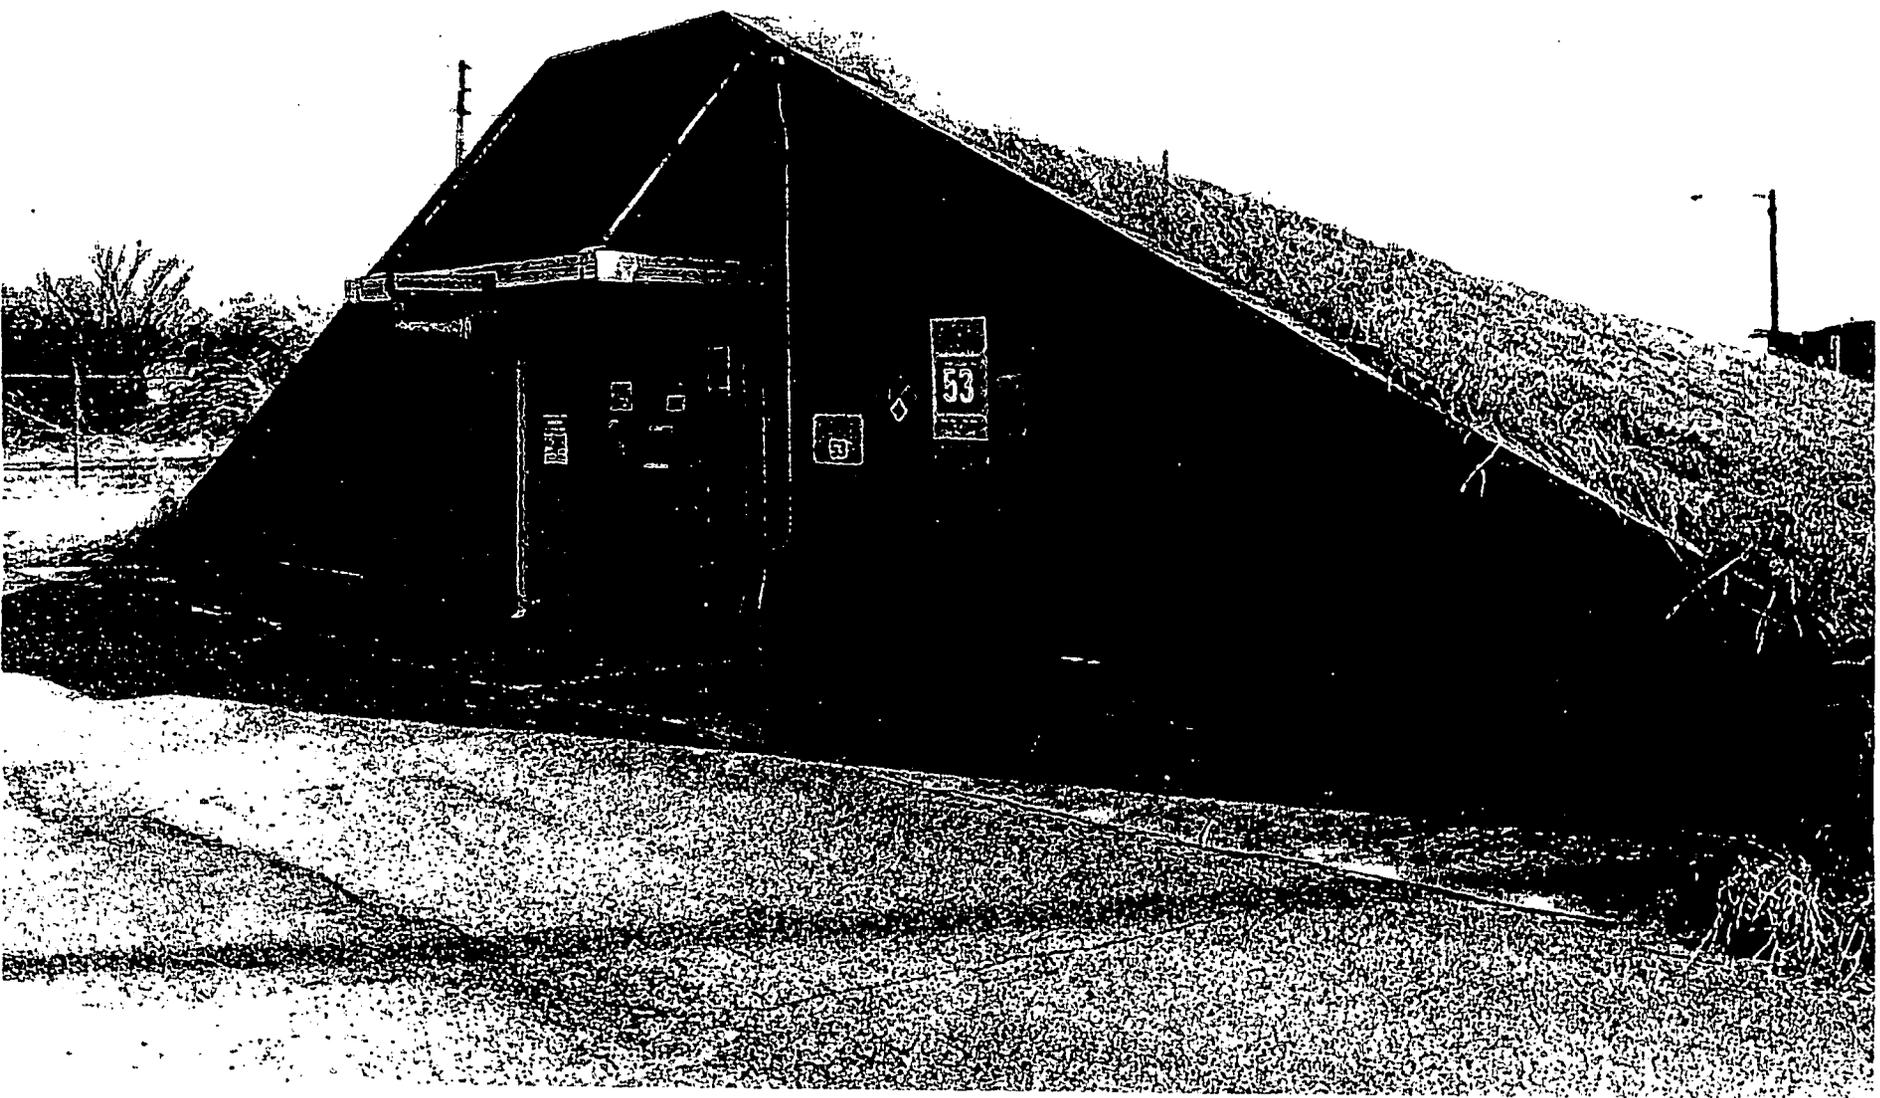
Mound Plant Magazine 53

Although Magazine 53 is included throughout this document, the Core Team decided on May 14, 1997 that this magazine would be excluded from the binning recommendation. Magazine 53 is included in the RCRA closure for the Burn Area. Finalization of the RCRA closure will allow the Core Team to reevaluate Magazine 53. The building investigation was conducted by EG&G personnel on March 26, 1997 and April 14 through April 28, 1997.

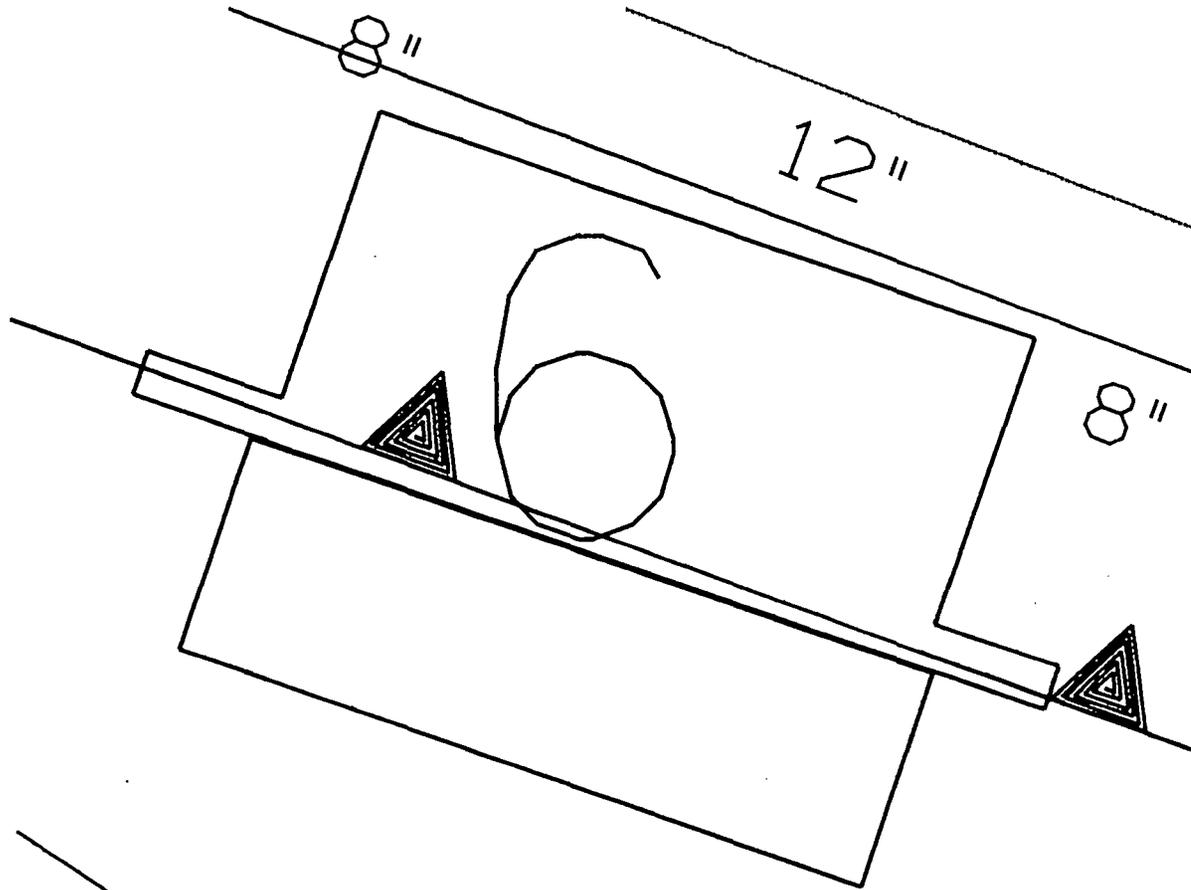
E.G. & G. - MOUND
UNDERGROUND WATER & WASTE LINES
MAGAZINE 6
DATE: 3-14-96

Magazine 6 consists of two storage cells. A continuous concrete canopy protects the entrance to cells. The roadway ends at the edge of the foundation. This building was constructed as a slab on grade building, with reinforced concrete walls and roof that was covered with about two feet of earth. At some time the earth was removed. Materials were removed by September 30, 1994.

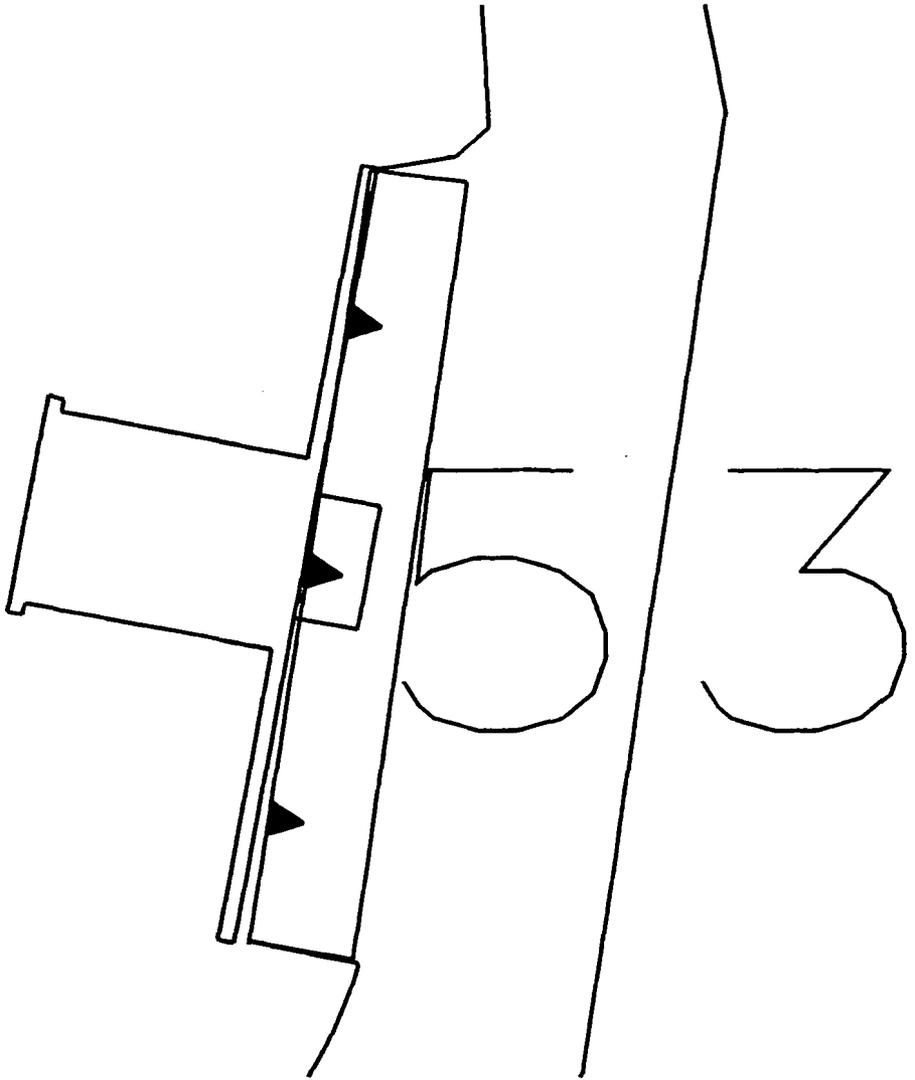
E.G. & G. - MOUND
 UNDERGROUND WATER & WASTE LINES
 MAGAZINE 53
 DATE: 3-14-66

Magazine 53 consists of a single cell. A canopy protects the entrance to the cells. The roadway ends at the edge of the foundation. This building was constructed as a slab on grade building, with reinforced concrete walls and roof that was covered with about two feet of earth. The roof and sidewall construction of this magazine is corrugated steel rather than concrete. The end walls are 12" reinforced concrete. This bunker was used for the temporary storage of waste products. Materials were removed from this magazine at some time prior to the end of 1996. This magazine has neither a heating or cooling system. Magazine 53 was included in the RCRA closure of the Burn Area. This magazine will be reviewed after the RCRA closure is completed.
