Miamisburg Closure Project CLOSEOUT REPORT

A Building

(Demolition)

Final
December 2004

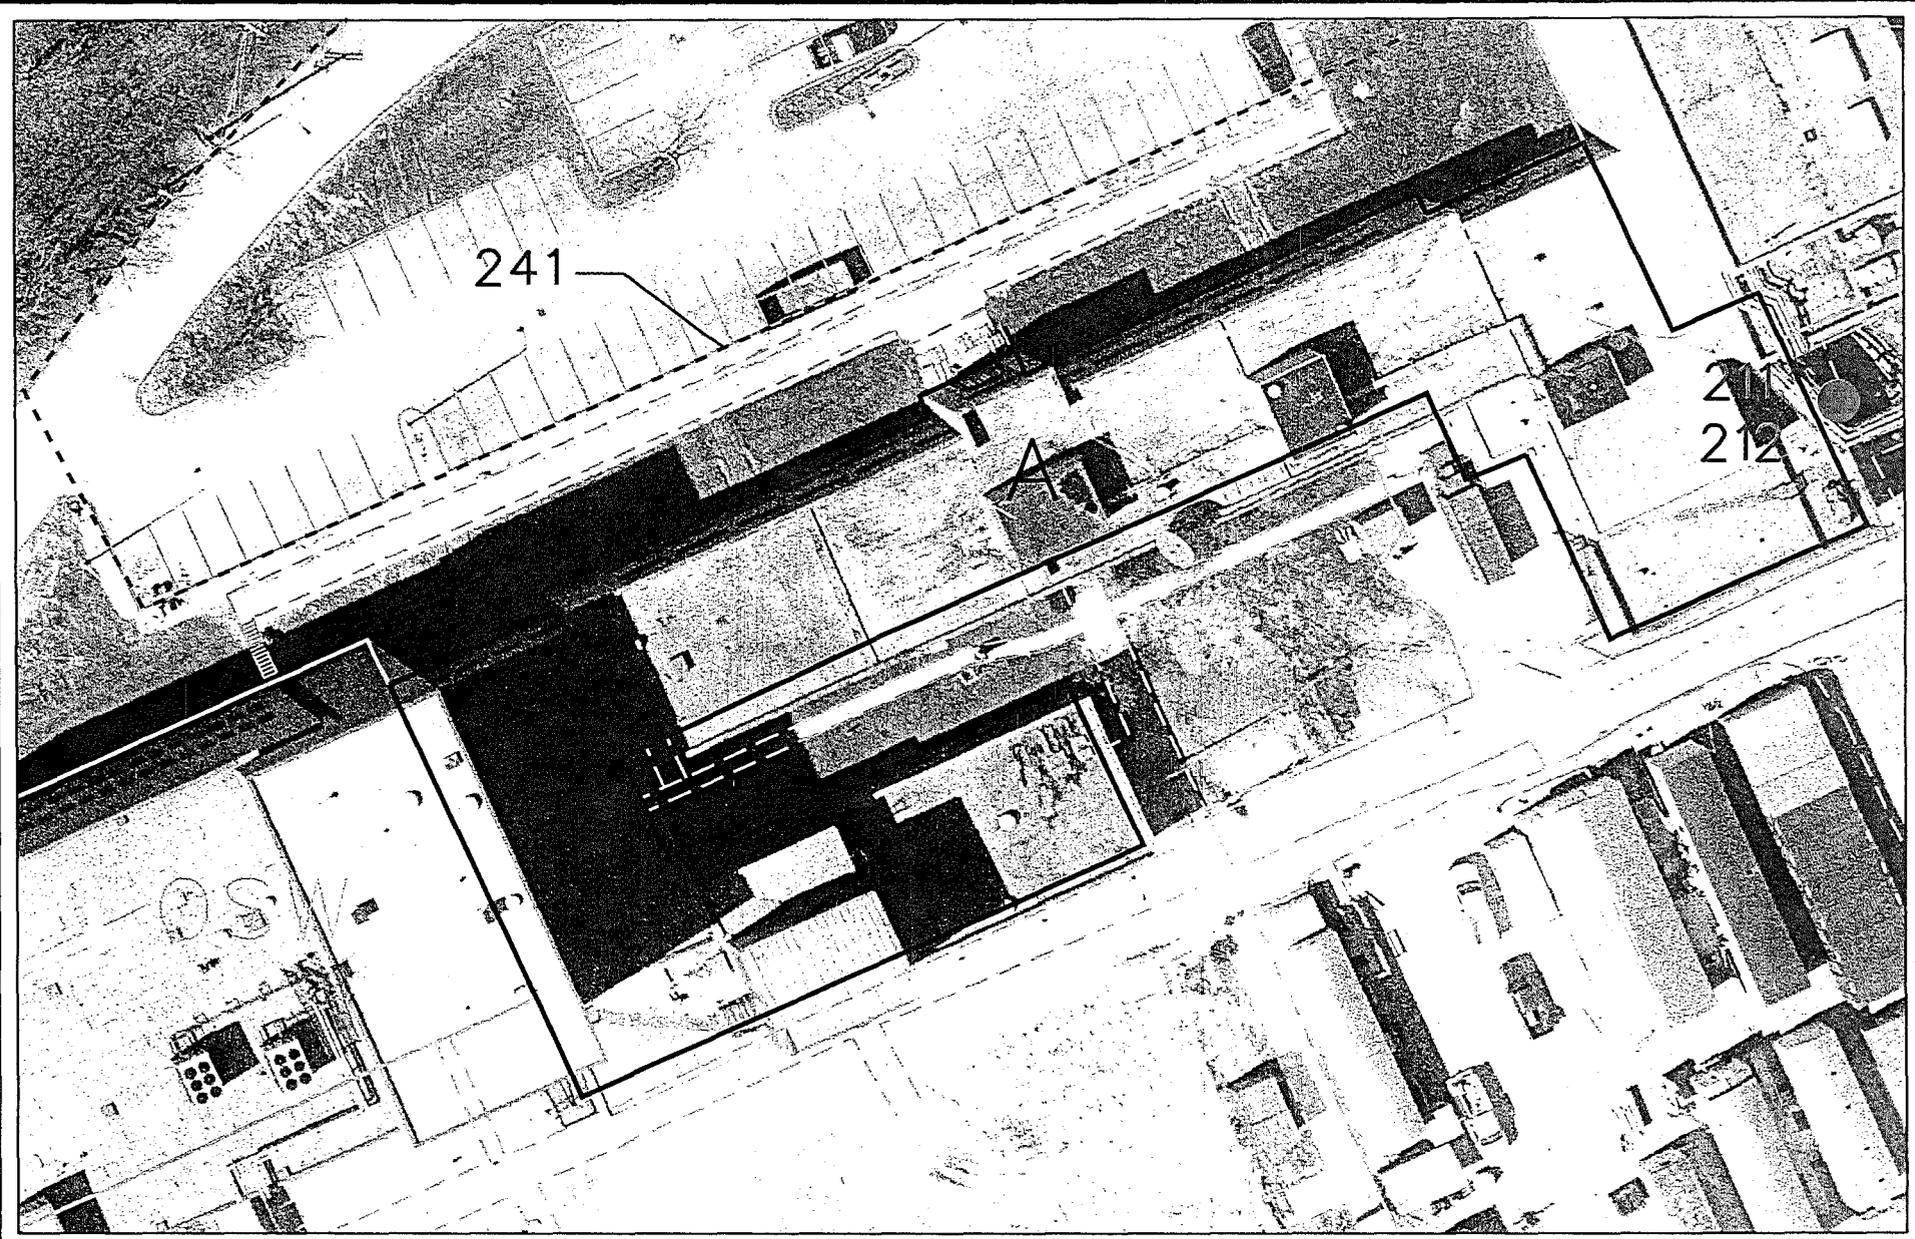
Figure 2:
A Building
and Vicinity

As a result of the investigations and documentation accomplished to comply with the CERCLA cleanup process via the Federal Facilities Agreement (FFA)/DOE Environmental Restoration (ER) Program, DOE and the site contractor tabulated all the PRSs identified under the various regulatory programs in effect at the site. Of these PRSs, three are at or near A Building, as identified in Table 3. The PRS locations are shown in Figure 2 and recommendation sheets are provided in Appendix C.

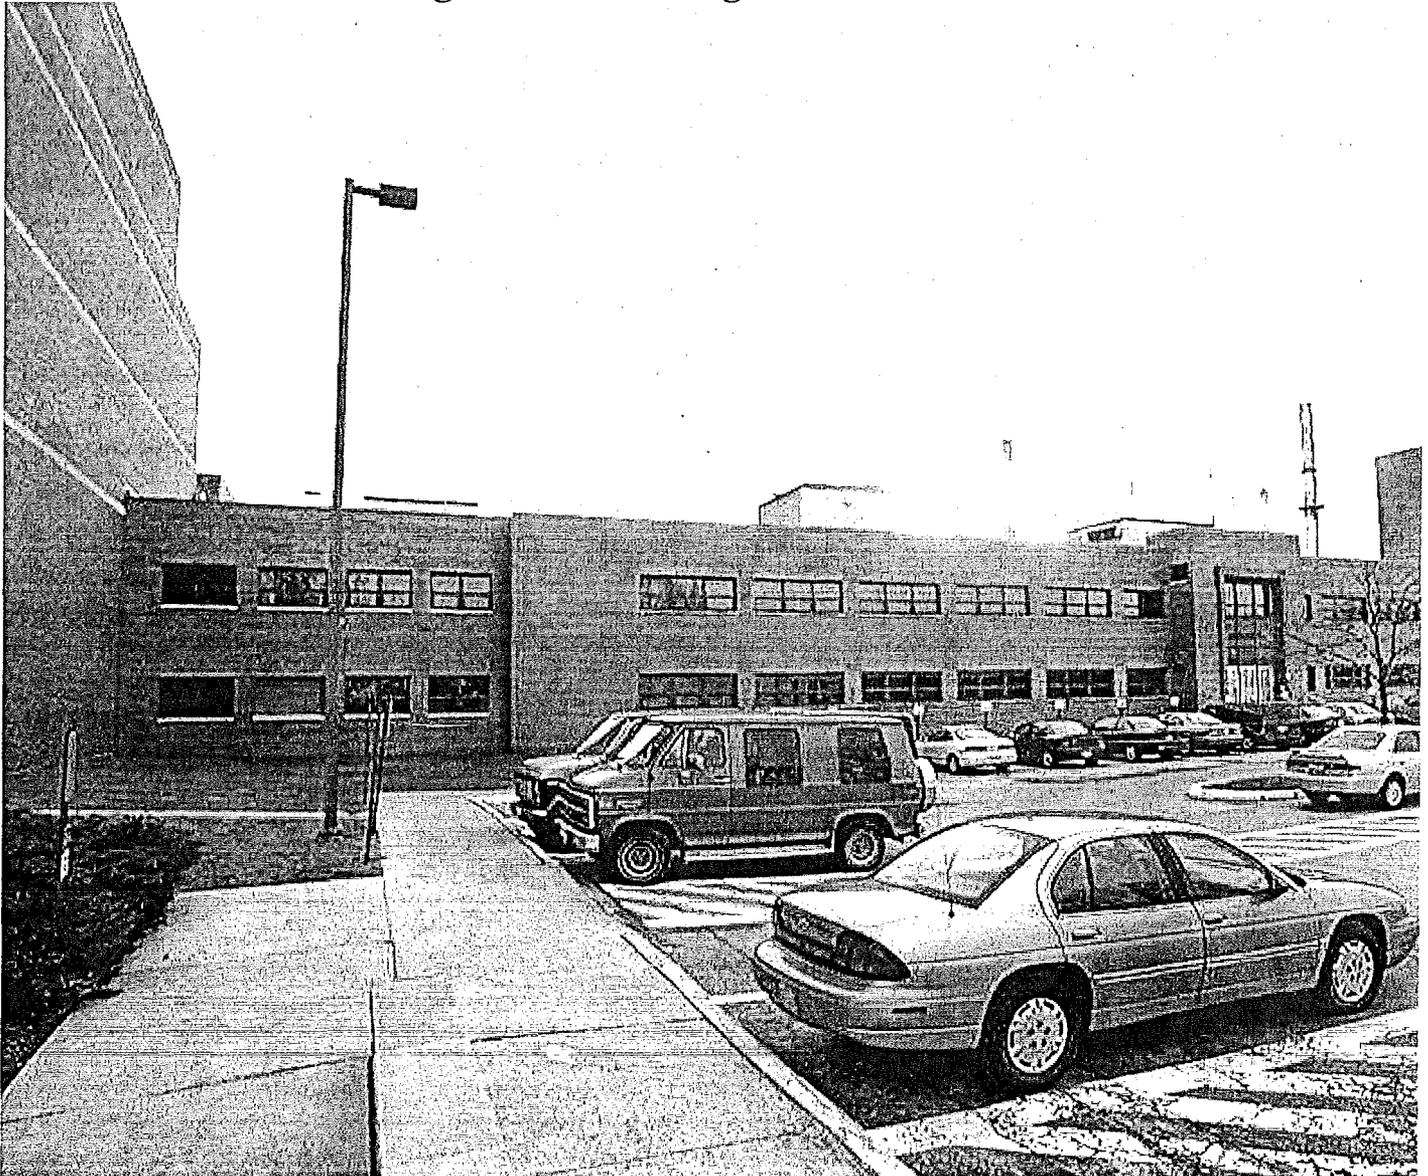
A3 of 7

**A Building
North view**

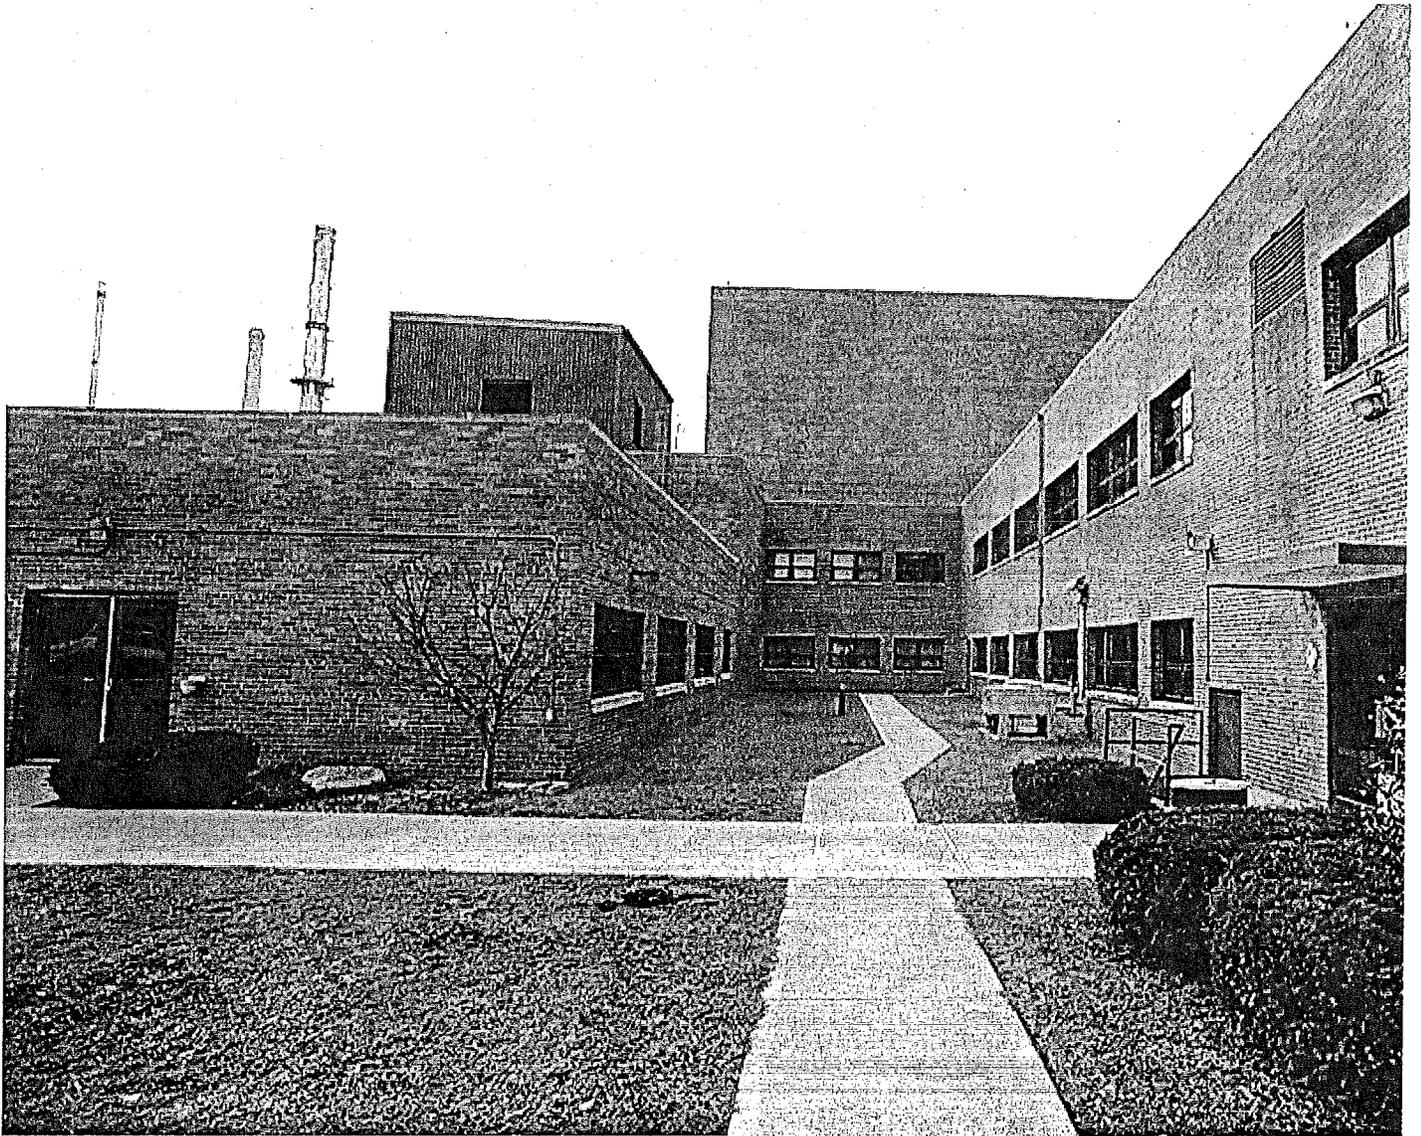
A407

**A Building
West view**

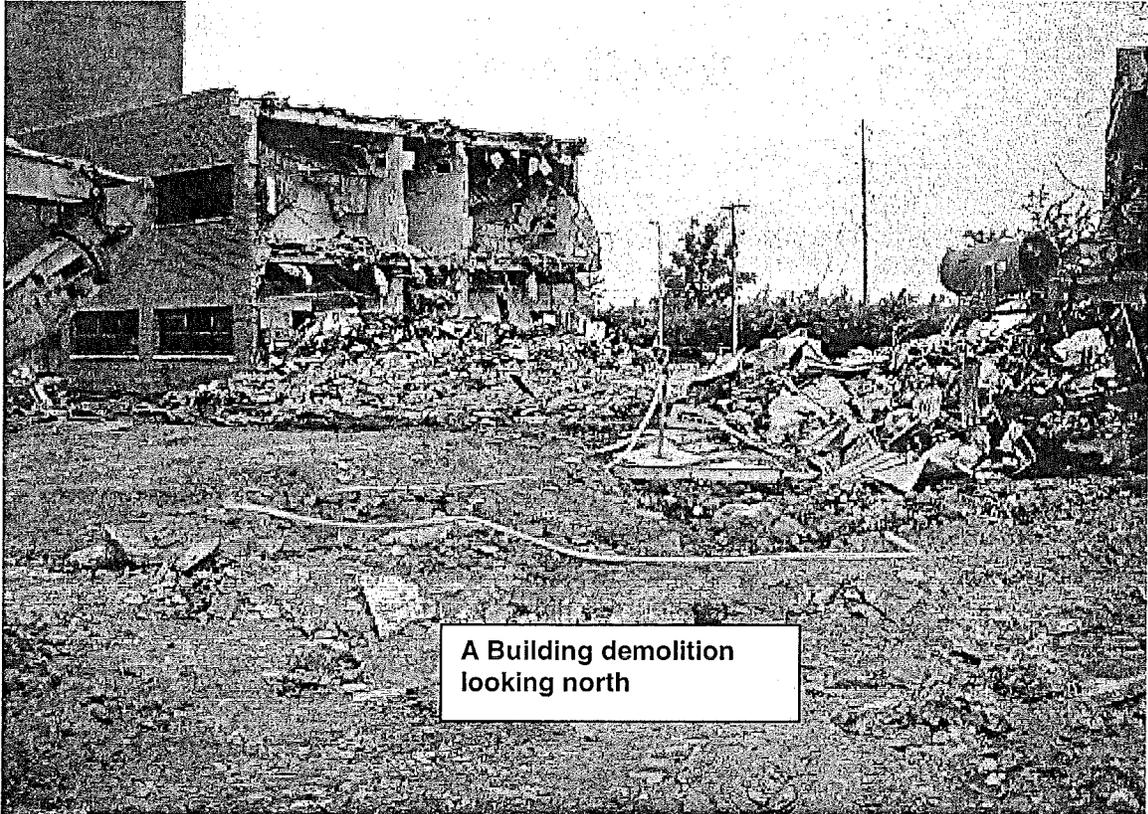
A Building demolition
looking north

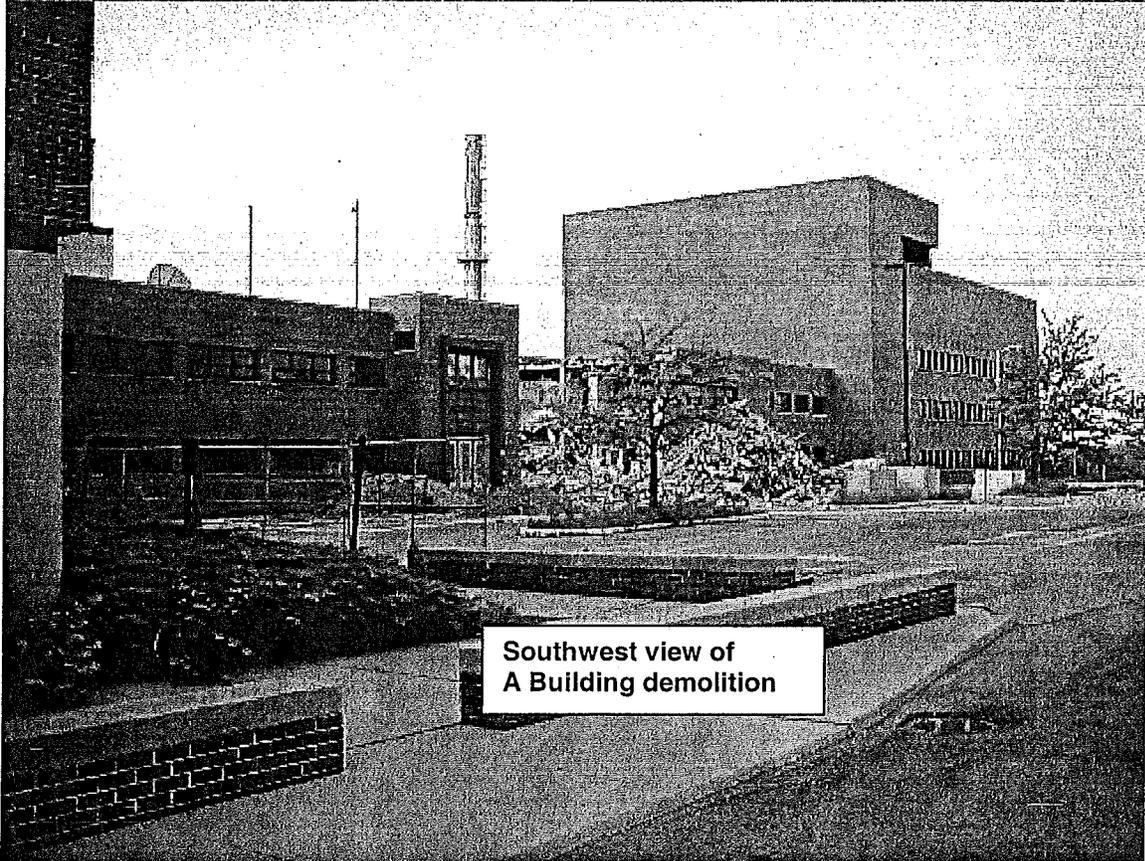
Southwest view of
A Building demolition

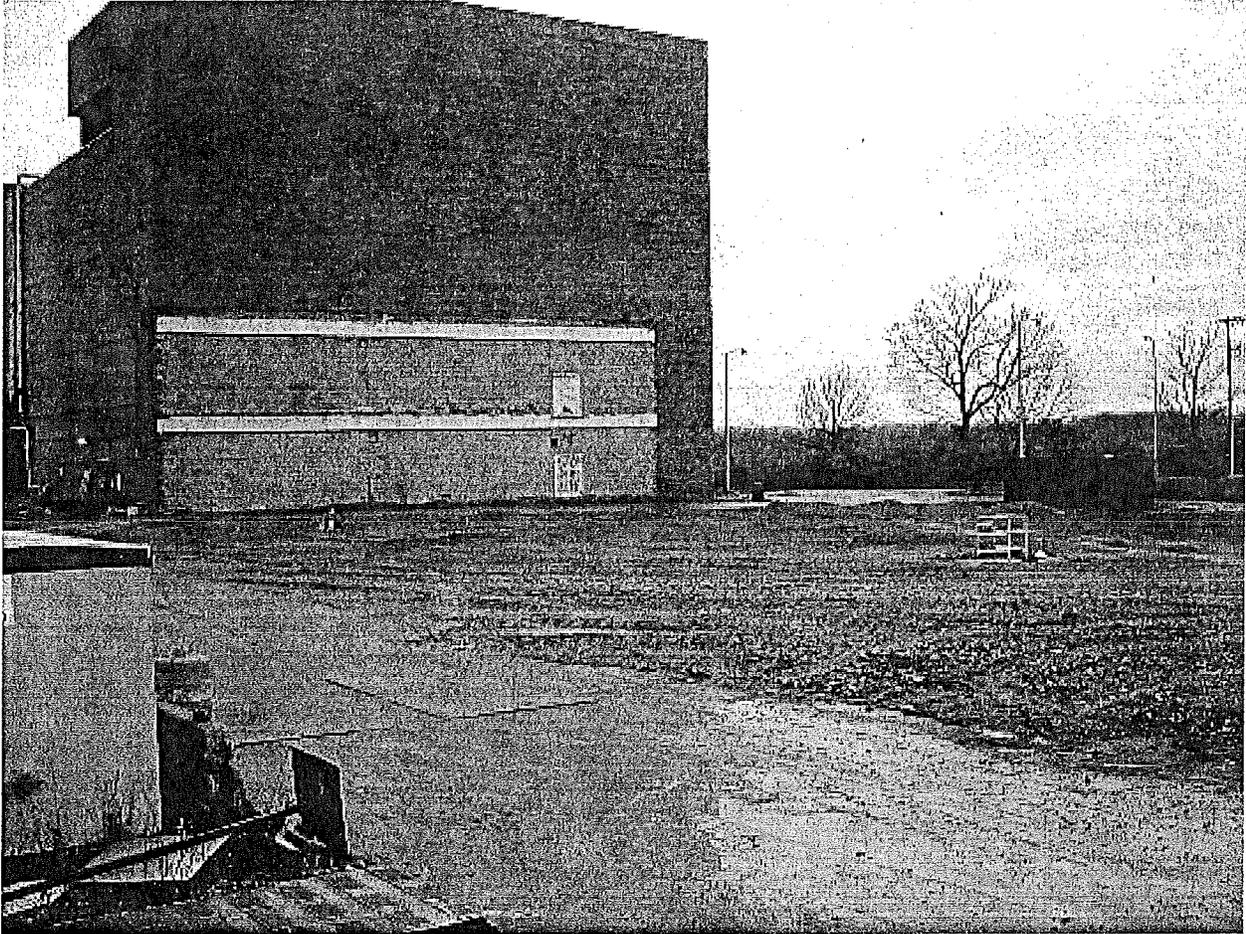
**A Building final restoration
View looking northwest**

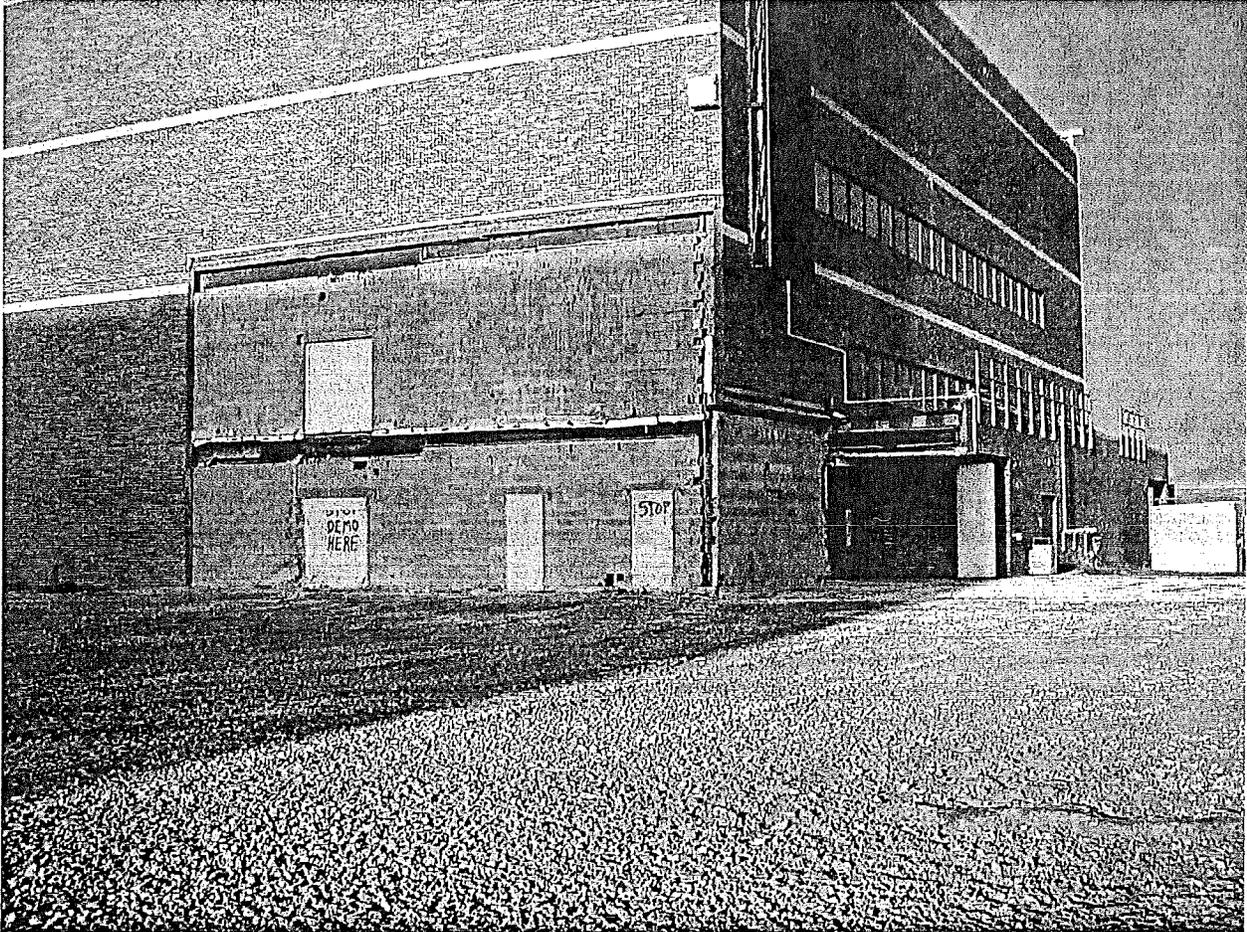
**A Building final restoration
View looking northeast**

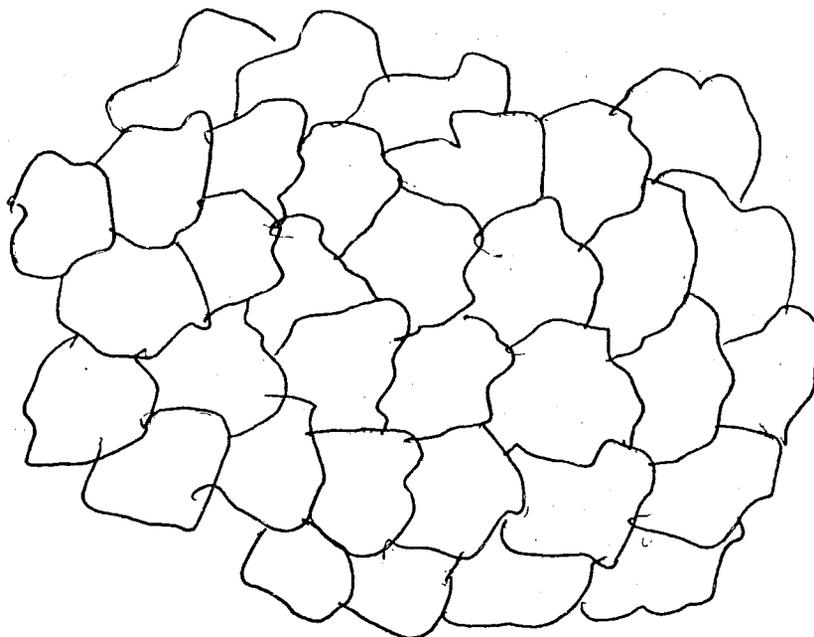
MAP / DRAWING

LOCATION: (BLDG./AREA/ROOM)	A-ANNEX	SURVEY NO.	04-TF-0163
PURPOSE:	RELEASE OF CONCRETE TO WASTE MANAGEMENT	RWP NO.	N/A
		DATE:	6-10-04
		TIME:	1430

* NOTE: FIDLER USED FOR INDICATION ONLY, NON-DETECTED ^{DETECTED} ~~DECT~~ ^{29A} 6-29-04
 INTEGRATED COUNT TAKEN IF ALPHA AUDIBLE DETECTED.
 NON-DETECTED ALL RESULTS

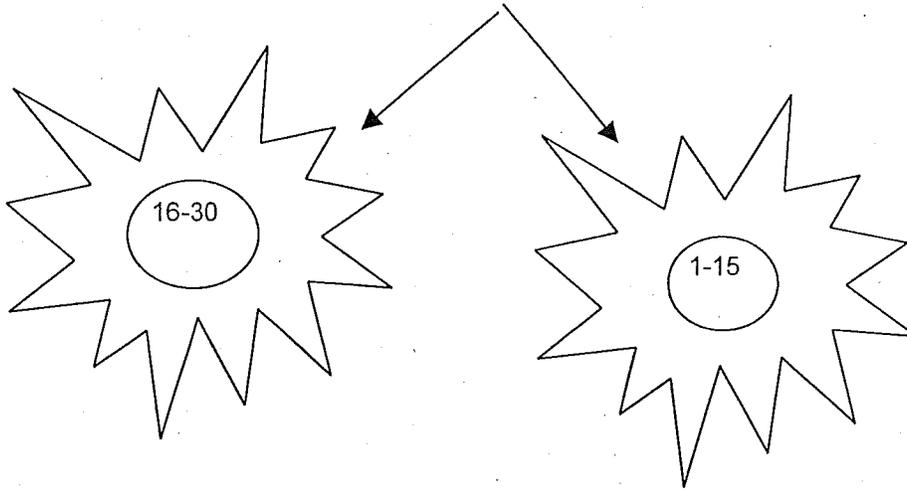
Concrete Debris

LOCATION: (BLDG./AREA/ROOM) A Building Annex	SURVEY NO. 04-TF-0177
PURPOSE: Debris Pile Survey of Concrete Rubble	RWP NO. None
	DATE: 6/17/04
	TIME: 13:00

Direct scan performed. No audible count rate increase detected.
Integrated counts not required.

FIDLER used for indication only. No increase above background. Background = ~200cpm

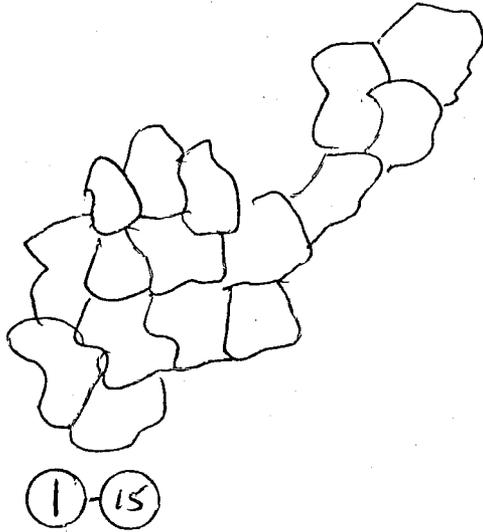
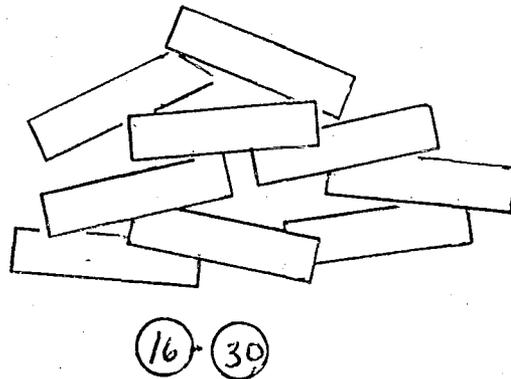
MAP / DRAWING

LOCATION: (BLDG./AREA/ROOM) A	SURVEY NO. 04-TF-0234
PURPOSE: Concrete released to wastemanagement	RWP NO. N/A
	DATE: 7/28/04
	TIME: 15:00

Scan & pause survey conducted
No clicks in required time
Integrated not required
