RF/RMRS-99-358.UN

# Closeout Radiological Survey Report For Building 729

Revision 0

April 1999

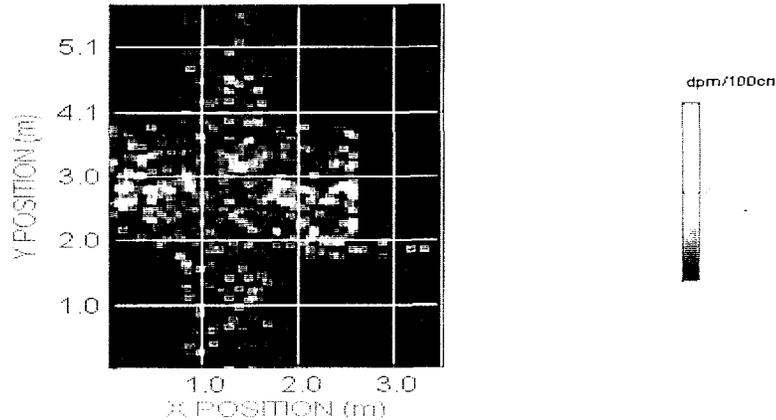
**Figure 5.1**  
**West Pit Initial Survey**

Initial characterization surveys of the west pit also indicated low levels of activity. A single 100 cm<sup>2</sup> area on the floor of the pit was determined to be approximately 337 dpm. Areas near the top of both the east and west wall of the pit indicated radioactivity in the range of 250 to 280 dpm/100 cm<sup>2</sup> distributed over areas of approximately 30 cm x 30 cm. Figure 5.1 is the two dimensional display of the pit area. The pit is represented as if the walls were laid out, with the floor area in the middle. The view is with the north wall toward the top of the display. The maximum 100 cm<sup>2</sup> area is in meter grid (2,3). The activity on the walls can be seen in meter grids (1,3), west wall, and (3,3), east wall. The areas were surveyed with a hand held NE Electra with a Model DP6 probe. These surveys confirmed the initial scan findings. The contaminated location on the floor was determined to be approximately 70 cm from the north wall of the pit and 40 cm from the east wall. The areas found on the walls were at the approximate mid points of the wall and extended from the top of the wall down approximately 35 cm. The areas as confirmed with the Electra, were marked and subsequently remediated. A needle gun was used to remove approximately 1/8" of the surface in areas roughly 40 cm x 40 cm around each of the three areas. The surface materials removed were disposed of as radioactive waste. Subsequent final status surveys with hand held instruments indicated that the pit area was below the DCGL<sub>EMC</sub> in the remediated areas. Final survey of the west pit is presented in Volume 2, Attachment D.

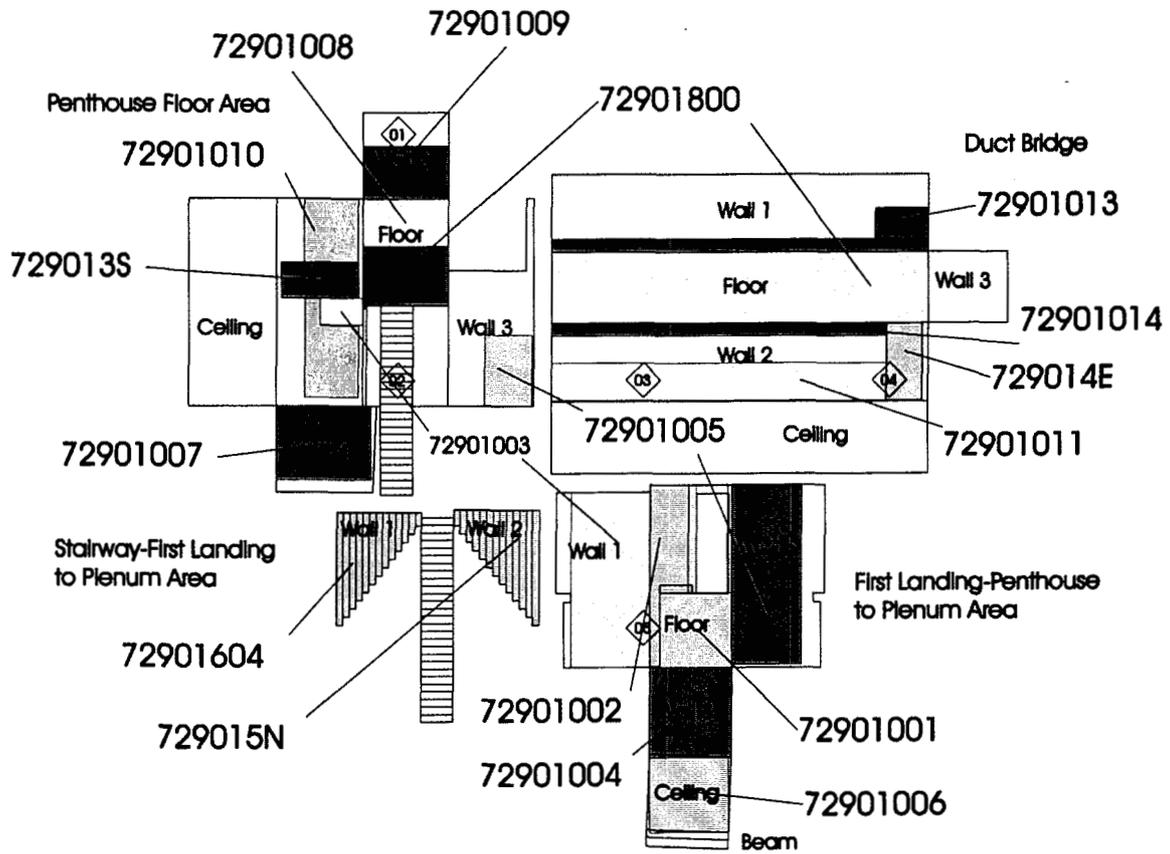
SURVEY UNIT 72901-MAP 1 OF 2

Survey Unit Description: Bldg. 729 Penthouse & Duct Bridge

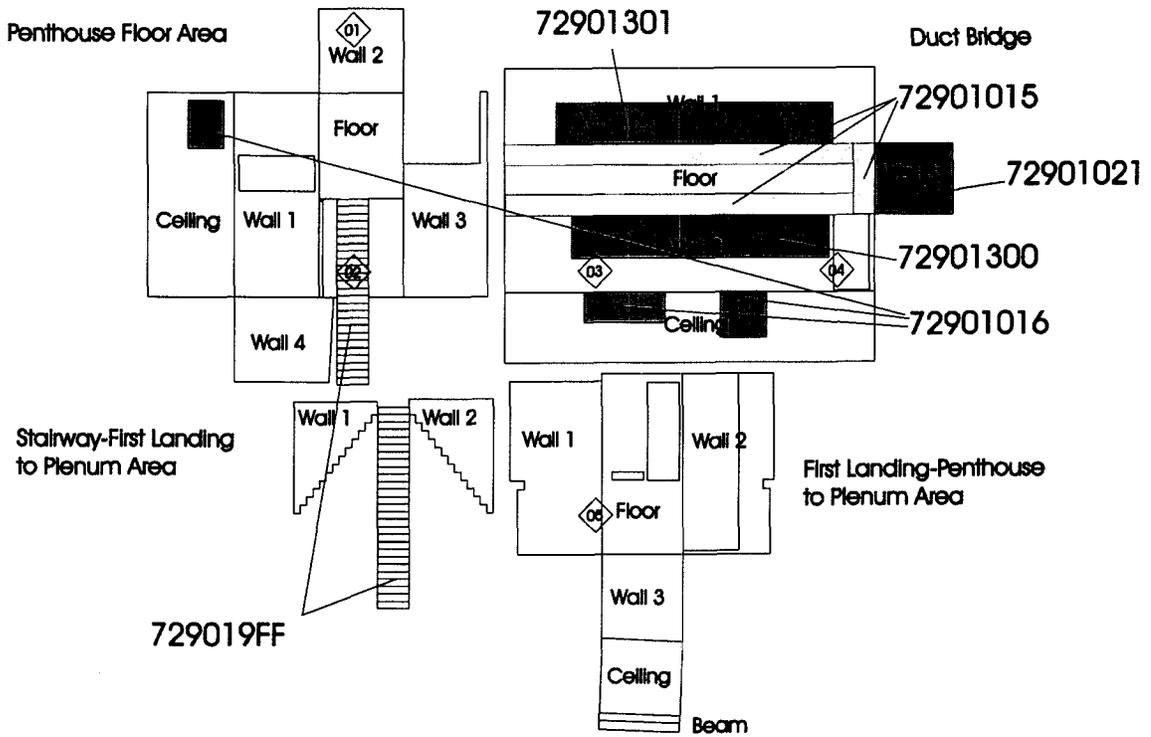
**SURVEY UNIT 72901-MAP 1 OF 2**

Survey Unit Description: Bldg. 729 Penthouse & Duct Bridge

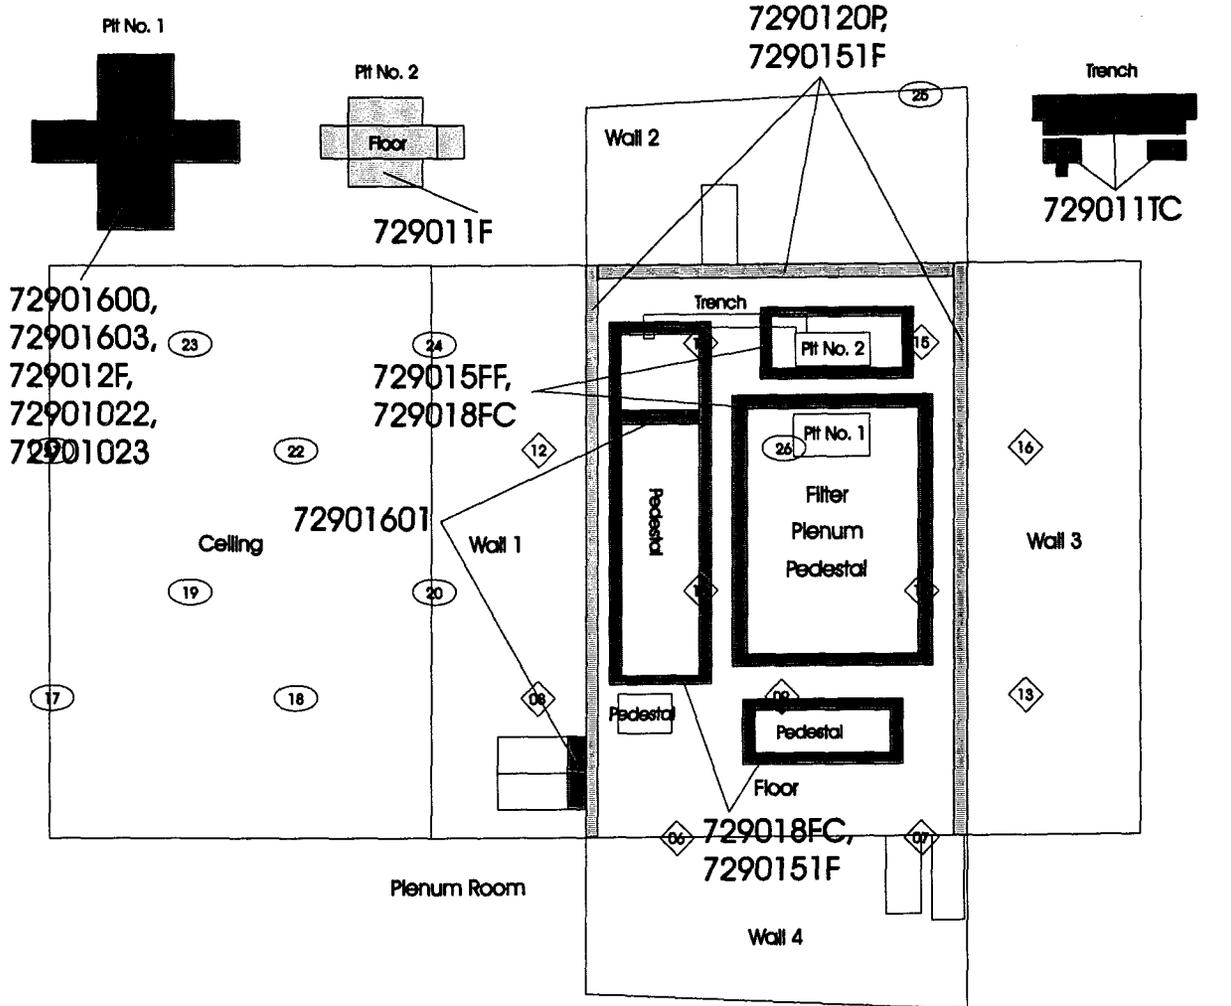
**SURVEY UNIT 72901-MAP 2 OF 2**

Survey Unit Description: Bldg. 729 Plenum Area

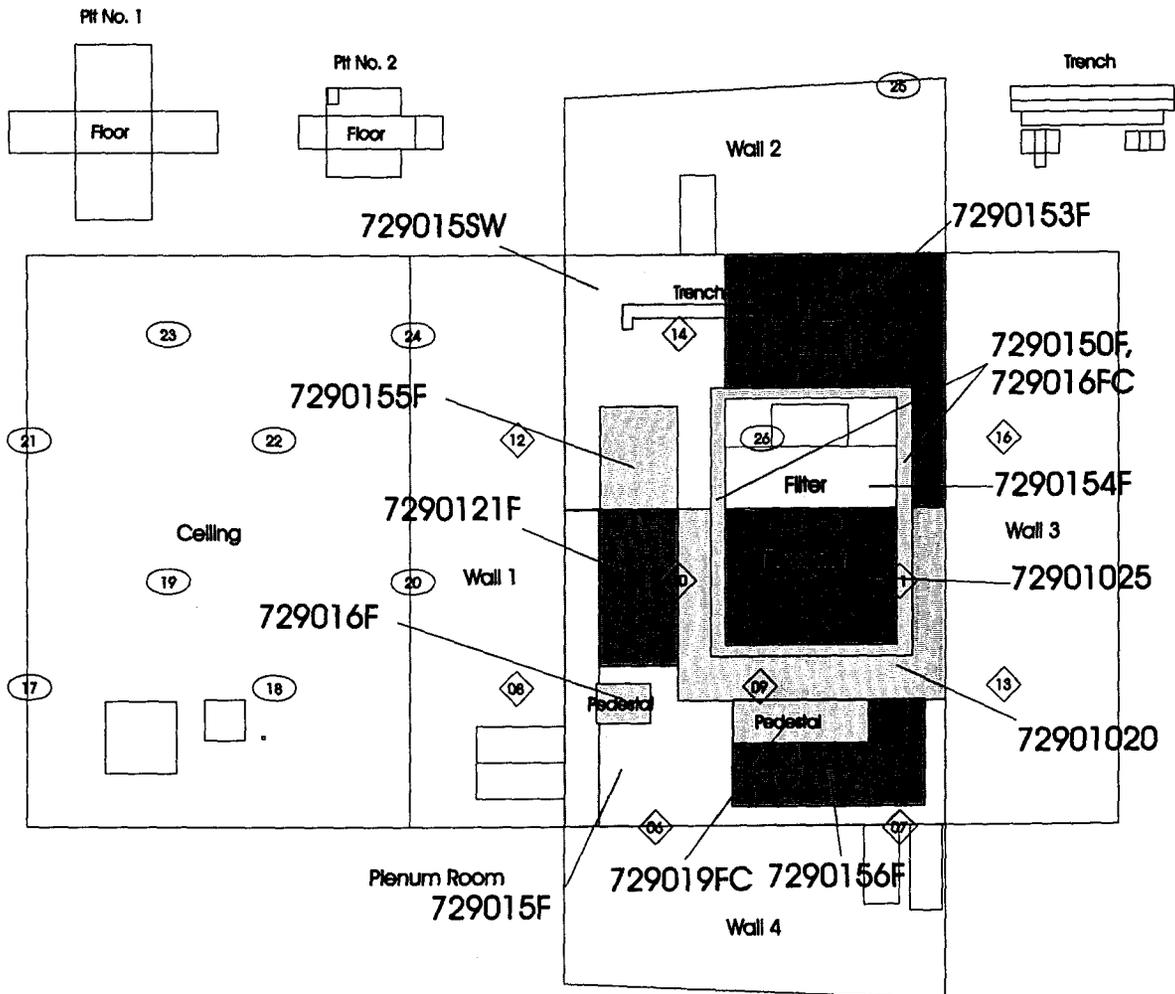
**SURVEY UNIT 72901-MAP 2 OF 2**

Survey Unit Description: Bldg. 729 Plenum Area

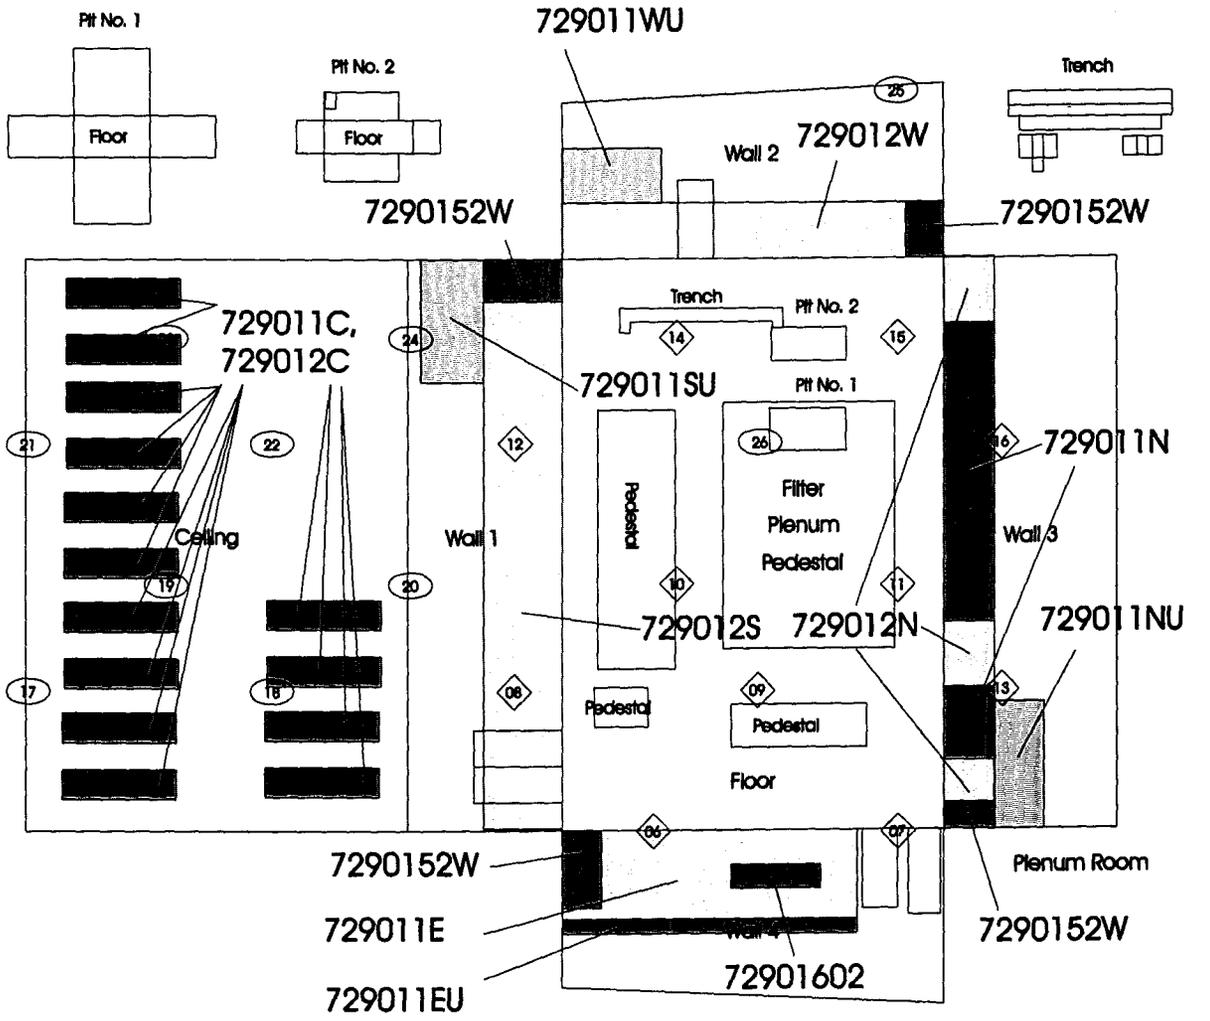
**SURVEY UNIT 72901-MAP 2 OF 2**

Survey Unit Description: Bldg. 729 Plenum Area

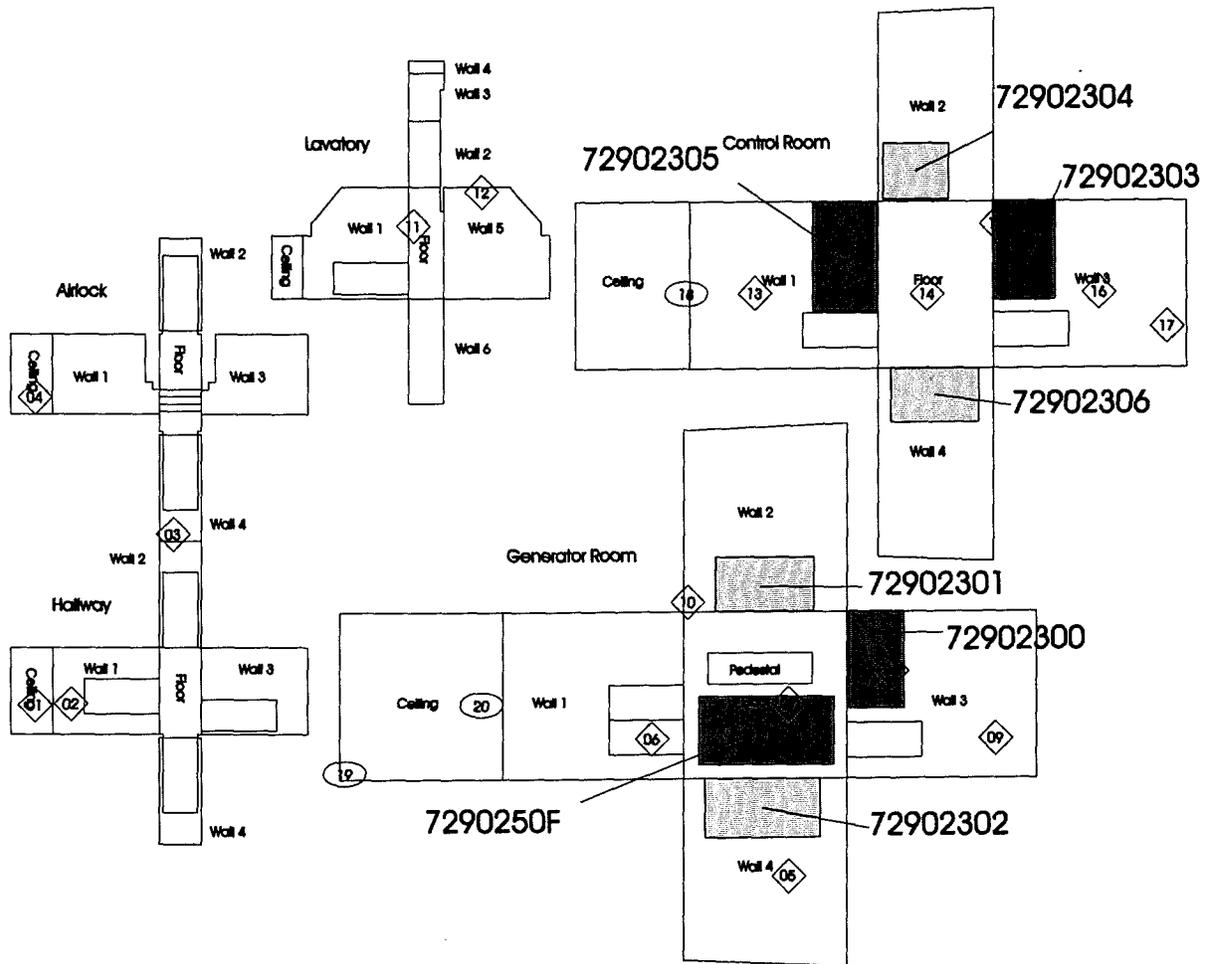
**SURVEY UNIT 72902-MAP 1 OF 1**

Survey Unit Description: Bldg. 729 Generator Room, Control Room, Airlock/Hallway & Lavatory

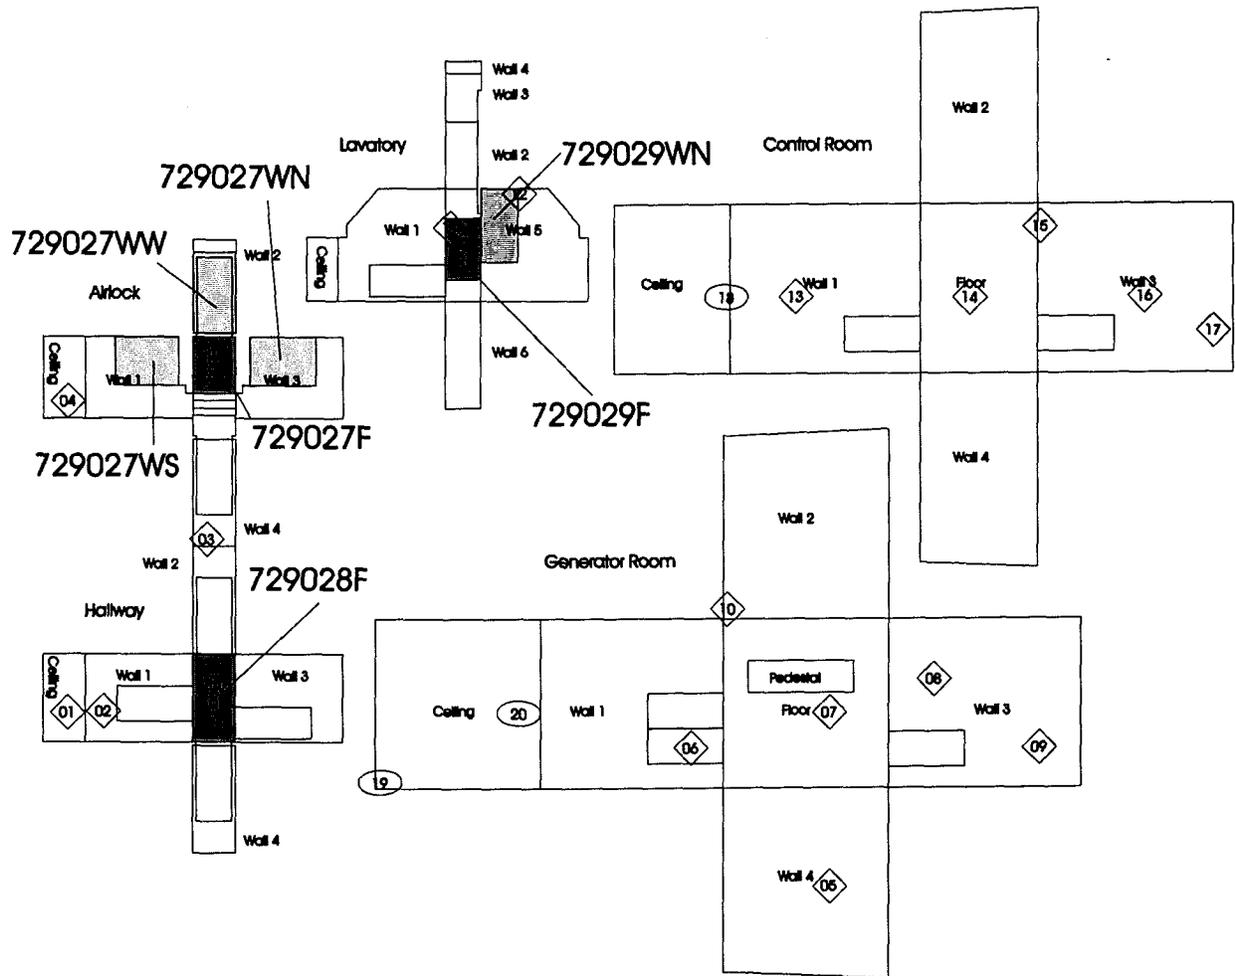
**SURVEY UNIT 72902-MAP 1 OF 1**

Survey Unit Description: Bldg. 729 Generator Room, Control Room, Airlock/Hallway & Lavatory

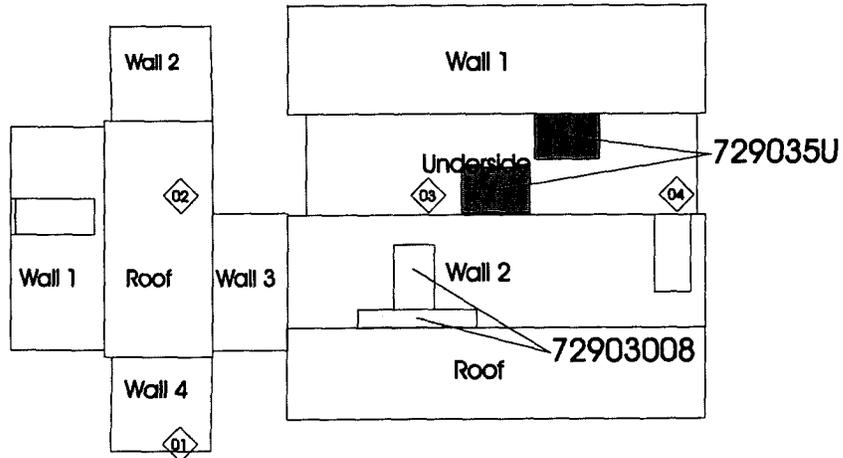
**SURVEY UNIT 72903-MAP 1 OF 2**

Survey Unit Description: Bldg. 729 Outside Walls, Roof & Duct Bridge

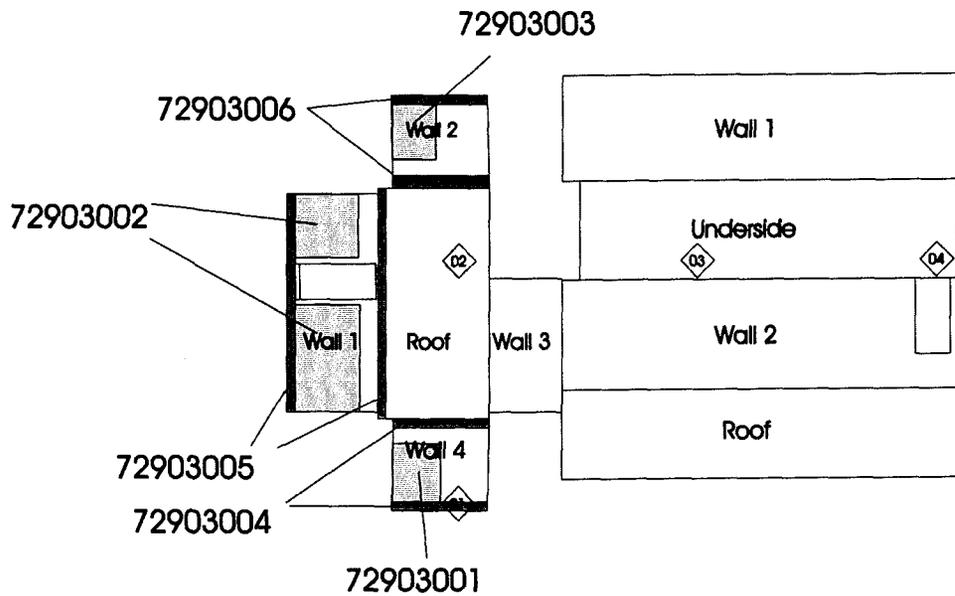
**SURVEY UNIT 72903-MAP 1 OF 2**

Survey Unit Description: Bldg. 729 Outside Walls, Roof & Duct Bridge

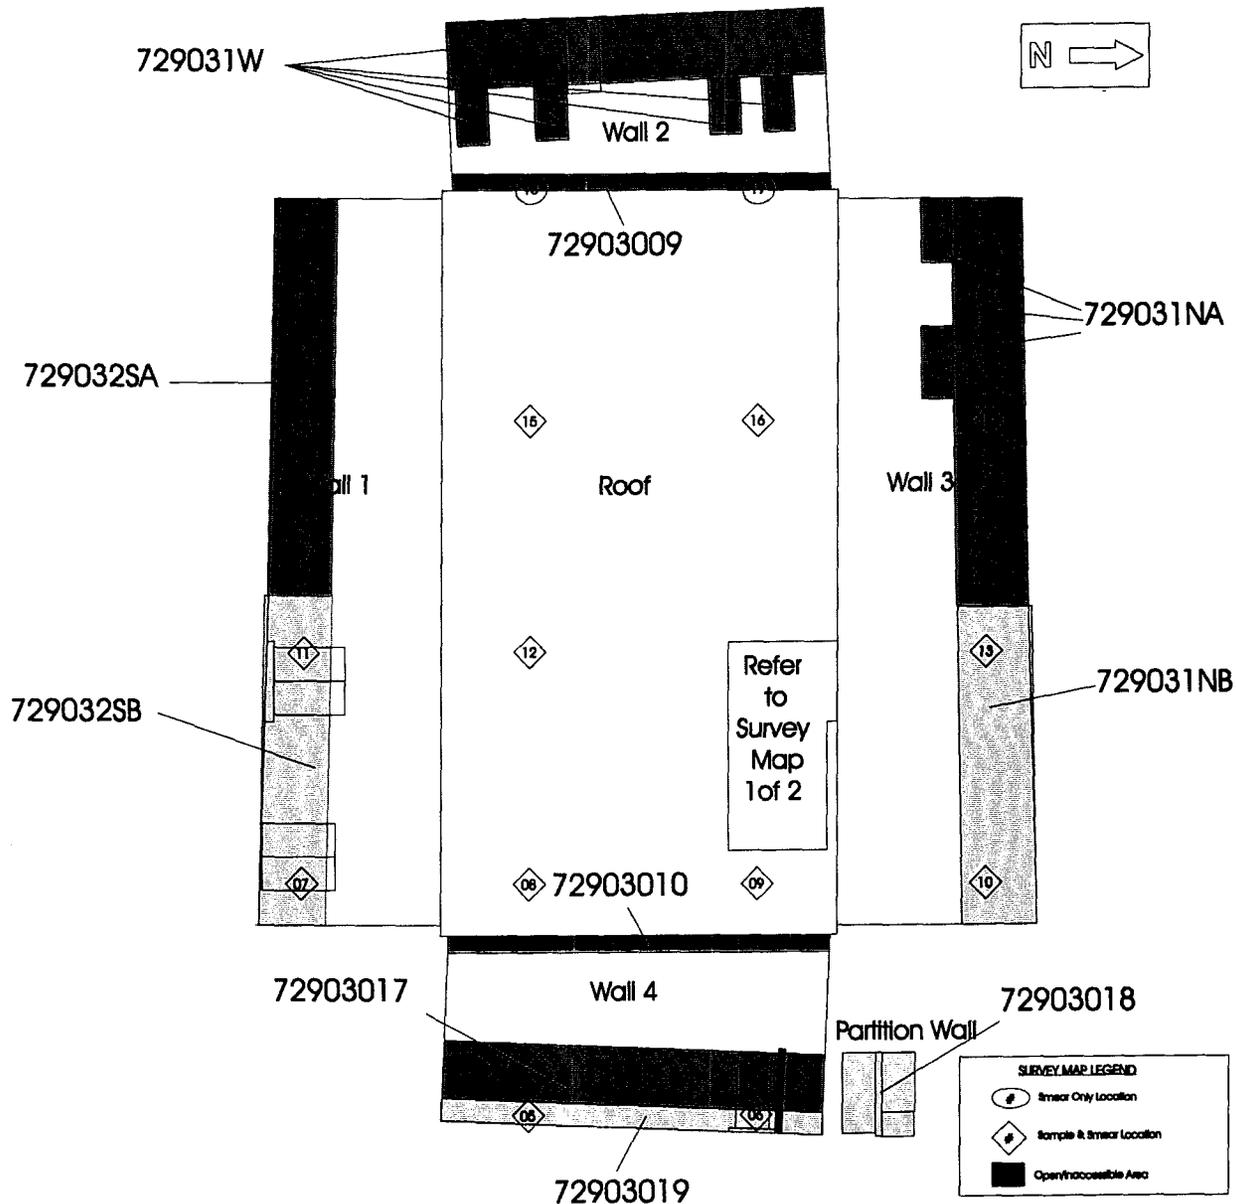
SURVEY UNIT 72903-MAP 2 OF 2

Survey Unit Description: Bldg. 729 Outside Walls, Roof, and Duct Bridge

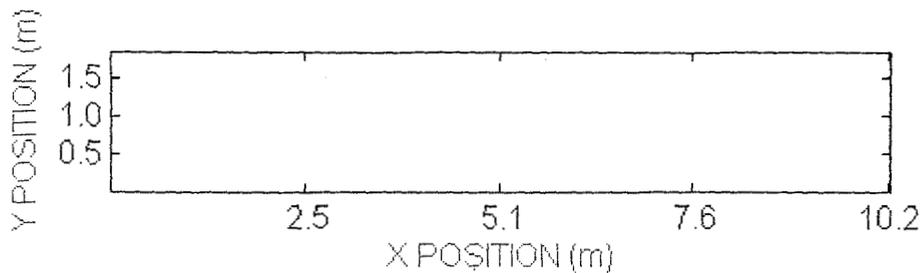
The survey results indicate that the maximum surface activity levels in the 100 square centimeter zones were above the DCGL<sub>EMC</sub>. Figure 3 details which zones were the DCGL<sub>EMC</sub>:

**Figure 3** Yellow pixels correspond to the upper left coordinate of a 100cm<sup>2</sup> area exceeding the DCGL<sub>EMC</sub>.

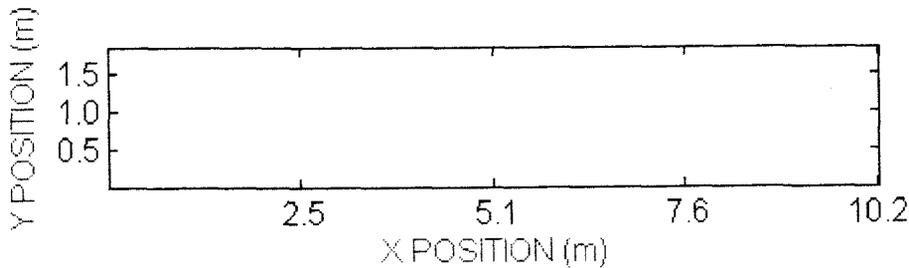
The survey results indicate that the maximum surface activity levels in the 100 square centimeter zones were above the DCGL<sub>EMC</sub>. Figure 3 details which zones were above the DCGL<sub>EMC</sub>:

**Figure 3** Yellow pixels correspond to the upper left coordinate of a 100cm<sup>2</sup> area exceeding the DCGL<sub>EMC</sub>.

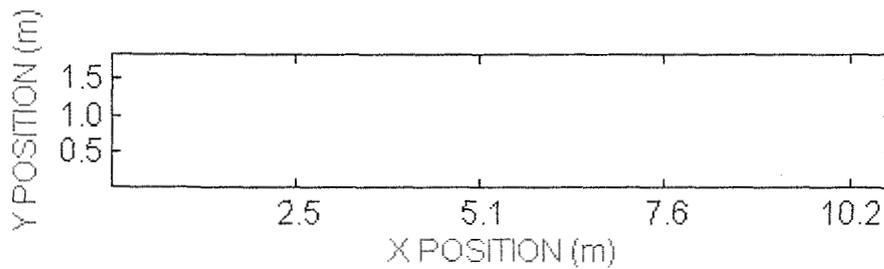
The survey results indicate that the maximum surface activity levels in the 100 square centimeter zones were above the DCGL<sub>EMC</sub>. Figure 3 details which zones were above the DCGL<sub>EMC</sub>:

**Figure 3** Yellow pixels correspond to the upper left coordinate of a 100cm<sup>2</sup> area exceeding the DCGL<sub>EMC</sub>.

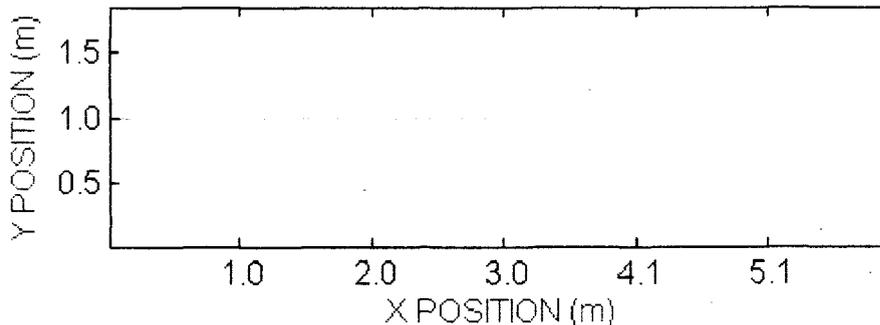
The survey results indicate that the maximum surface activity levels in the 100 square centimeter zones were above the DCGL<sub>EMC</sub>. Figure 3 details which zones were above the DCGL<sub>EMC</sub>:

**Figure 3** Yellow pixels correspond to the upper left coordinate of a 100cm<sup>2</sup> area exceeding the DCGL<sub>EMC</sub>.

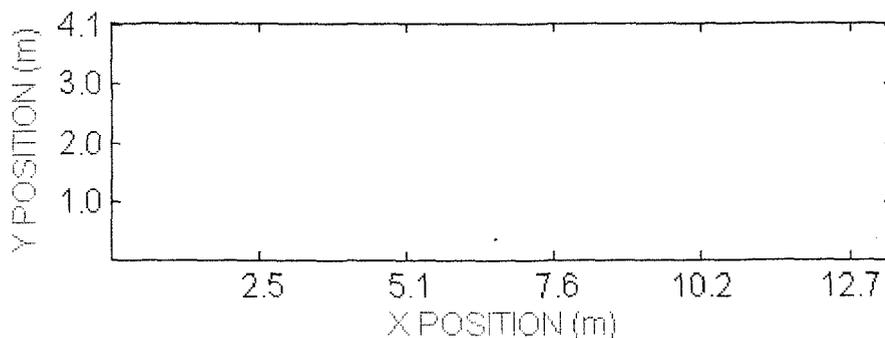
The survey results indicate that the maximum surface activity levels in the 100 square centimeter zones were above the DCGL<sub>EMC</sub>. Figure 3 details which zones were above the DCGL<sub>EMC</sub>:

Figure 3. Yellow pixels correspond to the upper left coordinate of a 100cm<sup>2</sup> area exceeding the DCGL<sub>EMC</sub>.
