SUMMARY OF B883 CLOSEOUT REPORT RESPONSE TO COMMENTS TO CDPHE

**Figure 7**  
**IHSS 800-3**  
**Structural Features Removed**  
**and Remaining**

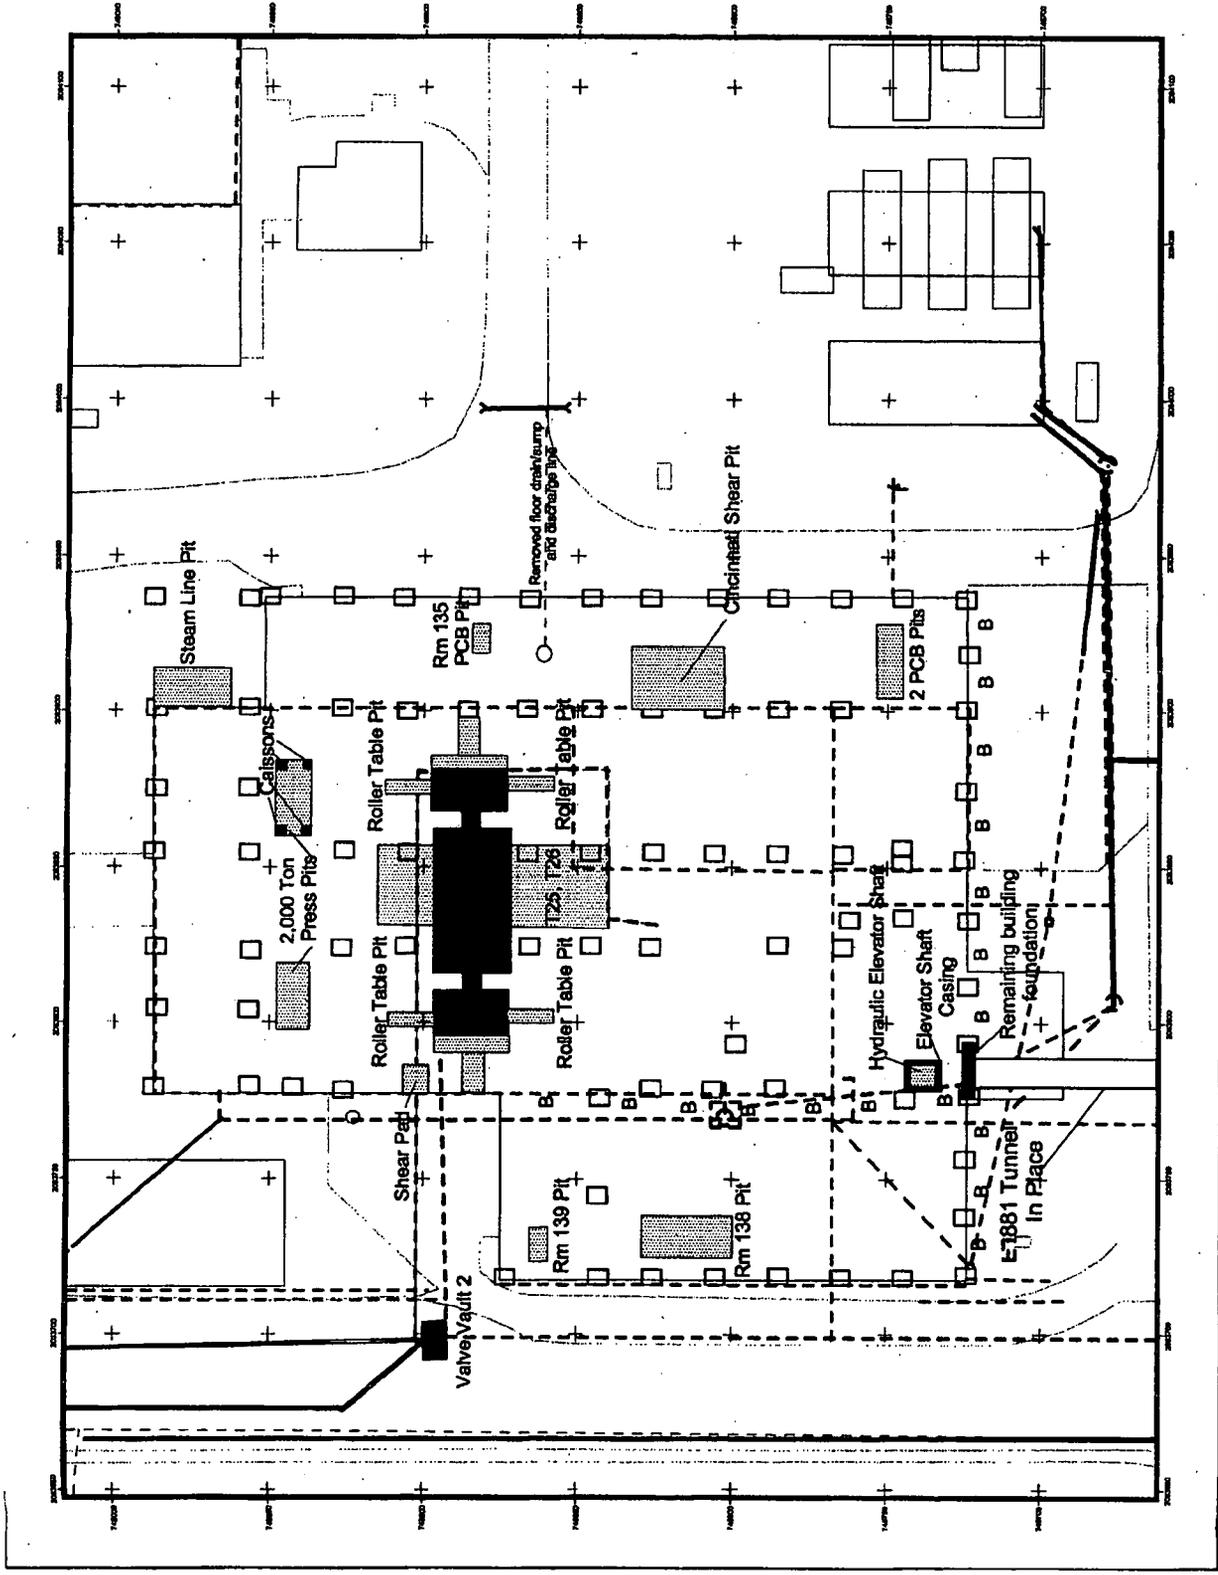
- Removed building
- Removed tank
- Remaining valve vault
- Remaining tunnel
- Remaining Pit Foundation
- Remaining column
- Remaining OPWL
- Remaining OPWL
- Remaining OPWL
- Removed sewer line
- Remaining sewer line
- Removed foundation drain
- Removed storm drain
- Remaining storm drain
- Removed drain
- Removed bottom beam
- Paved area
- Stream, ditch, or other drainage feature

All new process waste line (NPWL) from B883 to valve vault (VV) 2 was removed. NPWL from VV2 to VV3 was clean closed and left in place. Original process waste line (OPWL) P-9 was totally removed from B883 to a point west where the line depth is 4.7 feet below grade surface. From this point P-9 is grouted 75 feet to the manway at B889 at 6.4 feet below grade.

4. Section IX –
  - a) This discussion needs to include the remaining parts of the building, including the remaining foundation footers/columns as well as the 883/881 tunnel and remnant basement wall.
  - b) Please add a discussion regarding the removal and remaining process waste lines and their condition.
  - c) Please include a discussion of the condition of the water and sewer lines (flushed, plugged, etc).
  - d) Please discuss the condition of the foundation drain lines.
