Final Data Summary Report for the Characterization of UBCs 123 and 886

August 2001

Rev. 0

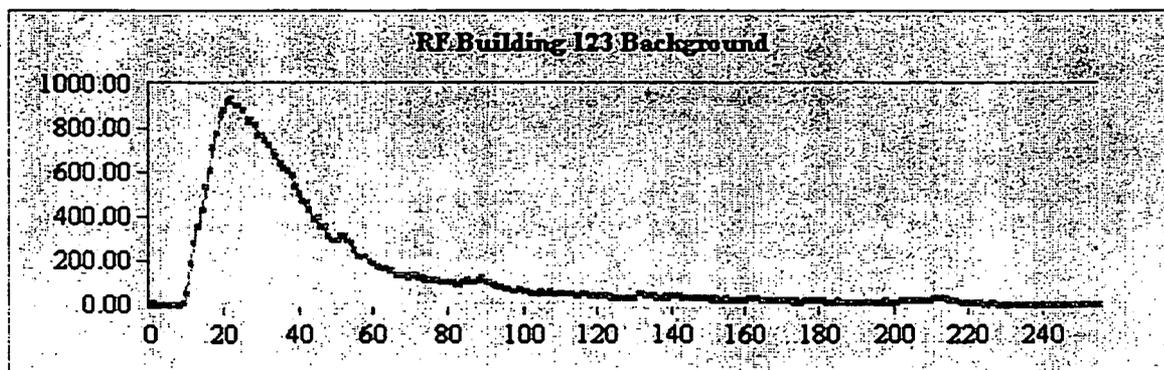
Figure 3. UBC-123 Gamma Spectrum background, Rocky Flats.

Before pulling away from the first bore site, bore #1 was logged. The tool was pulled-back one foot at a time and a spectrum was taken. This was the technique use to fully log the remaining bores. A few representative samples of these spectra are given in Appendix D: EMWD Gamma Spectra for UBC 123 HDD #1. These spectra are essentially the same as the background spectra.

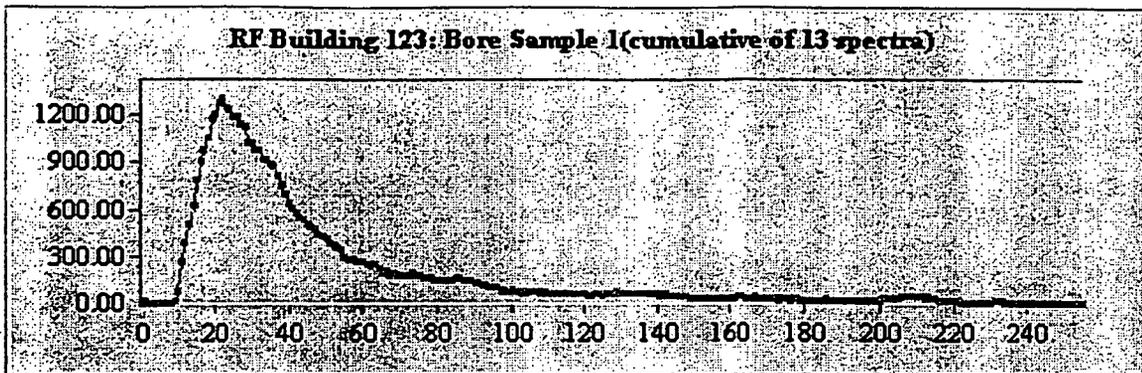
Figure 4. Cumulative Gamma Spectrum (13 spectra) from Bore 1 Sample 1, 20 ft into bore.

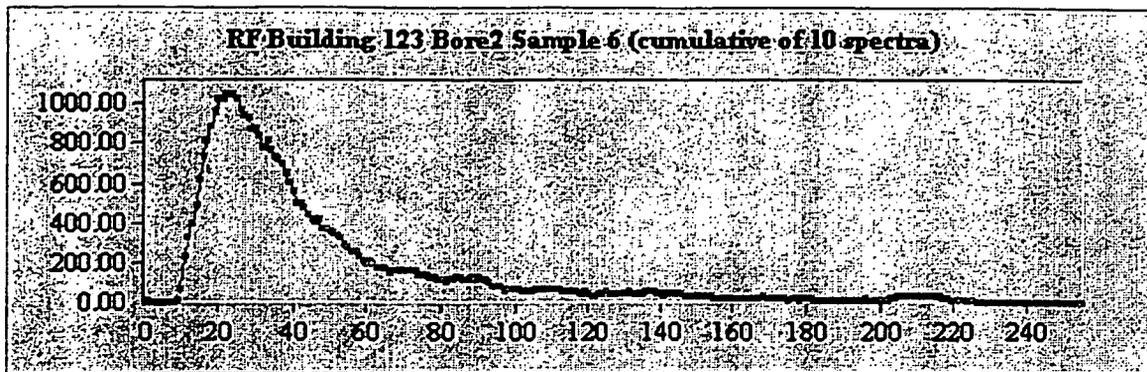
Figure 5. Representative gamma spectrum for UBC-123 Bore #2: Cumulative Gamma Spectrum (10 spectra) from Bore 2 Sample 6.

Soil Sampling Number	Location (feet advanced)	EMWD-GRS Number	Results of GRS Reading
HDD #2-01	10	1	No contamination detected
HDD #2-03	27	2	No contamination detected
HDD #2-04	42.3	3	No contamination detected
HDD #2-05	54.4	4	No contamination detected
HDD #2-06	74	5	No contamination detected
HDD #2-07	92.3	6	No contamination detected
HDD #2-08	100	7	No contamination detected
HDD #2-08	102	8	No contamination detected
HDD#2-10	126	9	No contamination detected

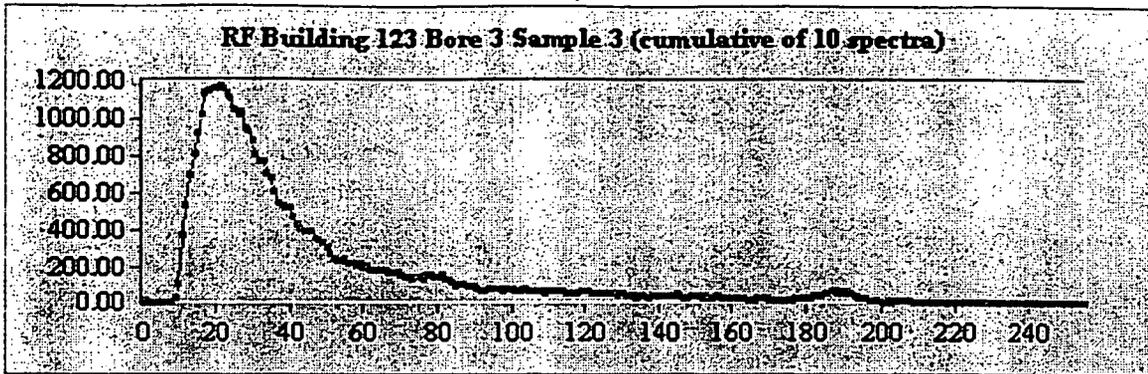
Figure 6. Representative gamma spectrum for UBC-123 Bore #3: Cumulative Gamma Spectrum (10 spectra) from Bore 3 Sample 3.

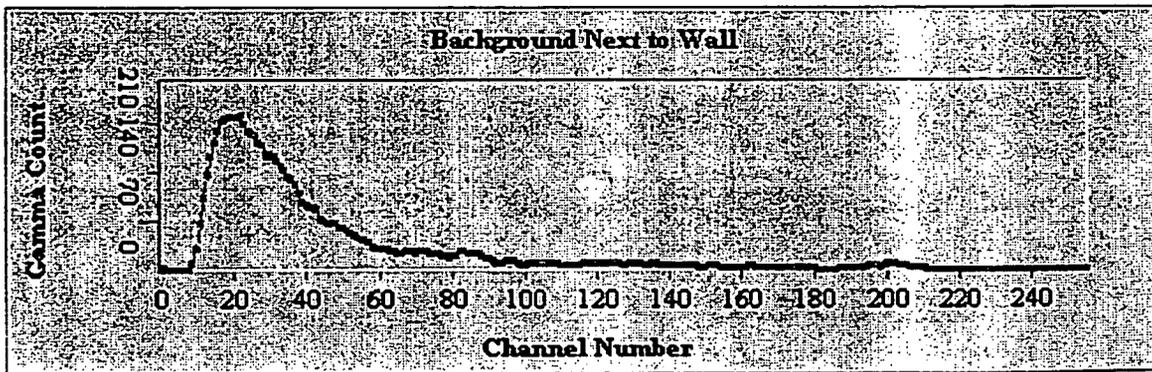
Figure 8. Building 886 Gamma Spectrum background, Rocky Flats.

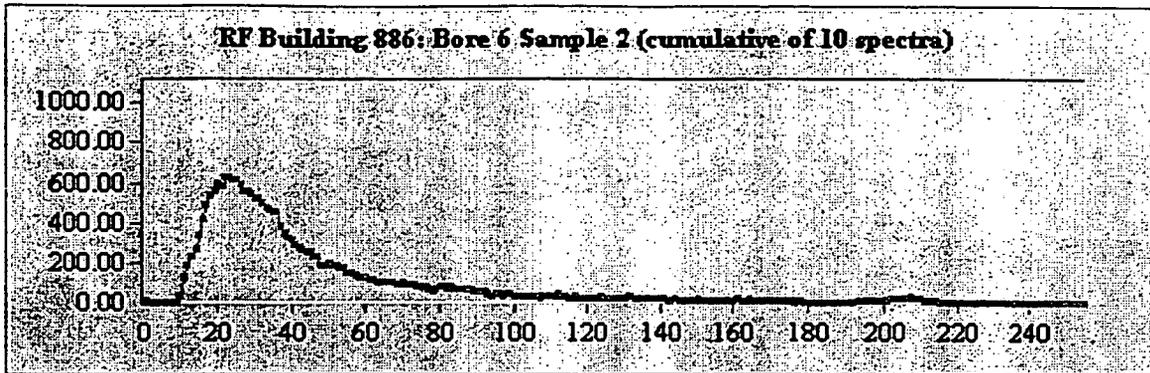
Figure 9. Representative gamma spectrum for Building 886 Bore #6: Cumulative Gamma Spectrum (10 spectra) from Bore 6 Sample 2.

Soil Sampling Number	Location (feet advanced)	EMWD-GRS Number	Results of GRS Reading
HDD #6-02	18	1	No contamination detected
HDD #6-01	10	2	No contamination detected
HDD #6-bore opening	0	2	No contamination detected

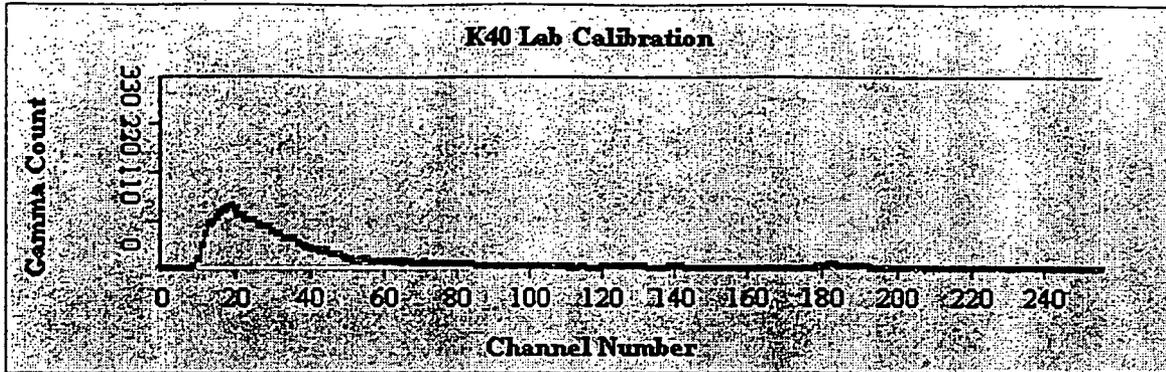
Figure C1a: Lab Calibration-Gamma Spectrum of K-40.

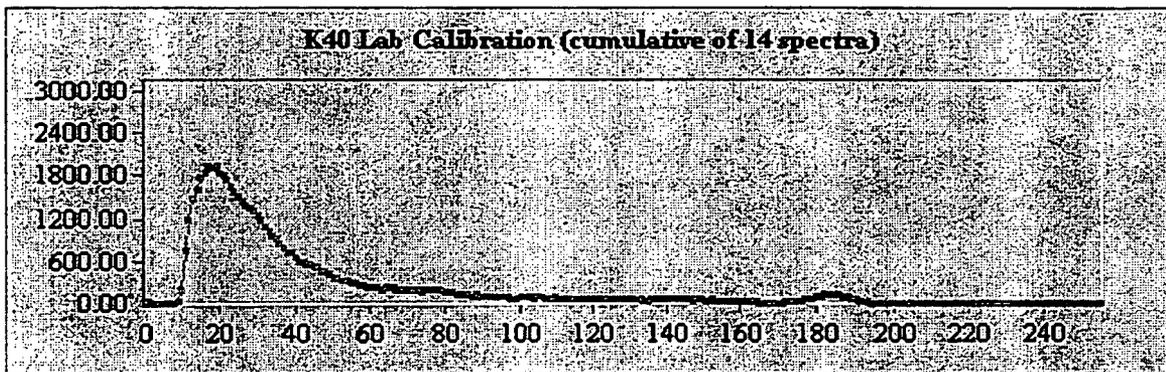
Figure C1b: Lab Calibration-Cumulative Gamma Spectrum (14 spectra) of K-40.

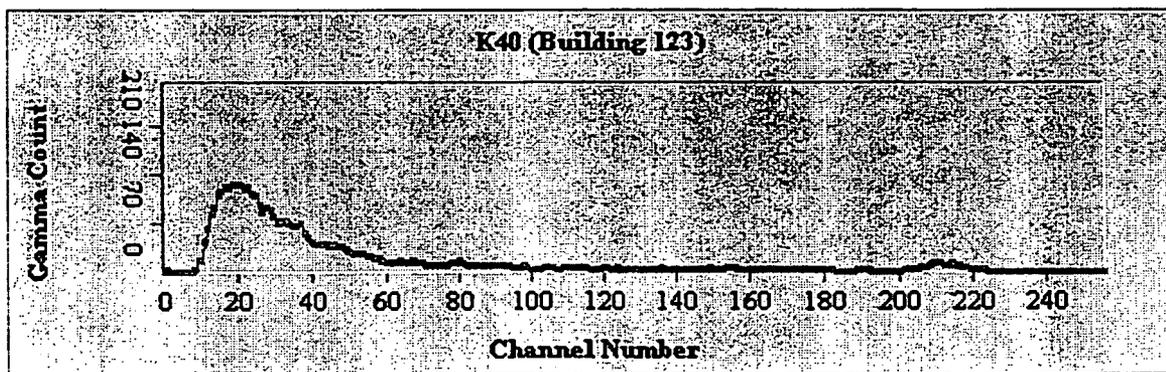
Figure C2a: Field Calibration-Gamma Spectrum of K-40 at UBC 123

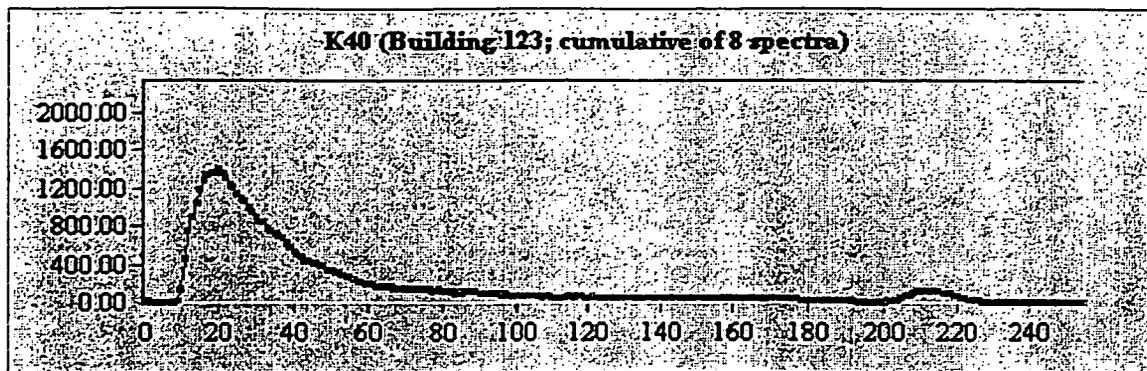
Figure C2b: Field Calibration-Cumulative Gamma Spectrum (8 spectra) of K-40 at UBC 123

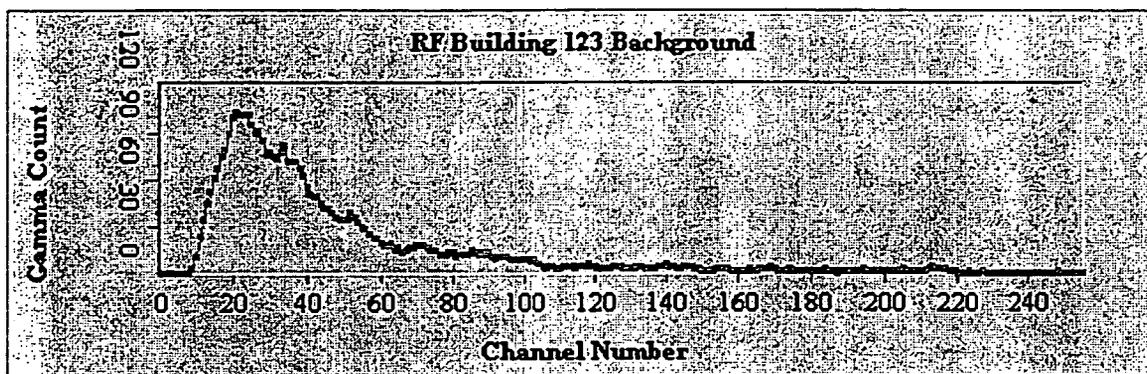
Figure C3a: Field Background Calibration-Gamma Spectrum of K-40 at UBC 123

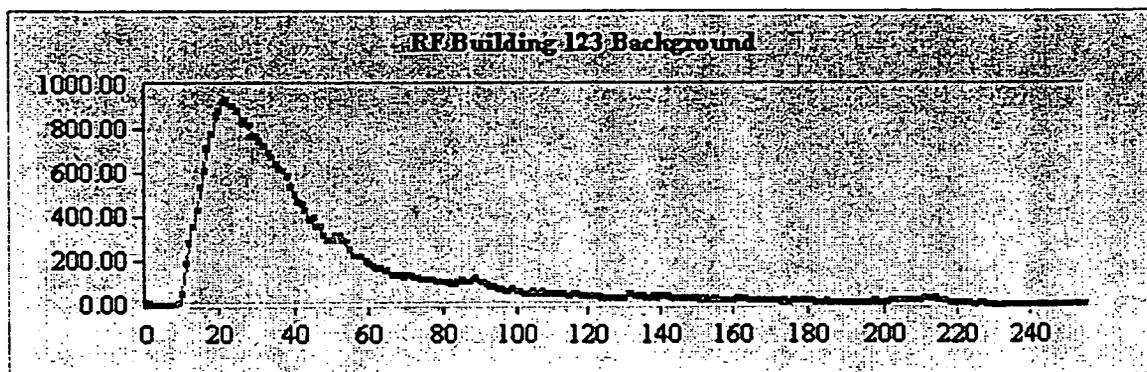
Figure C2b: Field Background Calibration-Cumulative Gamma Spectrum (8 spectra) of K-40 at UBC 123

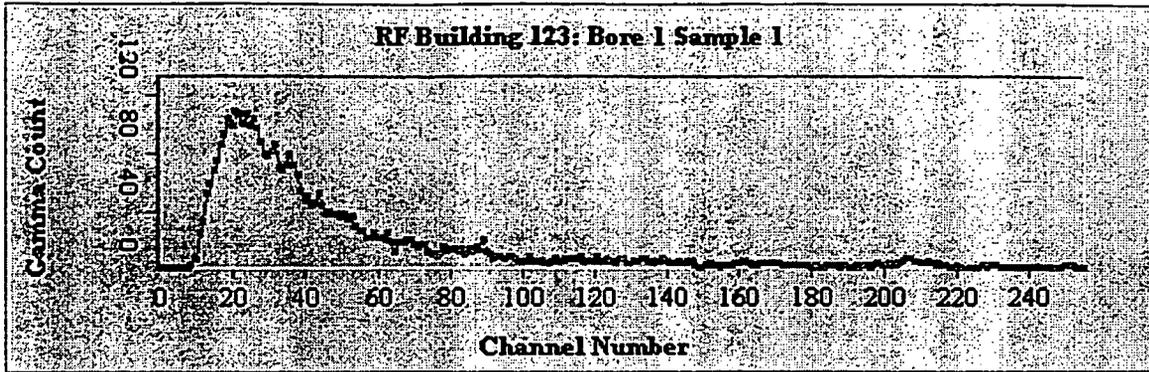
Figure D 1-1a: Gamma Spectrum from Bore 1 Sample 1.

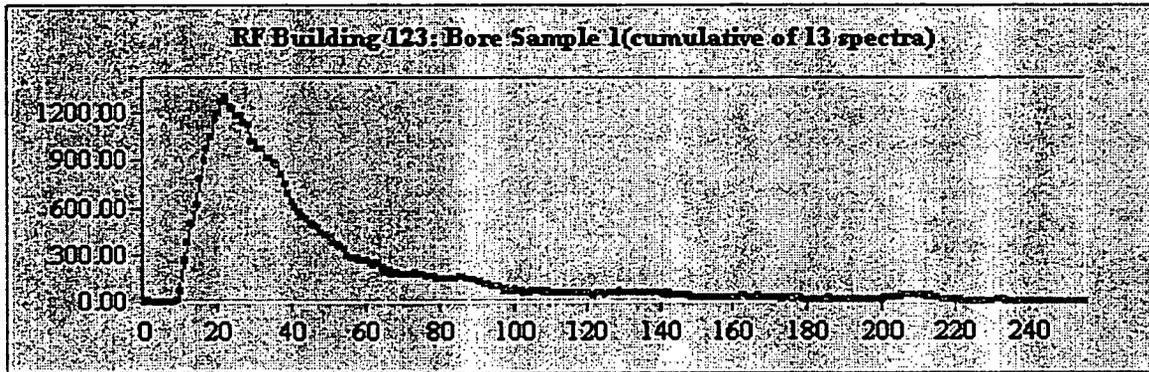
Figure D 1-1b: Cumulative Gamma Spectrum (13 spectra) from Bore 1 Sample 1.

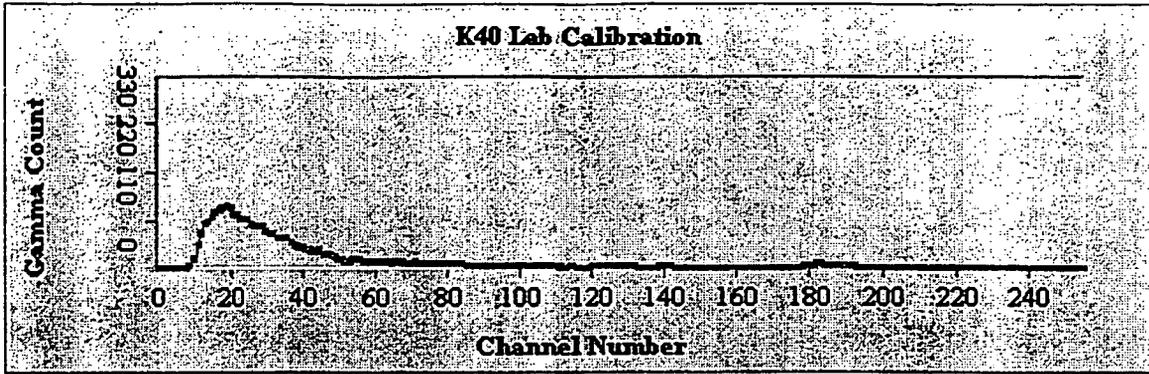
Figure E 1a: Lab Calibration-Gamma Spectrum of K-40

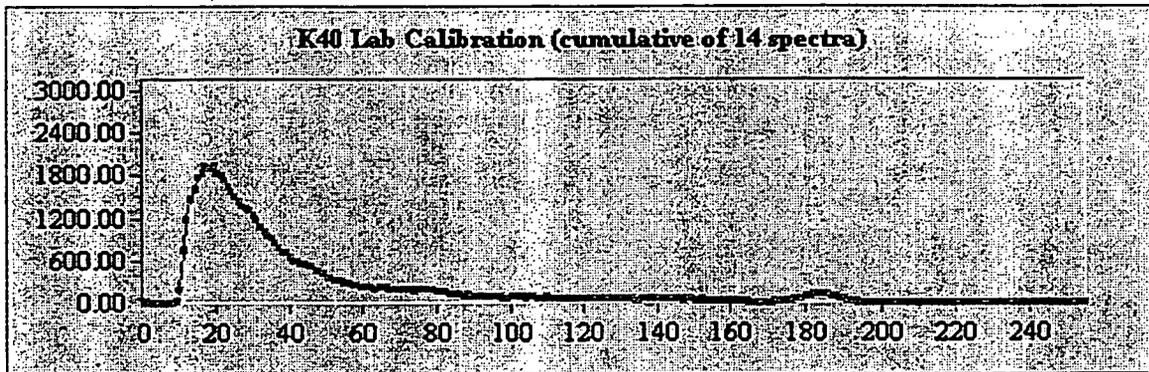
Figure E 1b: Lab Calibration-Cumulative Gamma Spectrum (14 spectra) of K-40.

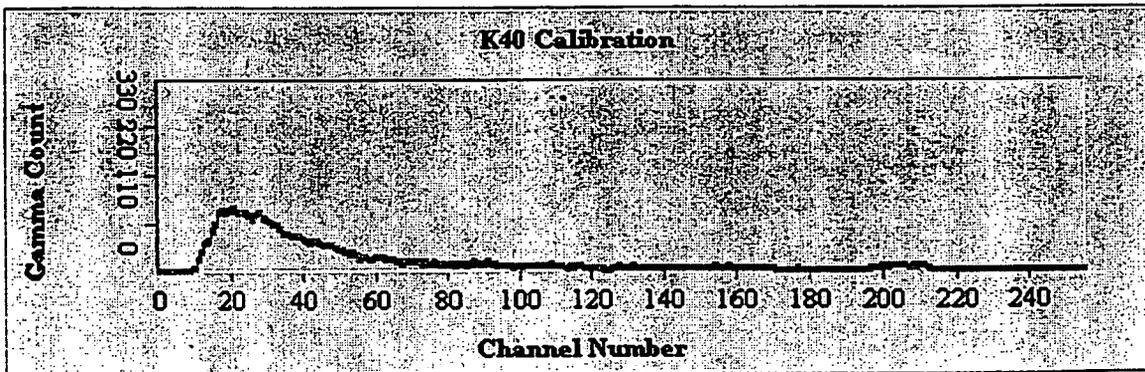
Figure E 2a: Field Calibration-Gamma Spectrum of K-40 at Building 886

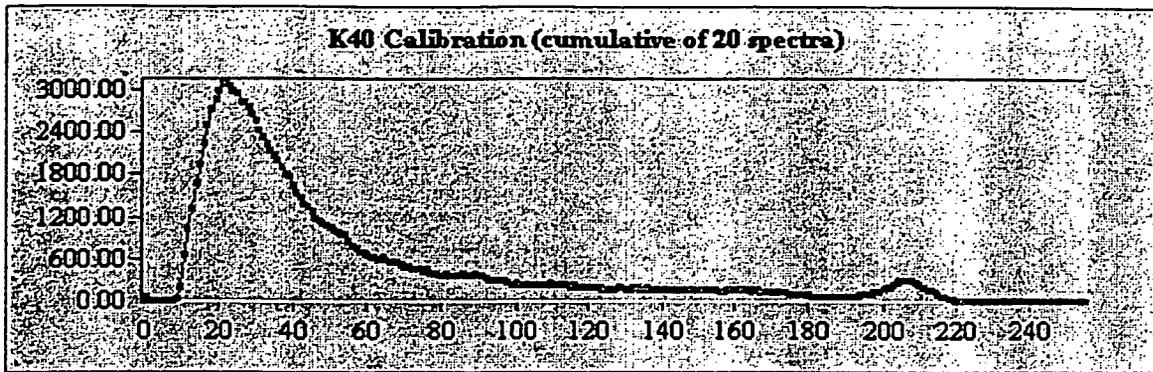
Figure E 2b: Field Calibration-Cumulative Gamma Spectrum (20 spectra) of K-40 at Building 886

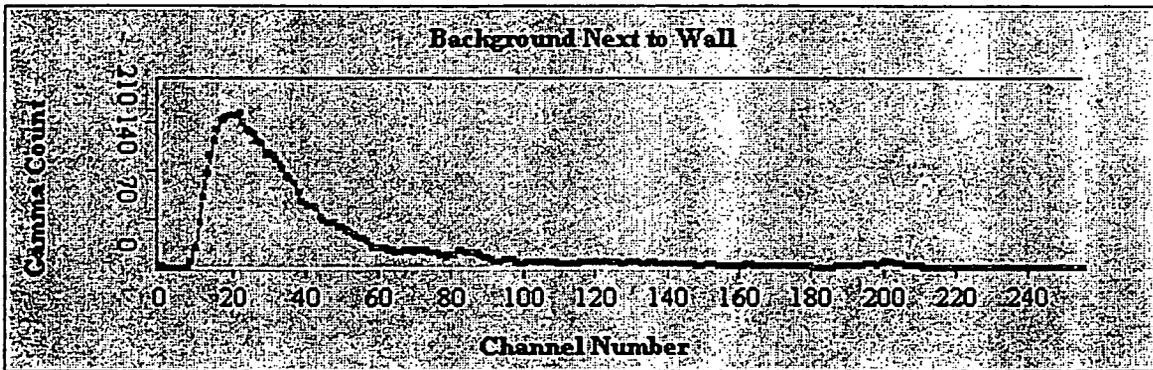
Figure E 3a: Field Calibration-Gamma Spectrum of K-40 at Building 886 next to wall

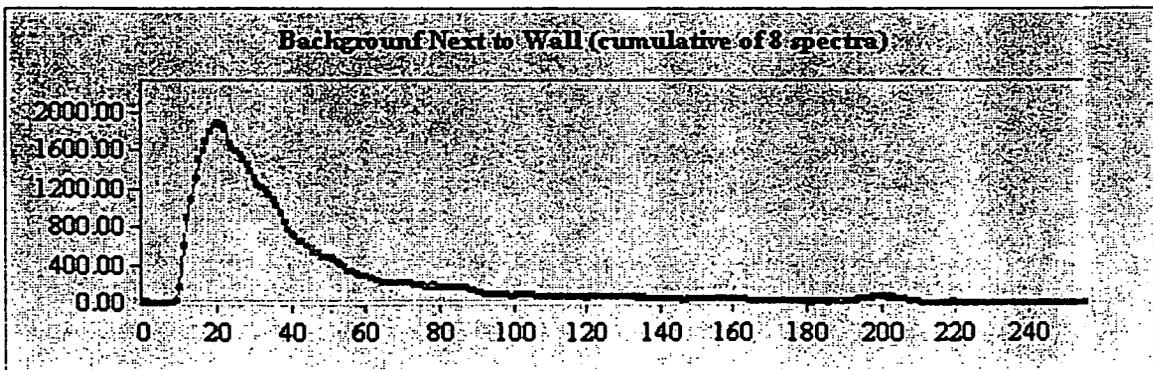
Figure E 2b: Field Calibration-Cumulative Gamma Spectrum (8 spectra) of K-40 at Building 886 next to wall.

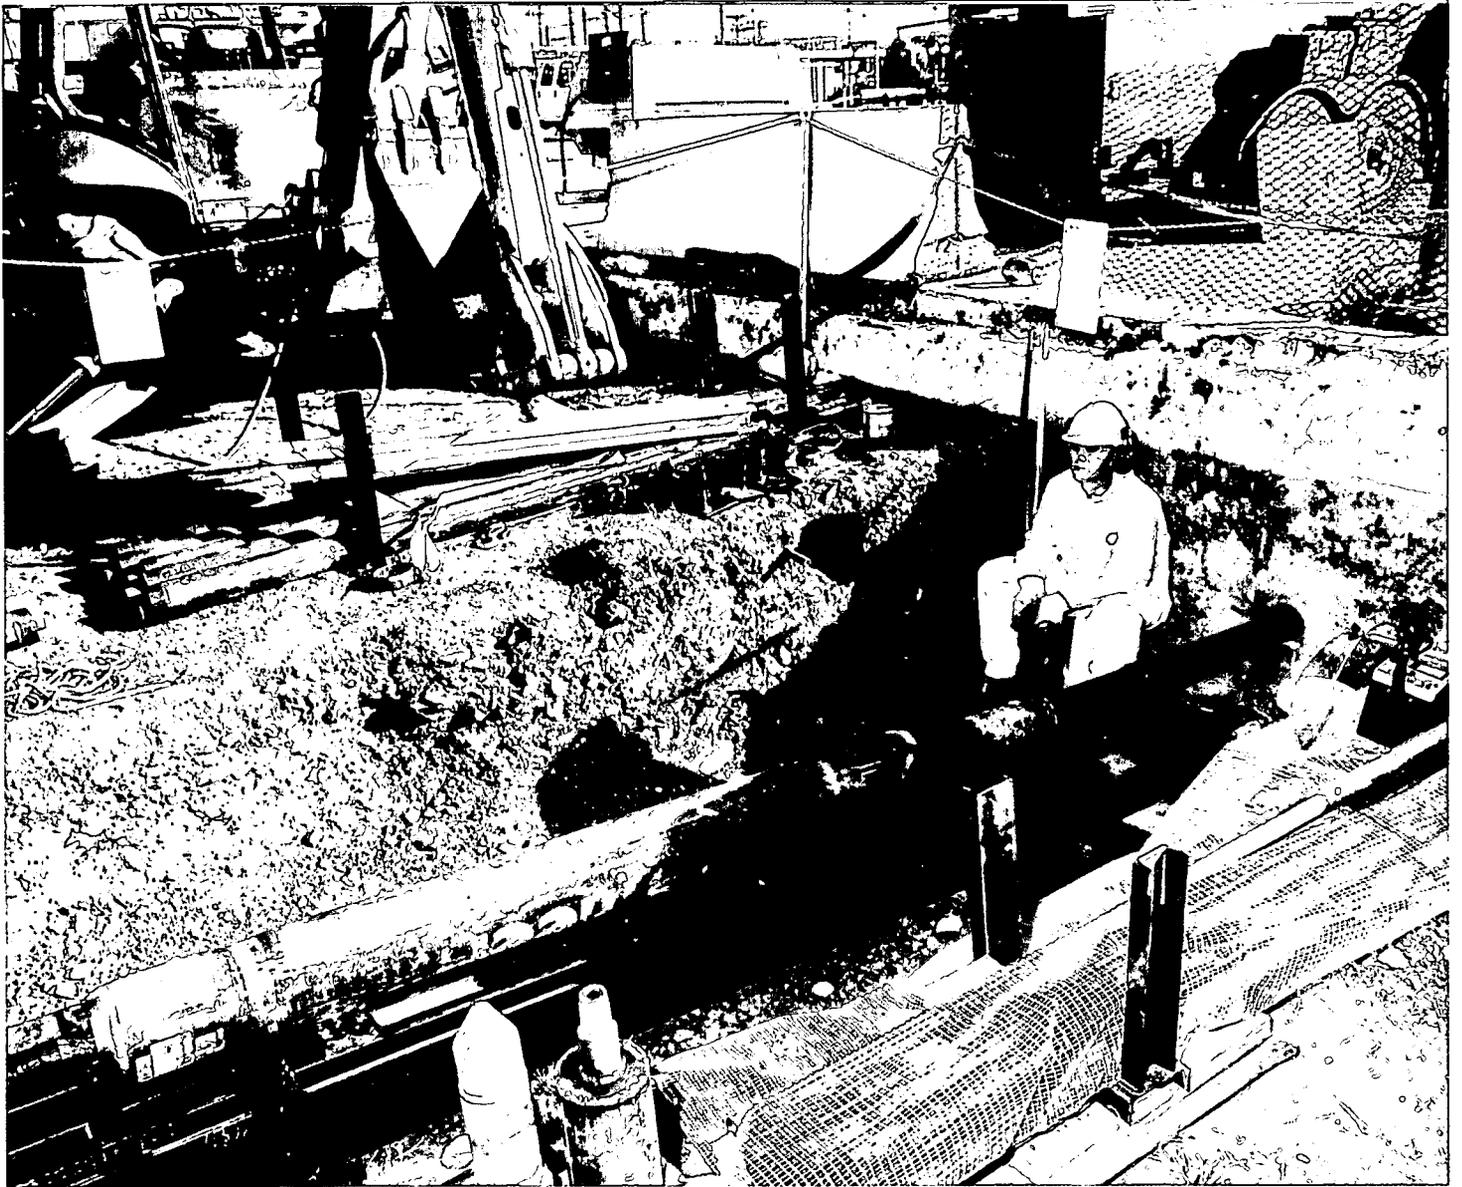
Picture 1 – Casing Advancement Frame Assembly (CAFA) and Support Equipment
in HDD Line 1 Trench, Building 123 Slab

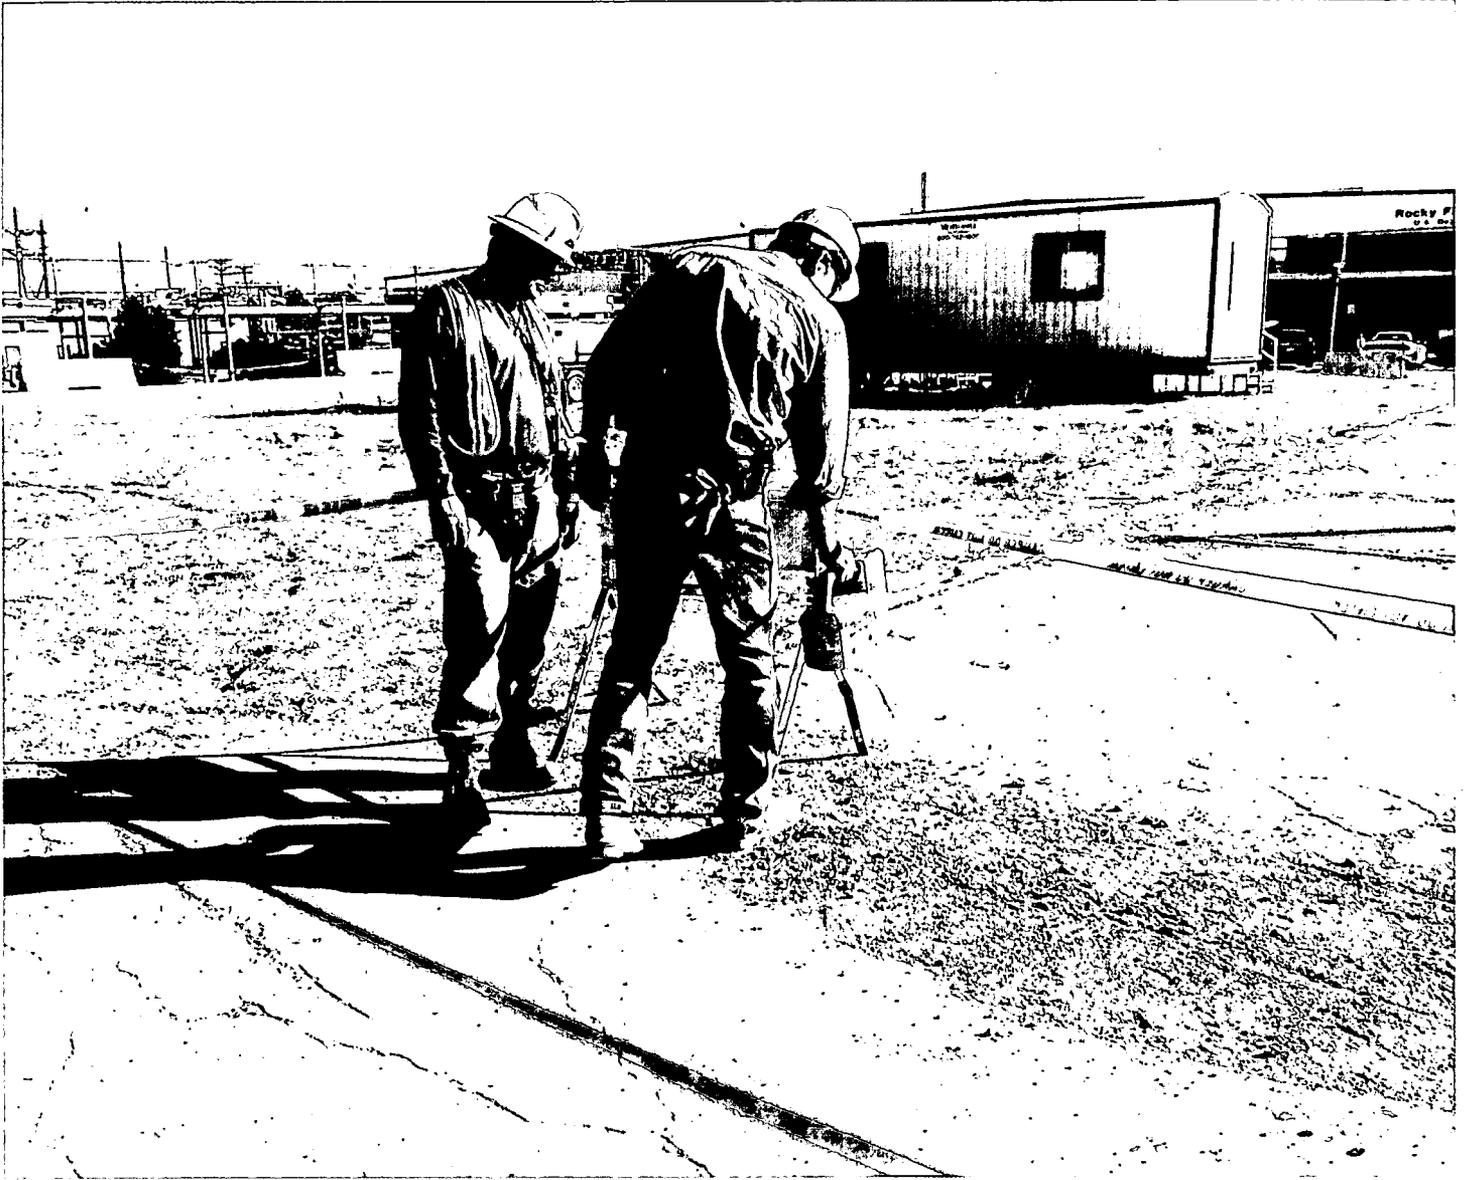
Picture 2 – HDD Bit Location with Digi-Trak Receiver, Building 123 Slab

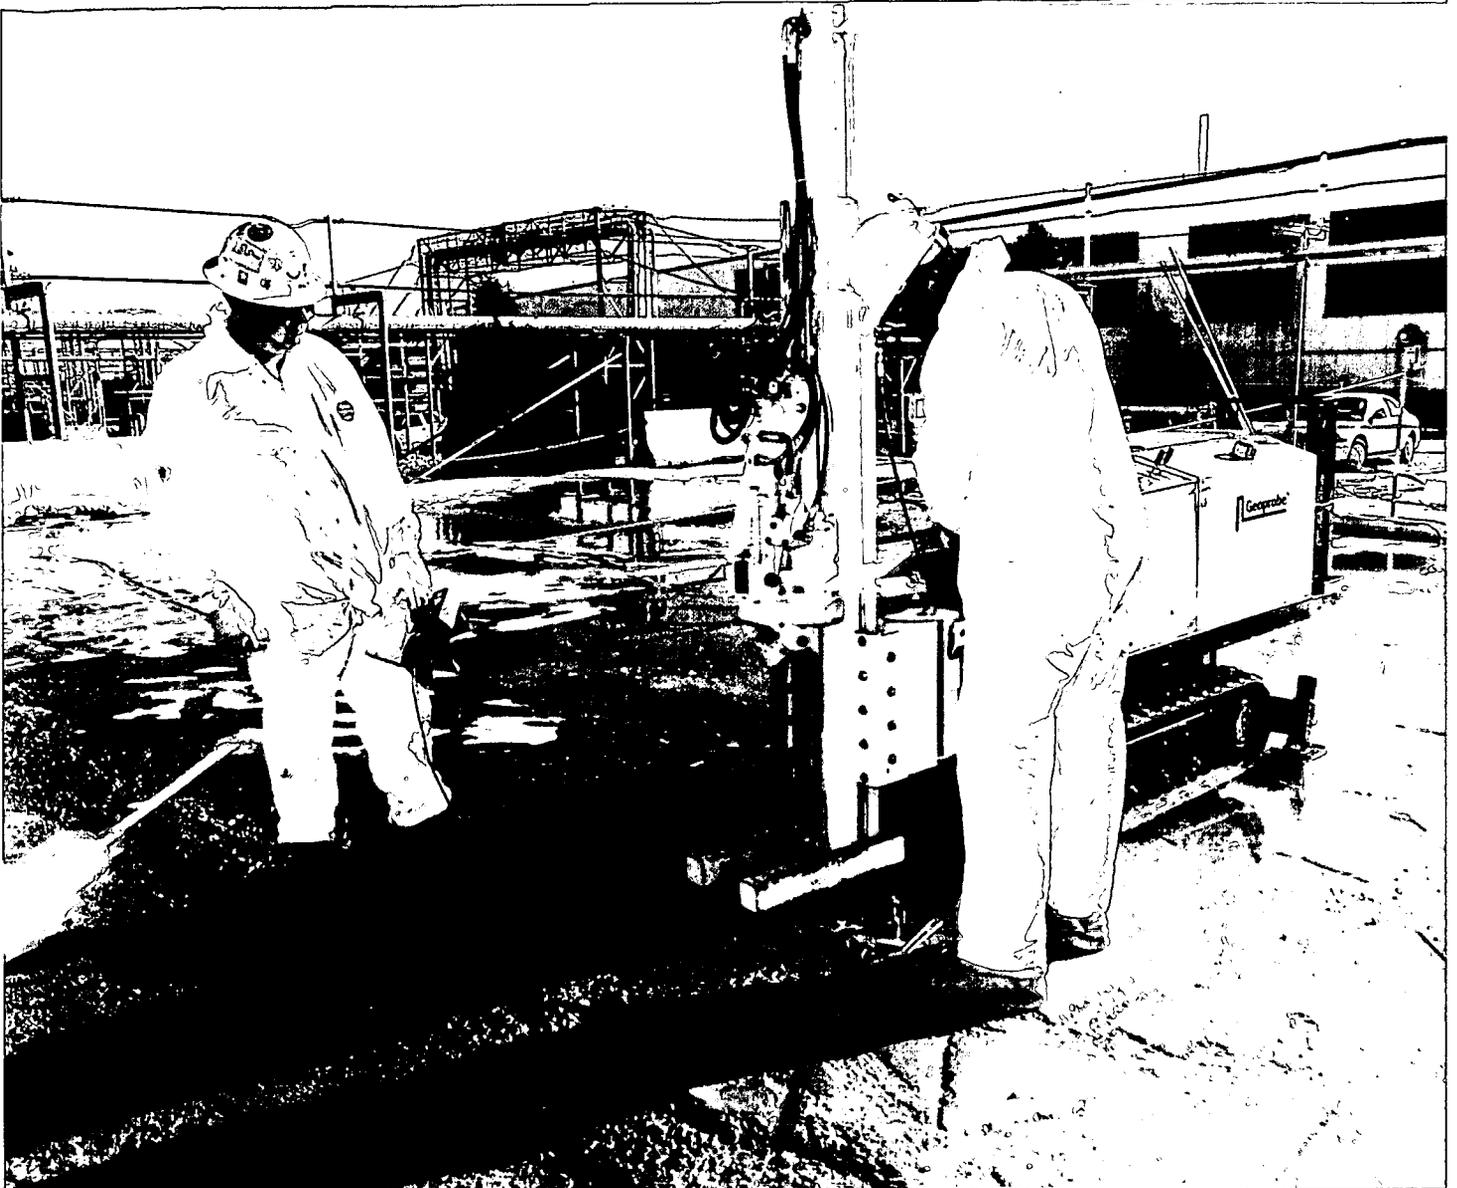
Picture 3 – Geoprobe Soil Sampling on the Former Building 123 Concrete Slab

For the 123 and 886 Geoprobe® characterization sampling, a Geoprobe® model 54LT and a two-inch diameter stainless steel Macro-Core sampler were utilized at all collection locations (see Picture 3). Sampling was initiated by coring a three-inch diameter hole through the concrete slab at each sample location. The slab thickness varied from 6 to 15 inches at the Building 123 slab and 7 to 10 inches on the two slabs west of Building 886. Once the concrete cores were removed and the underlying soil exposed, the Geoprobe® was positioned over the hole and the soil sample intervals were collected in accordance with Site procedure RMRS/OPS-PRO.124, *Push Subsurface Soil Sampling*, and the specifications and requirements of the SAP and Integrated Work Control Package (IWCP). The specific sample intervals collected are identified in Tables 3-3 and 3-4 below.

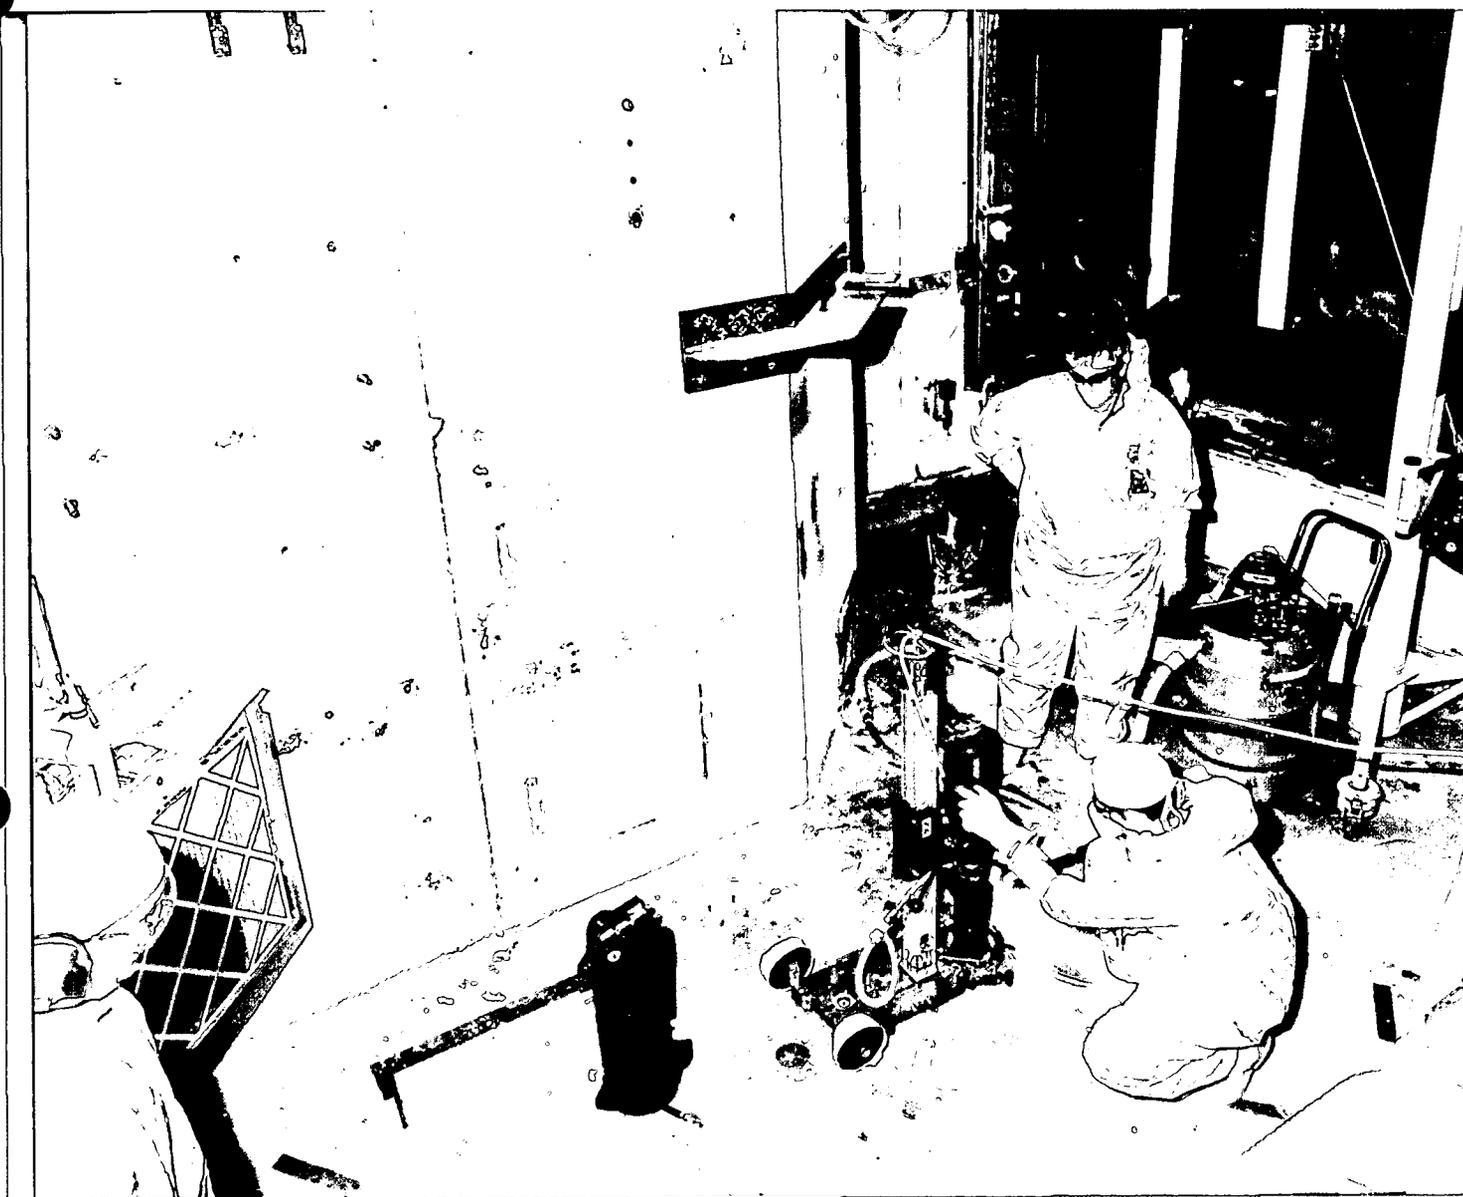
Picture 4 – Concrete Coring and Soil Sampling in Room 103 Pit, Building 886
