TYPE 1 RECONNAISSANCE LEVEL CHARACTERIZATION REPORT (RLCR)

AREA 2 GROUP 3 CLOSURE PROJECTS (Buildings 706, 928, T706A and T779A)

REVISION 0

March 25, 2003

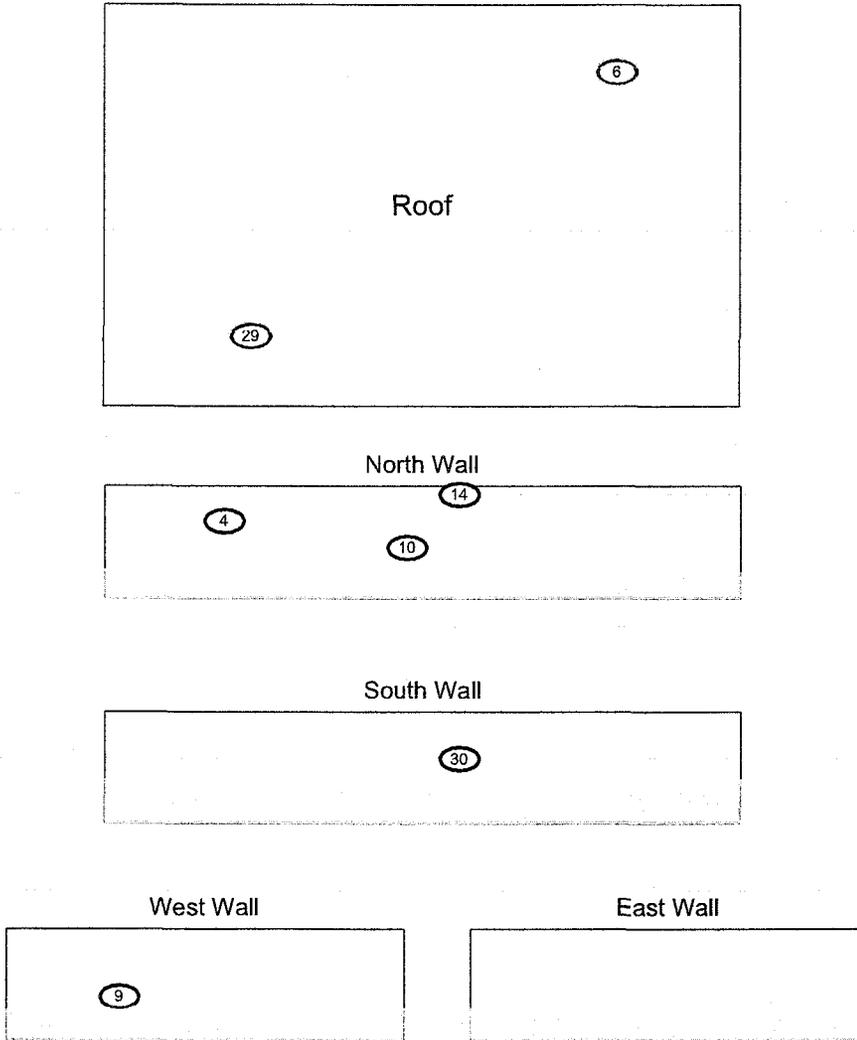
B706 Exterior

Survey Area: 2 Survey Unit: 706-A-001 Classification: 3
 Building: B706
 Survey Unit Description: Interior & Exterior
 Total Area: 2108 sq. m. Total Floor Area: 142 sq. m.

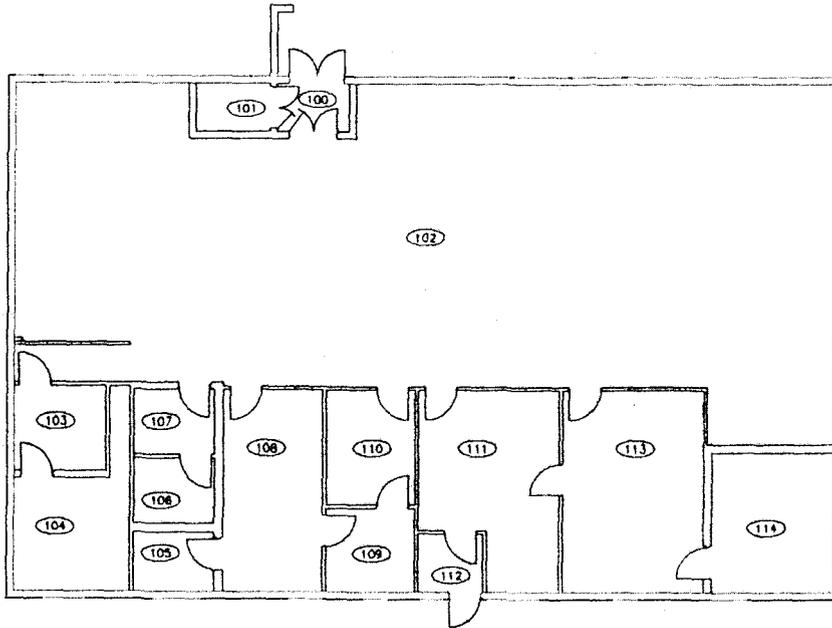
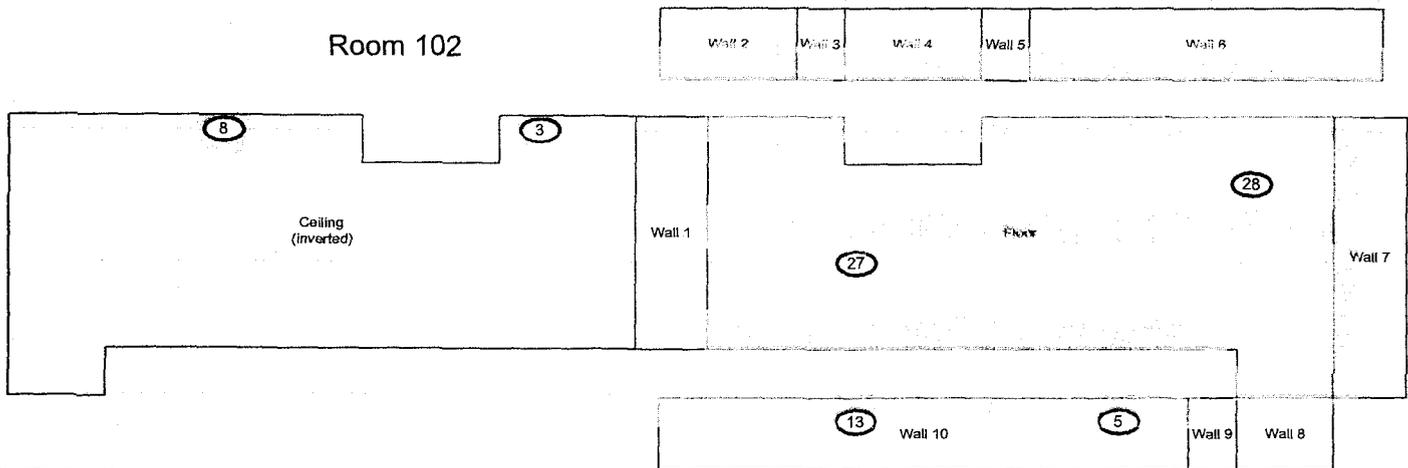
B706 Interior

Survey Area: 2 Survey Unit: 706-A-001 Classification: 3
 Building: B706
 Survey Unit Description: Interior & Exterior
 Total Area: 2108 sq. m. Total Floor Area: 142 sq. m.

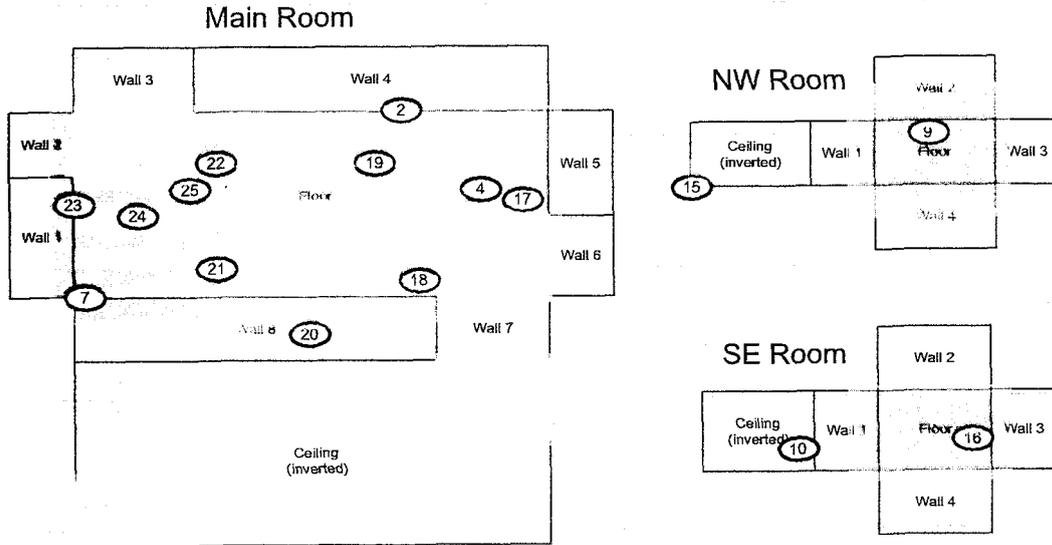
T706A Interior

Survey Area: 2 Survey Unit: 706-A-002 Classification: 3
 Building: T706A
 Survey Unit Description: Interior & Exterior
 Total Area: 878 sq. m. Total Floor Area: 156 sq. m.

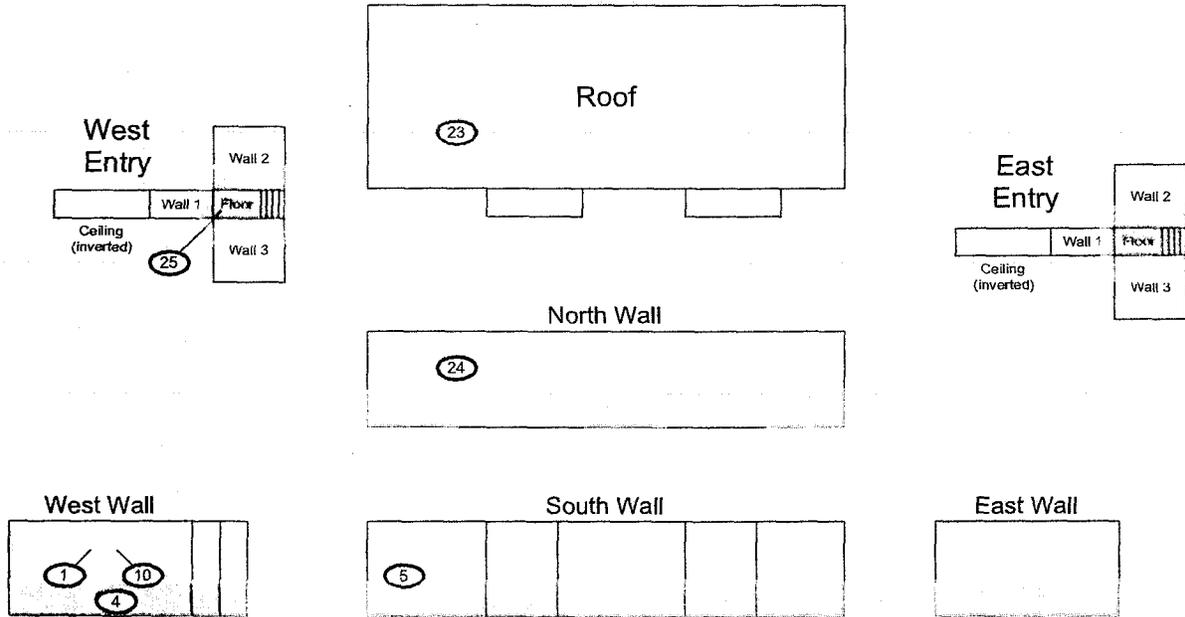
T779A Exterior

Survey Area: 2 Survey Unit: 779-A-003 Classification: 3
 Building: T779A
 Survey Unit Description: Interior & Exterior
 Total Area: 930 sq. m. Total Floor Area: 118 sq. m.

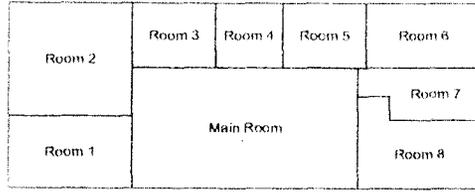
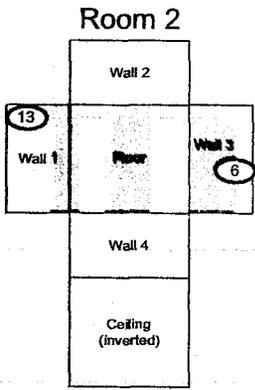
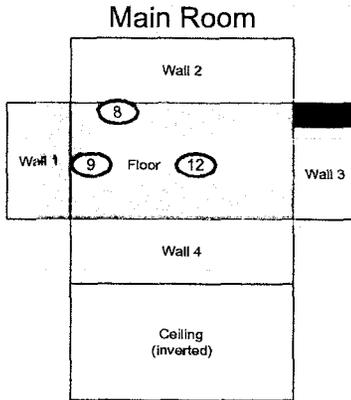
T779A Interior

Survey Area: 2 Survey Unit: 779-A-003 Classification: 3
 Building: T779A
 Survey Unit Description: Interior & Exterior
 Total Area: 930 sq. m. Total Floor Area: 118 sq. m.

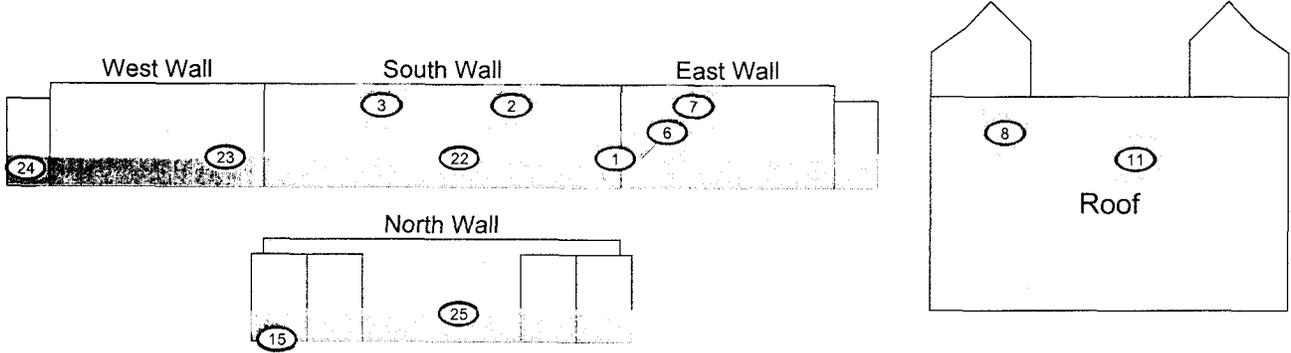
B928 Exterior

Survey Area: 2 Survey Unit: 928-A-004 Classification: 3
 Building: 928
 Survey Unit Description: Interior & Exterior
 Total Area: 892 sq. m. Total Floor Area: 133 sq. m.
