## TYPE 1 RECONNAISSANCE LEVEL CHARACTERIZATION REPORT (RLCR)

### AREA 3-GROUP 4 CLOSURE PROJECTS

(Buildings 302, 303, T303D, 308 and 375)

August 28, 2003

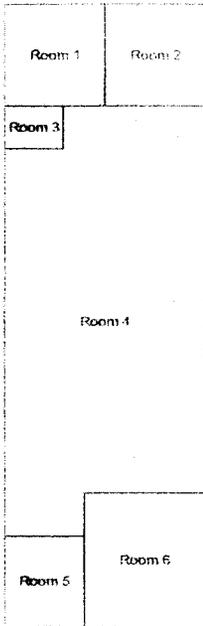
**T303D Interior**

Survey Area: 3      Survey Unit: T303D-A-003      Classification: 3  
 Building: T303D  
 Survey Unit Description: T303D Interiors  
 Total Area: 402 sq. m.      Total Floor Area: 124 sq. m.
