**Preble's Meadow Jumping Mouse  
Mitigation Tracking Spreadsheet for  
PBA Part II Activities**

**October 10, 2005**

Preble's Meadow Jumping Mouse Mitigation Tracking Spreadsheet for Part II activities in the PBA  
10/10/2005

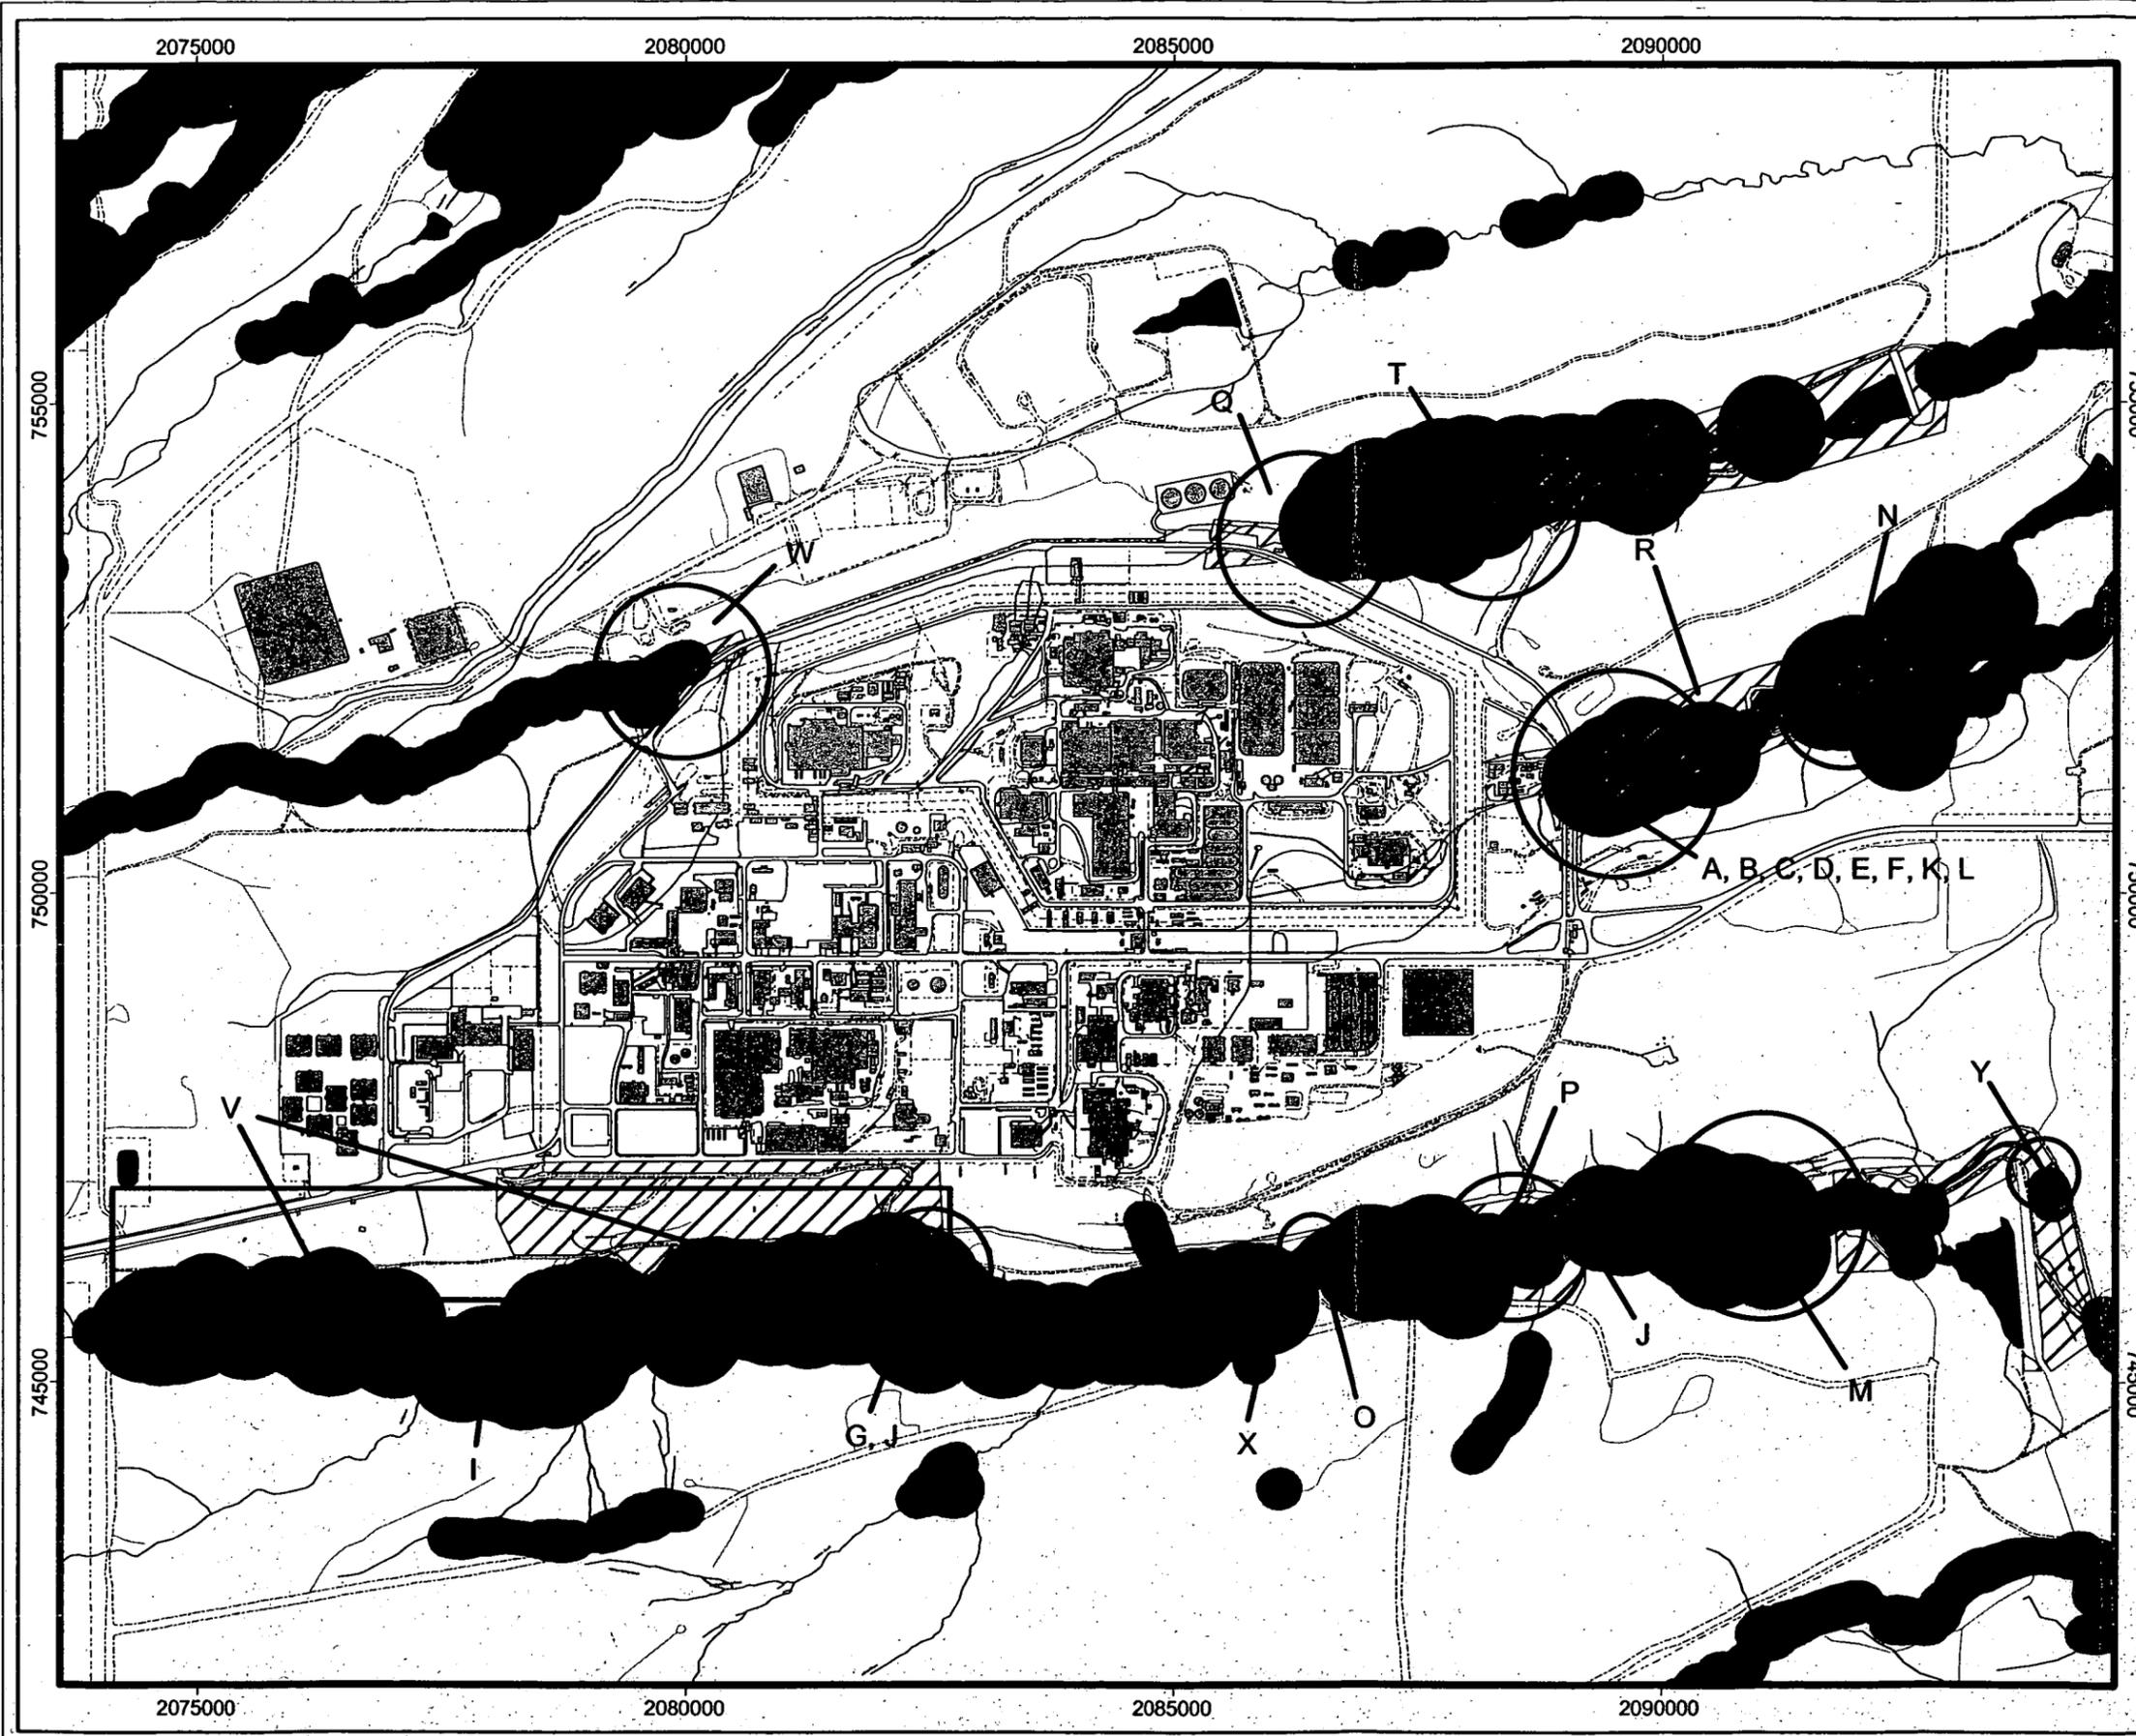
**Rocky Flats Environmental  
Technology Site  
Programmatic Biological  
Assessment  
Disturbance Tracking  
October 10, 2005**

Project Disturbances (Letter matches projects on spreadsheet)

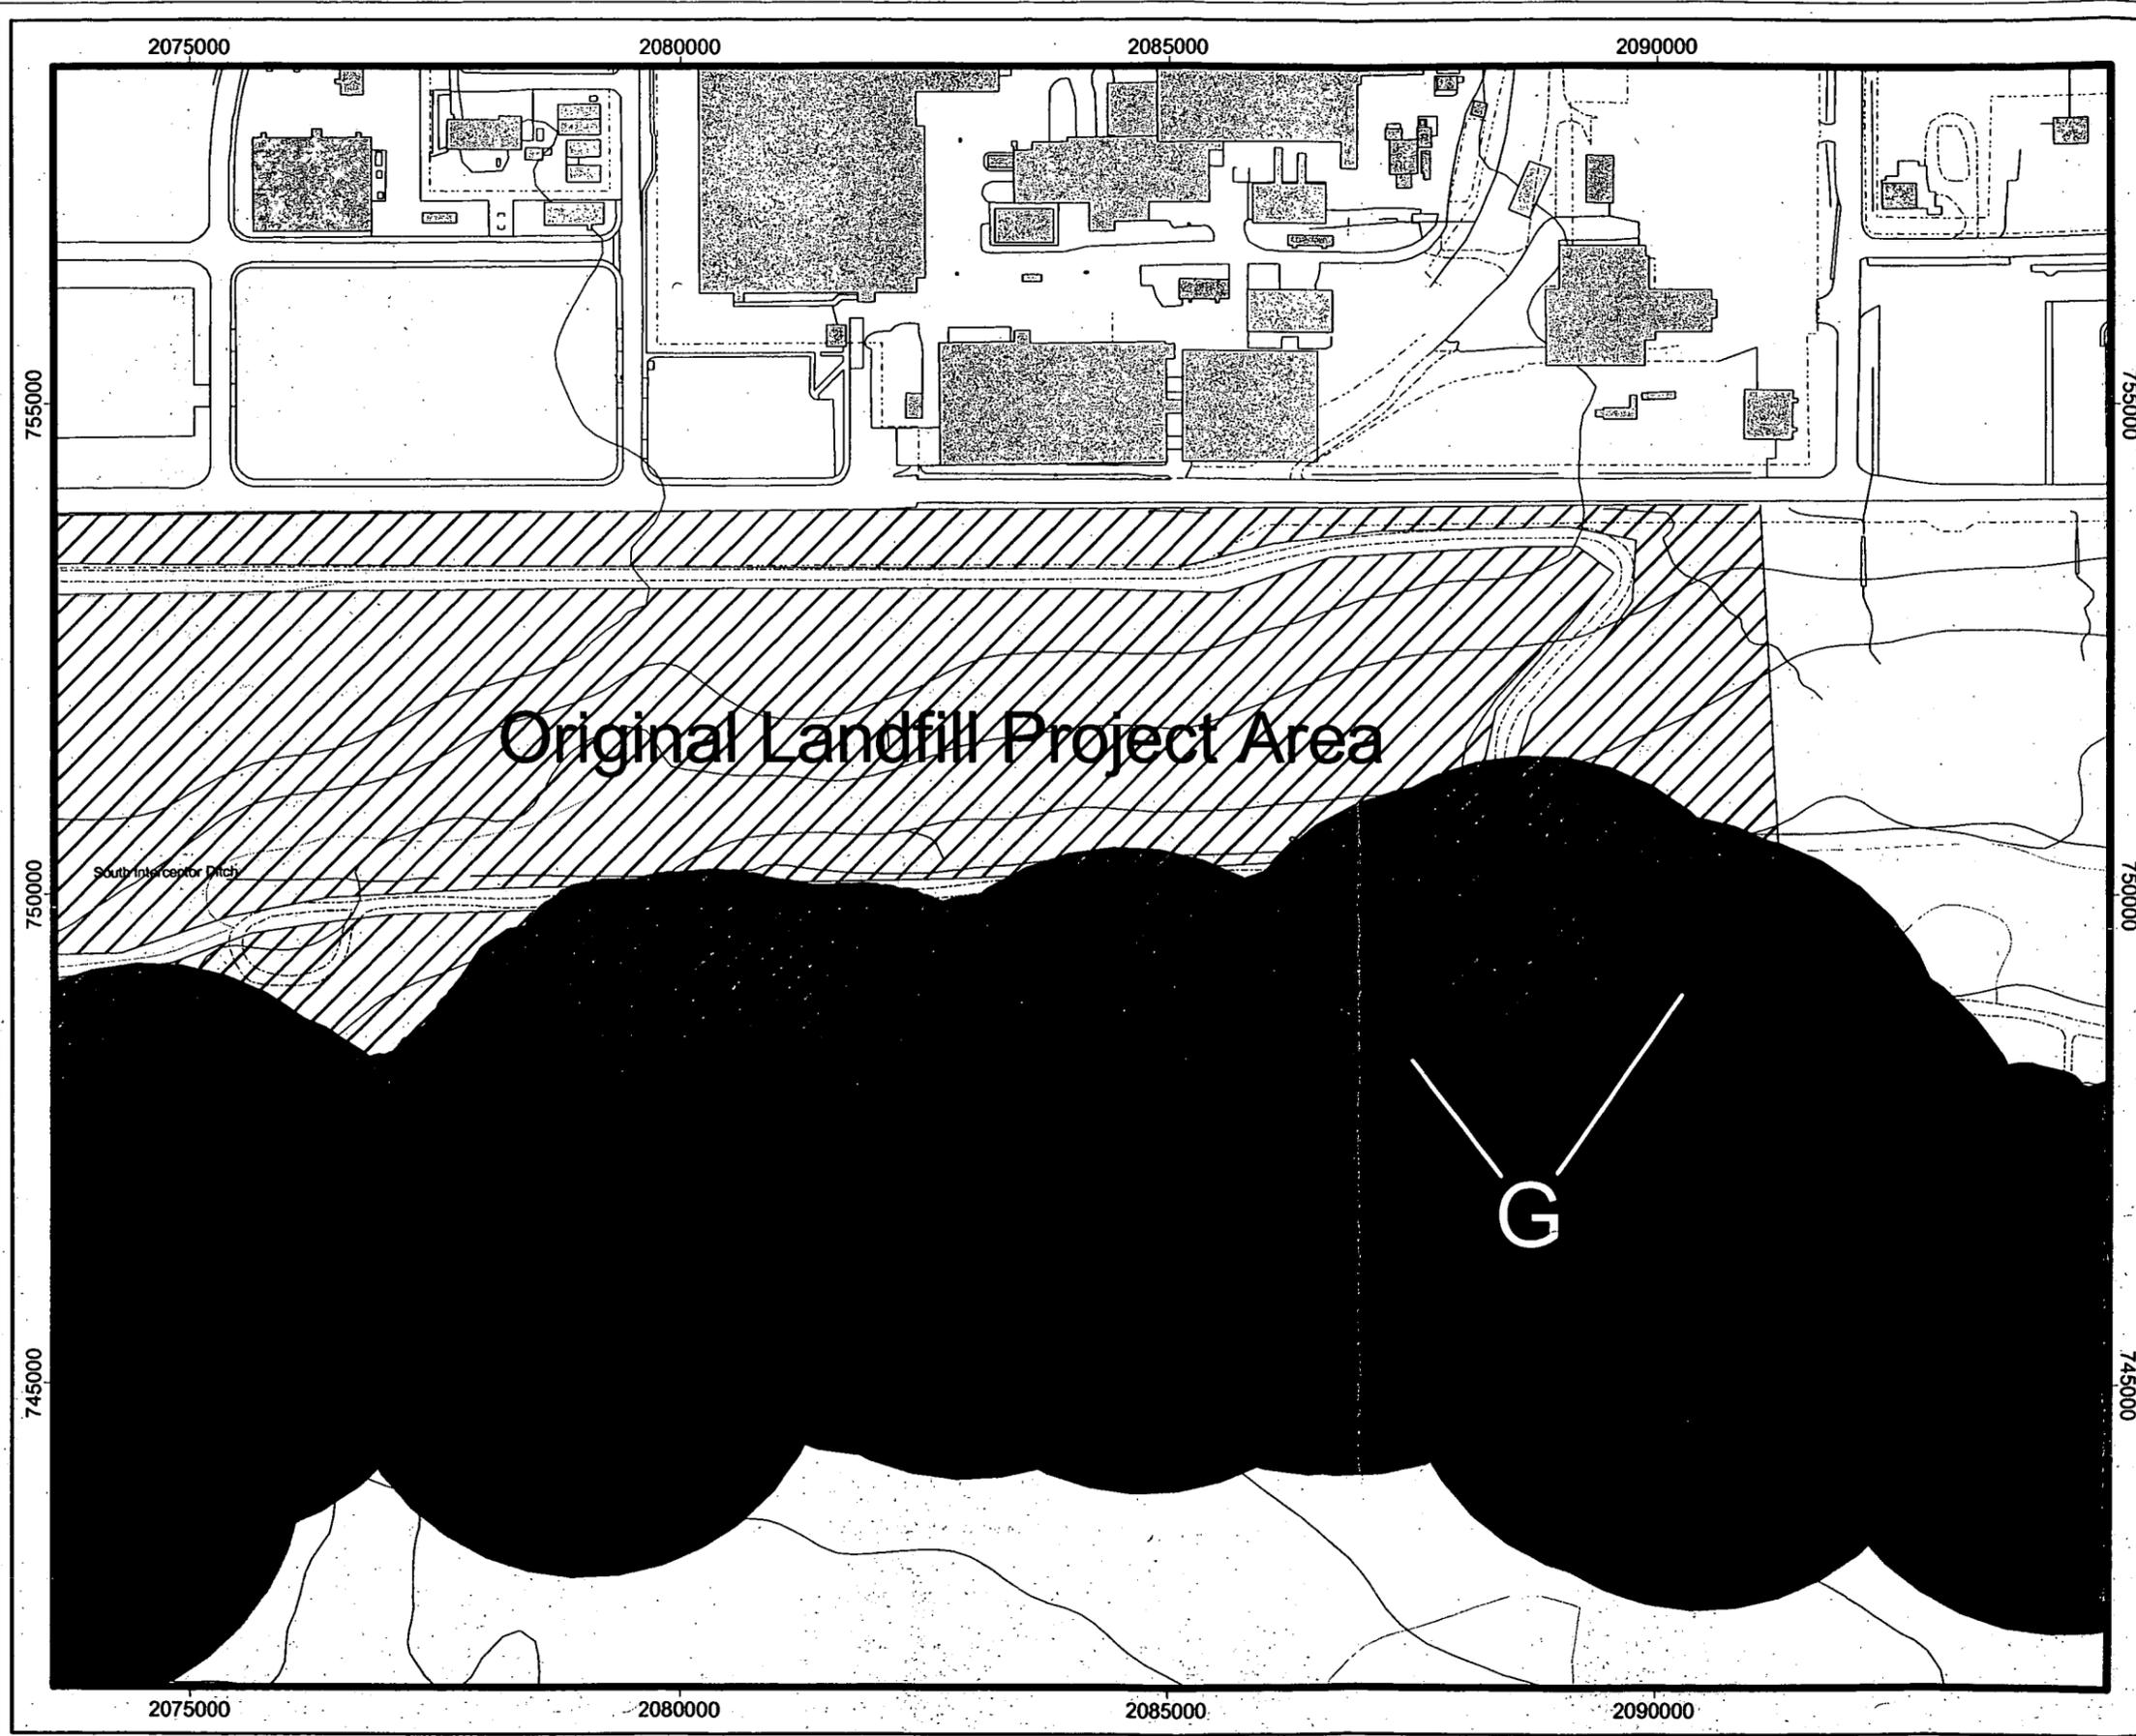
**Rocky Flats Environmental  
Technology Site  
Programmatic Biological  
Assessment  
Disturbance Tracking  
July 1, 2004**

Project Disturbances (Letter match projects on spreadsheet)

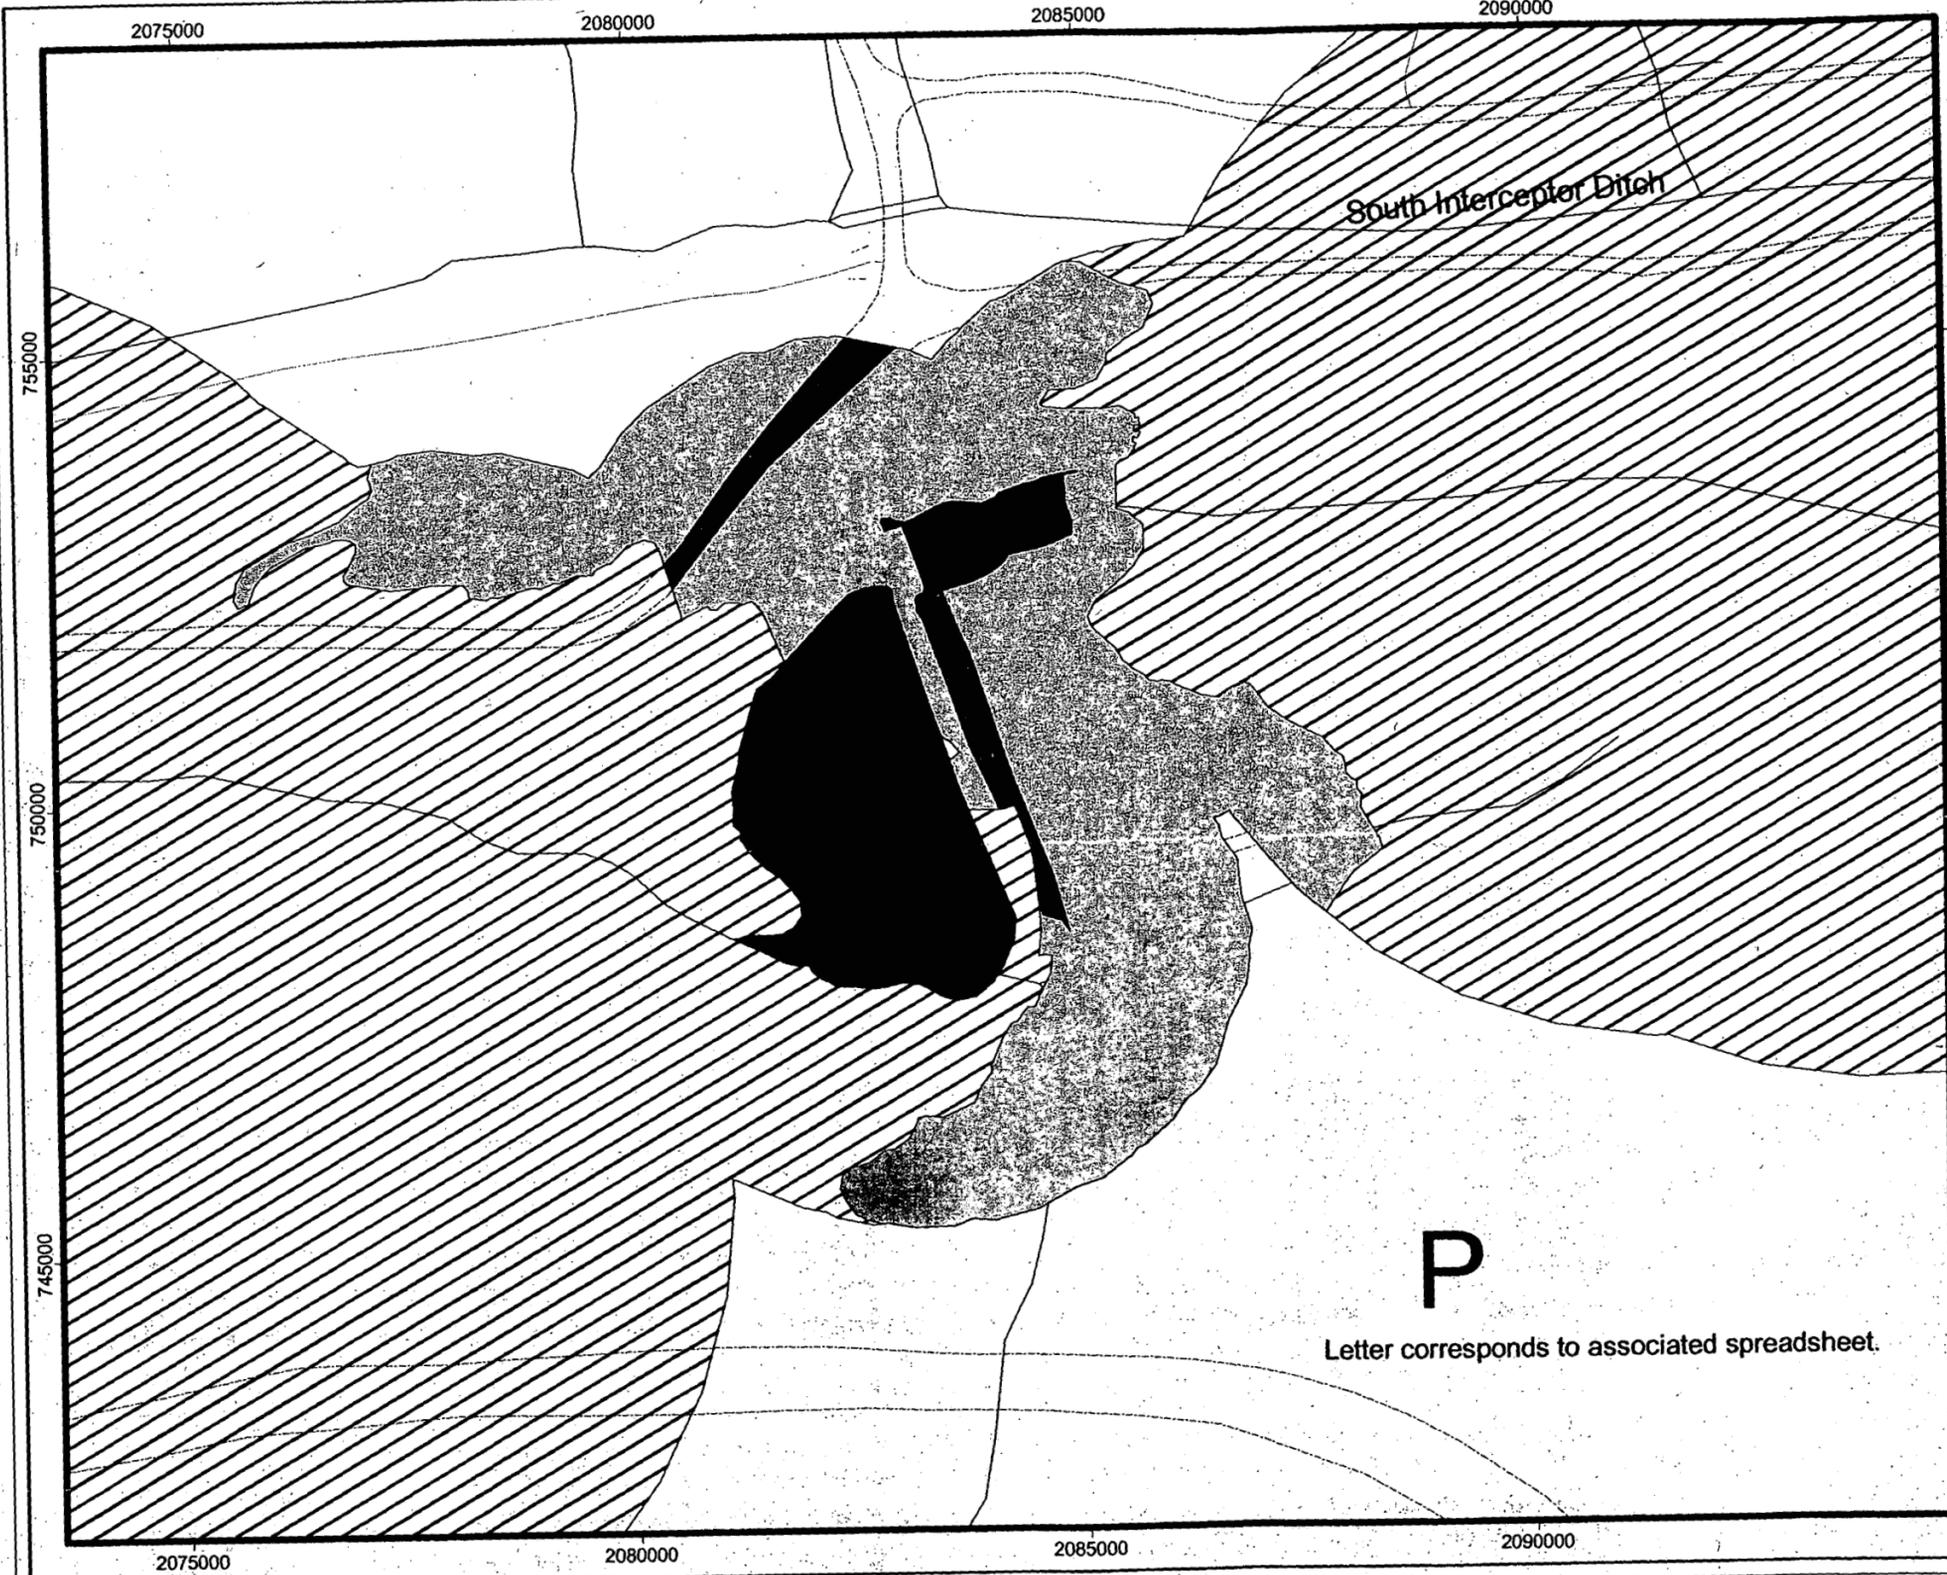
# C-1 Pond Dam Notch Programmatic Biological Assessment Disturbance Tracking

- Legend**
- Current Preble's Protection Areas
  - Temporary Disturbance
  - Non-Habitat Remaining (previously none habitat [road, riprap])
  - Permanent Loss (new spillway)

| GIS Ref # | Date Project Initiated | Date Project Completed | Project Description | Impacted Acres | Mitigation Ratio | Acres to Mitigate | Mitigation Project | Total Debit (-) Acres | Date Mitigation Initiated | Mitigation Agency Concurrence Date | Total Credit (+) Acres (In-situ) | Balance [Debit (-)/ Credit (+)] | Comment |
|---|---|---|---|---|---|---|--|---|---|---|---|---|--|
| P | 12/22/2004 | 3/4/2005 | C-1 Pond Notching | 1.4193 Lower Quality<br>0.1658 Higher Quality | 1.5 : 1<br>2 : 1 | 2.1290<br>0.3316 | Pond Remediation and Removal Projects | -2.4606 | 3/4/2005 | | [2.2091] | -2.4606 | Credit amount includes in-situ restored (1.5331 acres) and new habitat created where roads and spillway were located (0.6760 acres). |
