STATUS AND PLANS

REPORT

FORMER TECHNICAL AREA ONE

LOS ALAMOS SCIENTIFIC LABORATORY

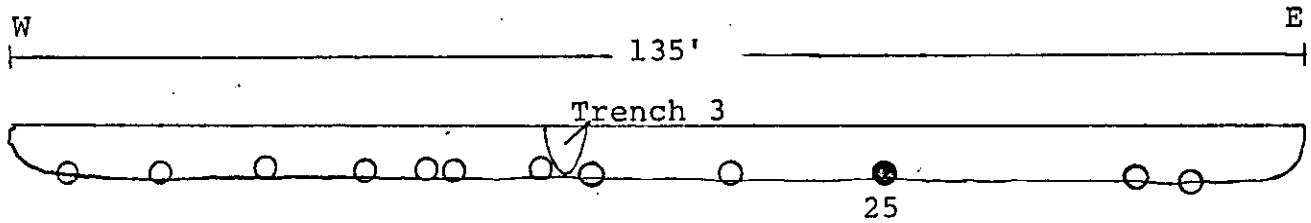
Post Clean-Up Detail
Cross-Section of J-2
Trench 3A After
Pipe Removal
Looking North
