ORNL/RASA-91/8

Results of the Radiological Survey at the New Betatron Building, Granite City Steel Facility, Granite City, Illinois (GSG002)

Date Issued - January 1992

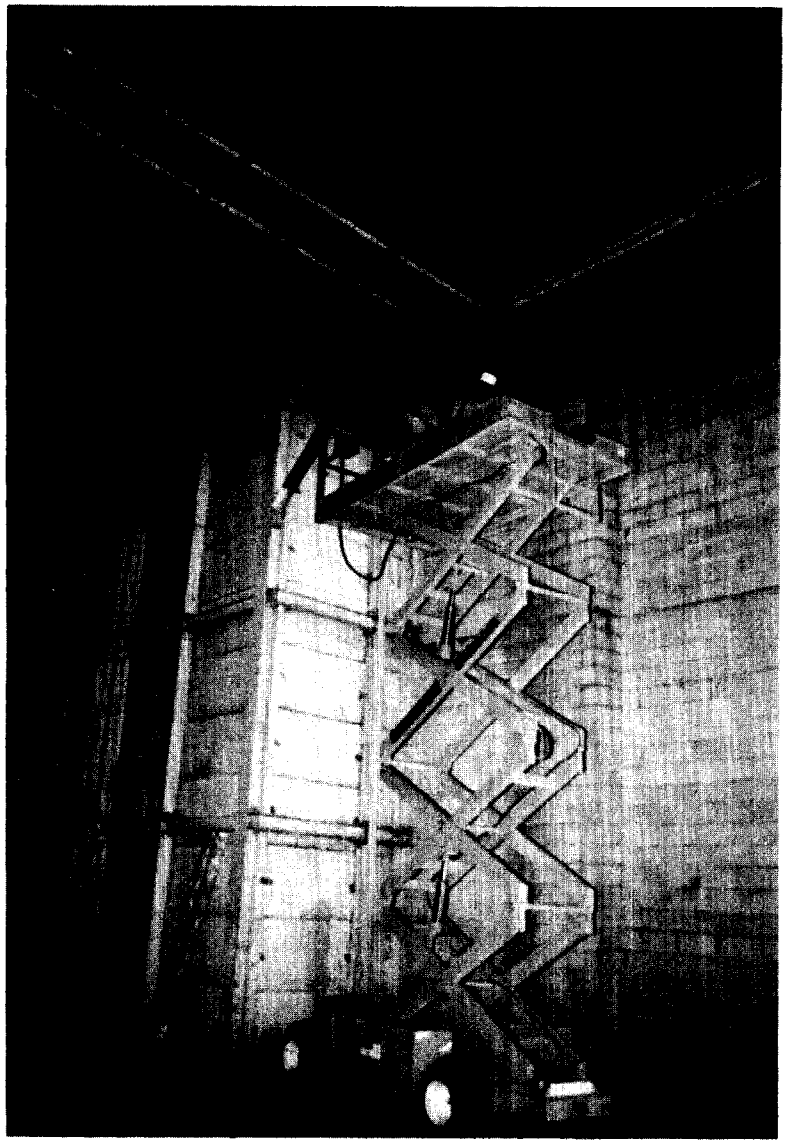
ORNL-PHOTO 11558-91

Fig. 10. View looking at southeast wall from the railroad track. Arrow denotes sample location M1.
