DOE/OR/20722-66

RADIOLOGICAL SURVEY REPORT FOR THE RESIDENTIAL PROPERTY AT 64 TRUDY DRIVE LODI, NEW JERSEY

MAY 1985

Bechtel National, Inc.

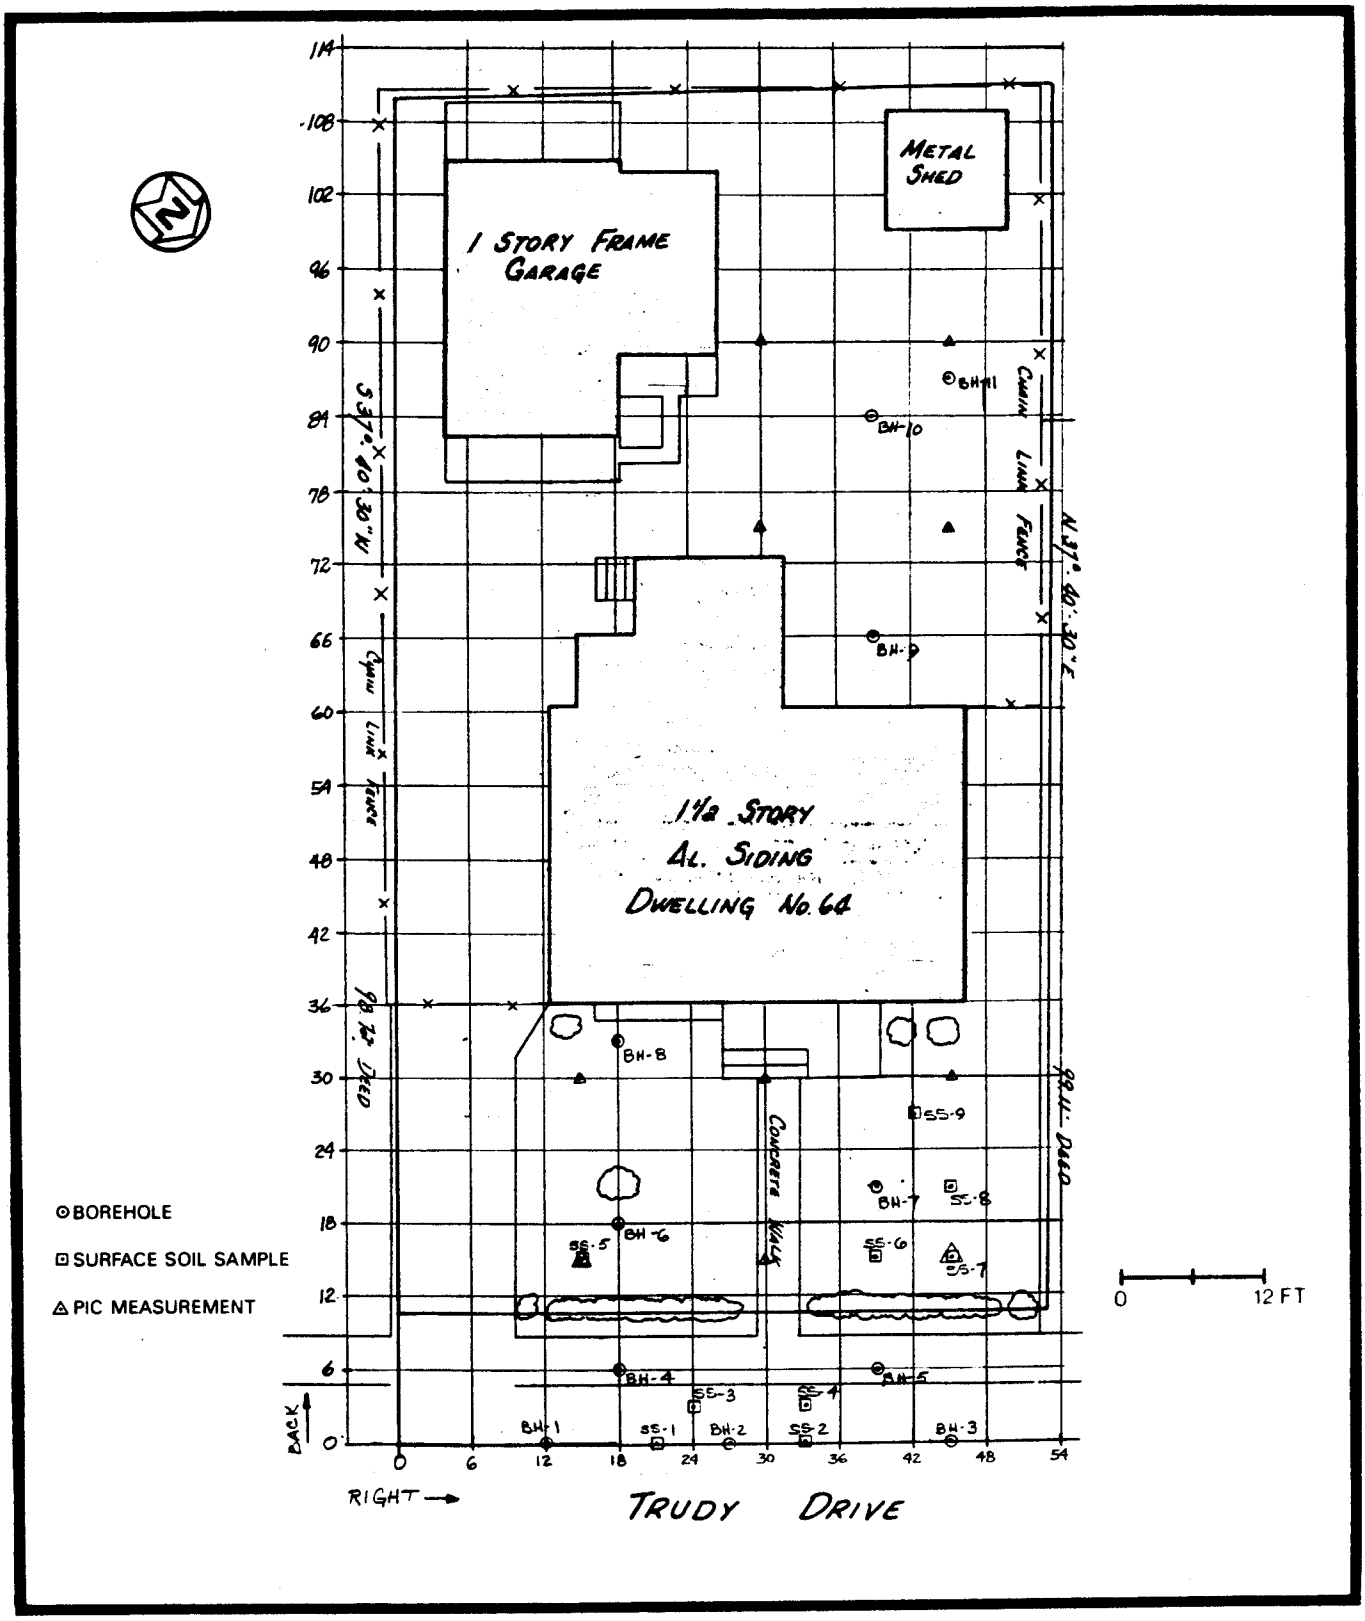
FIGURE 2-1 LOCATIONS OF BOREHOLES, SOIL SAMPLES, AND PIC MEASUREMENTS AT 64 TRUDY DRIVE

The results of the instrument measurements were used to select the locations at which to sample both surface and subsurface soil. These are shown in Figure 2-1. Surface soil samples (0-15 cm) were taken at nine locations and subsurface soil samples to depths of 3 ft were taken from eleven locations. Boreholes were also logged using the unshielded SPA-3 detector.

Pressurized ionization chamber (PIC) measurements of the exposure rate at a height of 1 m above the ground were made at the locations shown in Figure 2-1.

Surface and subsurface soil samples were taken from various locations on the property for radionuclide analyses. Locations of the surface samples (SS-#) and subsurface samples (BH-#) are shown in Figure 2-1, with results of laboratory analyses provided in Tables 3-3 and 3-4, respectively. Concentrations of thorium-232 exceeded the DOE remedial action guidelines in 10 surface and subsurface samples, indicating that thorium-232-bearing residues are present on this property.

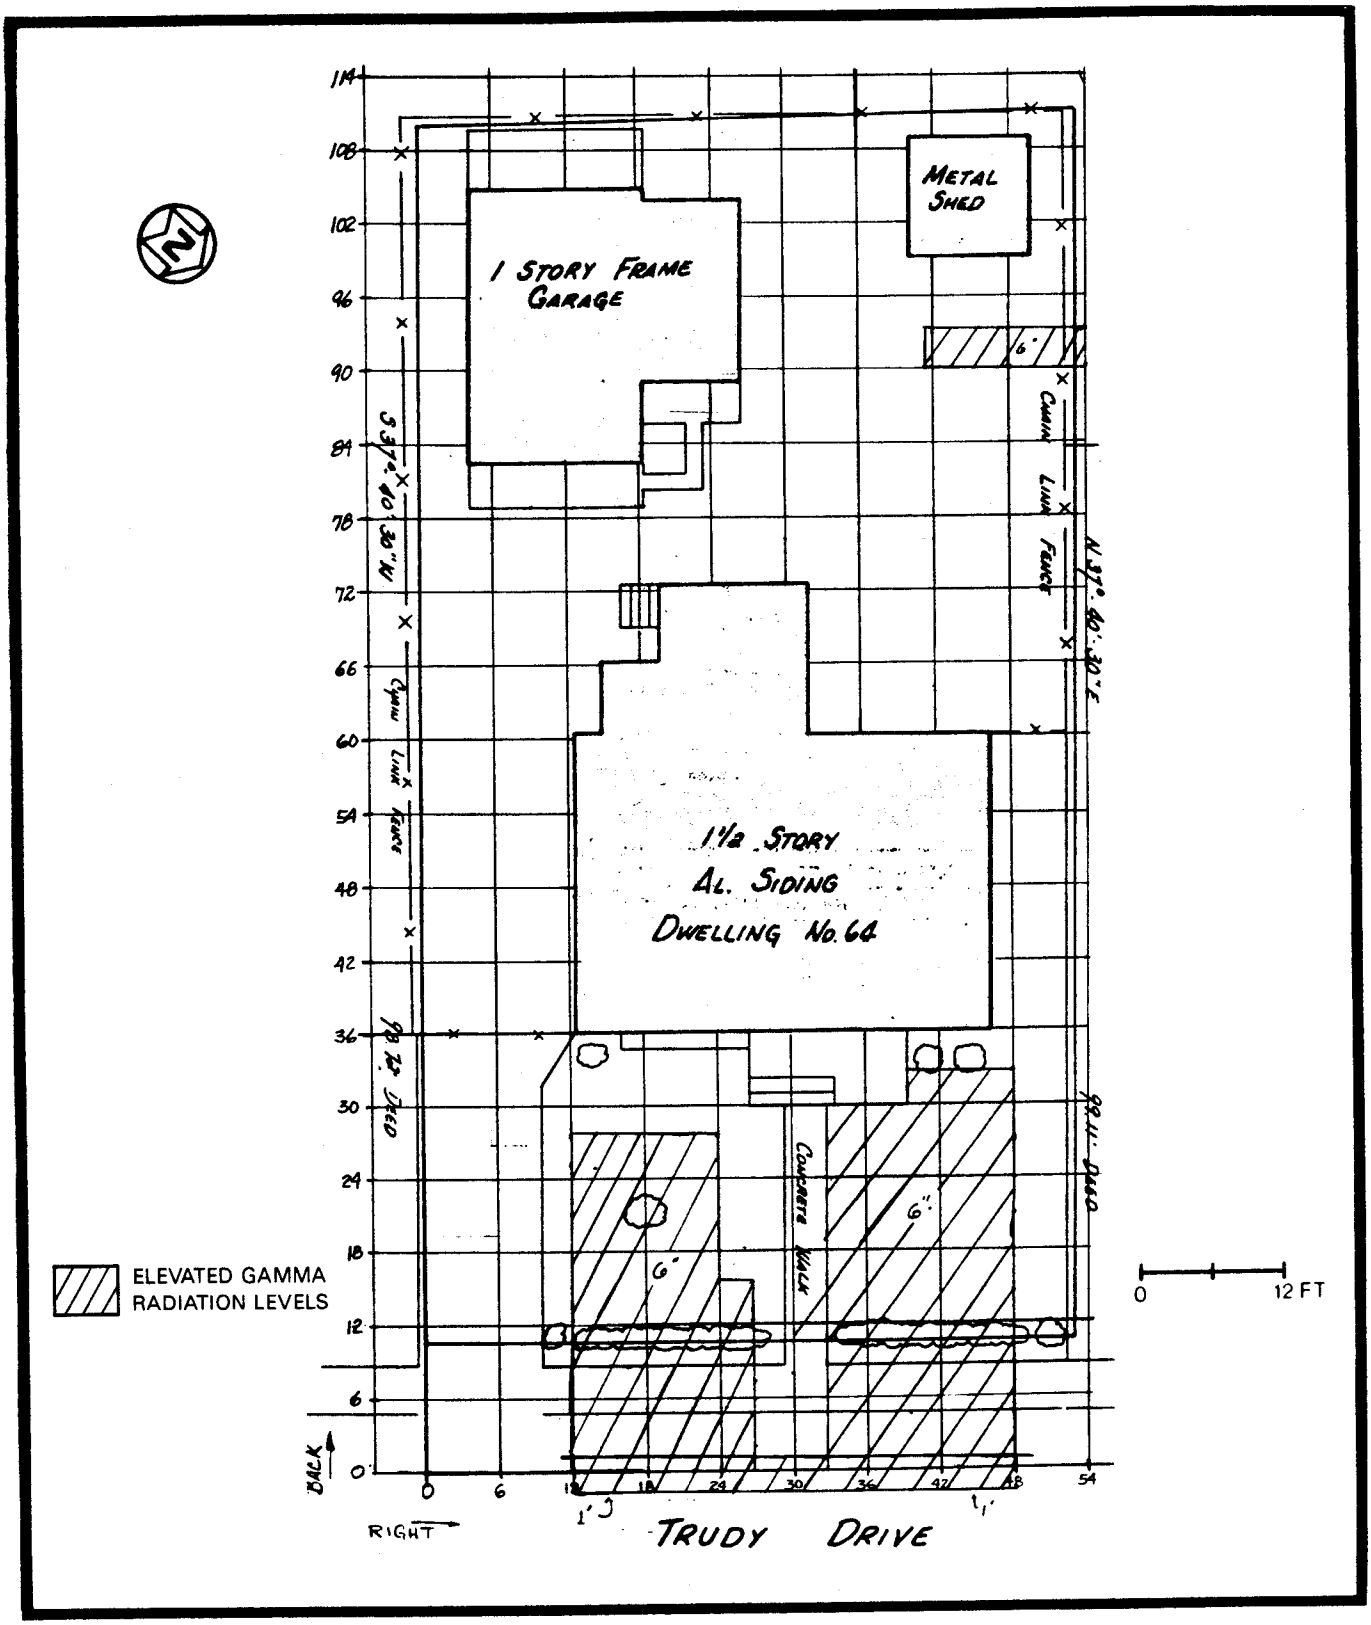
FIGURE 3-1 AREAS OF ELEVATED GAMMA RADIATION LEVELS AT 64 TRUDY DRIVE

Results of the gamma measurements on this property show areas where gamma exposure rates are in excess of background radiation levels. These areas are shown in Figure 3-1. These results suggest locations of potential thorium-232 contamination. Gamma exposure rate levels up to 19 μR/h were found on this property.

Measurements taken at 64 Trudy Drive indicate that radioactive contamination is present on the property, primarily from the thorium-232 decay chain and to a lesser extent from the uranium-238 decay chain. This contamination is found in the areas shown in Figure 3-1. Concentrations of radionuclides significantly above background and in excess of DOE guidelines were measured.
