DOE/OR/20722-64

RADIOLOGICAL SURVEY REPORT FOR THE RESIDENTIAL PROPERTY AT 123 AVENUE F LODI, NEW JERSEY

MAY 1985

Bechtel National, Inc.
Advanced Technology Division
Oak Ridge, Tennessee

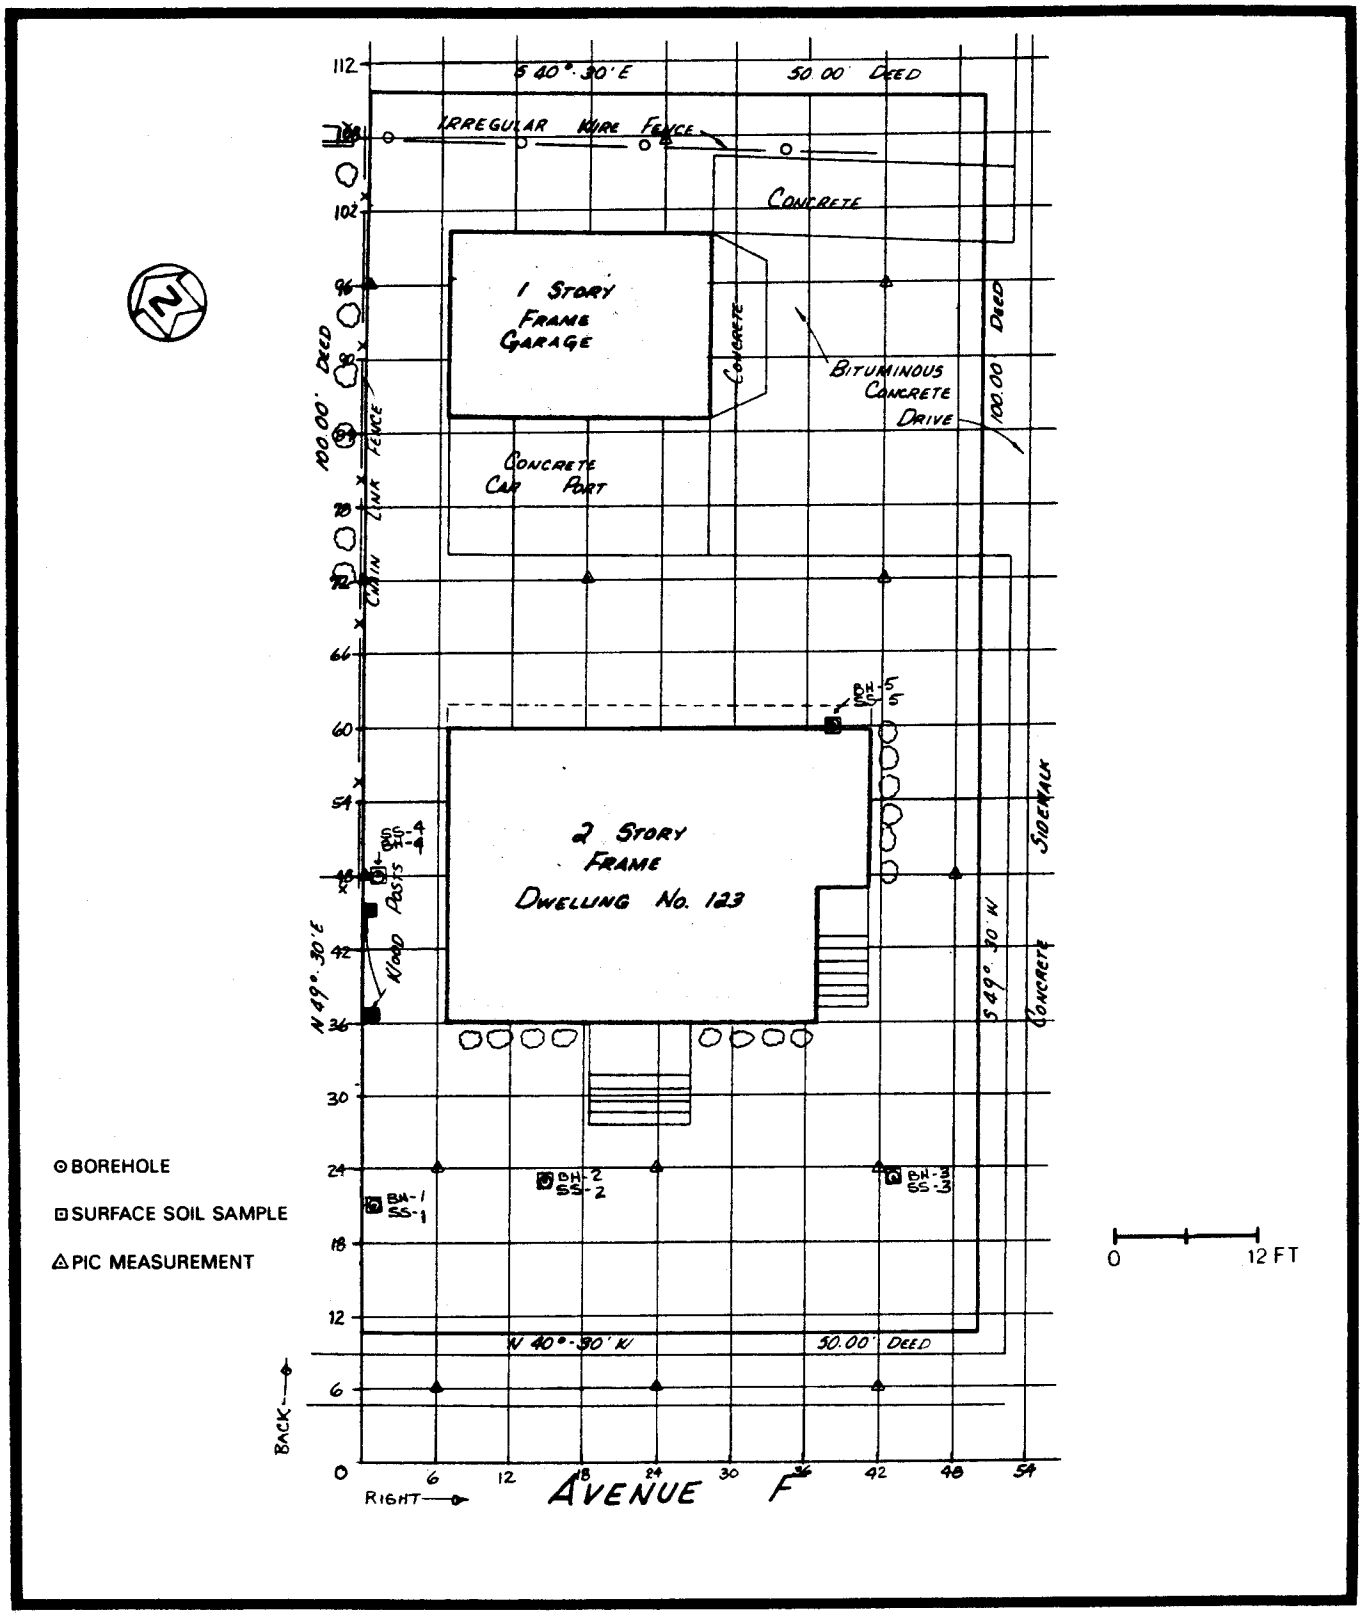
FIGURE 2-1 LOCATIONS OF BOREHOLES, SOIL SAMPLES, AND PIC MEASUREMENTS AT 123 AVENUE F

Surface and subsurface soil samples were taken from various locations on the property for radionuclide analyses. Locations of the surface samples (SS-#) and subsurface samples (BH-#) are shown in Figure 2-1, with results of laboratory analyses provided in Tables 3-3 and 3-4, respectively. Concentrations of thorium-232 exceeded the DOE remedial action guidelines in two surface samples, indicating that thorium-232-bearing residues are present on this property.

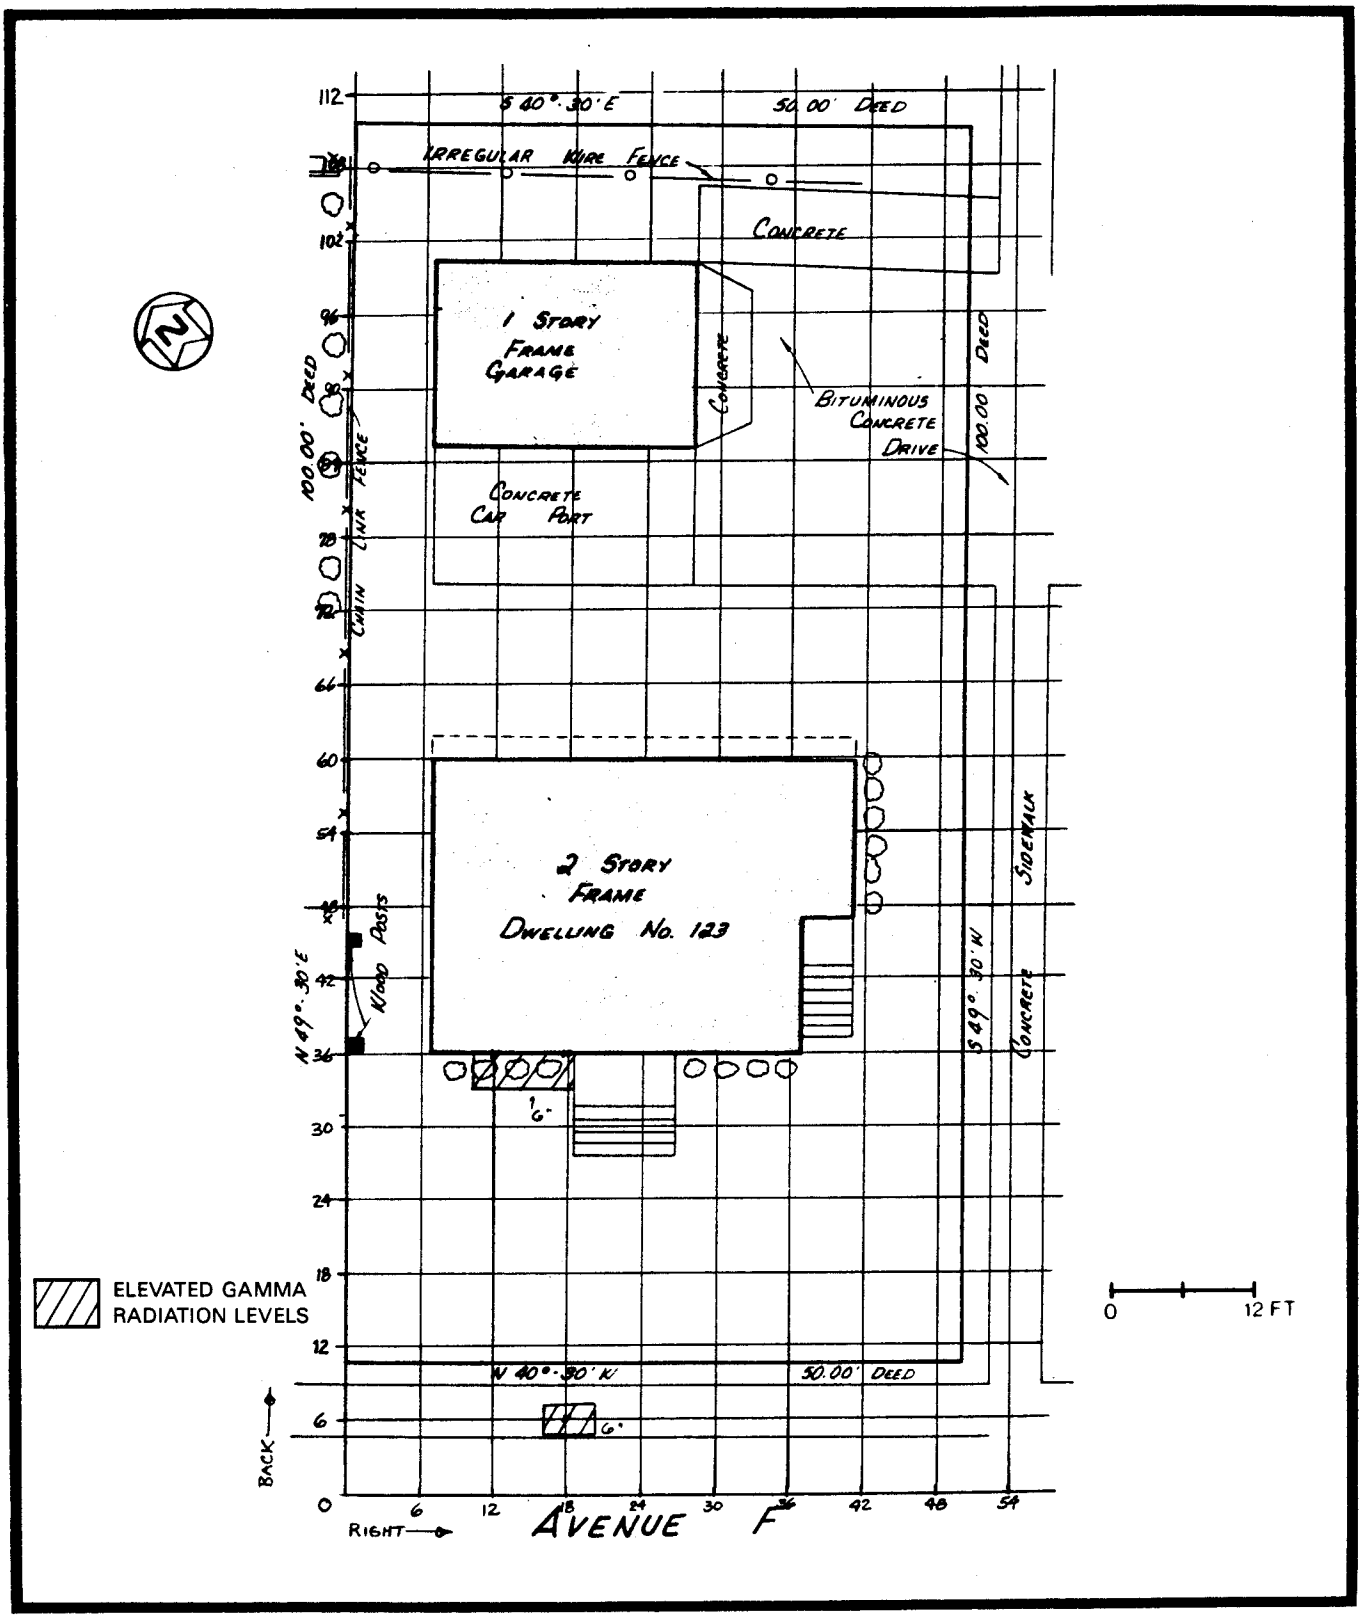
FIGURE 3-1 AREAS OF ELEVATED GAMMA RADIATION LEVELS AT 123 AVENUE F

Results of the gamma measurements on this property show areas where gamma exposure rates are in excess of background radiation levels. These areas are shown in Figure 3-1. These results suggest locations of potential thorium-232 contamination. Gamma exposure rate levels up to 10 μR/h were found on this property.

Measurements taken at 123 Avenue F indicate that radioactive contamination is present on the property, primarily from the thorium-232 decay chain and to a lesser extent from the uranium-238 decay chain. This contamination is found in the areas shown in Figure 3-1. Concentrations of radionuclides significantly above background and in excess of DOE guidelines were measured.
