Department of Energy
Office of Legacy Management

Subject: **Transmittal of the June 2009 Fernald Site Inspection Forms**

FERNALD PRESERVE FIELD WALKDOWN INSPECTION FORM

Fernald Preserve
Consolidated Finding Locations for June 2009 Site Inspection

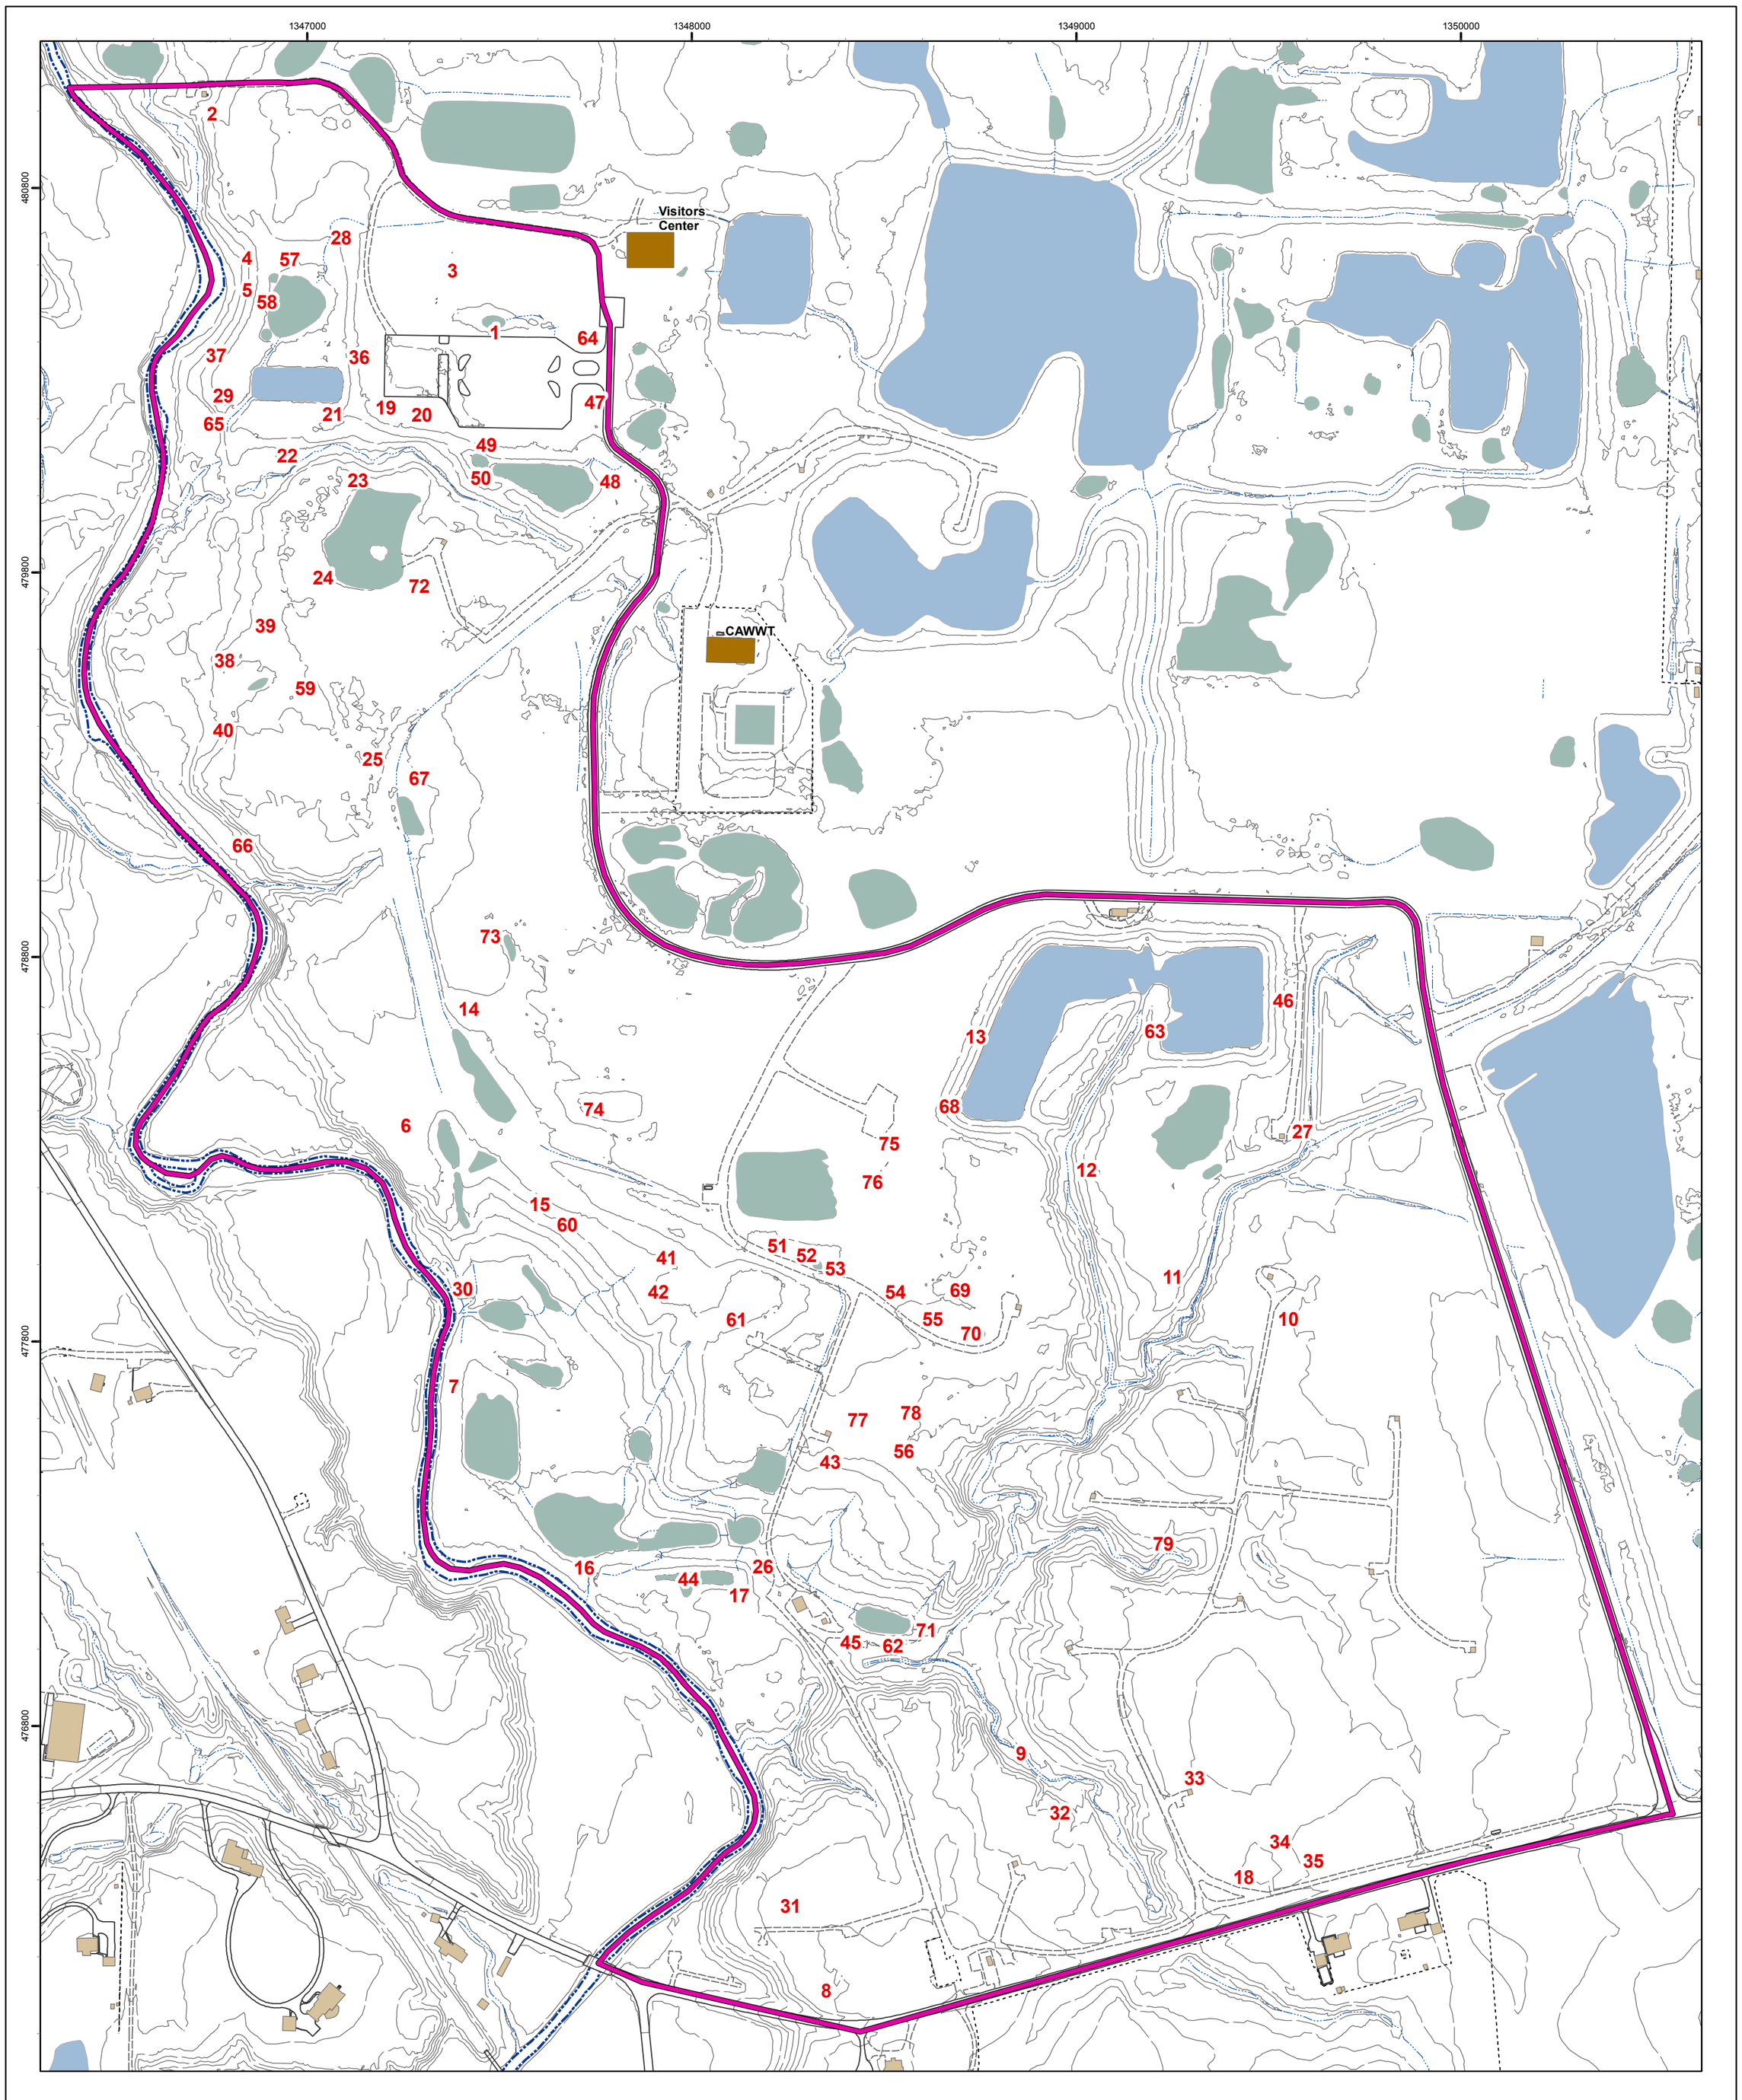
NOTE: Findings are numbered and provided on the June 2009 Field Walkdown Form.
