Appendix C: Landfill Inspection Forms – Fourth Quarter CY 2015

C.1 Original Landfill

ORIGINAL LANDFILL – MONITORING AND MAINTENANCE PLAN INSPECTION FORM

Attachment 1: October 2015
Monthly Report of the Original Landfill Inspections at the Rocky Flats Site

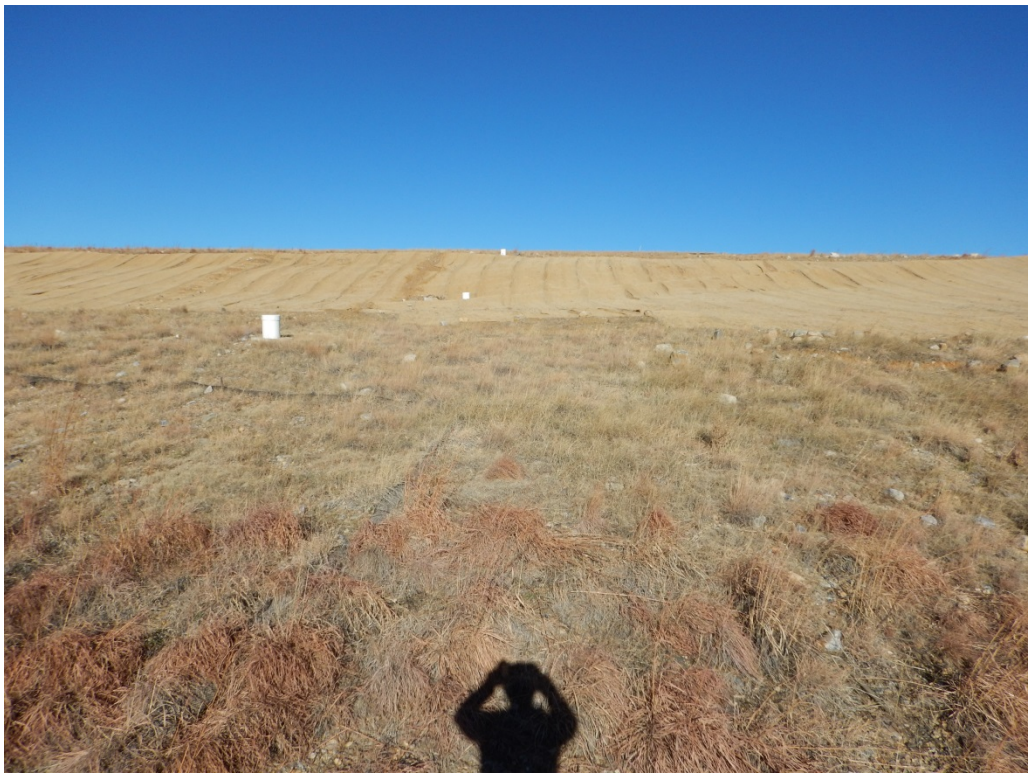
The OLF cover was in good condition, with no new movement or cracks observed. Specifically, the area of recent construction shows no signs of movement (Figures 1−3).

Figure 1: Rocky Flats site OLF. Looking west at the top of the EPC and recent construction area.

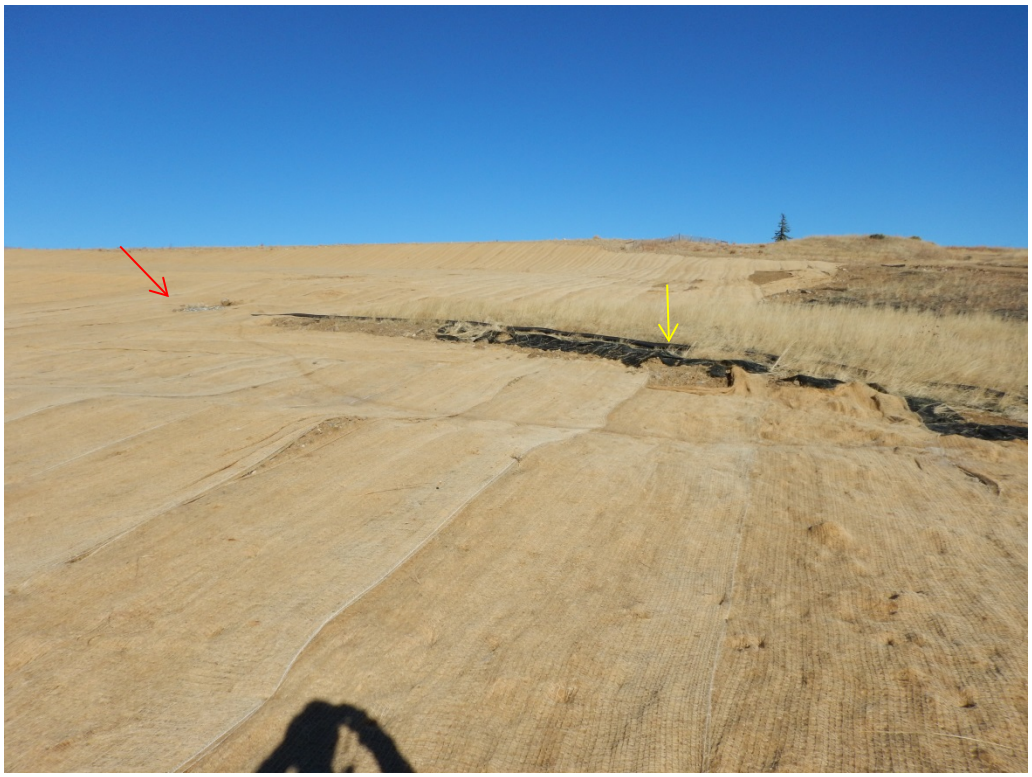
Figure 2: Rocky Flats site OLF. Looking north toward berm 1 and the recent construction area.

Figure 3: Rocky Flats site OLF. Looking east between berms 5 and 6 at recent construction area.
