WELDON SPRING SITE REMEDIAL ACTION PROJECT
7295 HIGHWAY 94 SOUTH
ST. CHARLES, MISSOURI U.S.A. 63304
PHONE: (636) 441-8086

SUBJECT: Contract No. DE-AC05-86OR21548
TRANSMITTAL OF THE POST REMEDIAL ACTION REPORT FOR VICINITY PROPERTY MDC-6

SUBJECT: CONFIRMATION RESULTS FOR VICINITY PROPERTY MDC-6 (RU12/CU141)

SOIL CONFIRMATION REMEDIATION DISPOSITION FORM

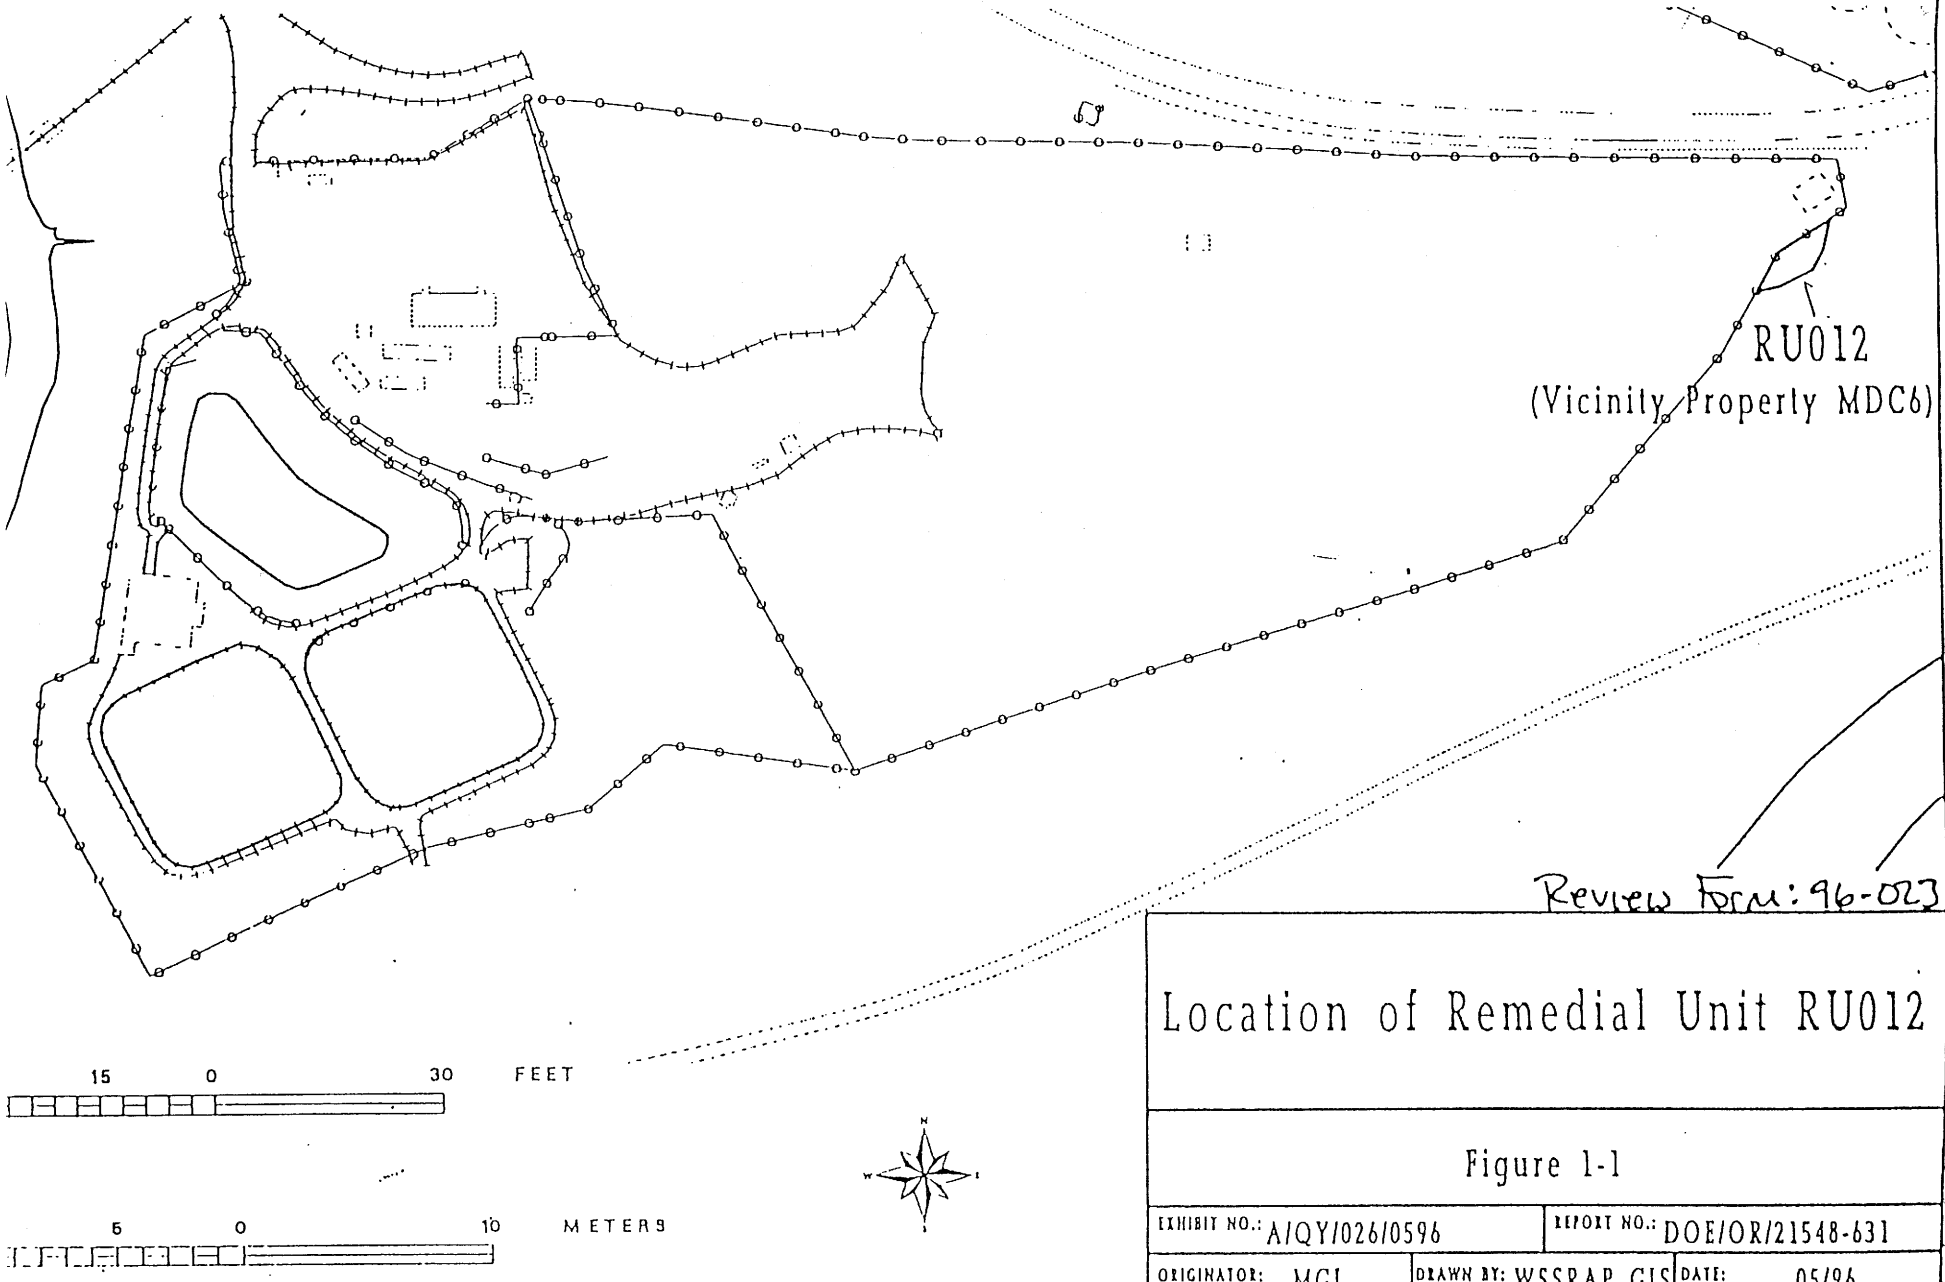
Figure 1-1

Location of Remedial Unit RU012

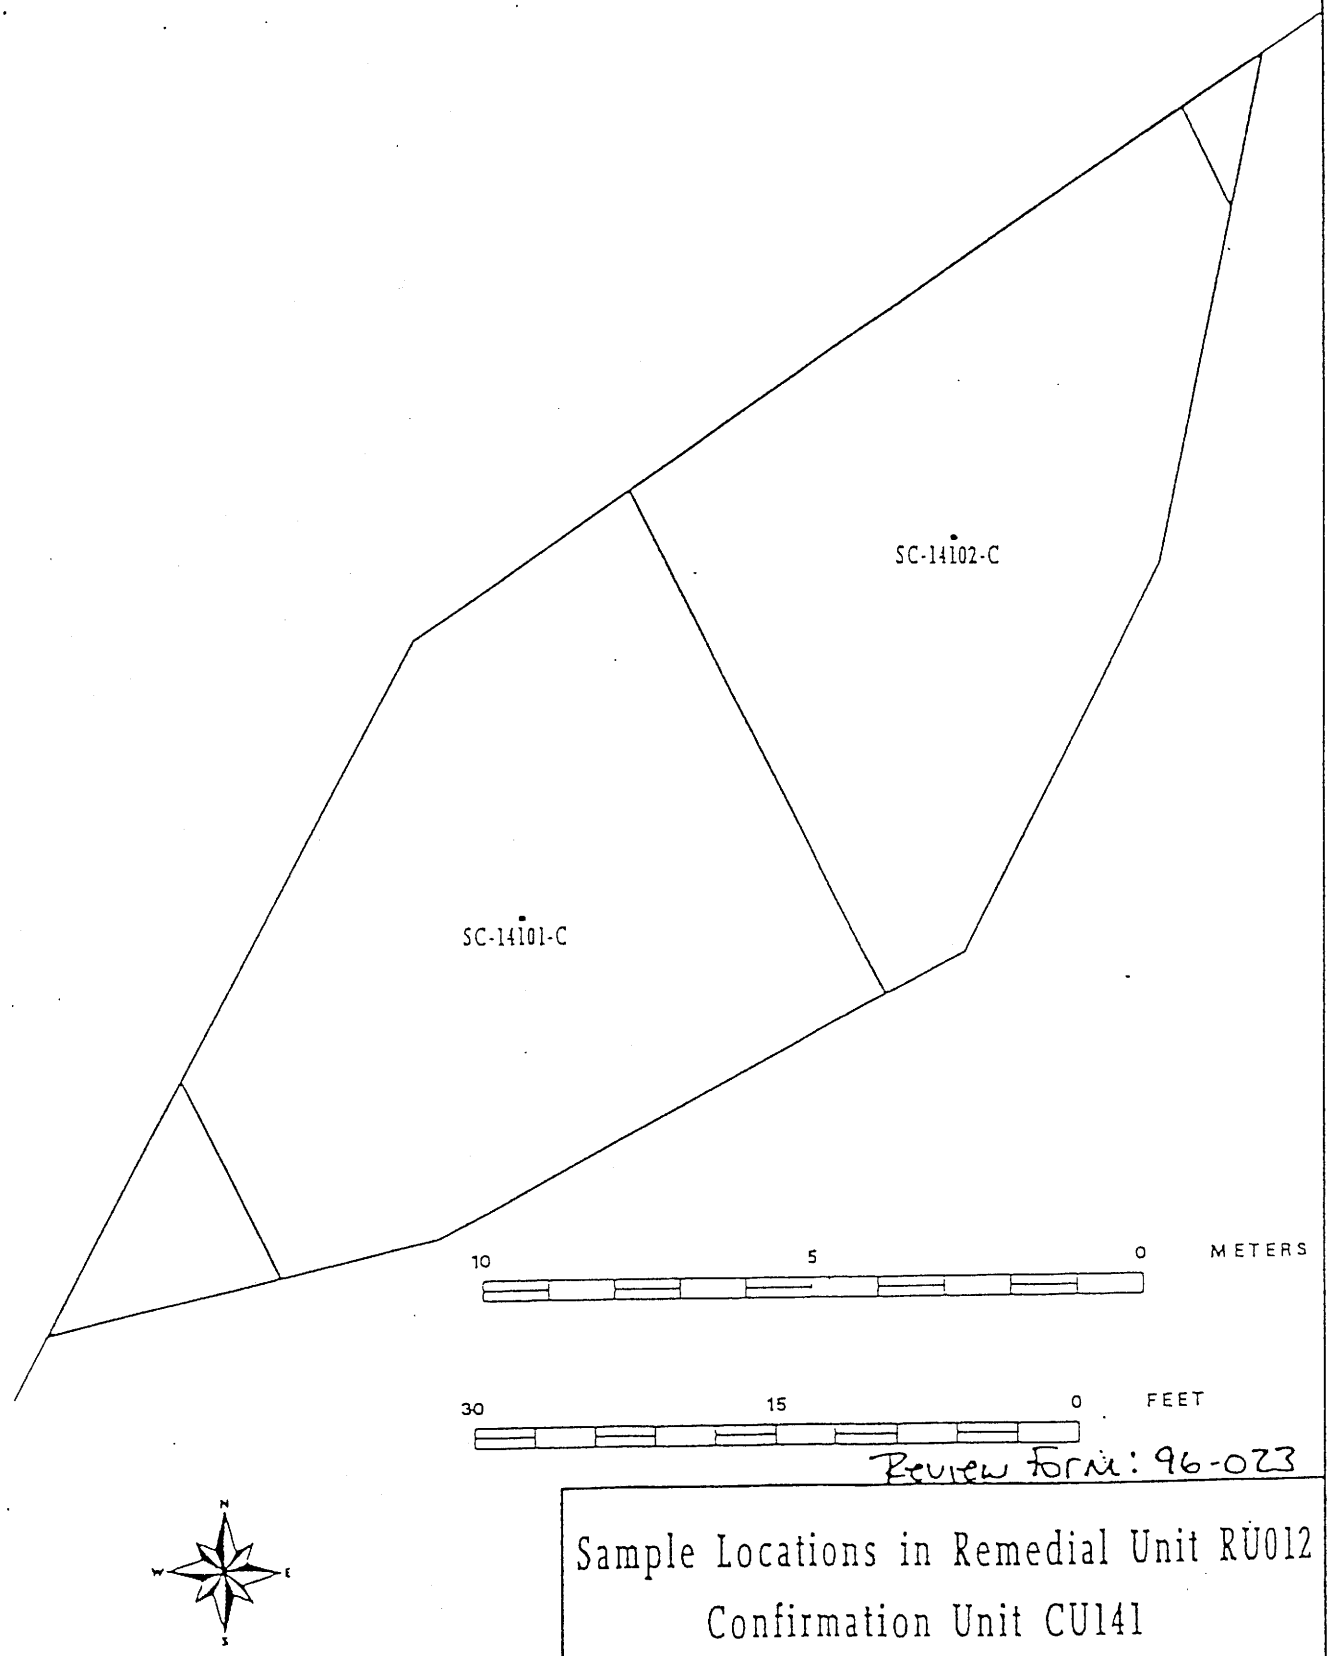
Figure 2-1

Sample Locations in Remedial Unit RU012
Confirmation Unit CU141
