Department of Energy
Office of Legacy Management

SUBJECT: **Transmittal of the December 2007 Fernald Site Inspection Checklist**

FERNALD PRESERVE FIELD WALKDOWN INSPECTION FORM

FERNALD PRESERVE DECEMBER 2007
FIELD WALKDOWN FINDINGS

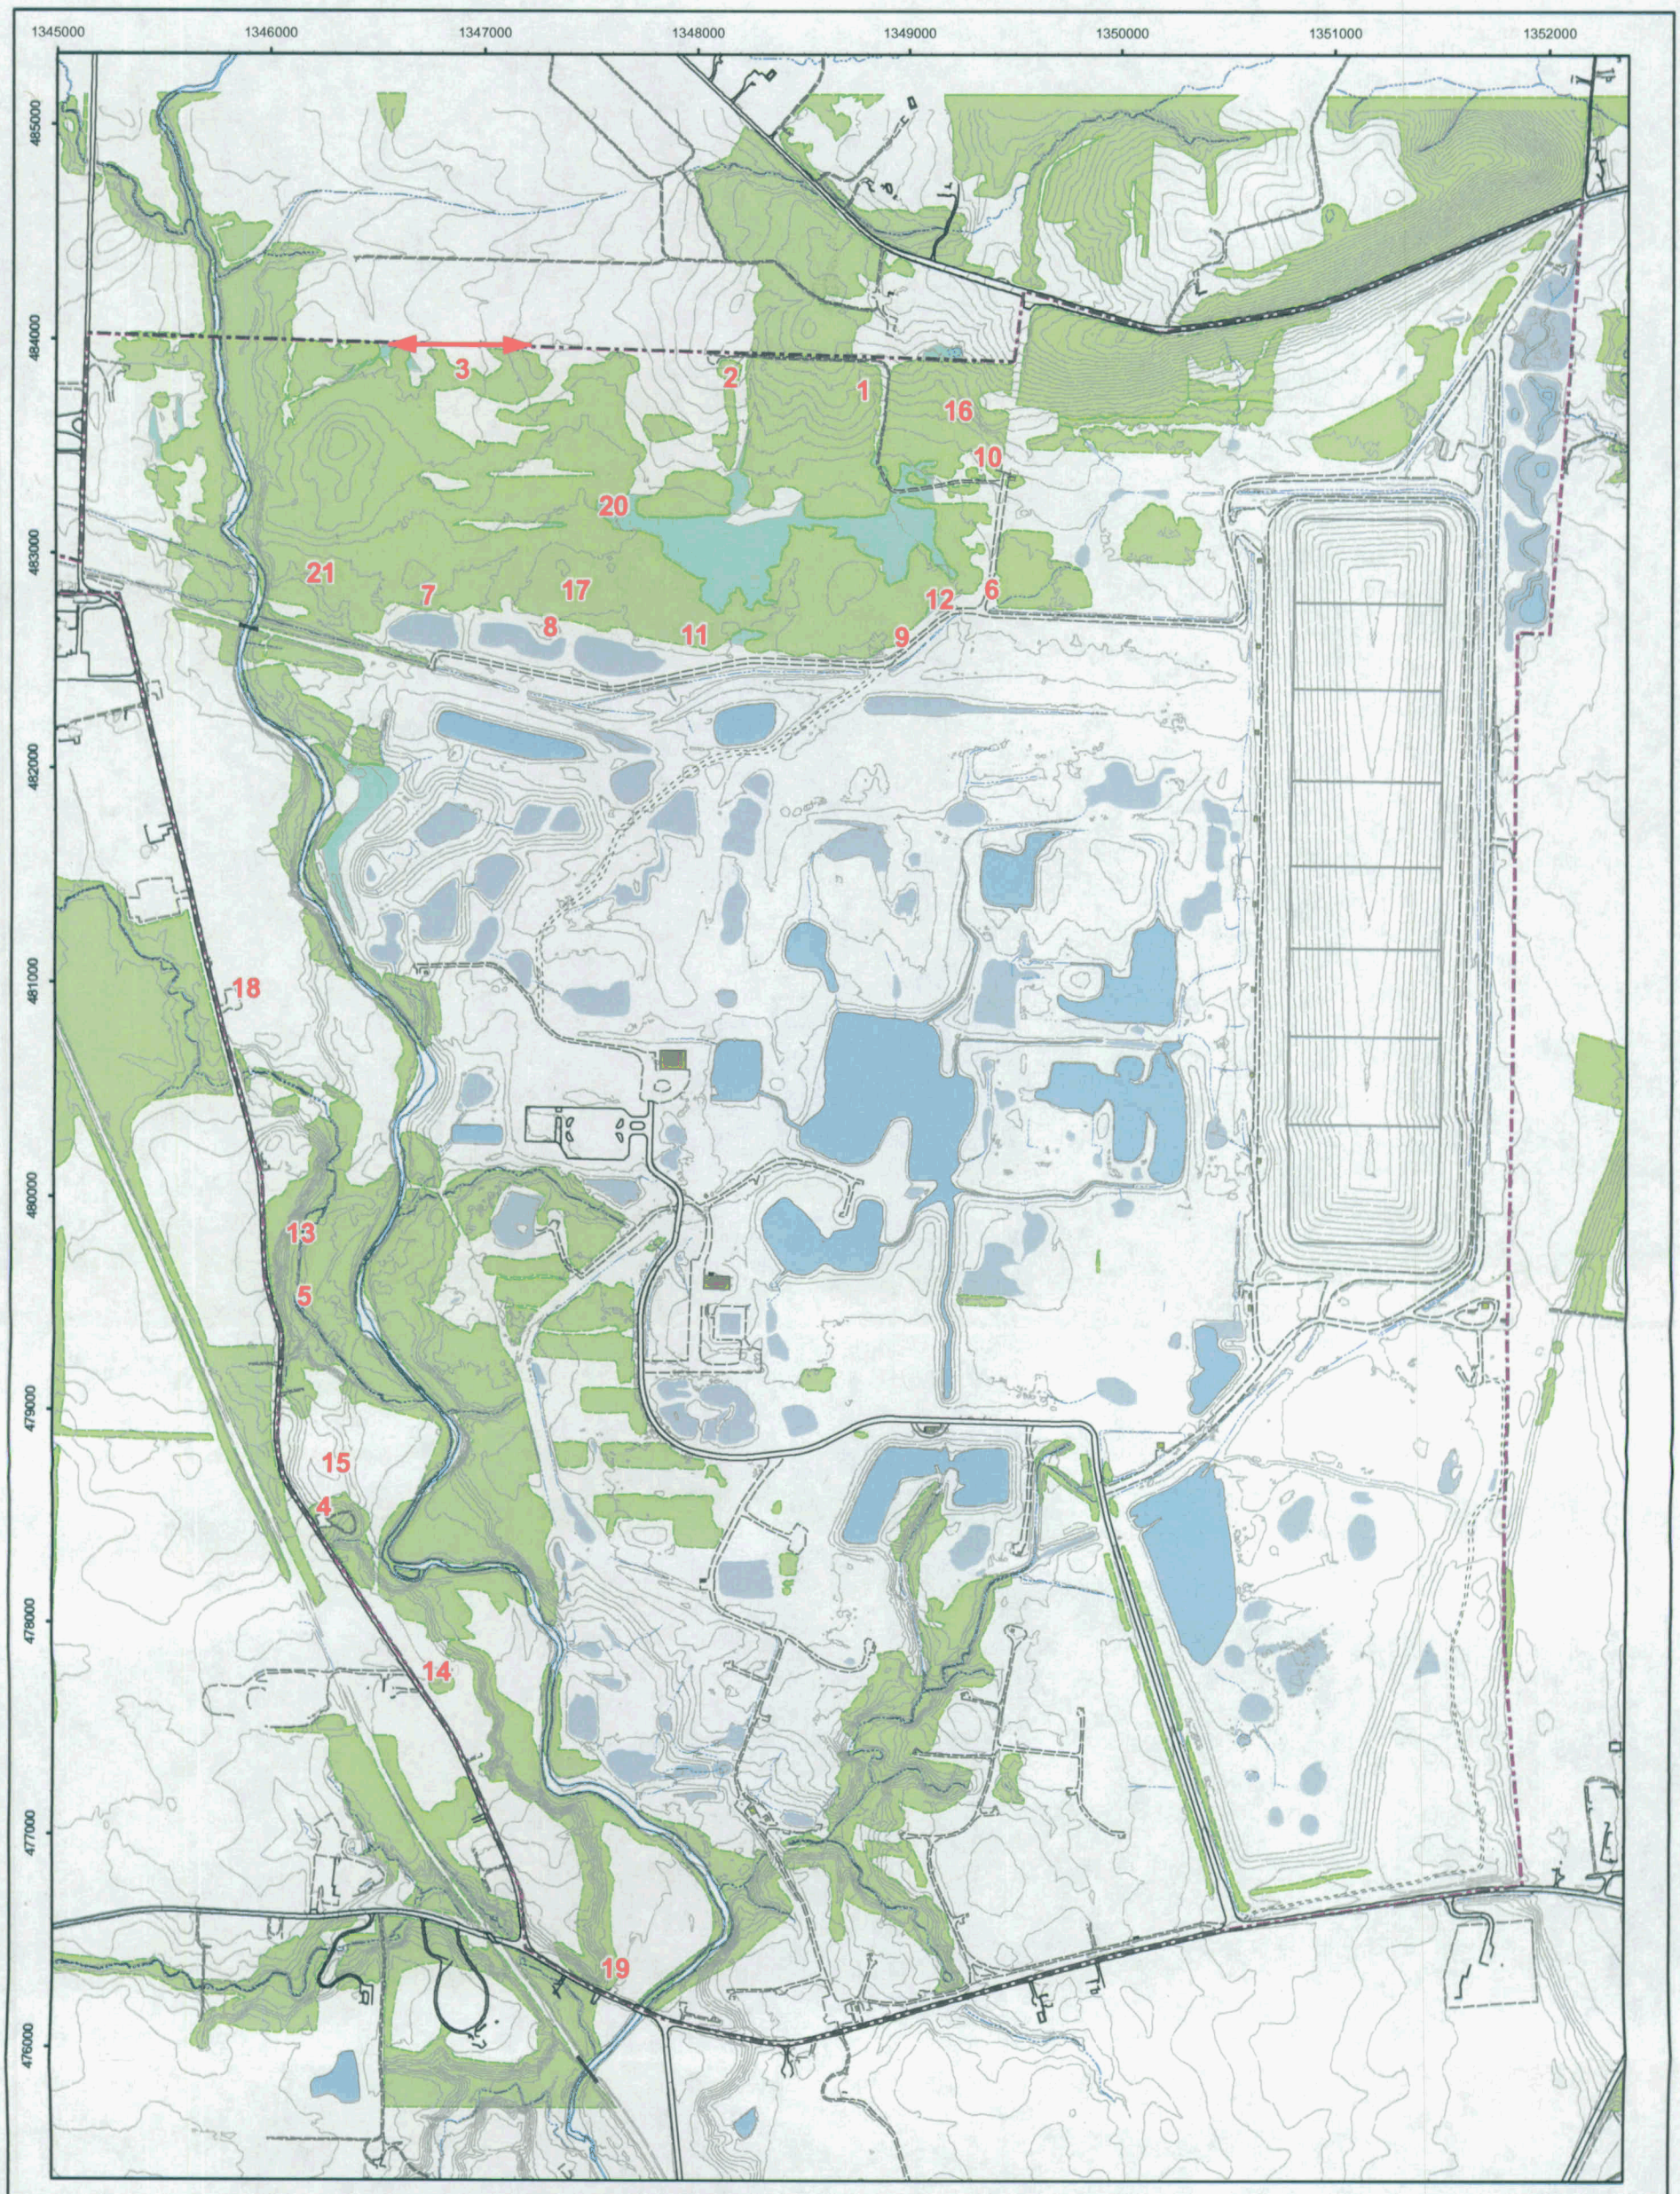
No.	Location (use map whenever possible)	GPS?	Type of Finding (see definitions back page)				Description	Photo? (file No.)	Followup		
			Unauth. Use	Disturbance	Vegetation	Other			Corrected	Maint. Required	Cont. Observation
1	Just west of gravel road, at bend by Neiman's property	no	X				Potential campfire site at two separate locations (see Note 1)		X		
2	Just west of culvert that goes under gravel road, along north property line	no	X				Fence is down (see Note 2)		X		
3	Various locations along north fenceline	no				X	Some "No Trespassing" signs are damaged or down			X	
4	Ecological Restoration Park	no	X				Trash is being dumped			X	
5	Oxbow Area, at a sycamore in the old Paddys Run streambed	no				X	Possible old laboratory bottle			X	
6	Old North Access Road	no				X	Bolt lying in road			X	
7	A6PI, north of chain-link fence, inside deer fence	no				X	Large roll of barbed wire			X	
8	A6PI, inside deer fence	no				X	Deer cages need to be removed			X

9	North woodlot, along south road	no		X			Big hole present				X
10	North woodlot, east side by road	no				X	Pull old fence			X

No.	Location (use map whenever possible)	GPS?	Type of Finding (see definitions back page): Unauth. Use	Disturbance	Vegetation	Other	Description	Photo? (file No.)	Followup: Corrected	Maint. Required	Cont. Observation
11	North woodlot deer fence	no		X			Tree down across deer fence - fence needs repair on east side as well			X	
12	North woodlot, along south road	no				X	Construction fencing, silt fence, and yellow iron plate present			X	
13	Paddys Run west, in trees by road	no				X	Two bricks			X	
14	Paddys Run west, at stand of trees north of substation	no				X	Piece of brick			X	
15	North of Ecological Restoration Park	no		X			Bird box down			X	
16	North woodlot, south of Neiman's barn	yes				X	Brick			X	
17	A6PI chain link fence	no				X	Take down "No Trespassing" signs			X	
18	Paddys Run west, south of prairie area	no				X	Roll of welded wire fence			X	
19	Fence line along Willey Road	no				X	"No Trespassing" sign down			X

20	North woodlot	no	X				Deer stand discovered in tree		X		X
21	Forest Demo Project	no			X		Tree tubes need to be removed			X

1. Observed locations and determined that they were not campfires. No further action needed.

2. The fence does not provide any security function and would have been removed but for the adjacent landowner's request. It is their responsibility to repair if so desired.
