Department of Energy
Office of Legacy Management

Subject: **Transmittal of the September 2008 Fernald Site Inspection Forms**

FERNALD PRESERVE FIELD WALKDOWN INSPECTION FORM

Fernald Preserve
Consolidated Finding Locations
for September 2008 Site Inspection

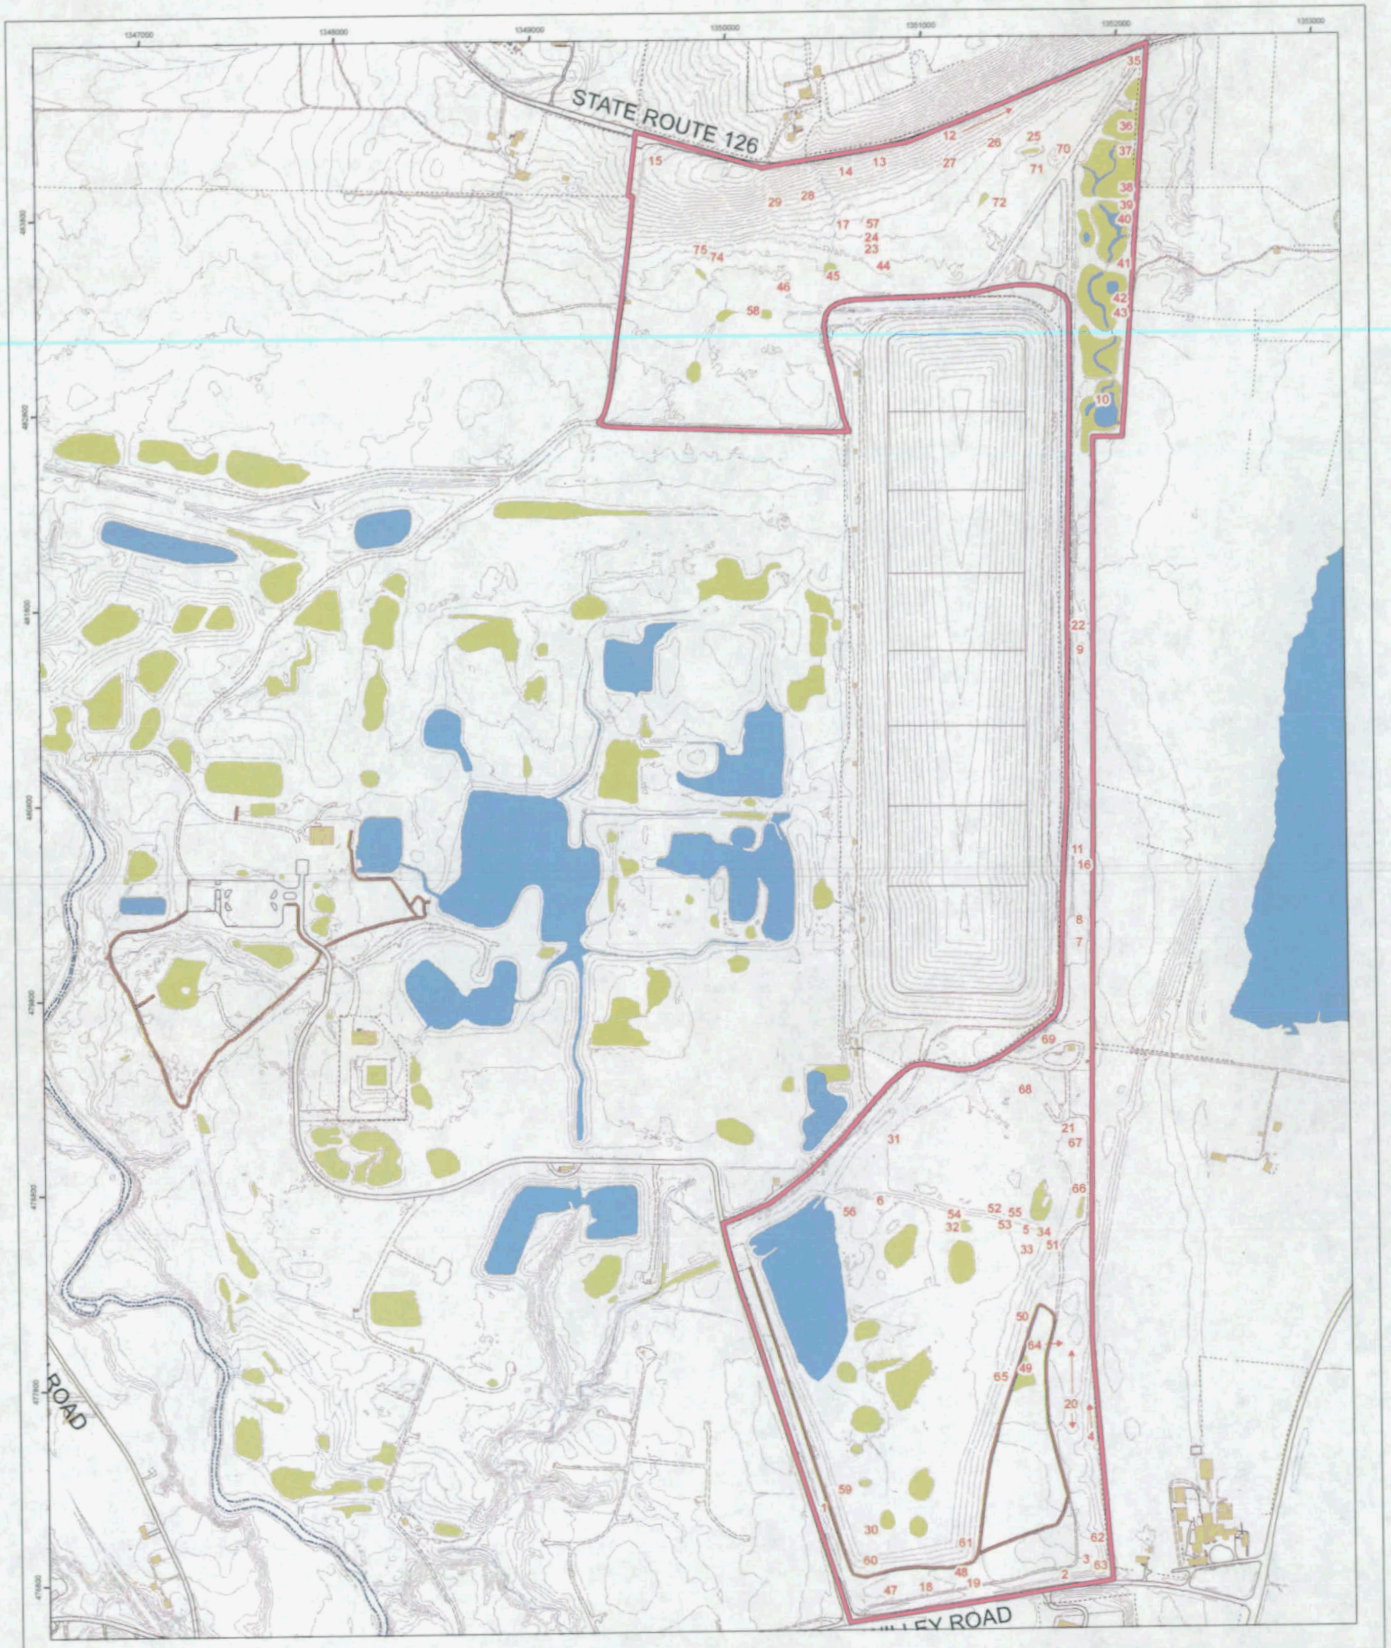
NOTE: Findings are numbered and provided on the September 2008 Field Walkdown Form.
