SUBJECT: **Transmittal of the December 2011 Fernald Site Inspection Forms**

Fernald Preserve Institutional Control Inspection

Fernald Preserve Field Walkdown Inspection

FERNALD PRESERVE MAINTENANCE AND REPAIR ACTION ITEMS

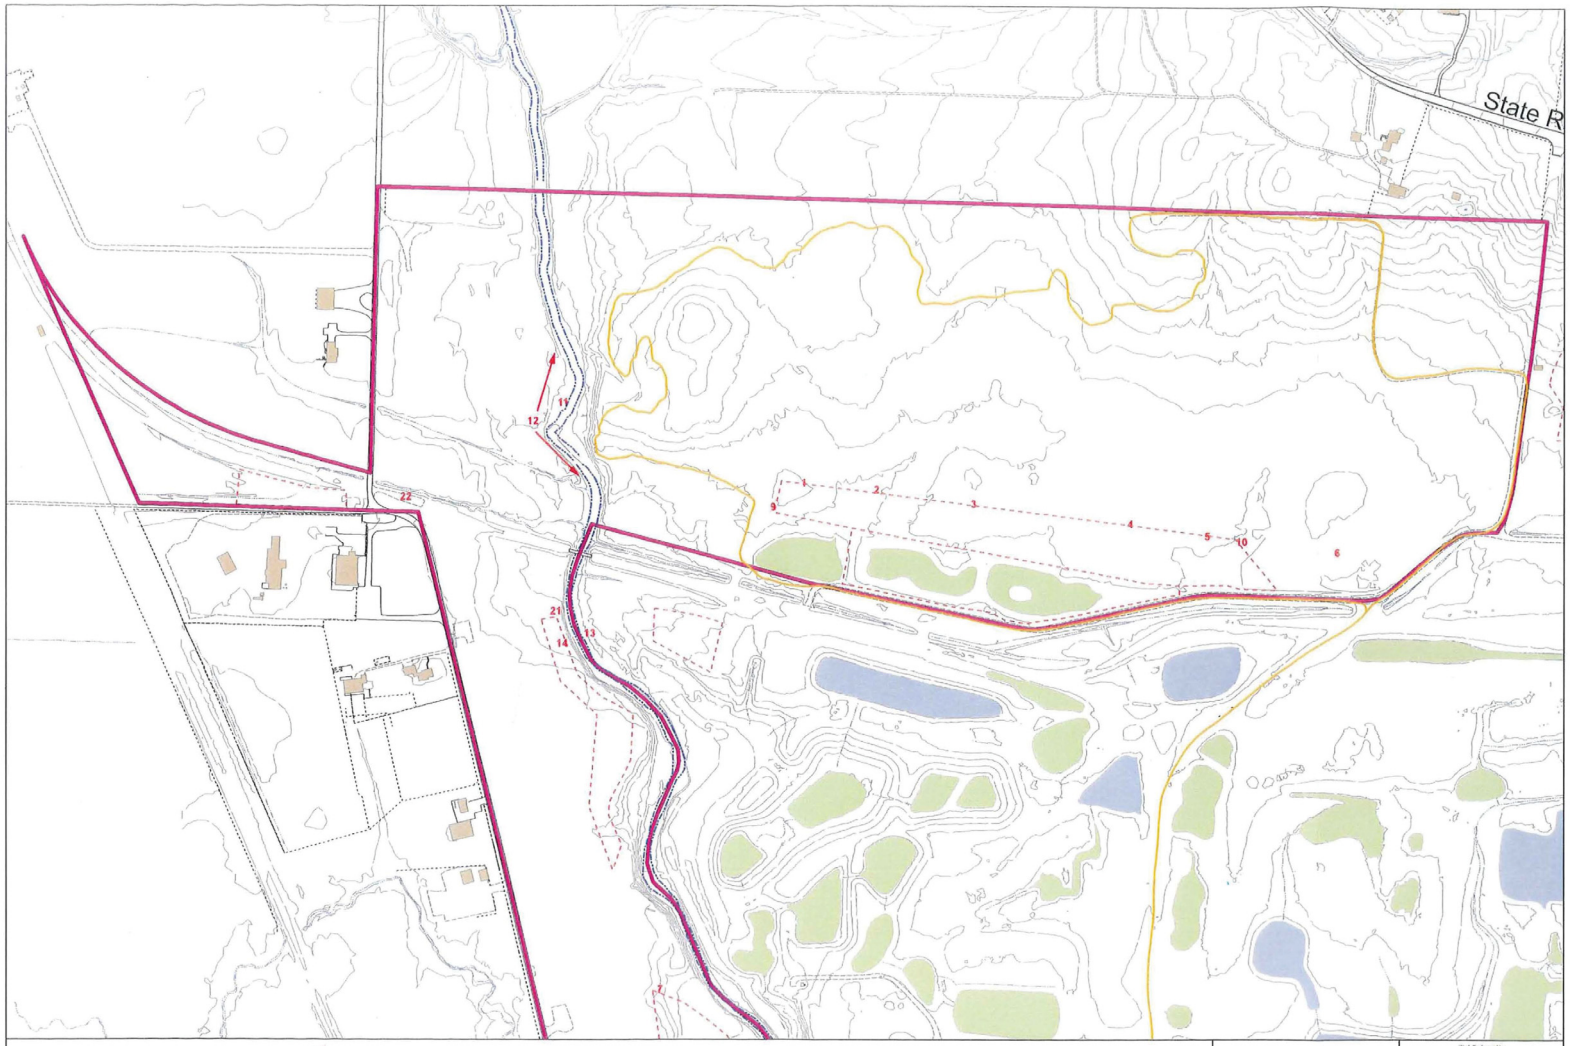
U.S. DEPARTMENT OF ENERGY HAMILTON, OHIO	Work Performed by S.M. Stoller Corporation Under DOE Contract No. DE-AM01-07LM00059
Fernald Preserve Consolidated Finding Locations for North Section of December 2011 Site Inspection	
DATE PREPARED December 6, 2011	FILENAME inspection_areas_4thqtr_2011_north_loc

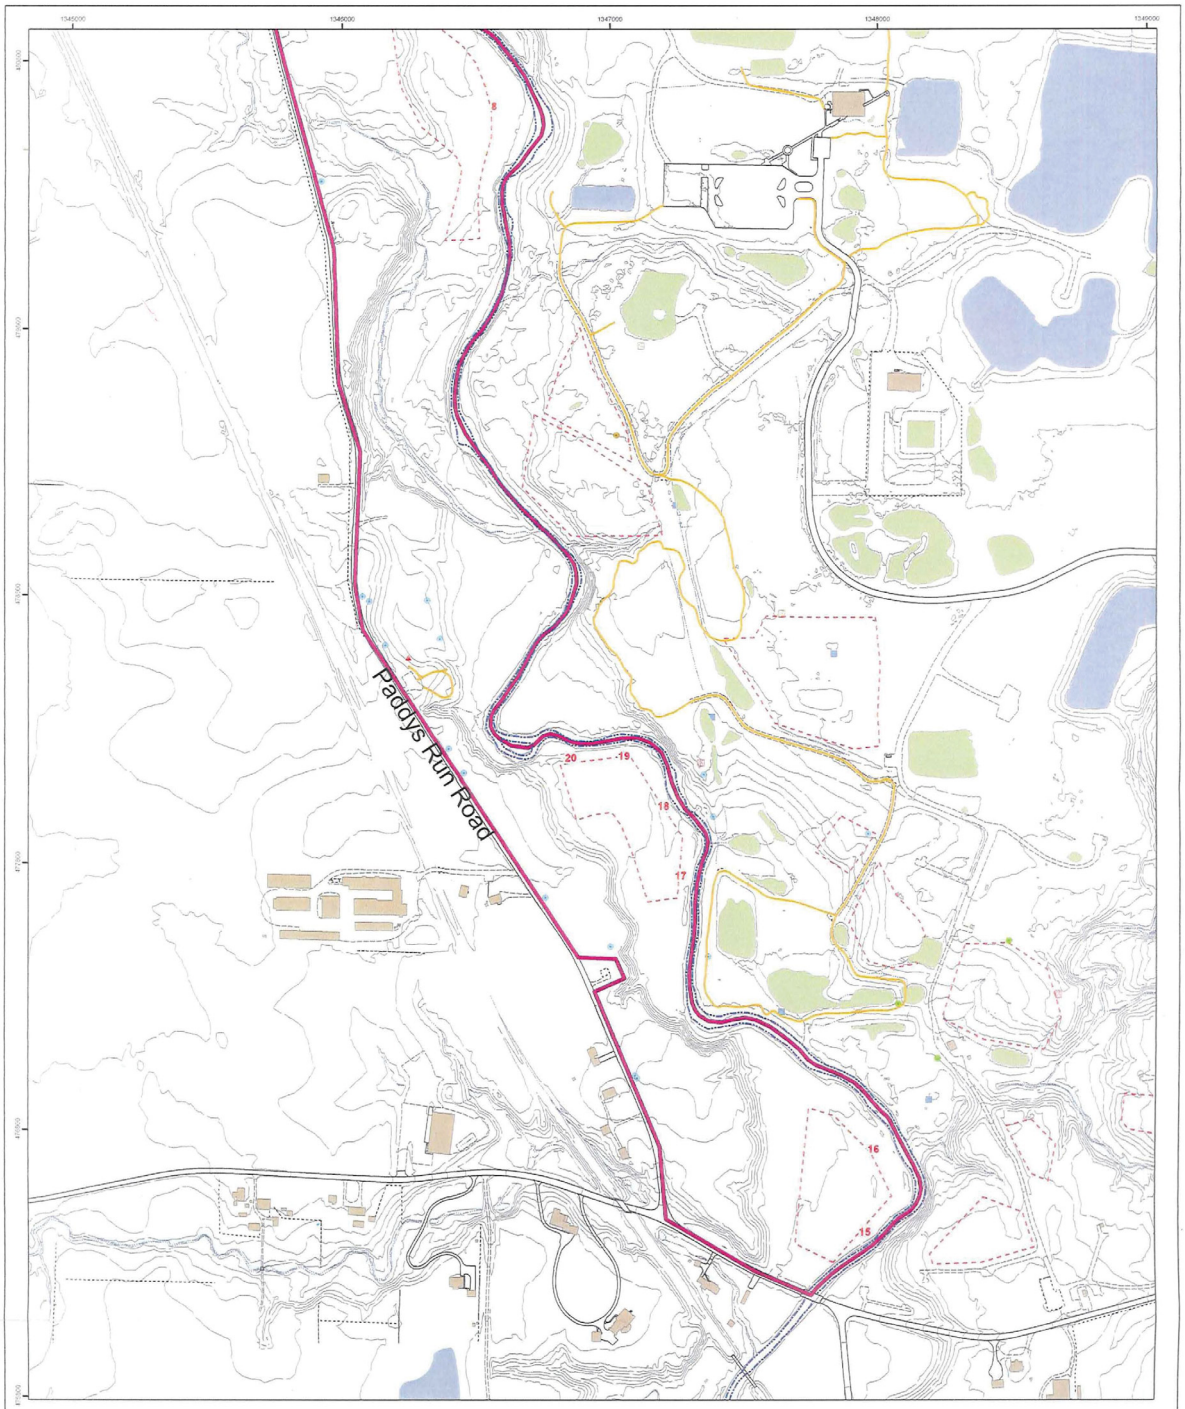
Fernald Preserve
Consolidated Finding Locations for South Section
of December 2011 Site Inspection
