Department of Energy
Washington, DC 20585

SUBJECT: **Transmittal of the September 2013 Fernald Site Inspection Forms**

Fernald Preserve Field Walkdown Inspection

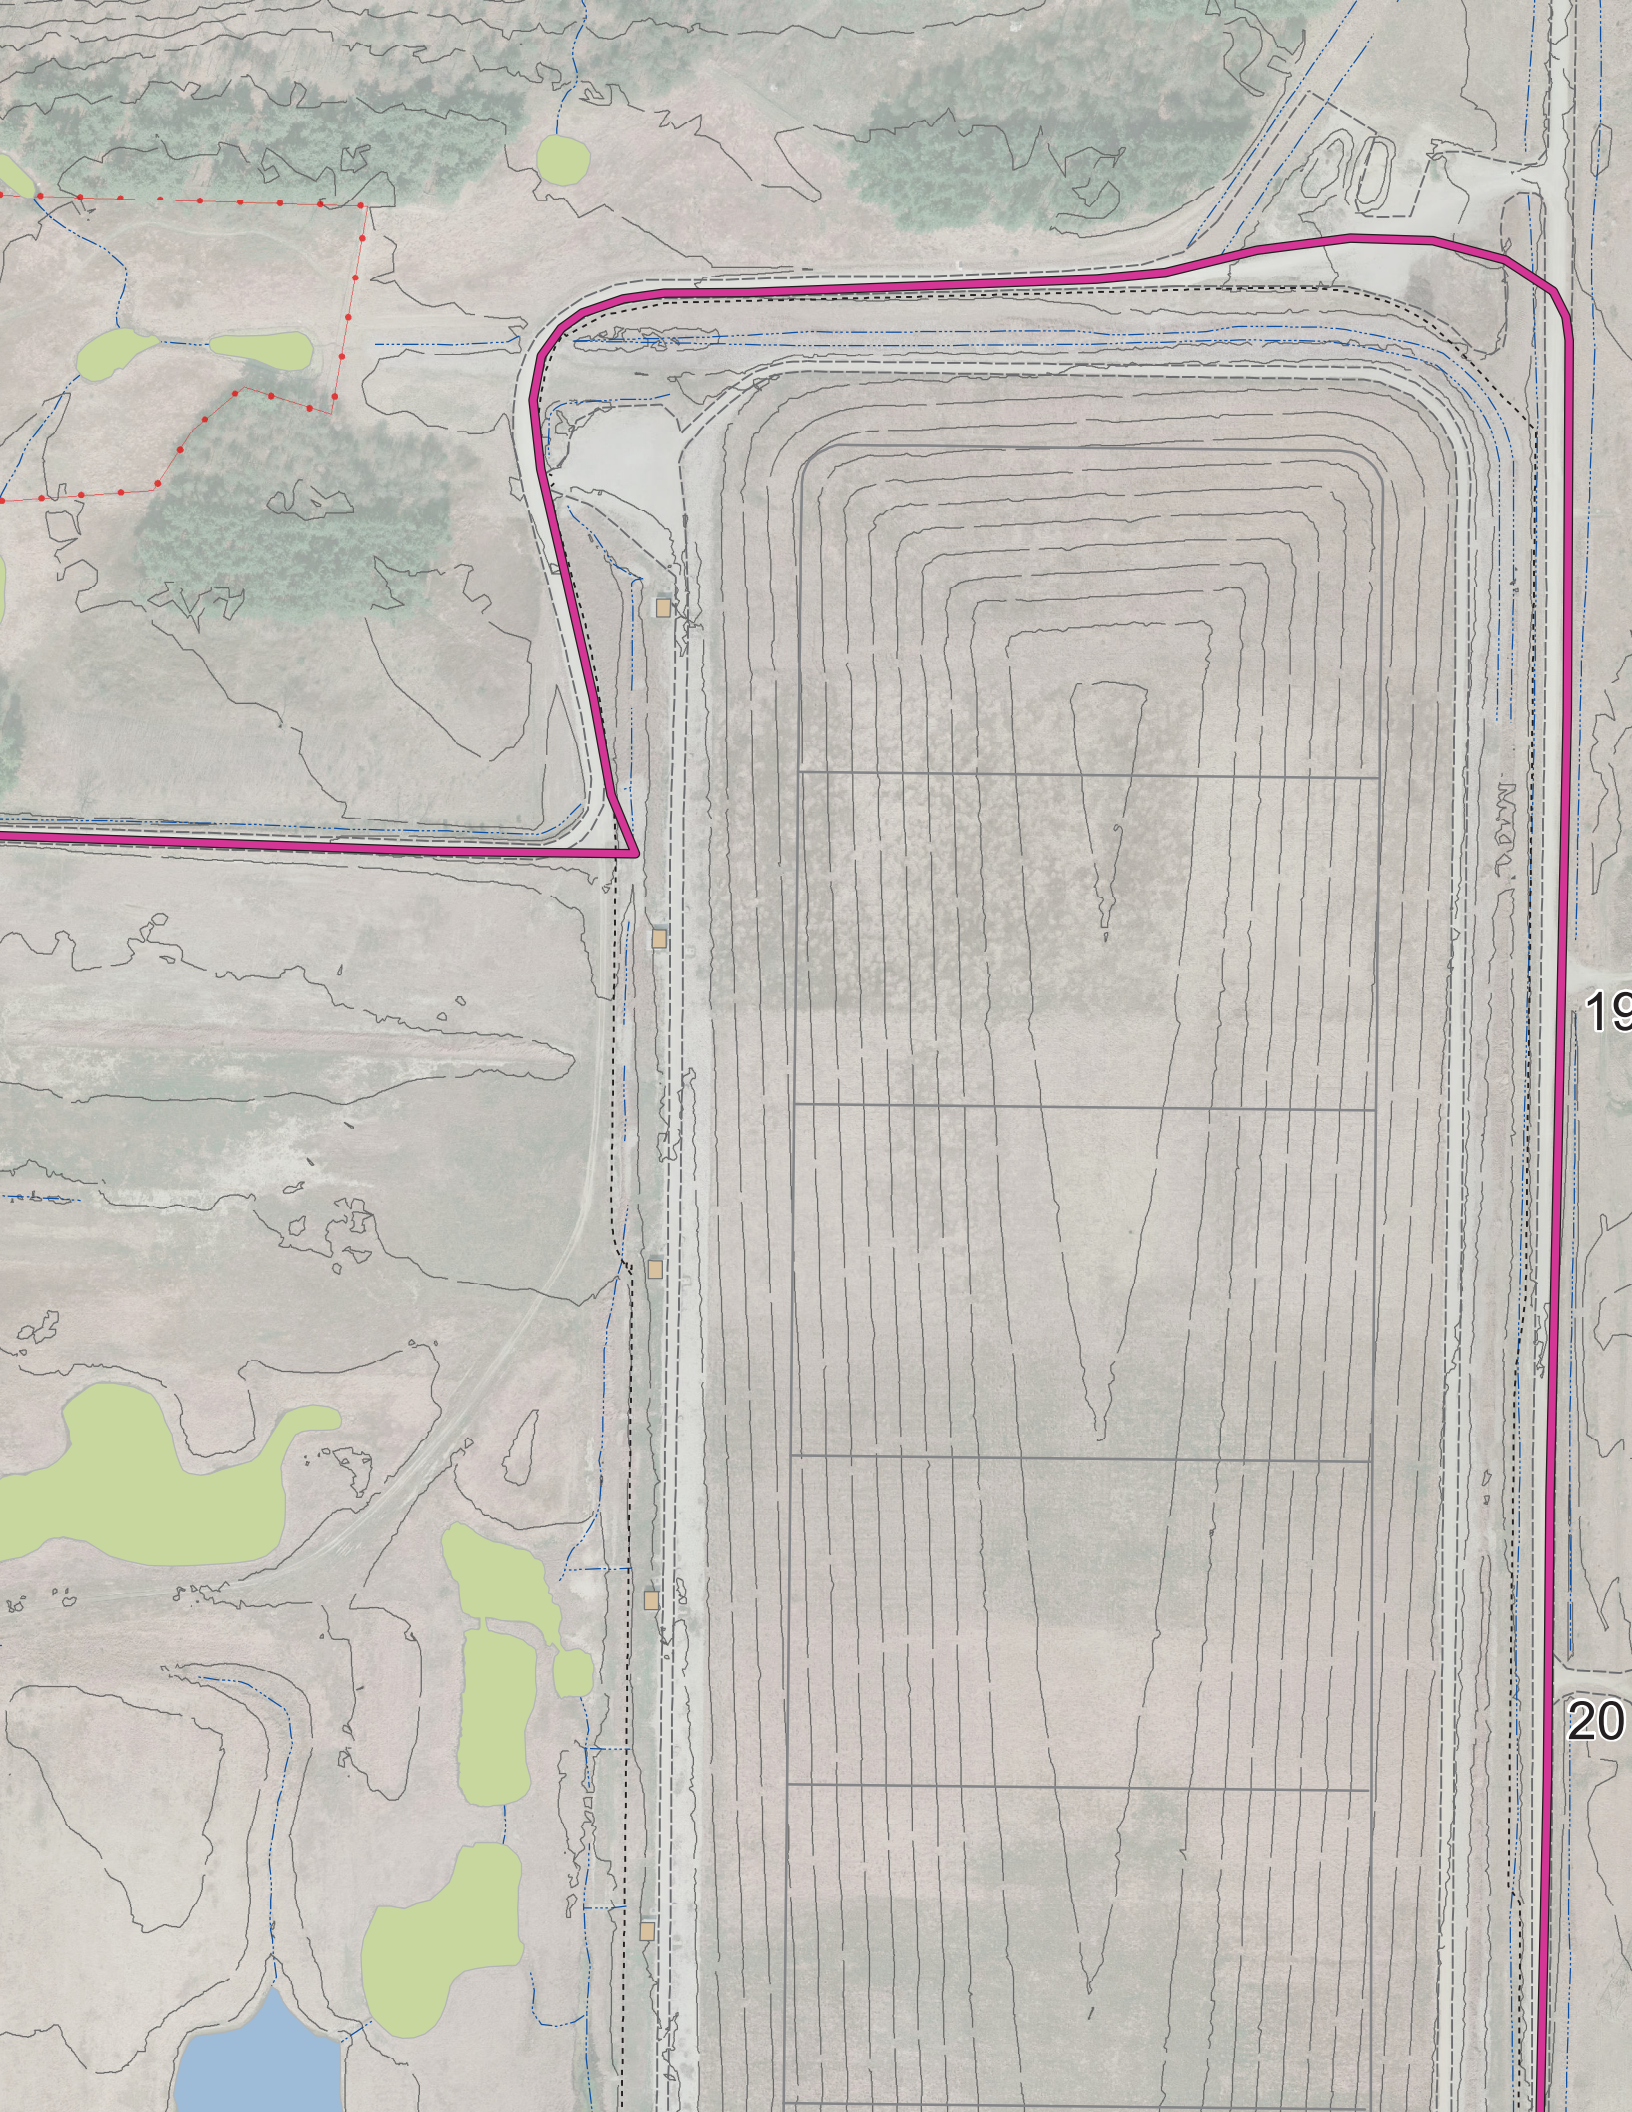
19
20

Type of Finding						Follow Up		
No.	Location (Use Map Whenever Possible)	GPS?	Unauthorized Use	Disturbance	Vegetation	Other	Description	Photo? (File No.)	Corrected	Maintenance Req'd	Cont. Observation
1	East perimeter across from Cell 7	NO			X		Poison ivy				X
2	East of Restoration shed	NO			X		Vines growing up deer fence			X	
3	Hill along SR 126	NO			X		Teasel and honeysuckle			X	
4	East fence WM1	NO			X		Callery pear			X	
5	East fence WM1	NO			X		Honeysuckle			X	
6	East fence WM1	NO			X		Teasel			X	
7	East fence WM1	NO			X		Teasel			X	
8	East fence WM1	NO			X		Callery pear			X	
9	East fence and south	NO			X		Callery pear			X	
10	Hill along SR 126	NO			X		Honeysuckle			X	
11	WM1 W6	NO			X		Teasel			X	
12	WM1 W6 berm	NO			X		Callery pear			X	
13	WM1 W1 berm	NO			X		Dead/dying ash tree			X	
14	Berm between WM1 W1 and WM1 W5	NO			X		Dead ash tree			X	
15	WM1 W2 south berm	NO			X		Dead/dying ash tree			X

16	WM1 W3 south berm	NO			X		Dying ash tree			X	
17	WM1 W4 between pond and swale	NO			X		Honeysuckle			X	
18	WM1 W4 SE edge	NO			X		Dying ash			X	
19	By well south of WM1	NO			X		Callery pear			X	
20	By road pull off	NO			X		Bare area			X
