Literature Review Update and Archaeological Survey of the E G & G Mound Facility and Adjacent Areas, City of Miamisburg Miami Township, Montgomery County, Ohio

ARCHAEOLOGICAL SERVICES CONSULTANTS, INC.
P.O. Box 02095
Columbus, Ohio 43202

E G & G Mound Applied Technologies, Inc.
P.O. Box 3000
Miamisburg, Ohio 45343-3000

April 16, 1991

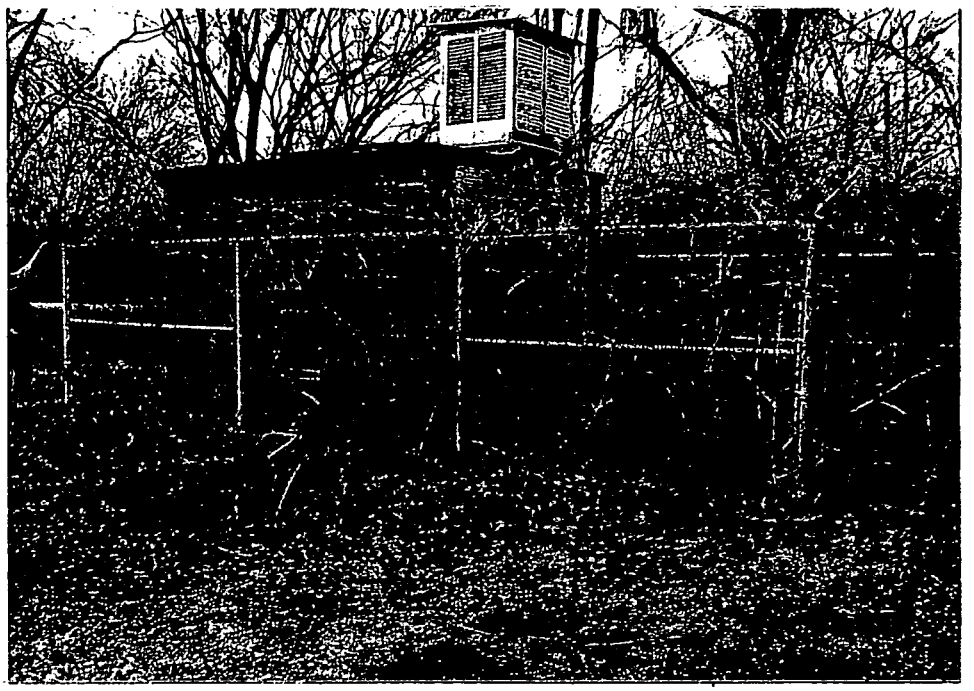
Plate 3. Modern pumphouse, facing southwest.

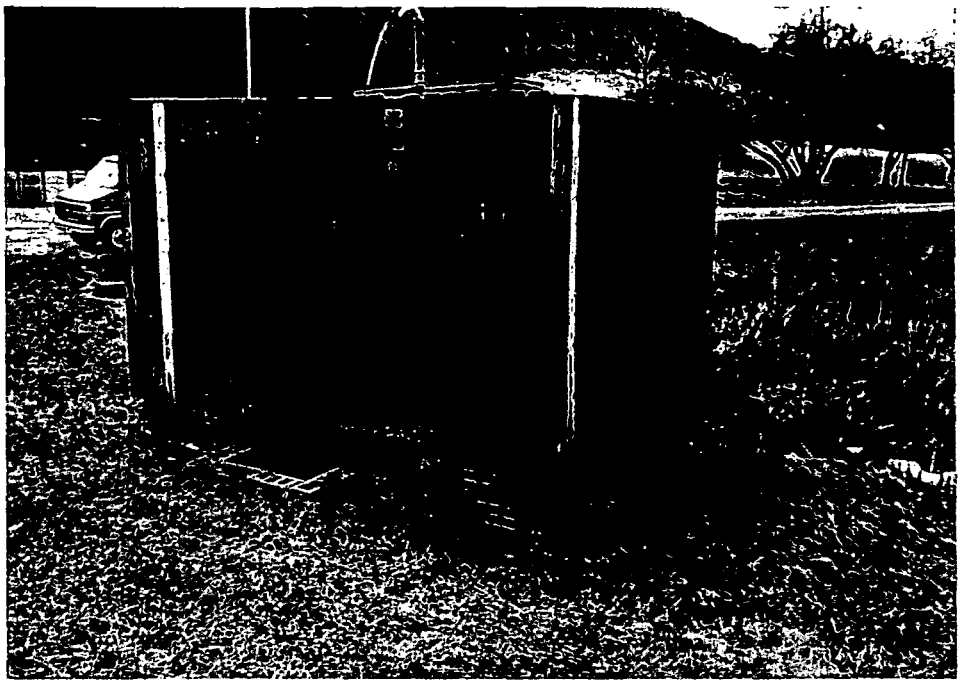
Both focus and visibility are good, resulting in good integrity. No important events, persons, or construction are associated with the site. Also no important information has been recovered nor likely to be recovered. As a result, the site is not eligible for the National Register of Historic Places, and no further work is recommended.

Plate 8. Field Site 4 1935 city water well, facing southeast.
