SUBJECT: **Contract No. DE-AC24-03OH20152:** Deliverable #36 Building Data Package; Section C.2.1.1 Facility Demolition; Buildings 23 and 125 OSC Report, Final

BUILDINGS 23 AND 125 REMOVAL ACTION

OSC REPORT

Buildings 23 and 125 (ATS), and PRS 160

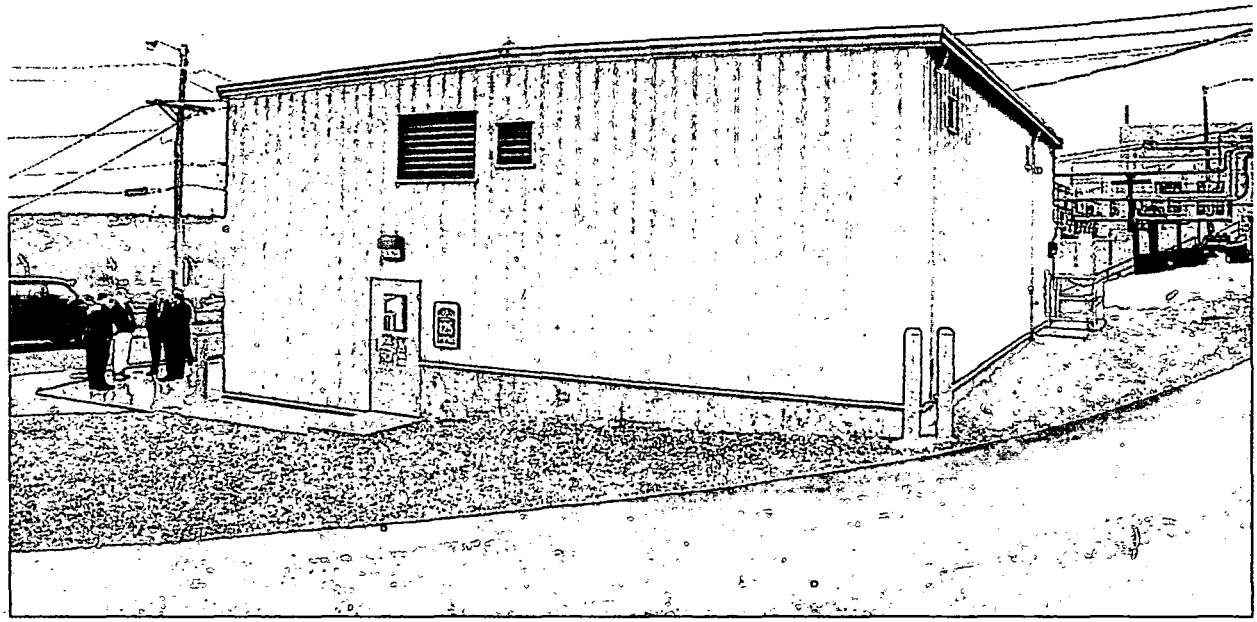
Photograph 1: Building 125 Prior to Demolition

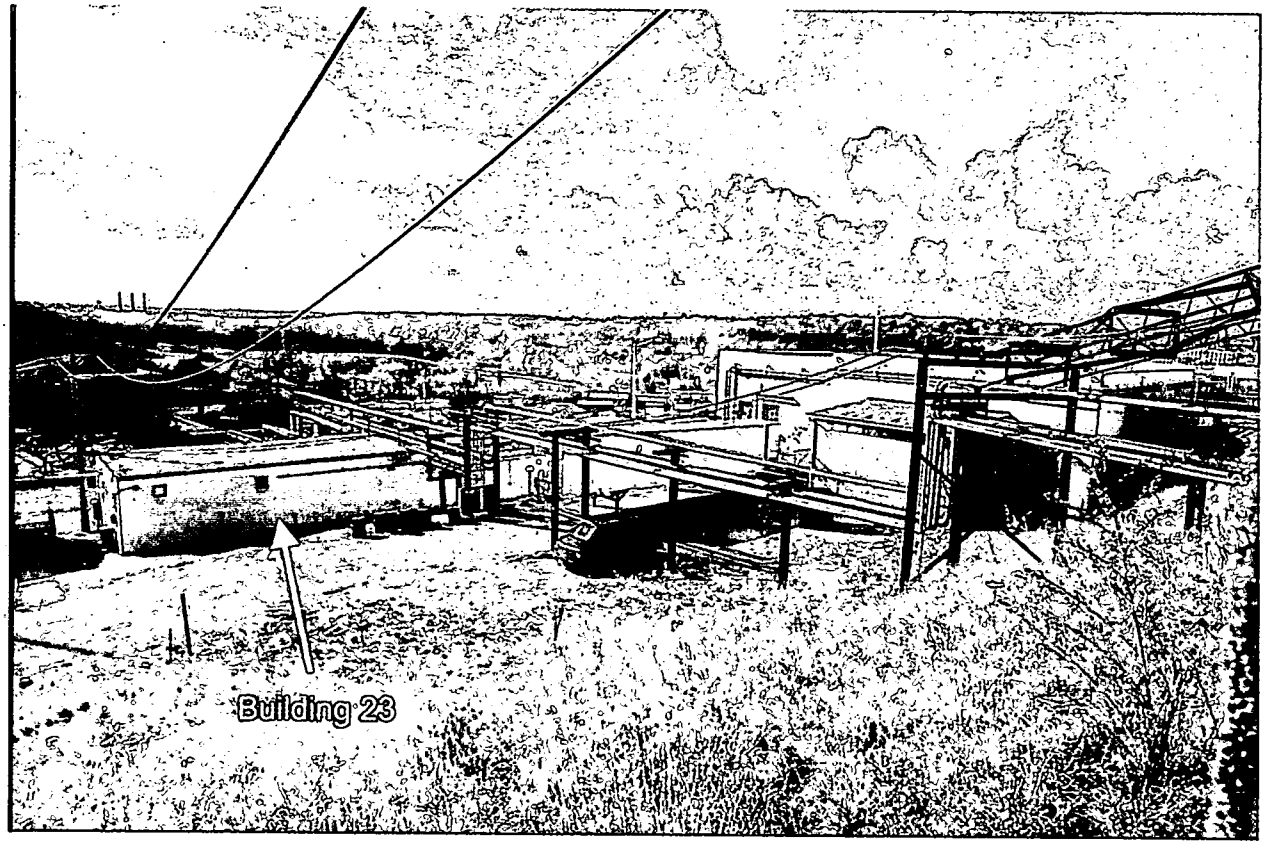
Photograph 2: Building 23 Prior to Demolition
