SUBJECT: Contract No. DE-AC24-03OH20152
Statement of Work Requirement 055 - Regulator Reports
BUILDING 22, BUILDING DATA PACKAGE, PUBLIC REVIEW DRAFT

Miamisburg Closure Project
Building Data Package

Building 22

Public Review Draft
October 2004

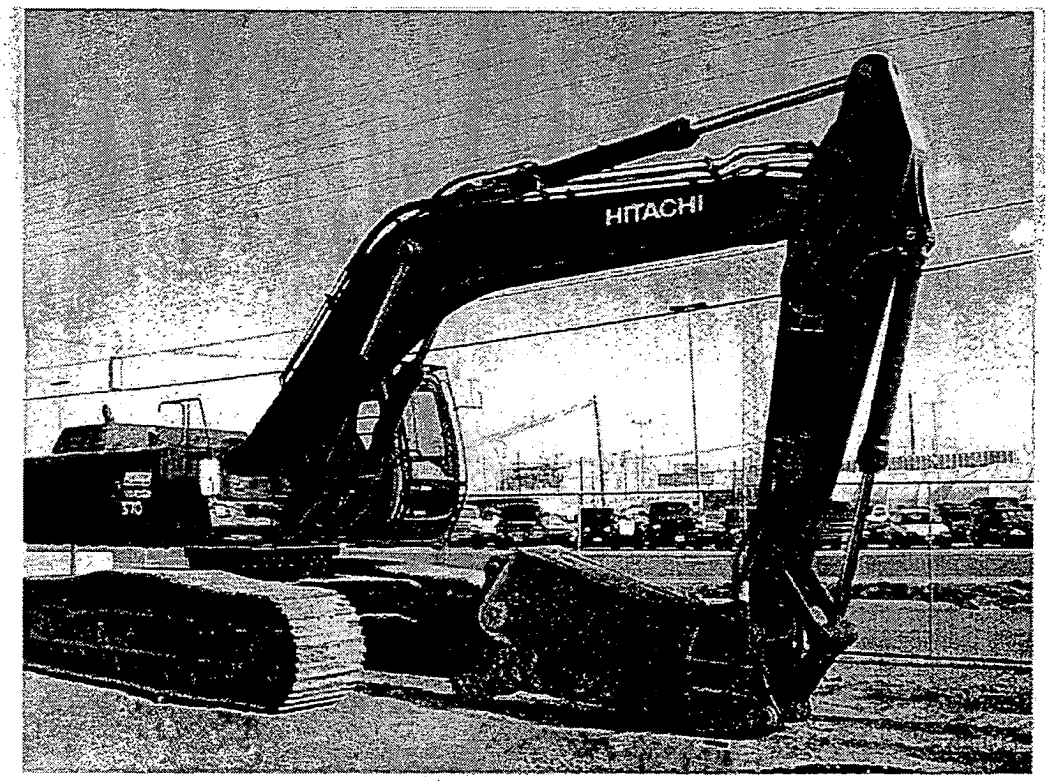
The equipment operator was moving the excavator to position it out of the work area by extending the boom to assist in turning (see Figure 1). During one of these maneuvers, the boom contacted the power line, which was approximately 23 feet above the ground. A spotter was not used because the excavator was not expected to operate near the overhead lines.

Figure 1. Excavator with boom positioned on the ground
