MOUND PLANT
Building Data Package
Building 100
Located within Release Block D

BDP 100

Mound Plant Recommendation
Building 100

BUILDING DATA PACKAGE (BDP)

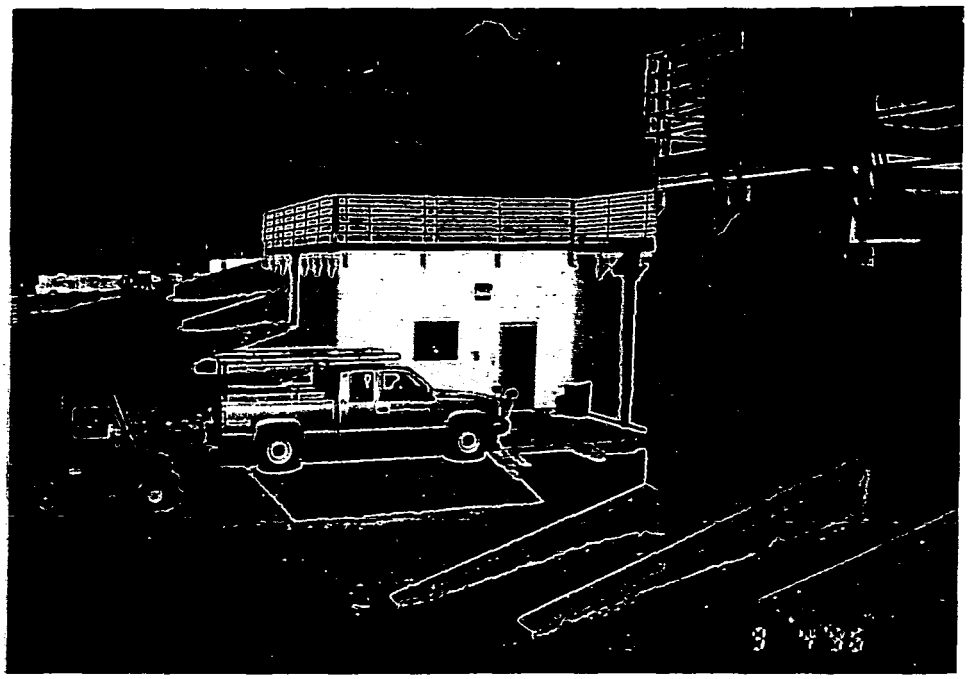
PHOTO 1:

SOUTH ELEVATION OF
BUILDING 100

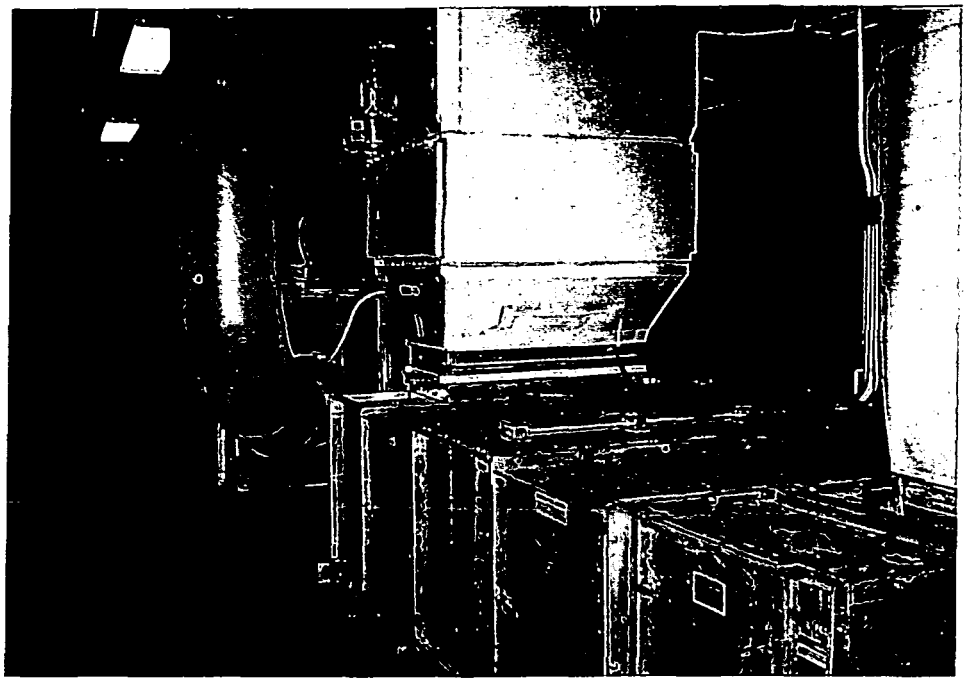
PHOTO 3:

Unlike most of the other buildings at Mound, Building 100 has a self-contained 10 ton air to air heat pump and air handler system (photo 3). As this building served as one of the security precincts, it was determined that uninterrupted HVAC and power was a priority. Room #117 was formerly known as the "Generator Room" and contained a diesel generator which was to be used in the event of commercial power interruption to the site. This generator was not on-site during the site inspection performed on April 9, 1996. No signs of fluid leakage were noted on the floor of Room #117.

AIR HANDLING EQUIPMENT
IN MECHANICAL ROOM
(#119)

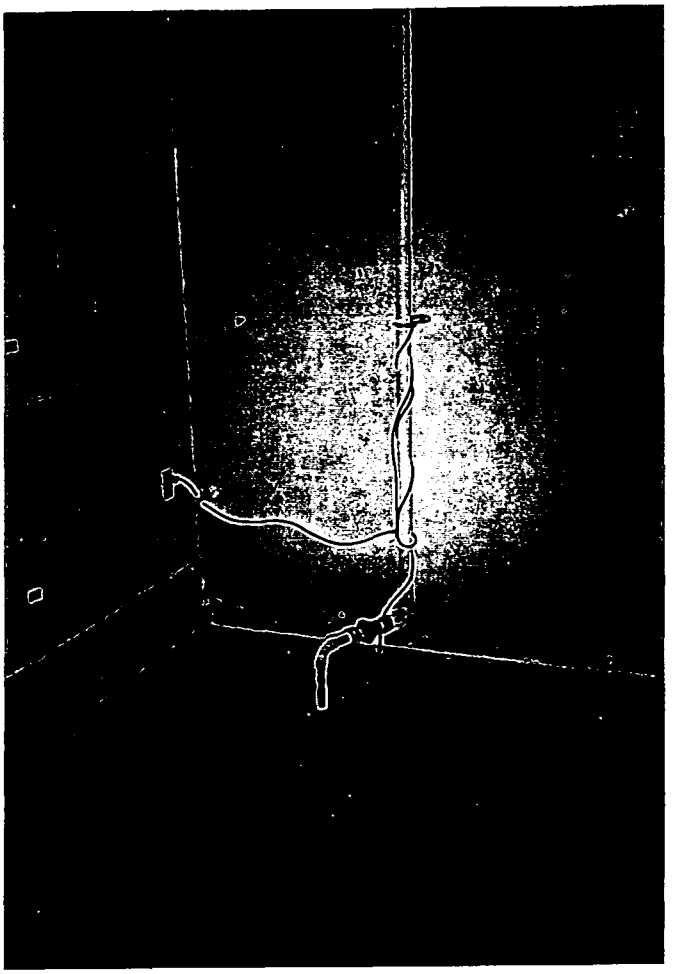
PHOTO 4:

There was no evidence of septic systems (such as leaching field or septic tank vent pipes) in the vicinity of Building 100. Building prints show a sewage ejector station to the west of the building (photo 4). This station is necessary as the elevation of this area is below the Mound sanitary sewer line.

There are approximately twenty 2,000 gallon water tanks located to the west of this site (photo 4). These tanks contain purge water and well water from Mound Operations. The Building 100 Technical Review, indicates that:

SEWAGE LIFT STATION
WEST OF BUILDING 100

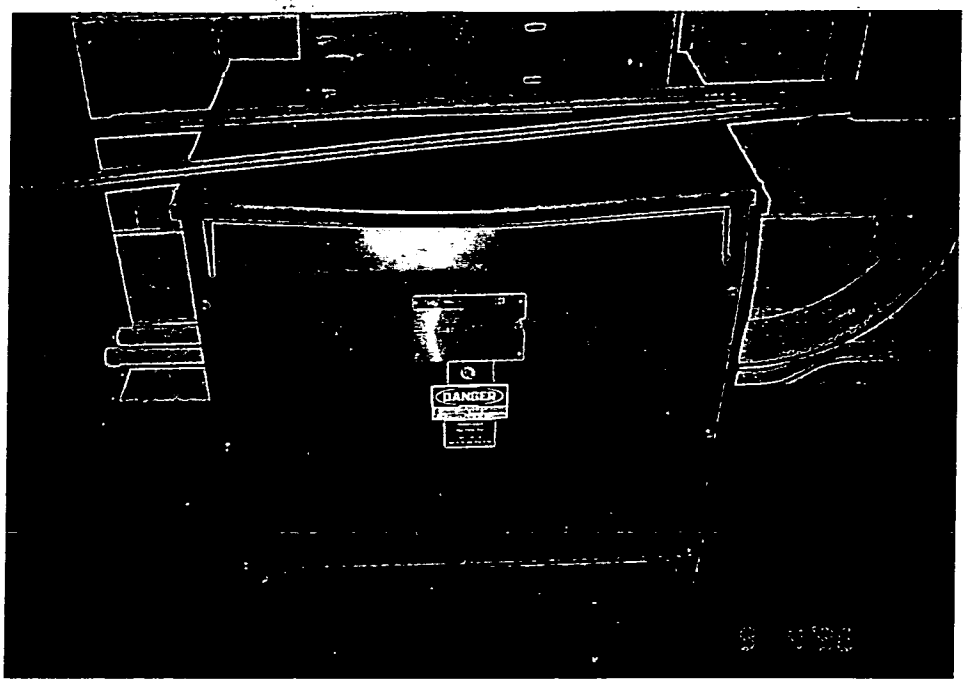
PHOTO 8:

There was no evidence of underground storage tanks at this site. One four inch PVC pipe stub was noted at the southeast corner of the building (photo 8). Based on a review of building prints, this is a cleanout for a storm sewer line.

PVC PIPE AT SOUTHEAST CORNER
OF BUILDING 100 (CLEANOUT)

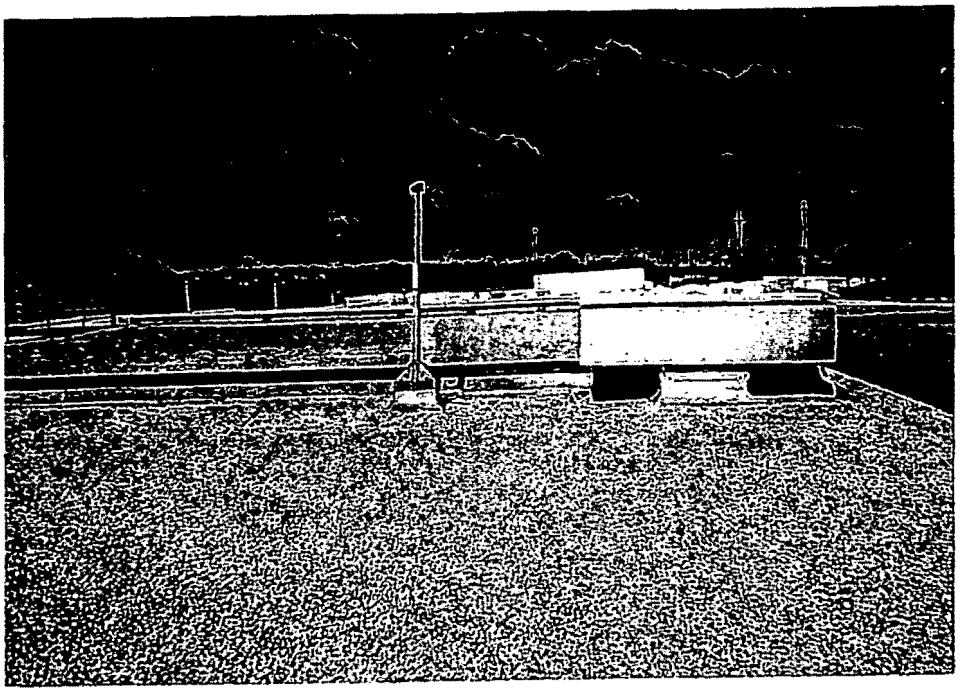
PHOTO 9:

VENT FROM FORMER
COMPRESSOR ROOM

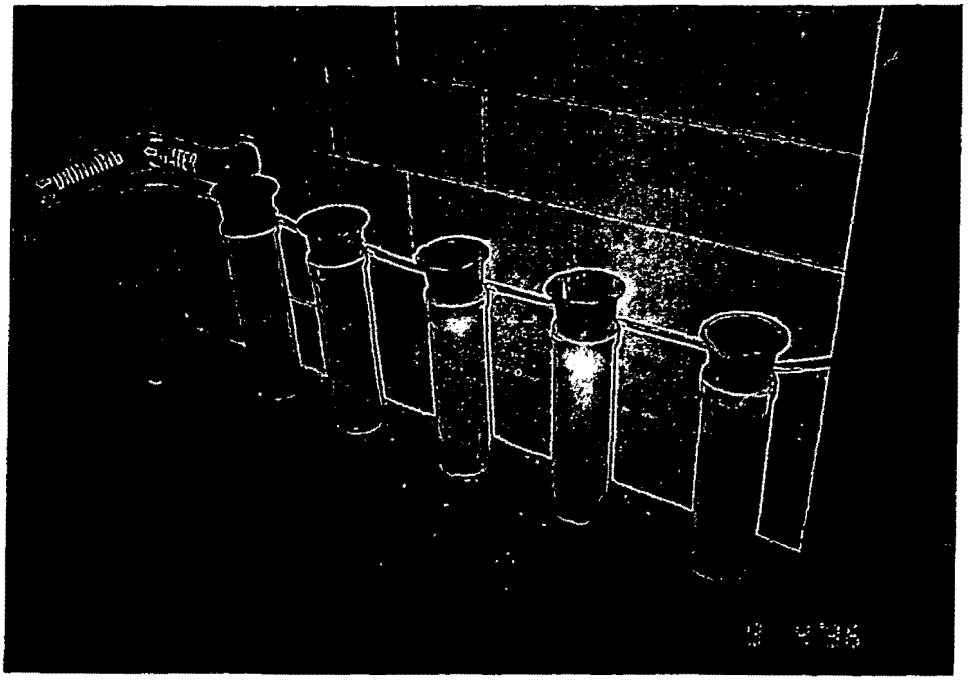
PHOTO 10:

CONDUITS IN
MECHANICAL ROOM
#119
