Miamisburg Closure Project
LEASING DATA PACKAGE
Resubmittal

Mound Sanitary Sewer System

Final Edited Submittal January 2005

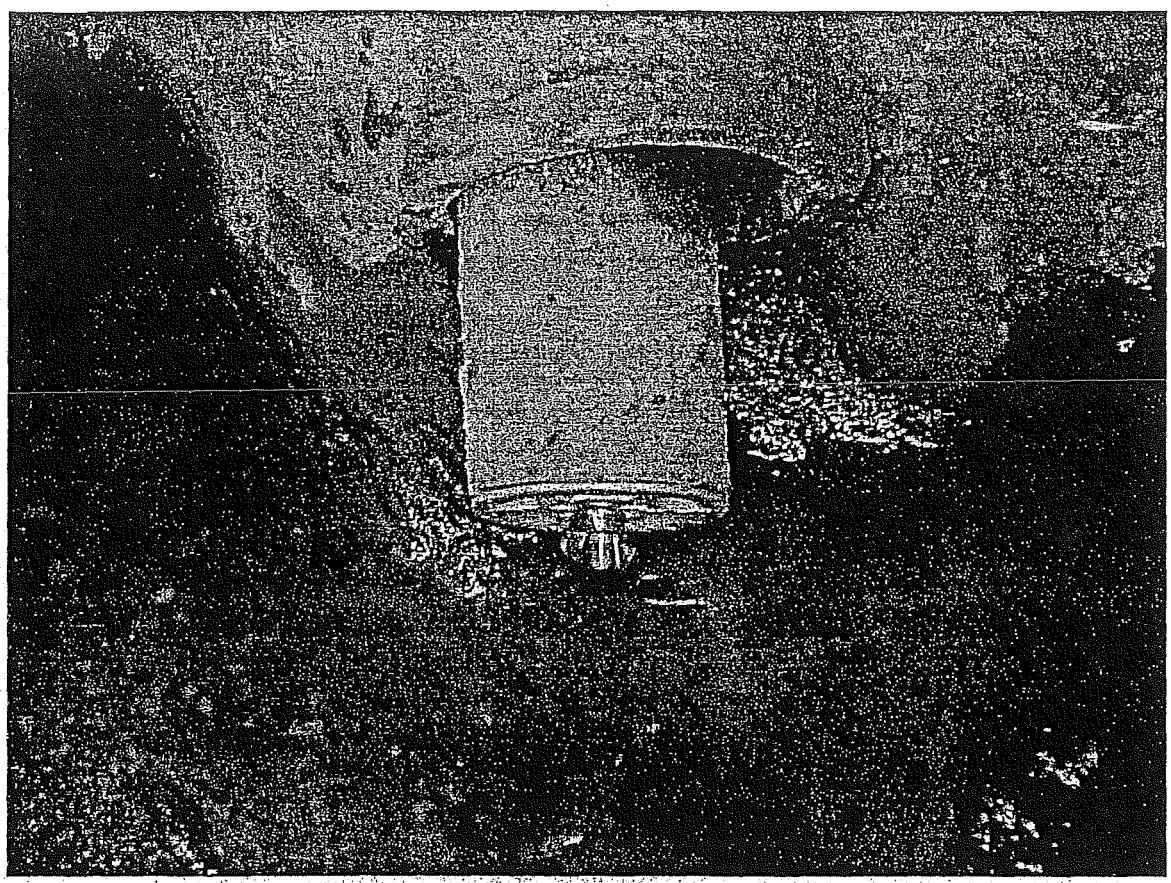
Figure 2: 6 inch san. Plug at building 40
