MOUND PLANT
Building Data Package
Building 2

Final, Rev. 1
June 2002

BDP Building 2: EM Test Facility

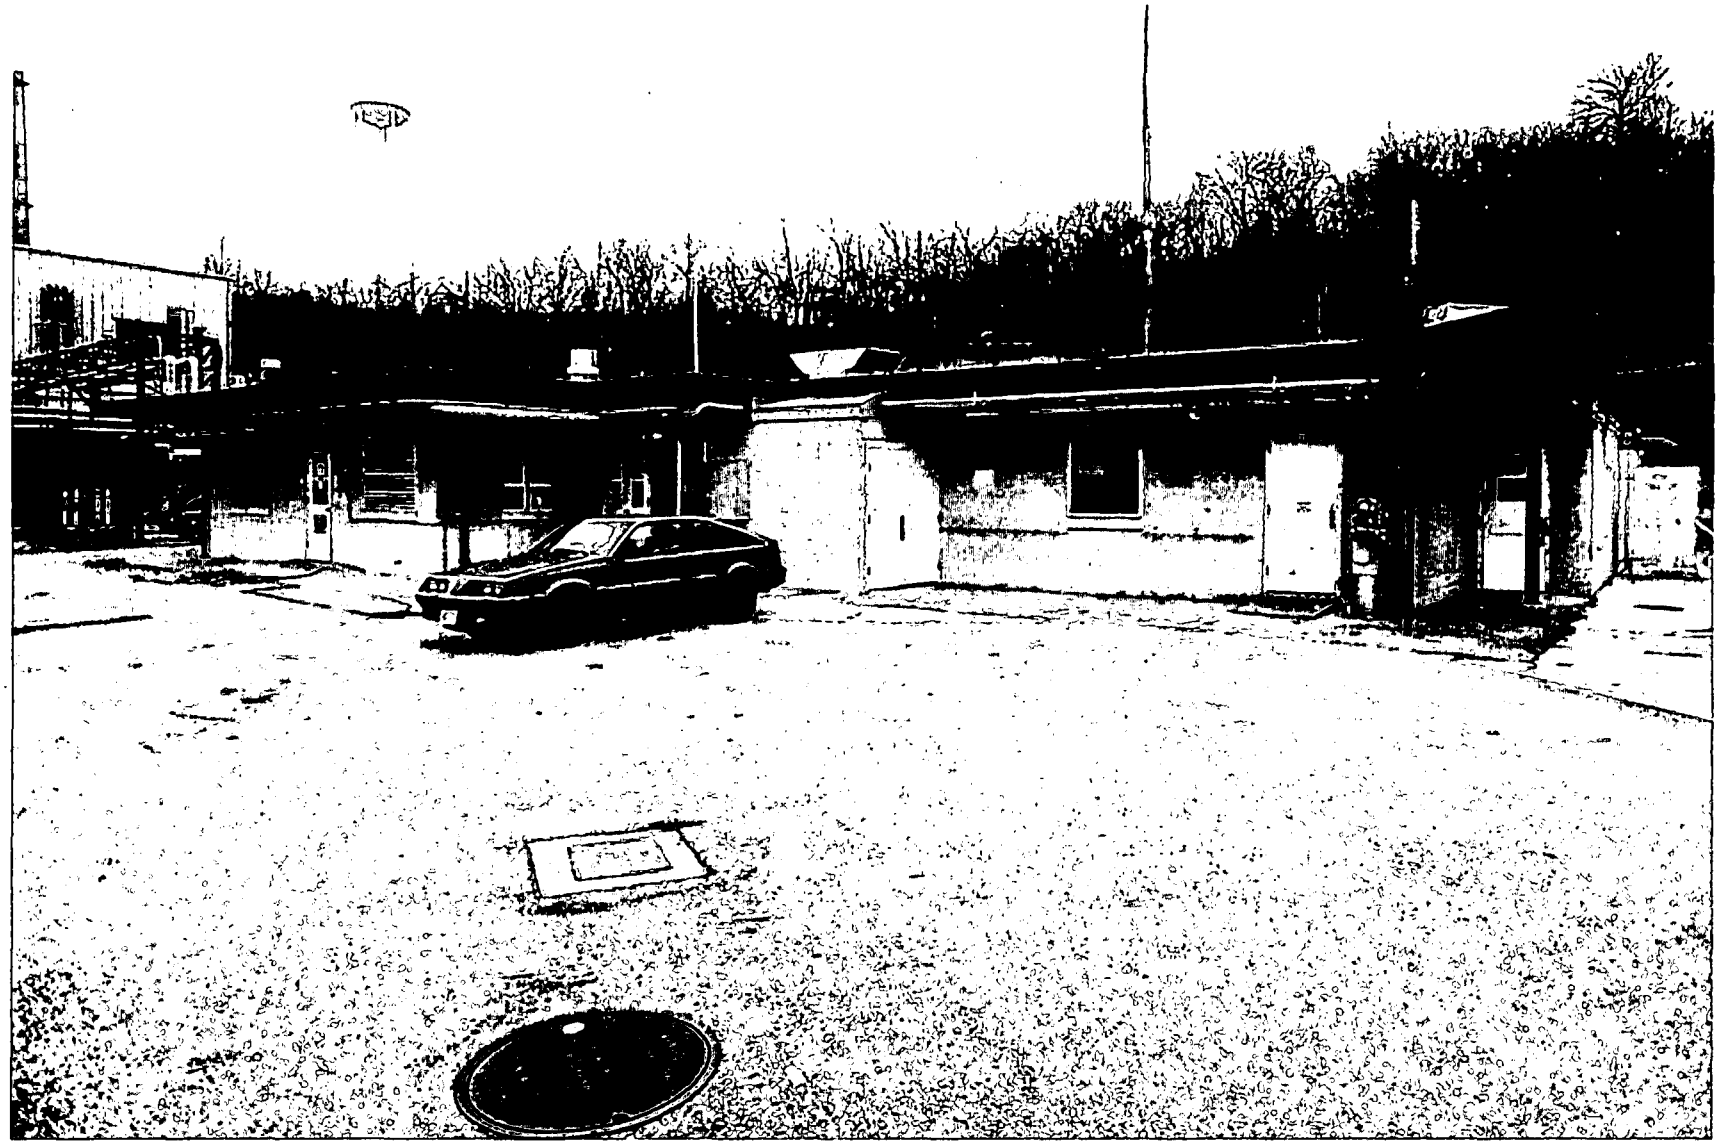
FIGURE 3 :Photo of Building 2

03/06/96 Bldg. 2 *960654

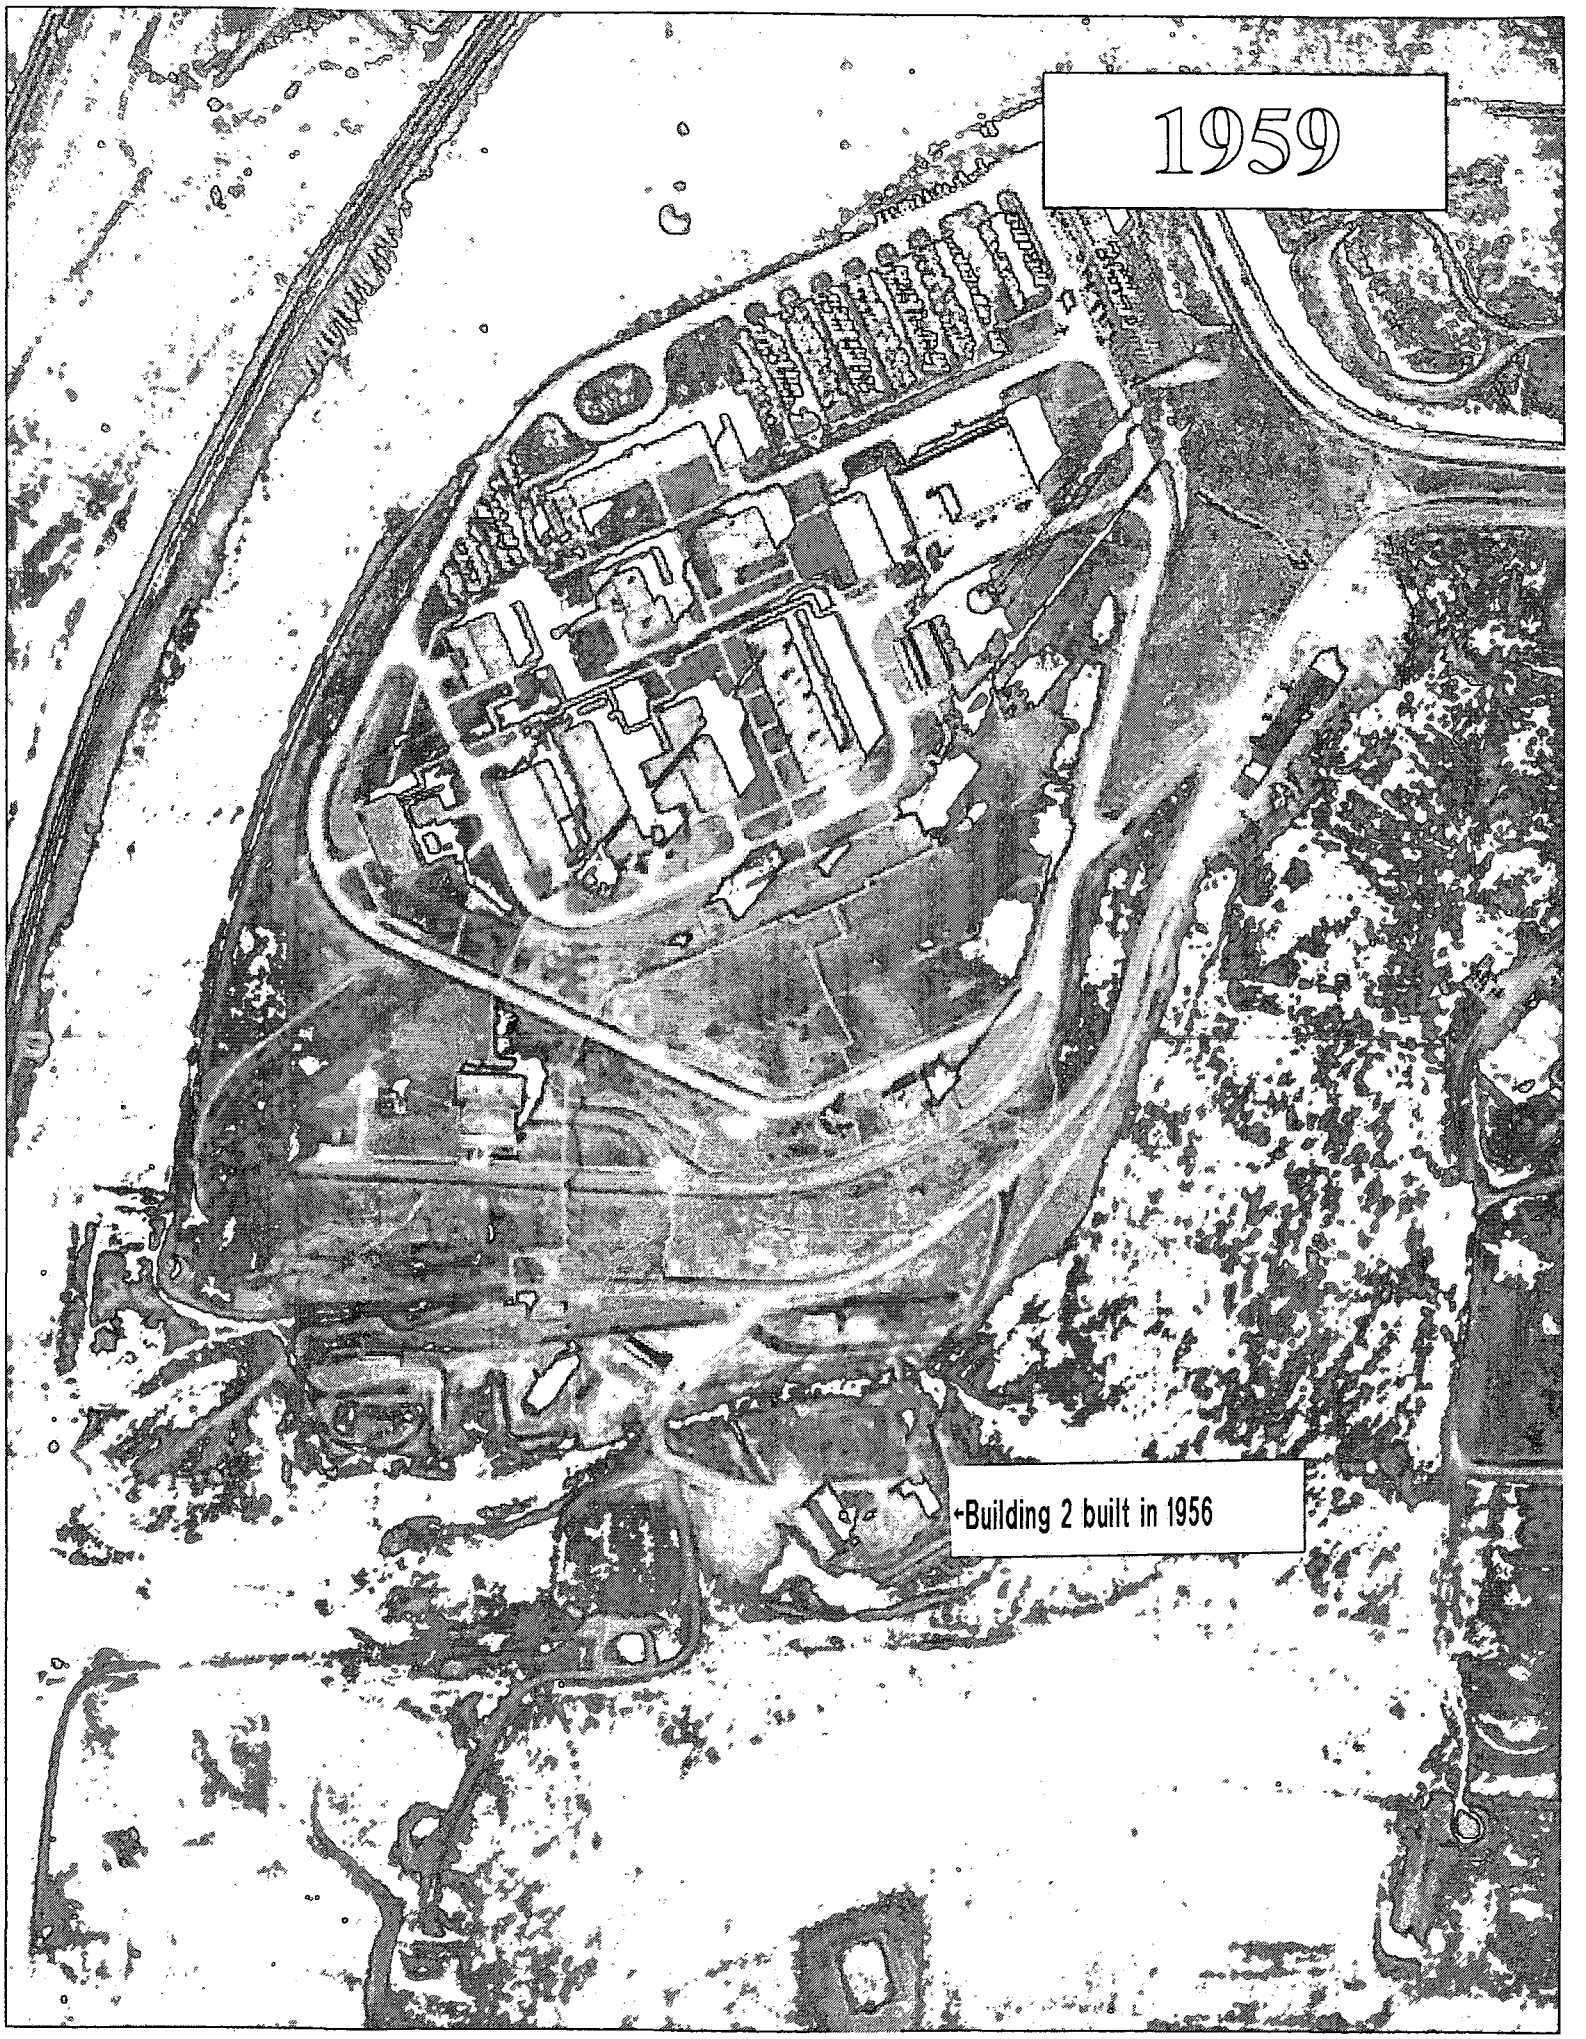
1959
←Building 2 built in 1956

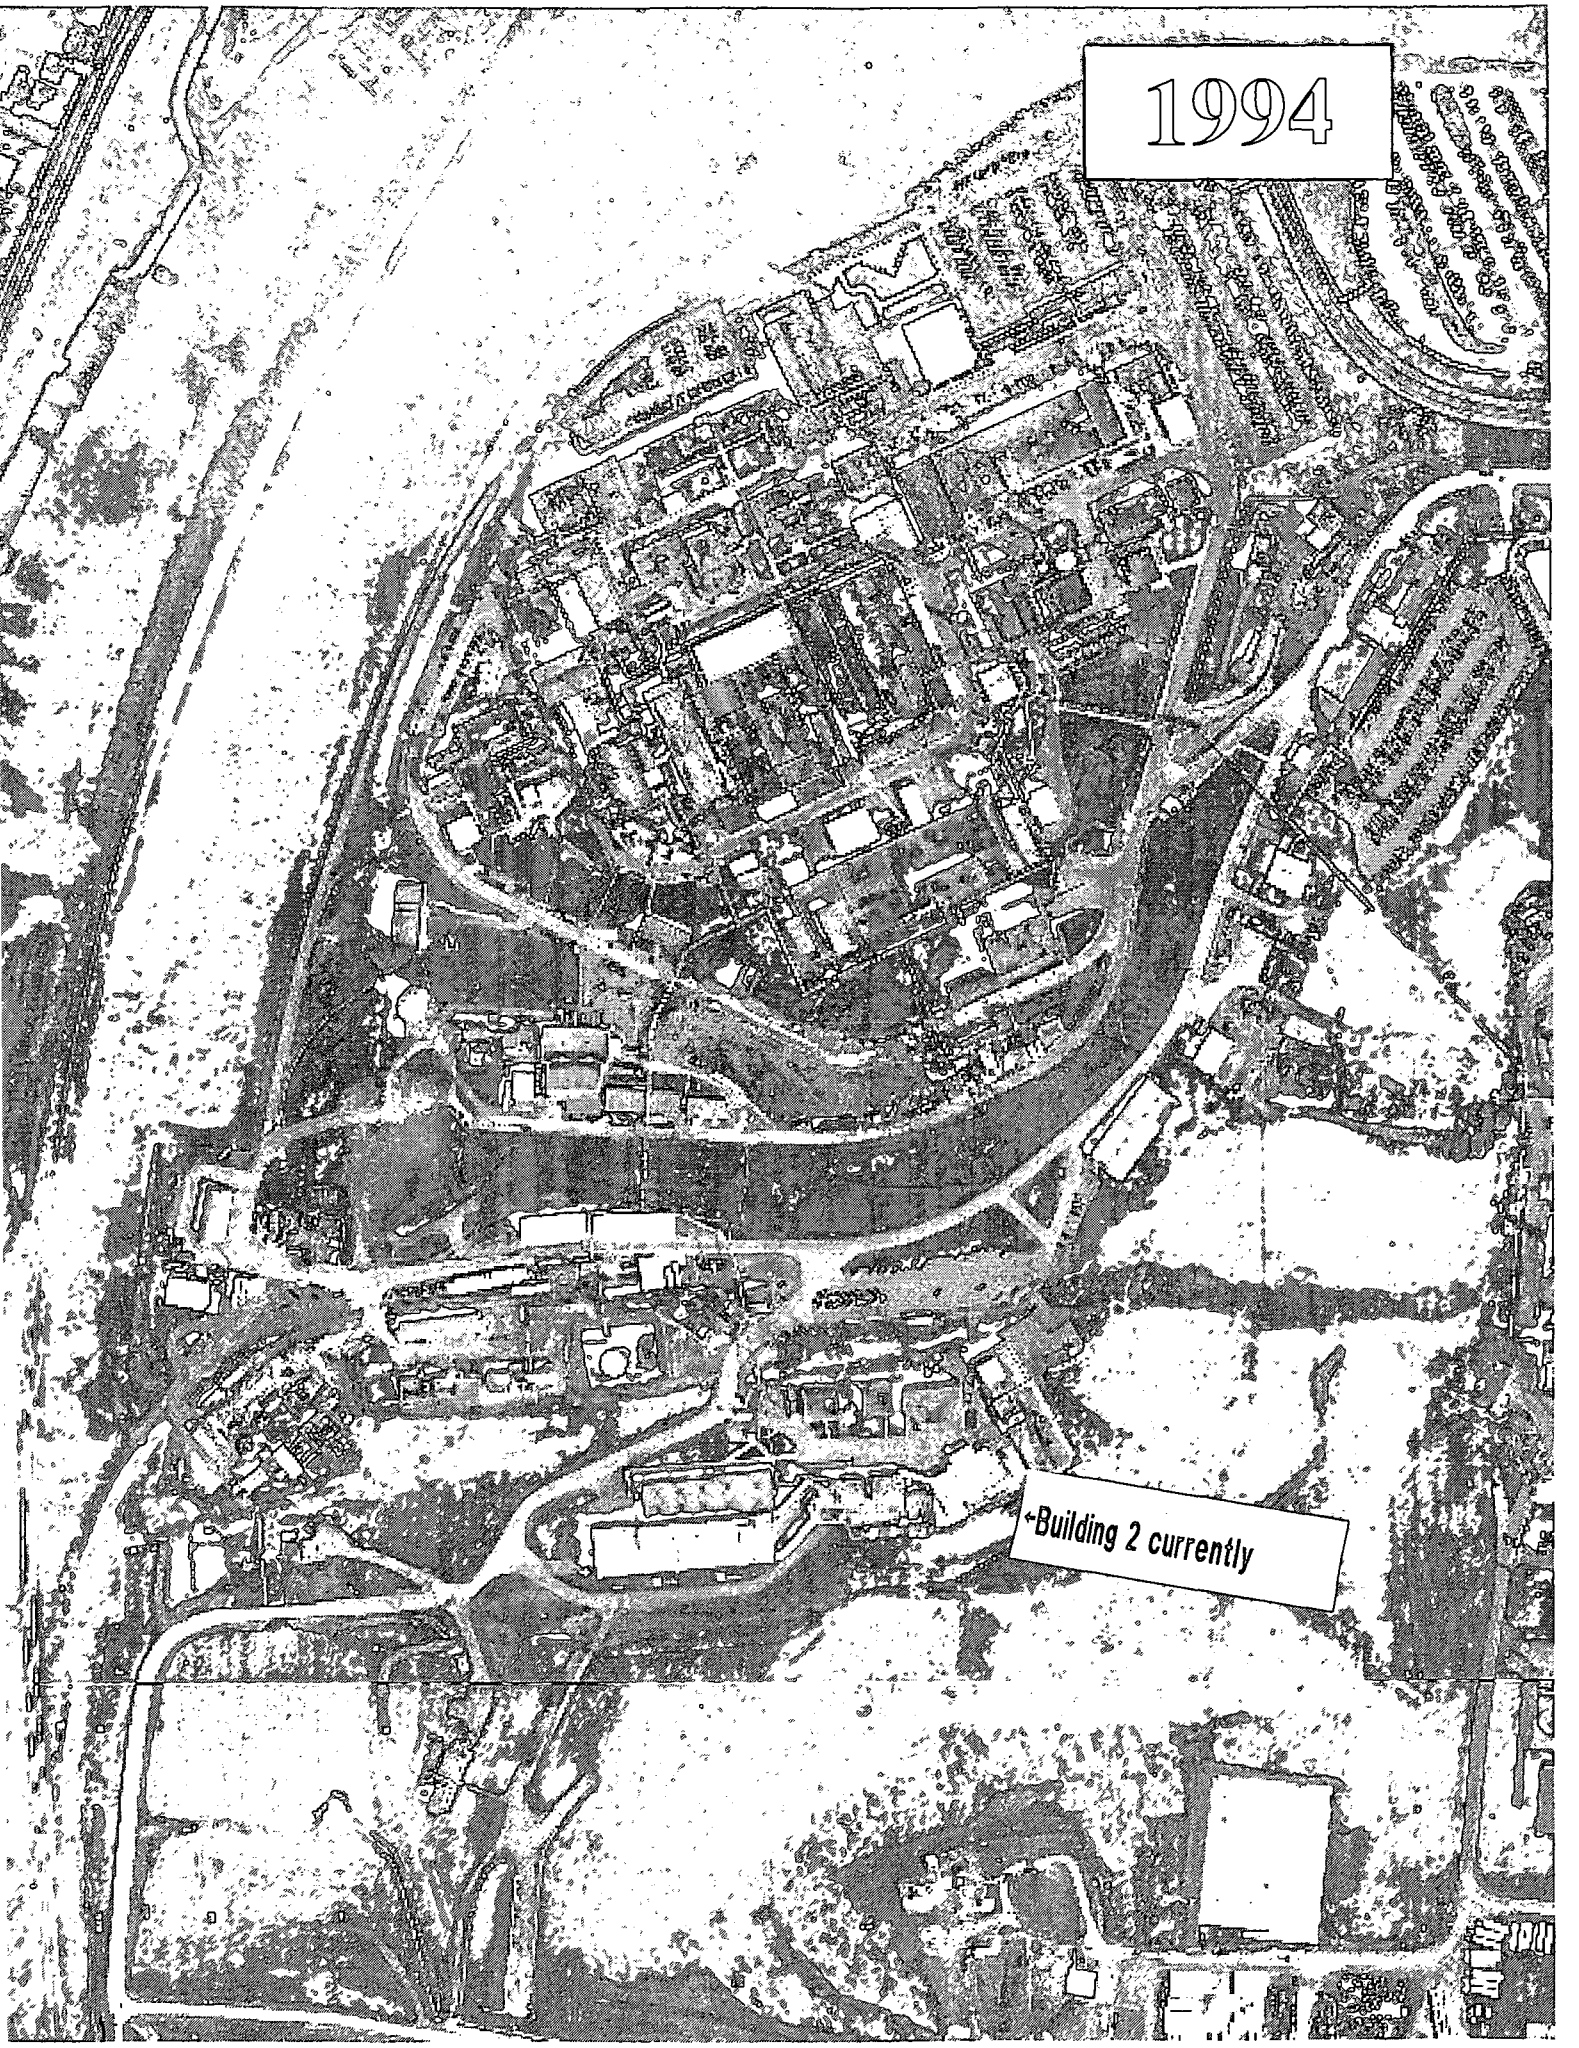
1994
←Building 2 currently
