SUBJECT: Contract No. DE-AC24-97OH20044
BUILDING 42, BUILDING DATA PACKAGE, PUBLIC REVIEW DRAFT

MOUND PLANT
Building Data Package
Building 42

Public Review Draft
May 2002

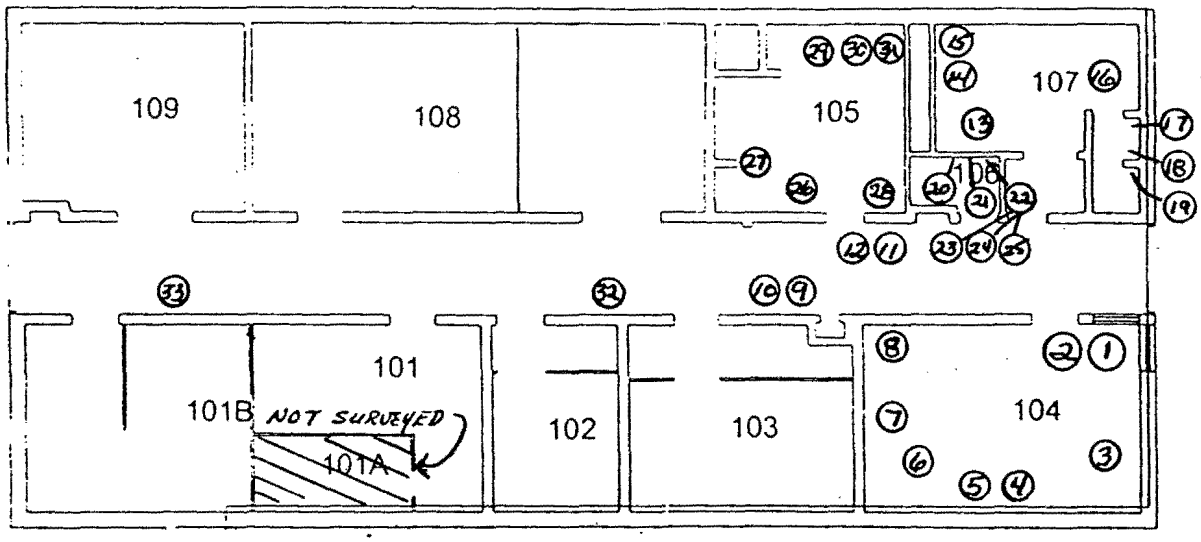
NOTE: Rm. 101A not surveyed per L. Lamsa (Engr.) ... concerns by safety of explosive dusts potential.

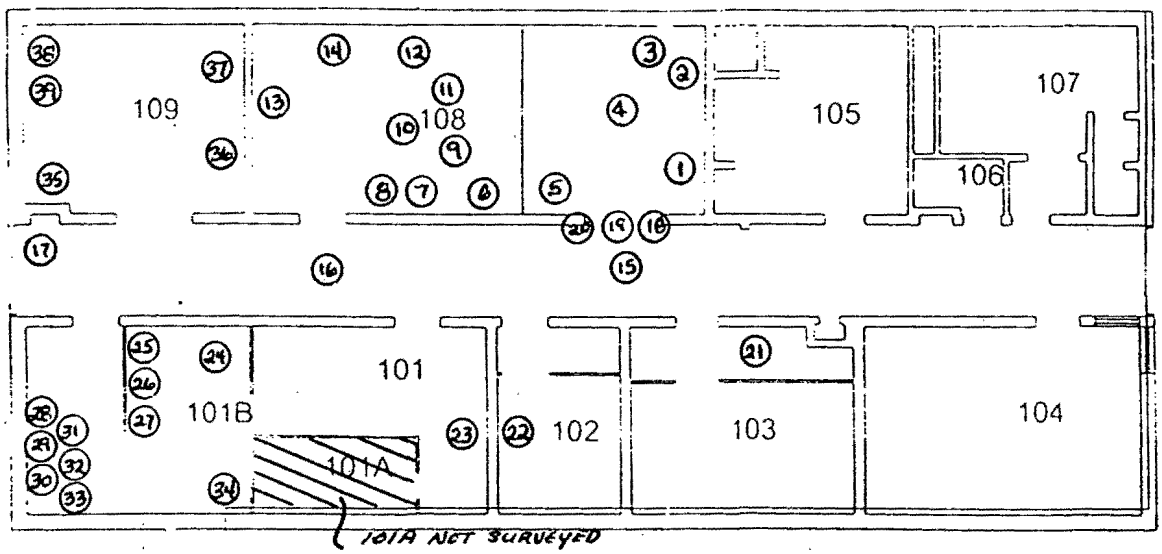
LOCATION: (BLDG./AREA/ROOM) BLDG. 42	SURVEY NO. 00-TF-395
PURPOSE: Pre-work conditions I.H. to sample for asbestos	RWP NO. N/A
	DATE: 11-08-00
	TIME: 1545

No Radiological Postings
BLDG. 42

Direct Scan of Smear Locations:
< 5000 dpm/100cm² β⁻
< 100 dpm/100cm² α

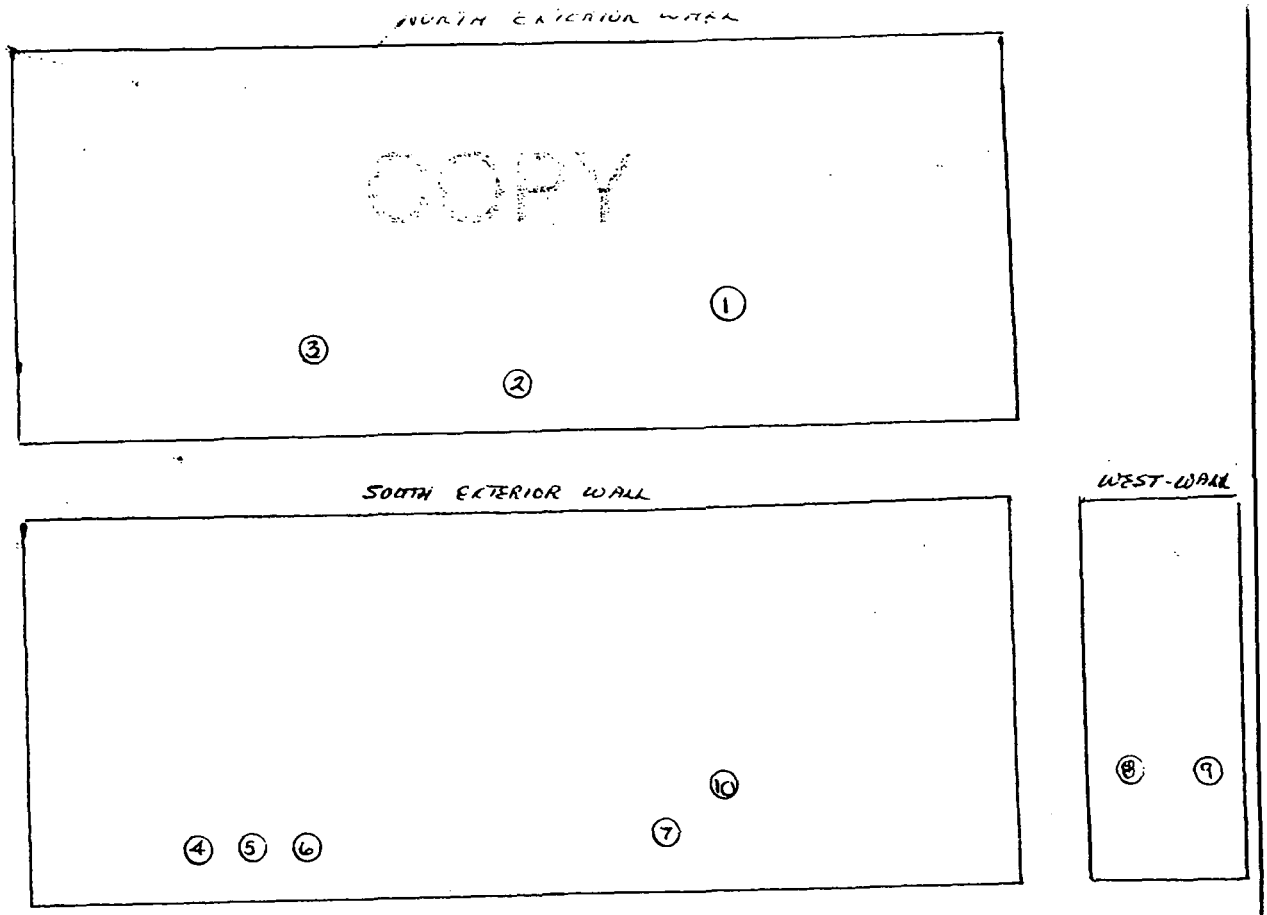
LOCATION: (BLDG./AREA/ROOM) 42 - Exterior Walls	SURVEY NO. 00-TF-403
PURPOSE: Prework Survey Asbestos Sampling	RWP NO. N/A
	DATE: 11-15-00
	TIME: 1445

Direct Scan of Smear Locations
<5000 dpm/100cm² β⁻ ; <100 dpm/100cm² α

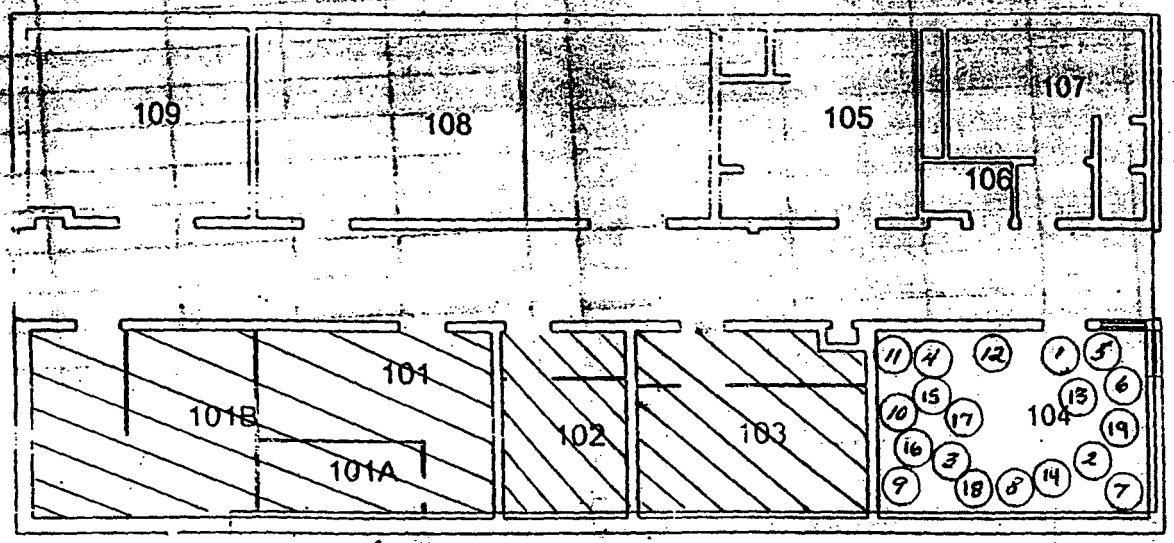
Rms. 101 ~ 101A ~ 101B ~ 102 ~ 103 not surveyed at this time. Floor covered w/ water and ice.

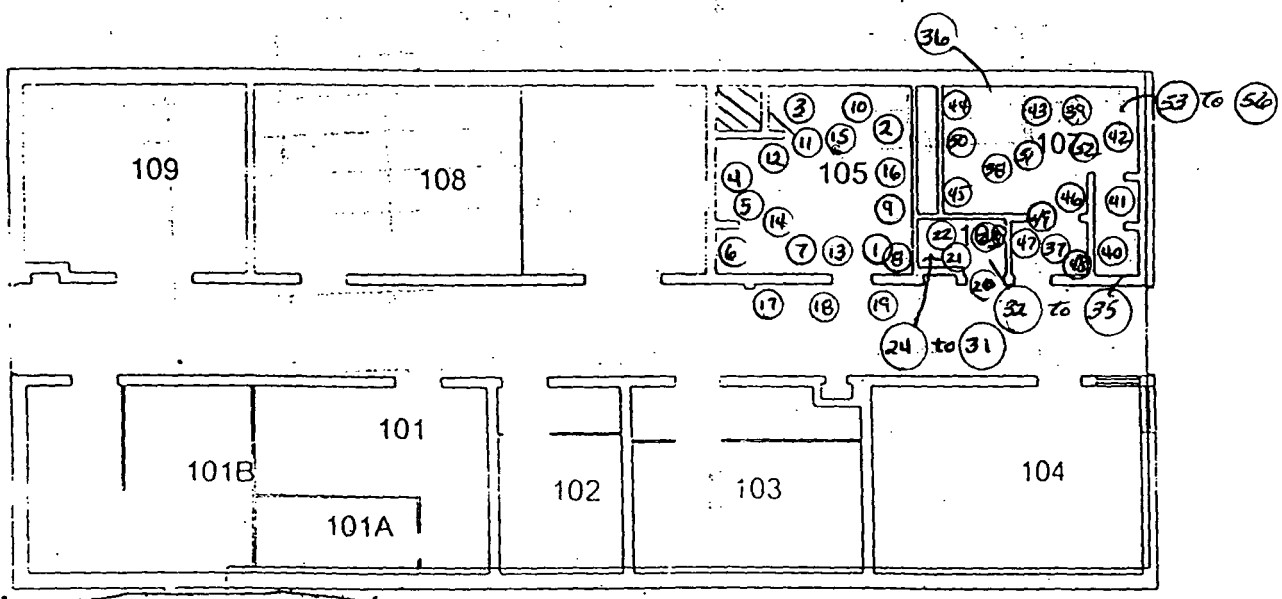
Smears Nos. 32, 33, 34, 35 not included in this survey, area is Non-Permit Req'd. Confined Space; entry requires o/s attendant from I.H. not available at time of this survey.

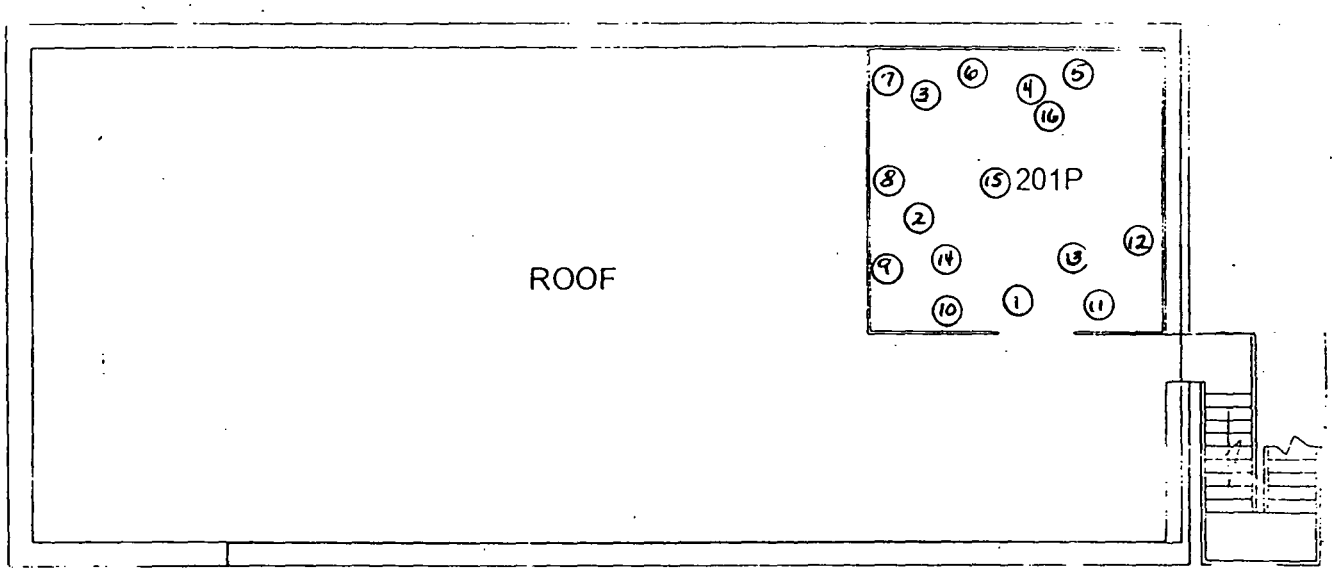
LOCATION: (BLDG/AREA/ROOM) 42 ~ Roof & Penthouse	SURVEY NO. 00-TF-411
PURPOSE: BIN BLDG Verification Survey	RWP NO. N/A
	DATE: 11-28-00
	TIME: 1530

Bldg. not Posted.

Direct Scan of Smear locations
ALL <5000 dpm/100cm² β⁻
<100 dpm/100cm² α

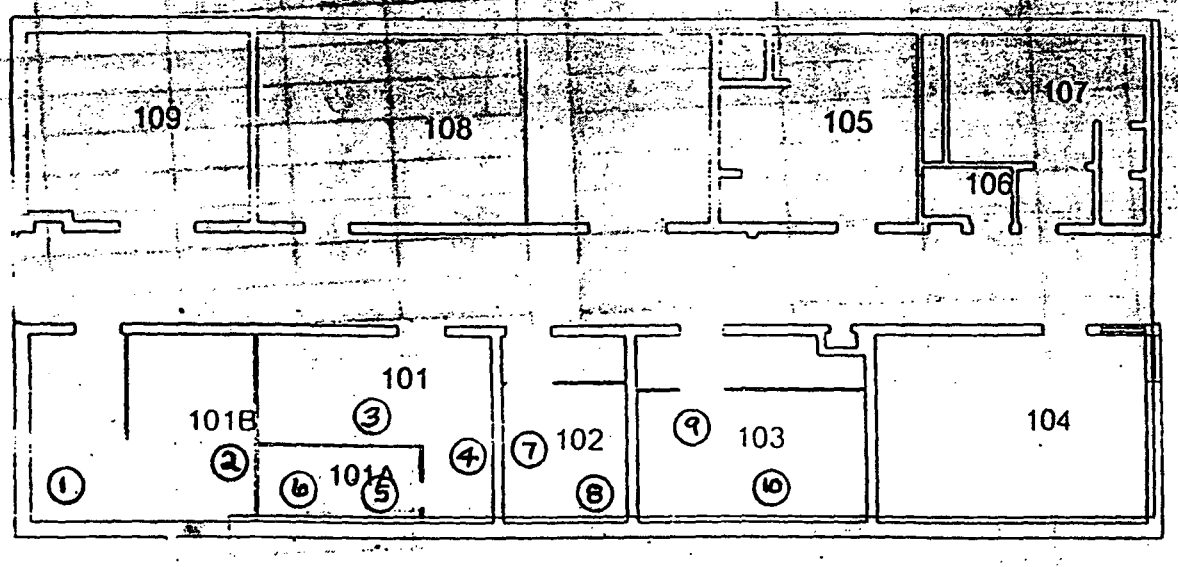
LOCATION: (BLDG/AREA/ROOM) [illegible]	SURVEY NO. [illegible]
PURPOSE: BIN VERIFICATION Liquid samples taken from floor [illegible]	RWP NO. N/A
	DATE: [illegible]
	TIME: 1300

(#) denotes location of water samples submitted to Envir. Lab.

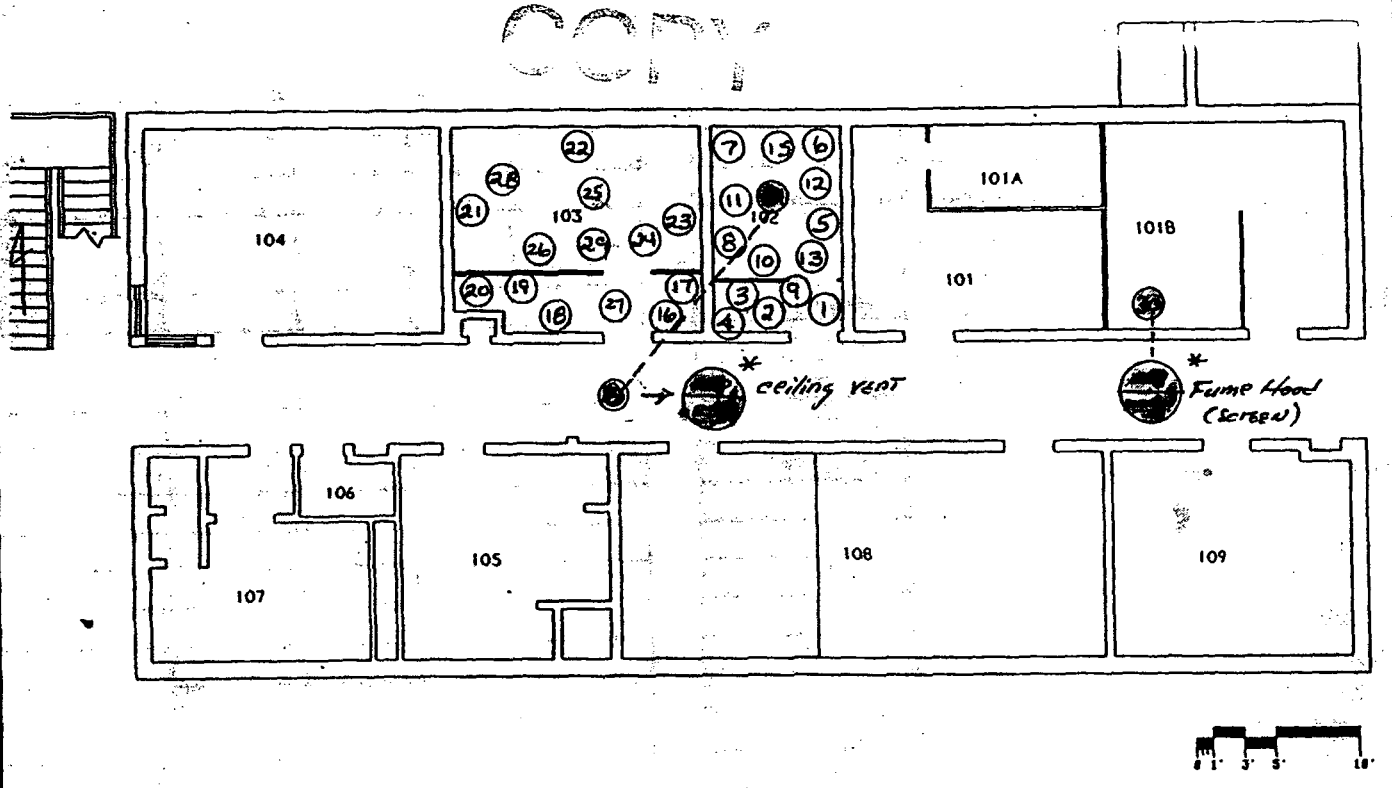
* Late Entry 12/20/00 - HP 7787
Fume Hood & Ceiling Vent re-survey RSDS 00-TF-443
12/20/00: <100 dpm/100cm² α
<5000 dpm/100cm² β-
demonstrating Radon decay.

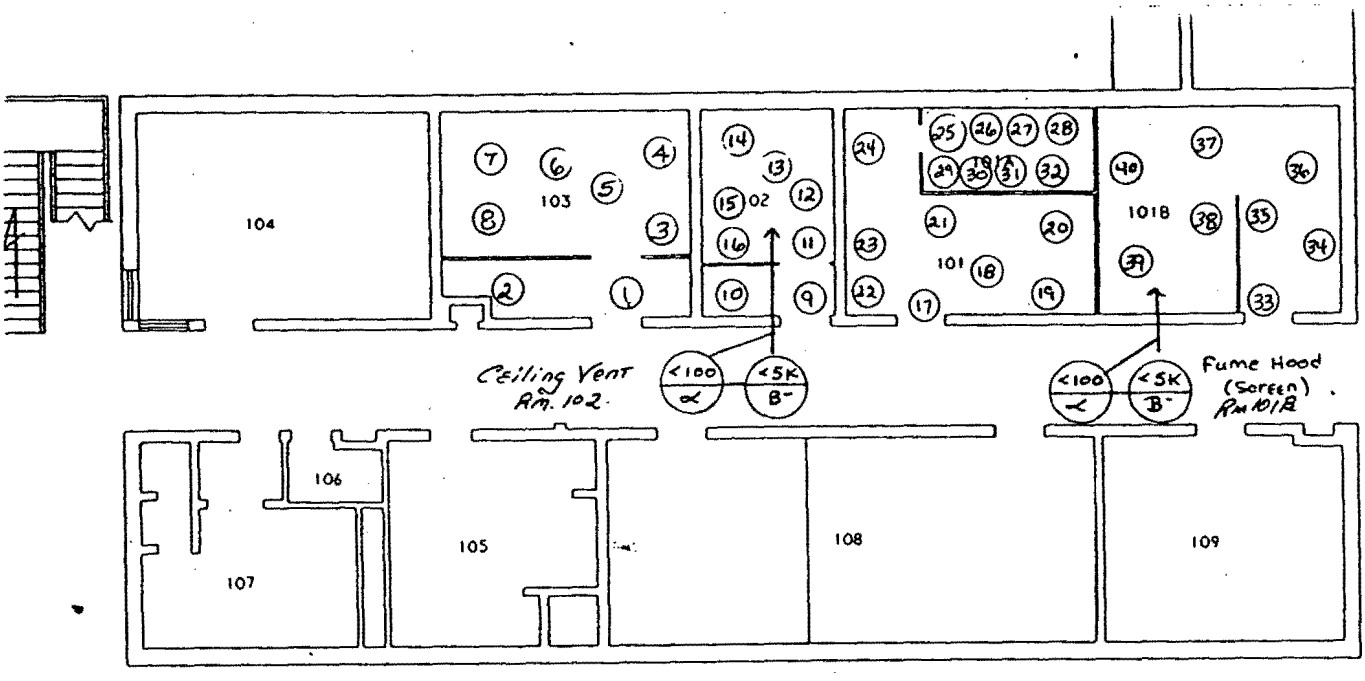
BLDG #42
FIRST FLOOR
BLDG CODE:3042

LOCATION: (BLDG./AREA/ROOM) 42 ~ Rms. 101/101A/101B/102/103	SURVEY NO. 00-TF-443
PURPOSE: BLDG. BIN VERIFICATION (Floor Surfaces Only) Re-survey Condition of 101B Fume Hood & 102 Ceiling Vent	RWP NO. N/A
	DATE: 12-20-00
	TIME: 1300

Direct Scan of Fume Hood Screen (Rm 101B) and Ceiling Fan/Vent (Rm. 102)
All < 100 dpm/100cm² α
< 5000 dpm/100cm² β -
Ref. RSDS. Nos. 00-TF-414
00-TF-413
