FINAL CLOSE-OUT REPORT

BUILDING 123 DECOMMISSIONING PROJECT

REVISION 1

FEBRUARY 1999

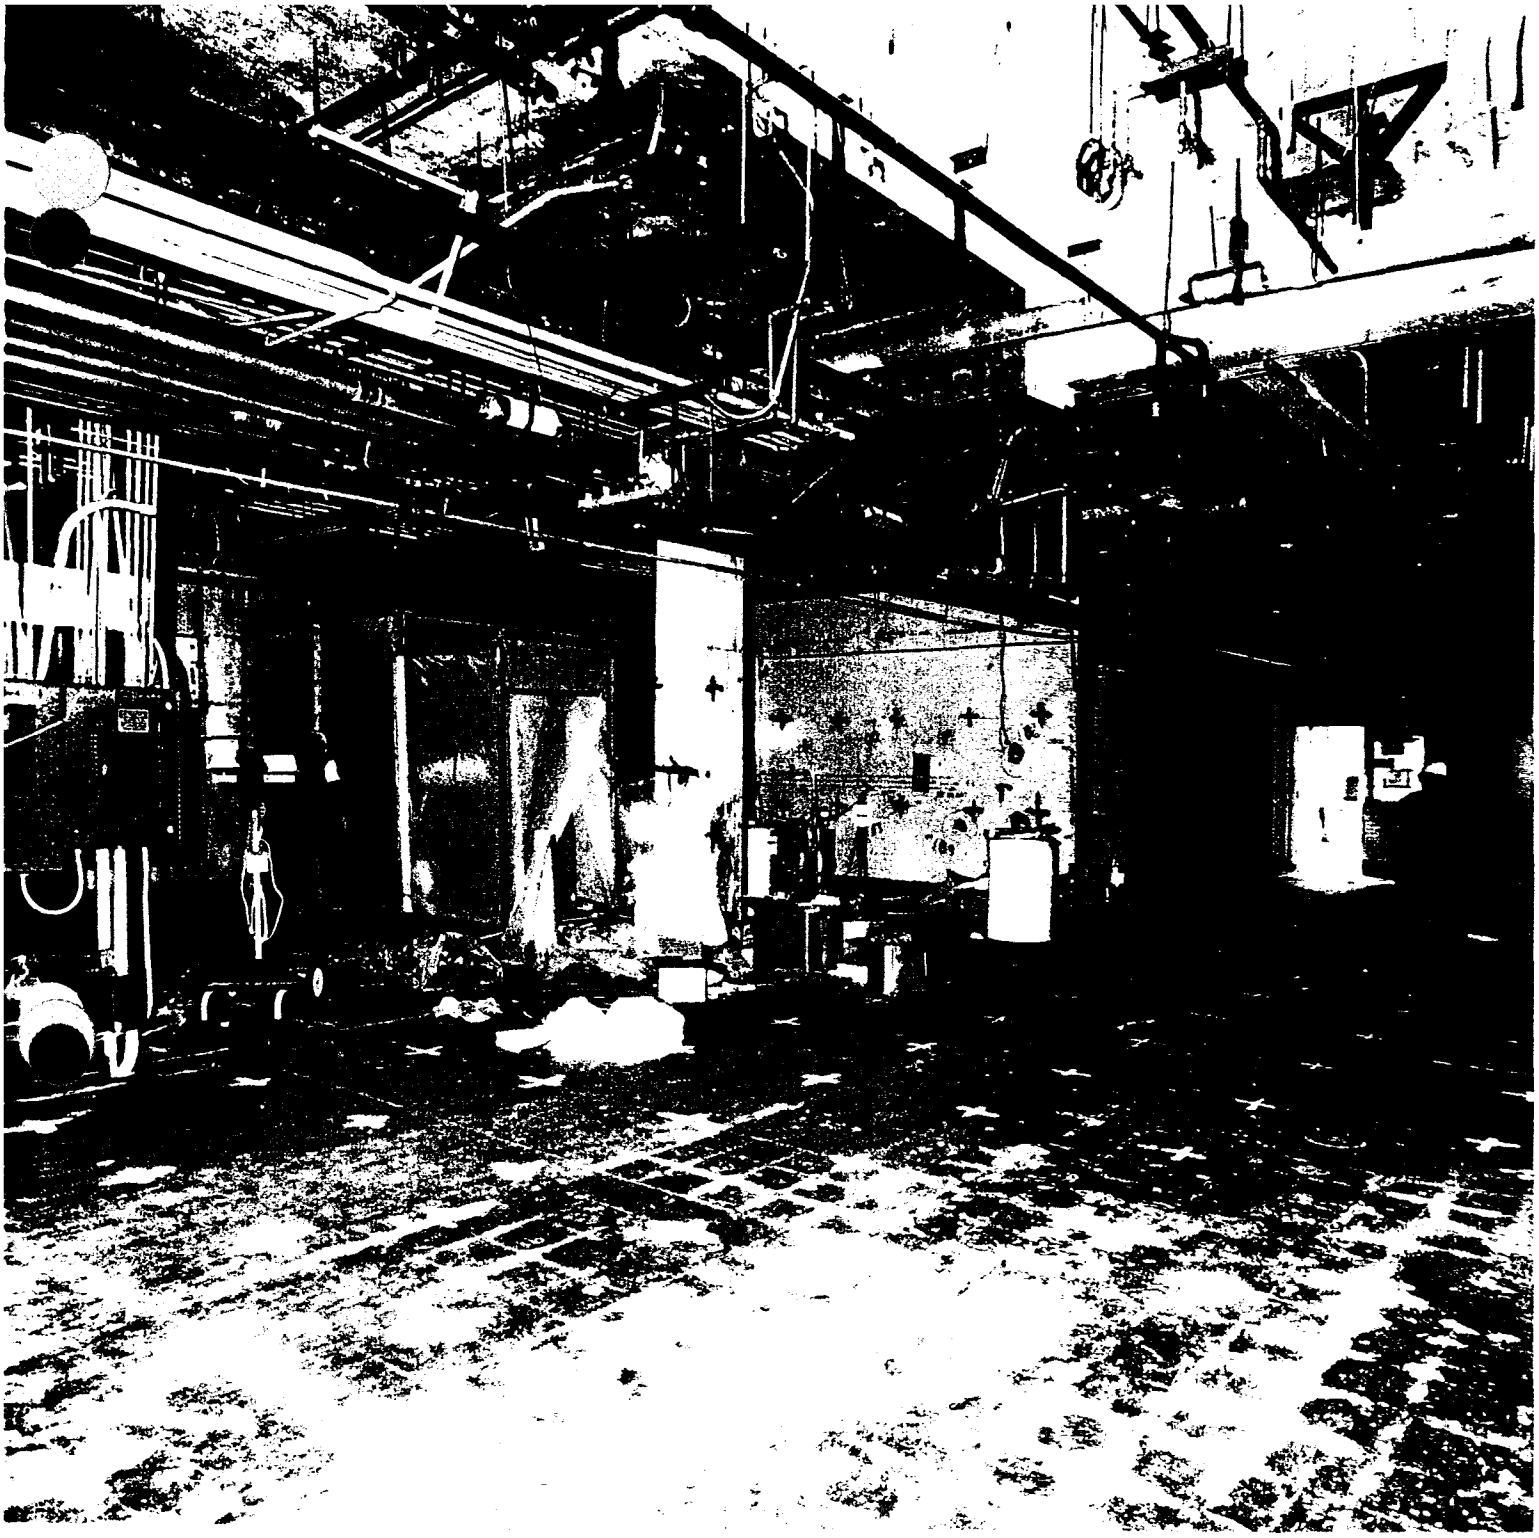
DESCRIPTION - ROCKY FLATS FIELD OFFICE
BLDG. - 123
CONTRACTOR - DENVER WEST REMEDIATION & CONSTRUCTION
#50563 - 09 - A PLASTIC CONTAINMENT IS CONSTRUCTED TO SCABBLE CONTAMINATED PAINT FROM THE SOUTH WALL OF ROOM 111
4/23/98
