Rocky Flats Environmental Technology Site

PRE-DEMOLITION SURVEY REPORT (PDSR)

Indirect/Direct Evaporative Cooling Building (IDEC)

July 12, 2004

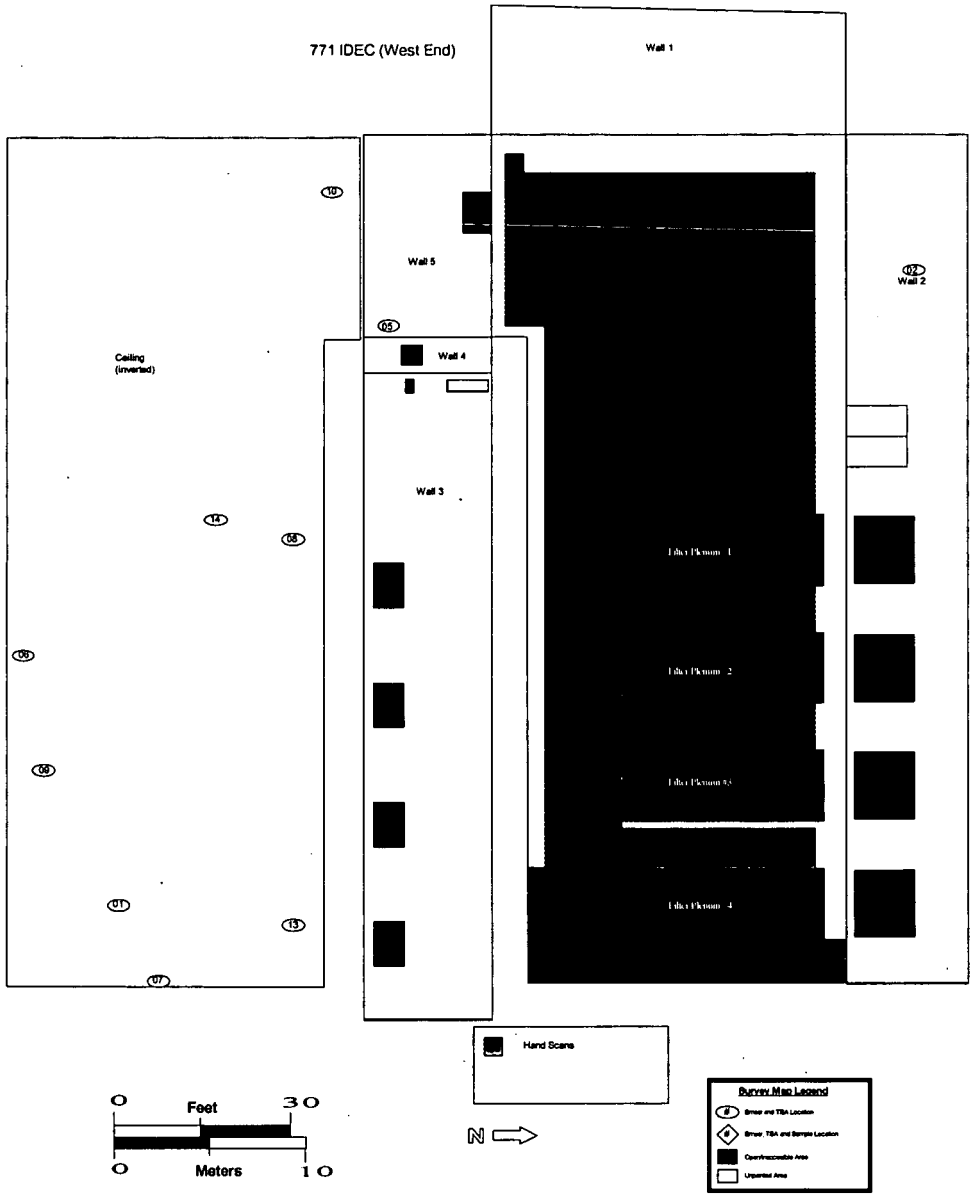
SURVEY UNIT 771026 - MAP 1 OF 2

All scans, surveys, and media sample results in survey unit 771026 were less than the applicable PDS transuranic DCGL values. Radiological survey data, statistical analysis results, survey locations, and radiological scan maps for survey unit 771026 are presented in Attachment B, *Survey Unit 771026 Radiological Data Summary and Survey Map.*

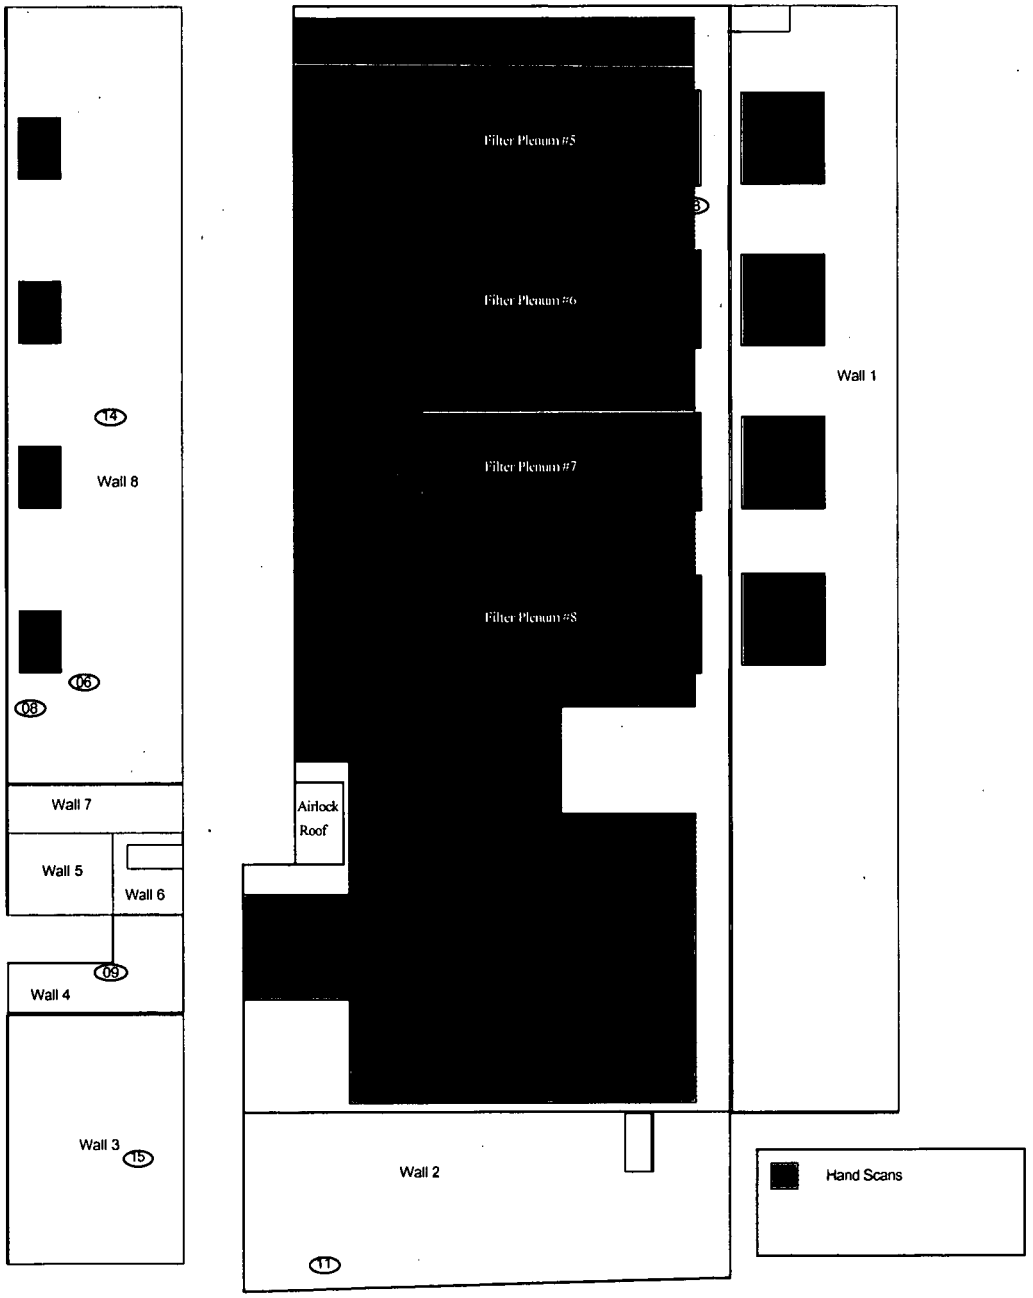
SURVEY UNIT 771027 - MAP 1 OF 2

All scans, surveys, and media sample results in survey unit 771027 were less than the applicable PDS transuranic DCGL values. Radiological survey data, statistical analysis results, survey locations, and radiological scan maps for survey unit 771027 are presented in Attachment C, *Survey Unit 771027 Radiological Data Summary and Survey Map.*

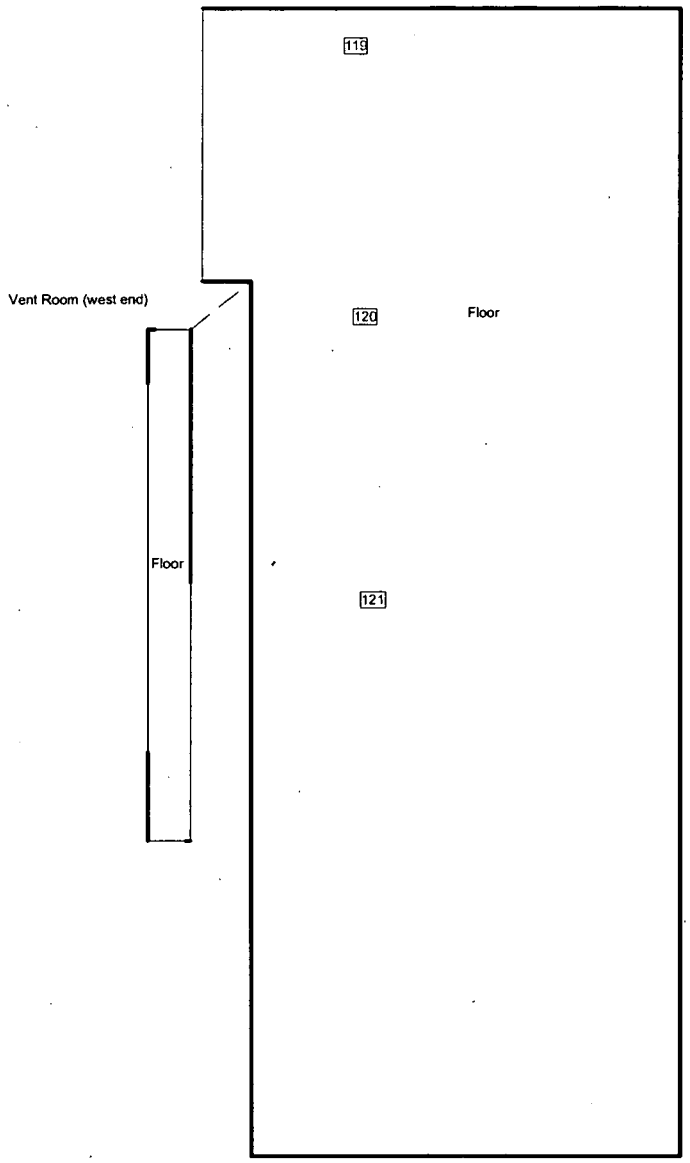
SURVEY UNIT 771026 Be - MAP 1 OF 1

Sample location	Sample Number	Sample Result
119 thru 121	771-06-17-2004-76-119 thru 121	<0.1 ug/100 sq. cm
	771-06-17-2004-76-122B-123B	Blanks

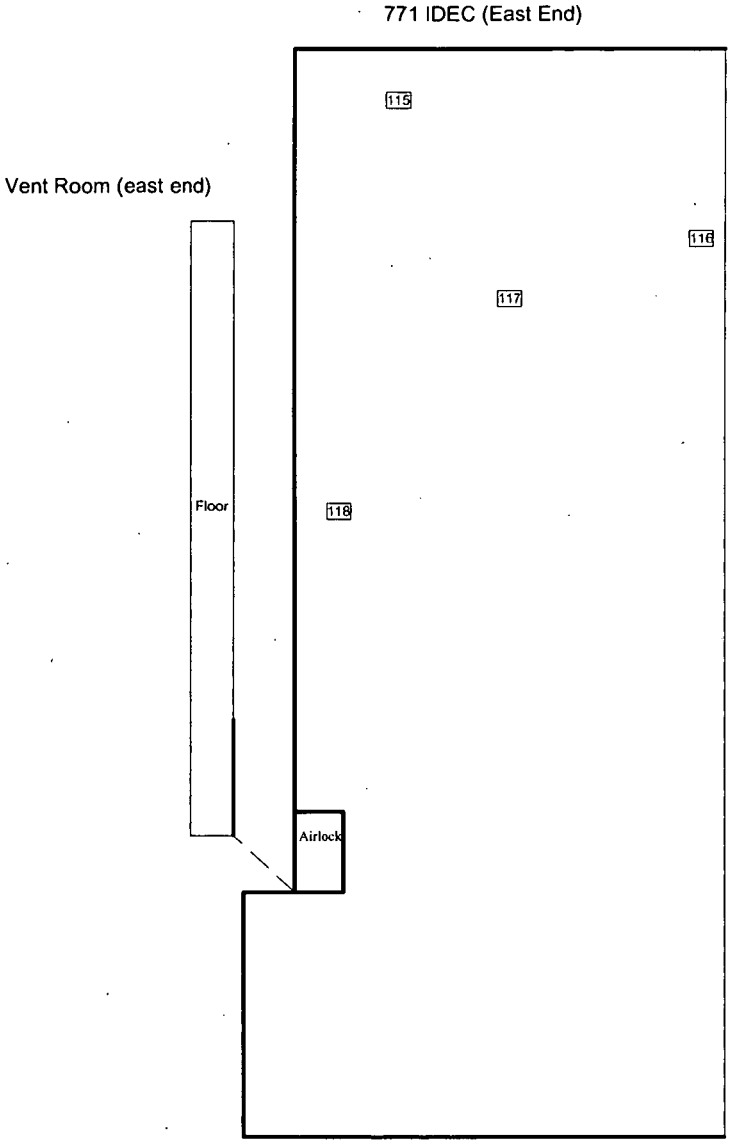
SURVEY UNIT 771027 Be - MAP 1 OF 1

Sample location	Sample Number	Sample Result
115 thru 118	771-06-17-2004-76-115 thru 118	<0.1 ug/100 sq. cm
	771-06-17-2004-76-122B-123B	Blanks
