RF/RMRS–2000-012.UN

DECOMMISSIONING CLOSEOUT REPORT

779 CLOSURE PROJECT

Revision 0
April 2000

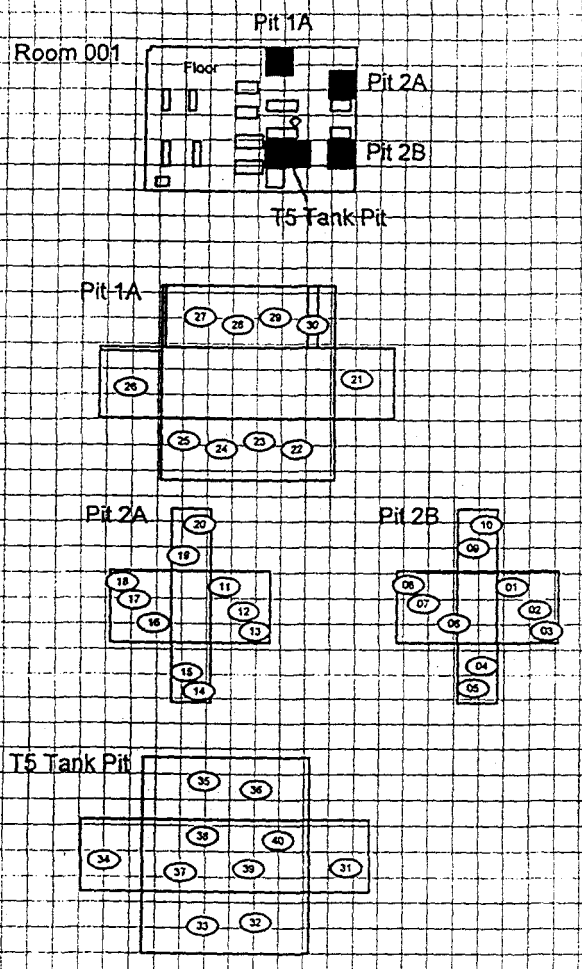
Room 001 Pits Characterization

Total Room 001 Pit Floor Area: 47 sq. m **Total Pit Area: 183 sq. m**

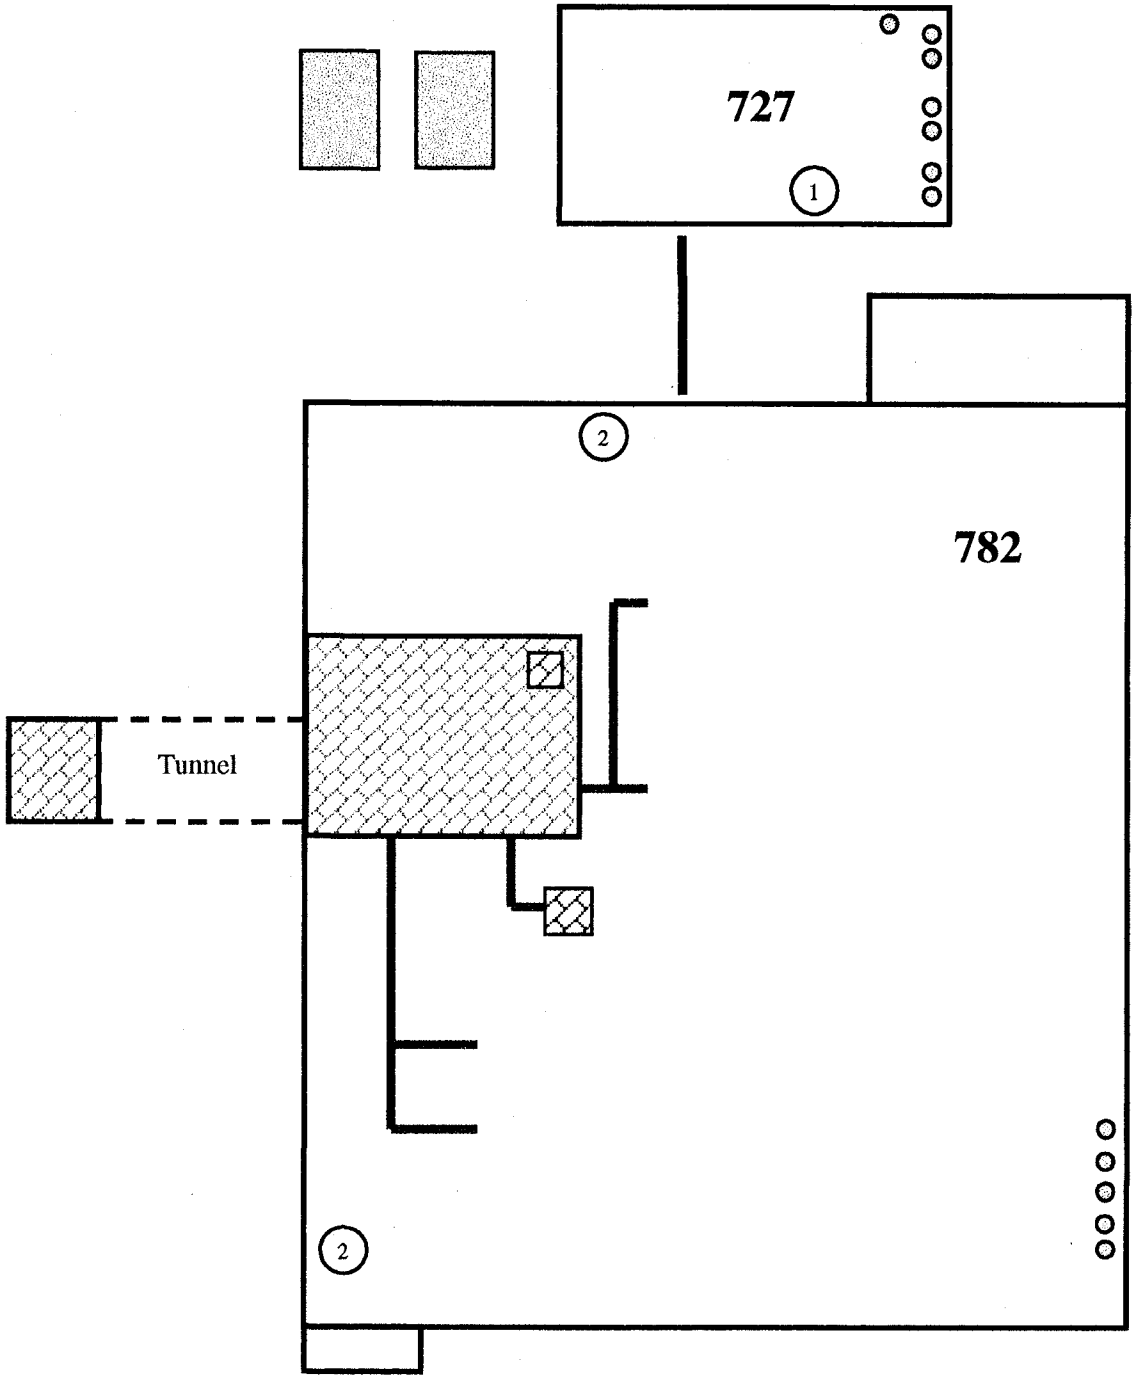
BUILDING 727 and 782 - Slab Details

Pipe and conduit openings in the Building 782 slab were plugged and grouted at the foundation level. Process waste piping penetrations were covered with metal plates that are fastened to the foundation. After the Building 782 structure was removed, a cover was constructed over the Building 782 pit. The pit cover is constructed so that groundwater migration into the Building 782 pit can be sampled and removed. Preliminary data has been obtained from water samples that have been collected from this pit. (This data is contained in IWCP TOO96268, *Waste Sampling Characterization for Building 779*.) The groundwater infiltrate will be sampled on a periodic basis.

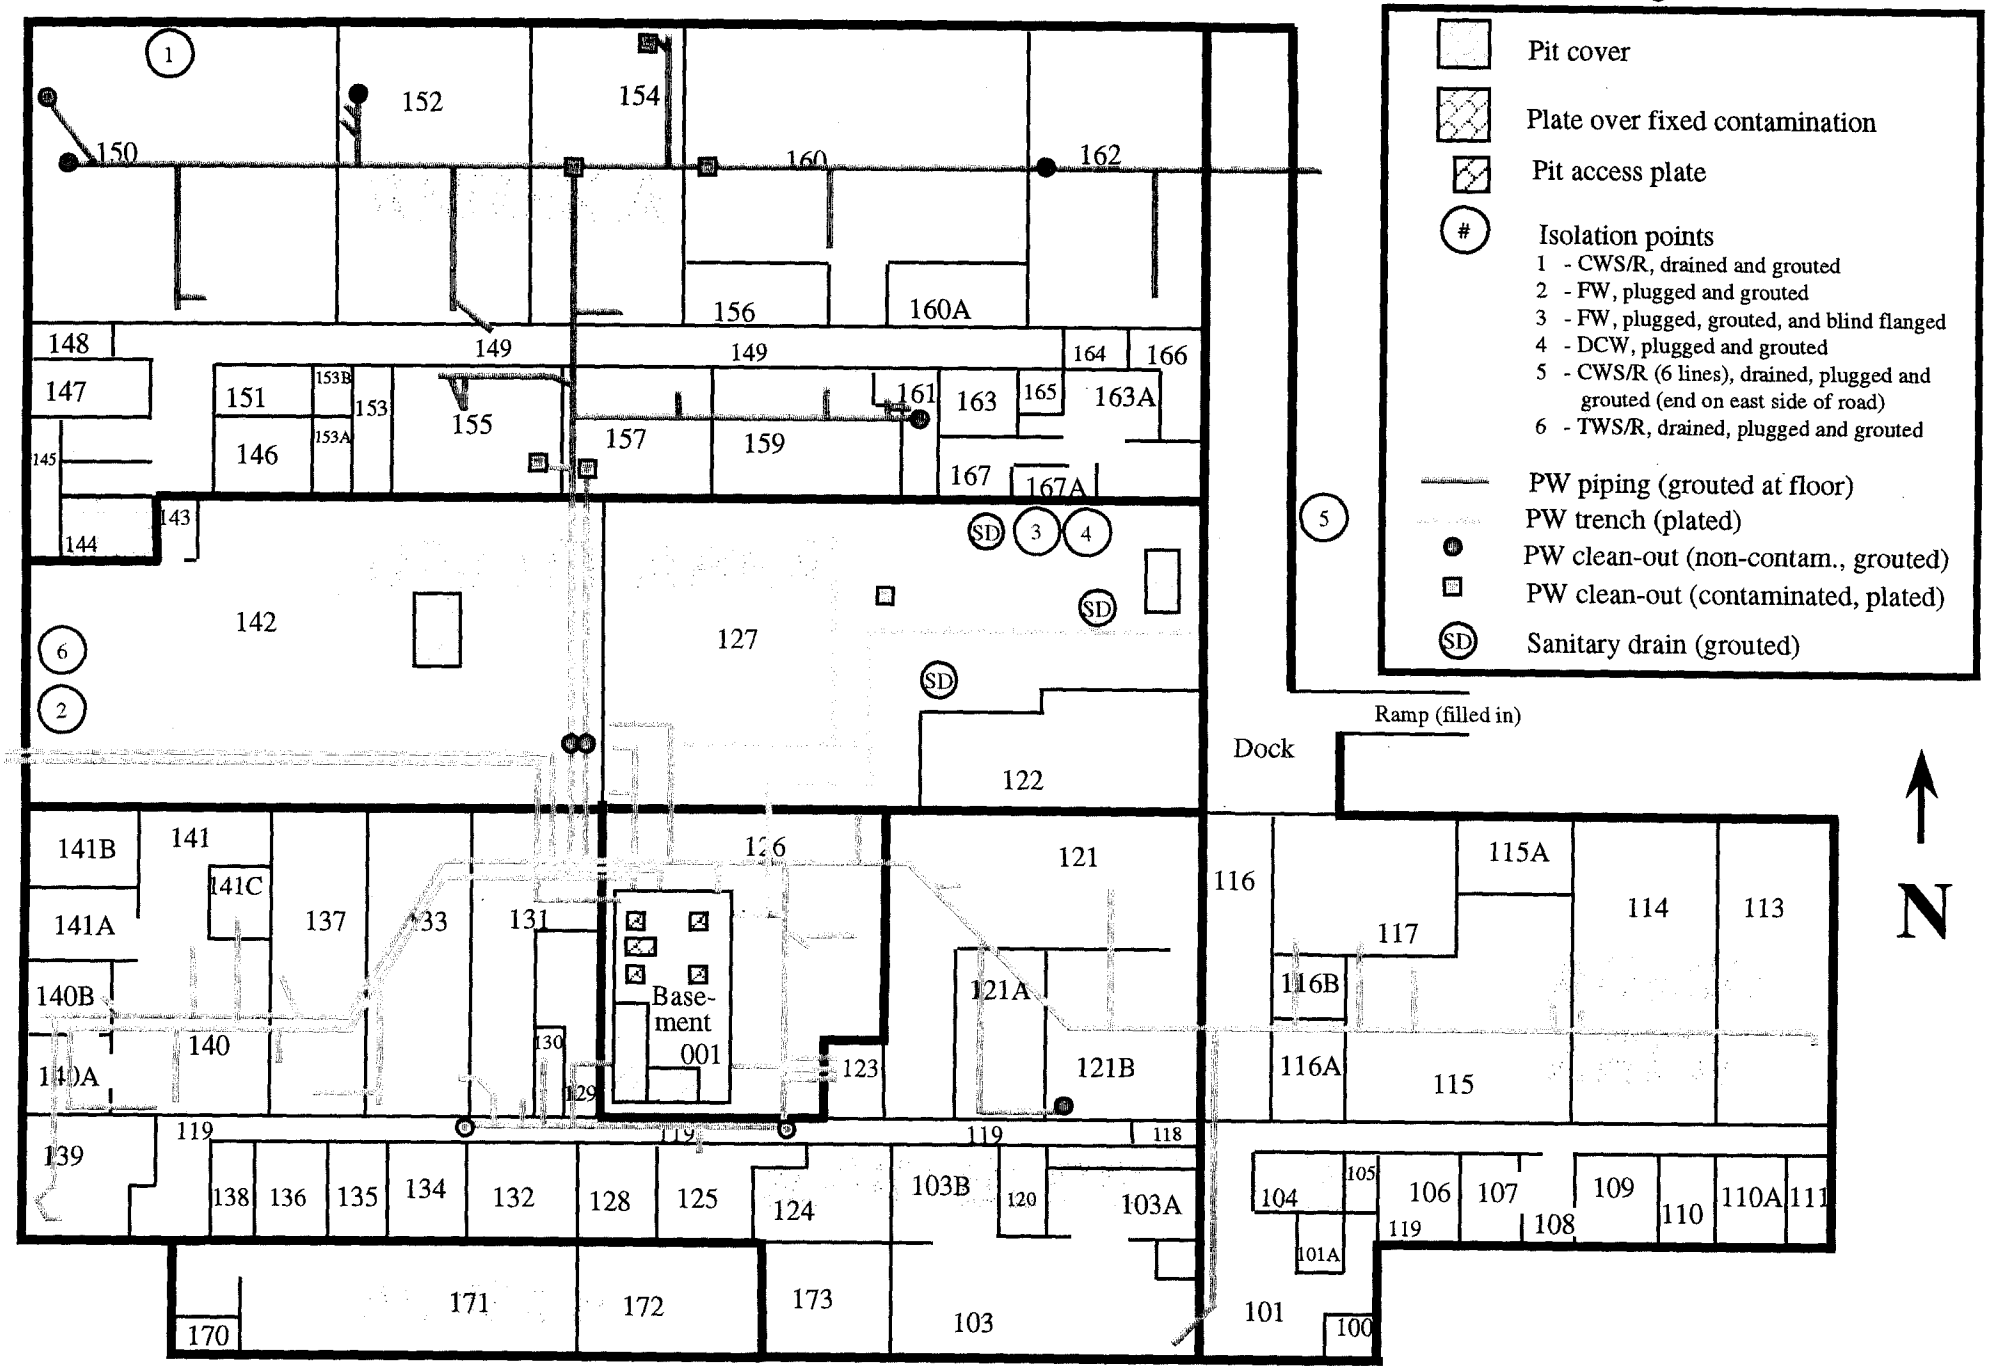
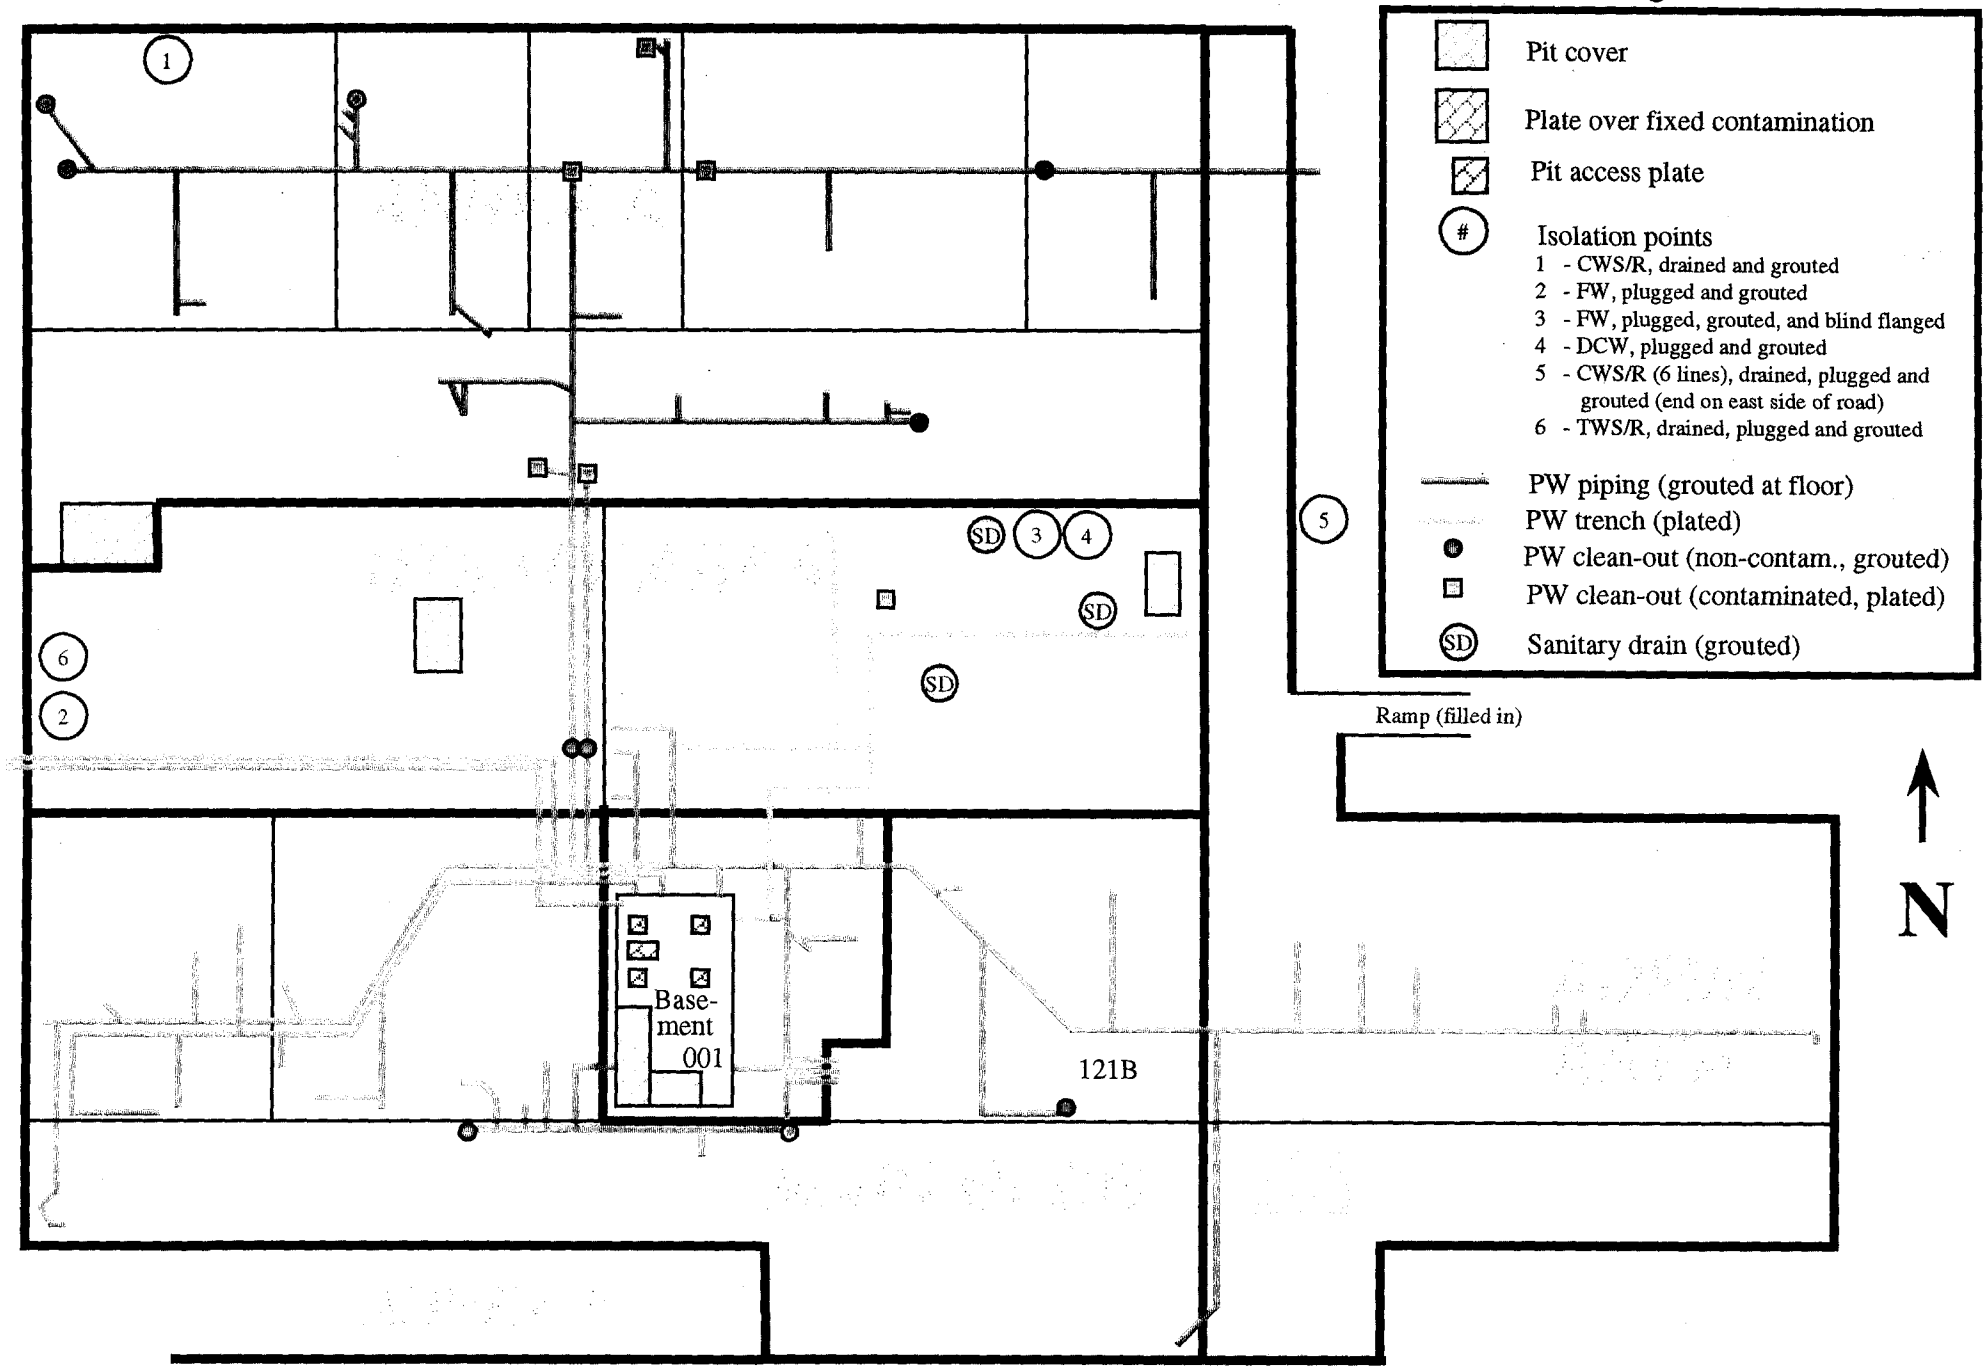
BUILDING 779 FIRST FLOOR - Slab Details

The Building 779 and 782 slabs were decontaminated to levels less than the DOE Order 5400.5 limits. Contaminated process drains penetrating the foundation slabs were filled to grade with grout. Large penetrations, such as drain clean-outs, were covered with metal plates prior to demolition to maintain the integrity of the grout. The plates will remain in place until the Environmental

Building 779 was demolished to its main slab. Several pits exist within the slab including two elevator shafts (approx. 6 ft. long by 7 ft. wide by 3 ft. deep), the plenum deluge drain pit (approx. 6 ft. long by 4 ft. wide by 4 ft. deep, the basement pit area (approx. 29 ft. long by 20 ft. wide by 20 ft. deep), and a pump pit (approx. 6 ft. long by 4 ft. wide by 4 ft. deep). A process waste trench network approximately 50 ft. in length exists on the east-side of the slab. Metal covers were placed over these areas to eliminate the safety hazard of the foundation openings. The truck ramp located on the east side of the building, approx. 25 ft. long and sloping to a depth of 4 ft., was filled with building rubble. See Section 10 for additional information on slab penetrations and in-slab waste.

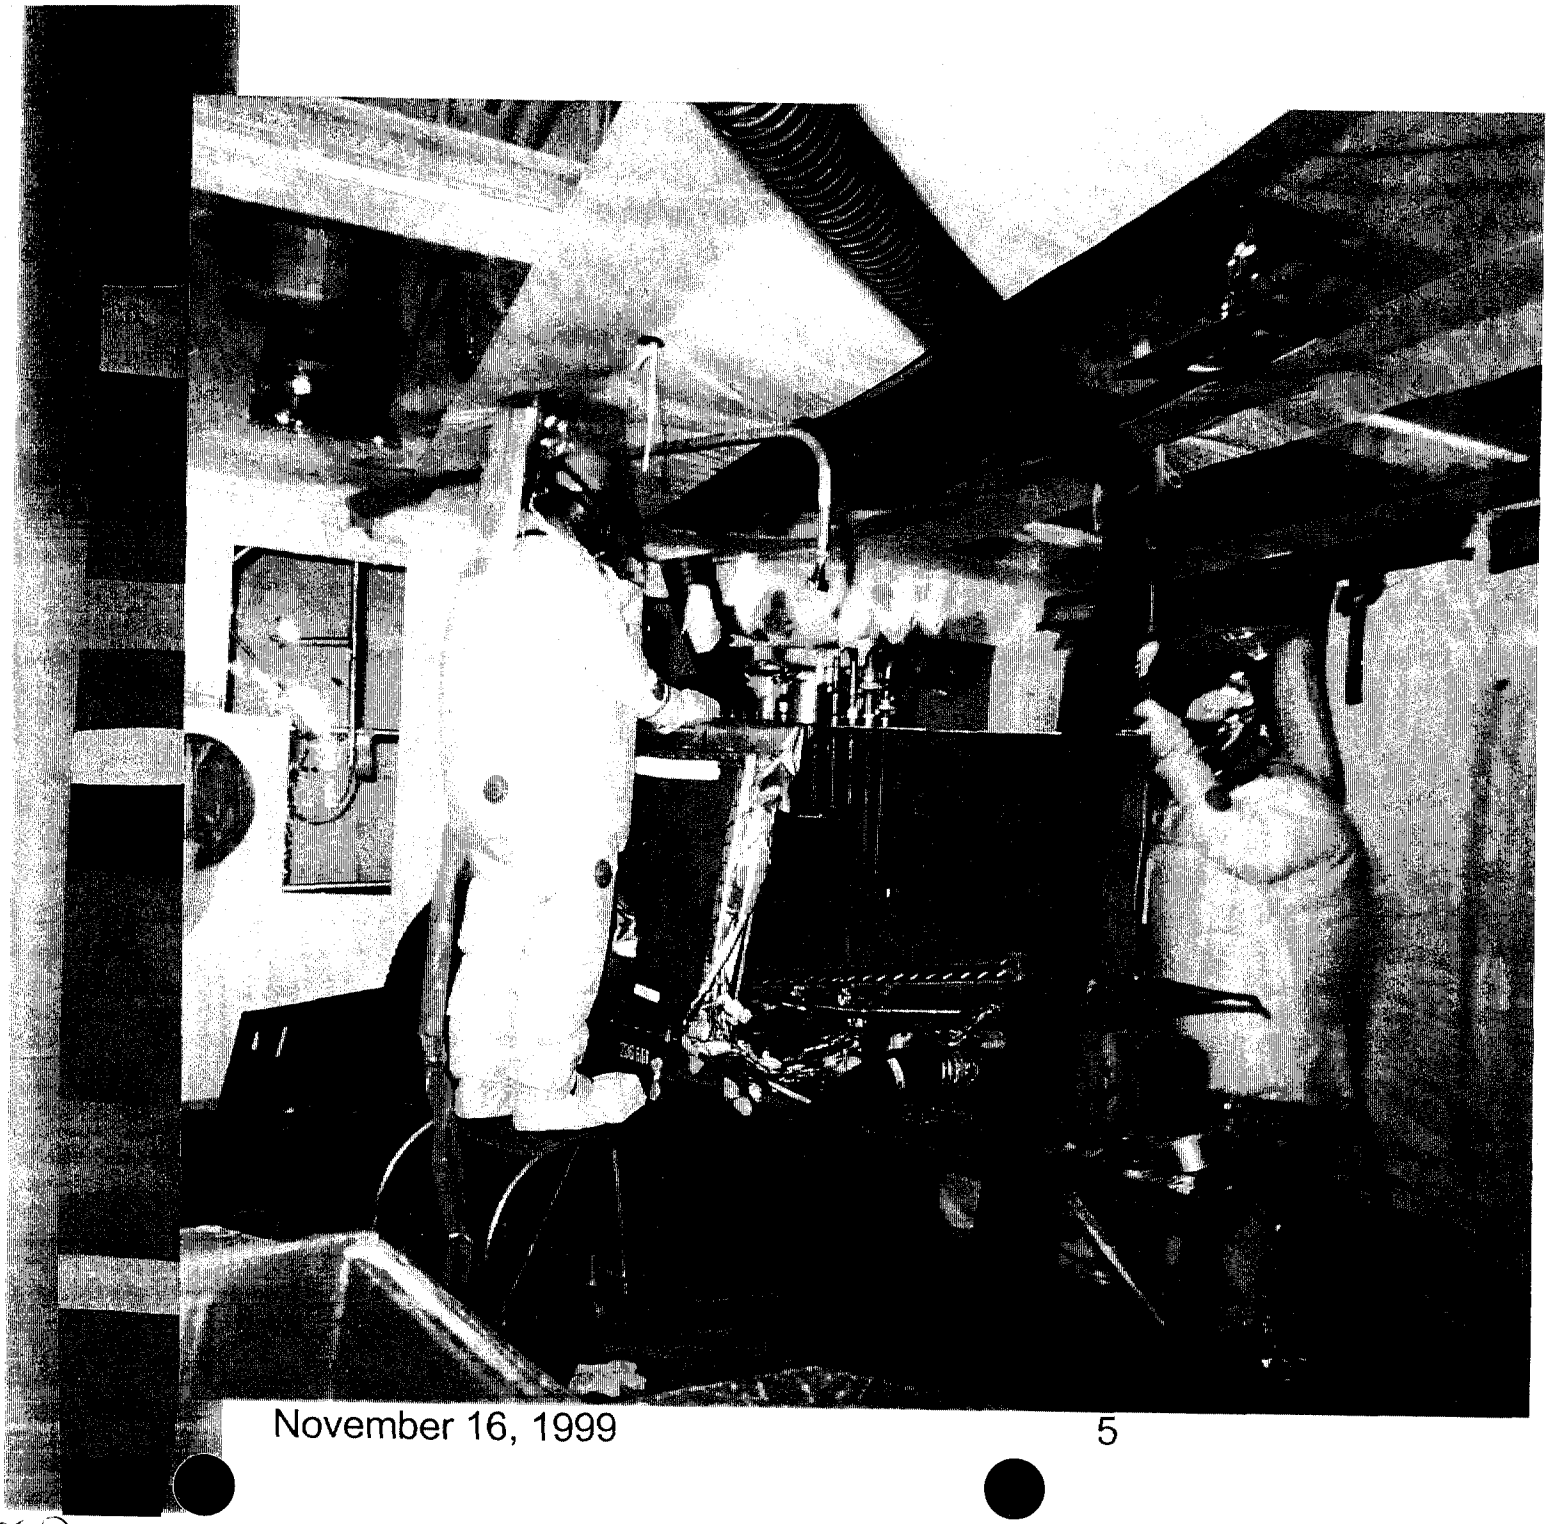
Building 779 - Room 140

BREATHING AIR WORKER CUT HAND

- CAUSE WAS INADEQUATE LEATHER GLOVES
- BARTLETT TLC USE CAUSED TAPE TO NOT STICK TO SHARP EDGES
- HOISTING & RIGGING MUST BE CONSIDERED DURING ENGINEERING OF SIZE REDUCTION TENTS
- ENSURE GLOVES UTILIZED ARE LONG ENOUGH
- FIXATIVES USED MUST BE CONDUCIVE TO THE JOB (ABC/3M FIRE DAM)

Workers Dis-mantling Glovebox in Pre-Fab Tent

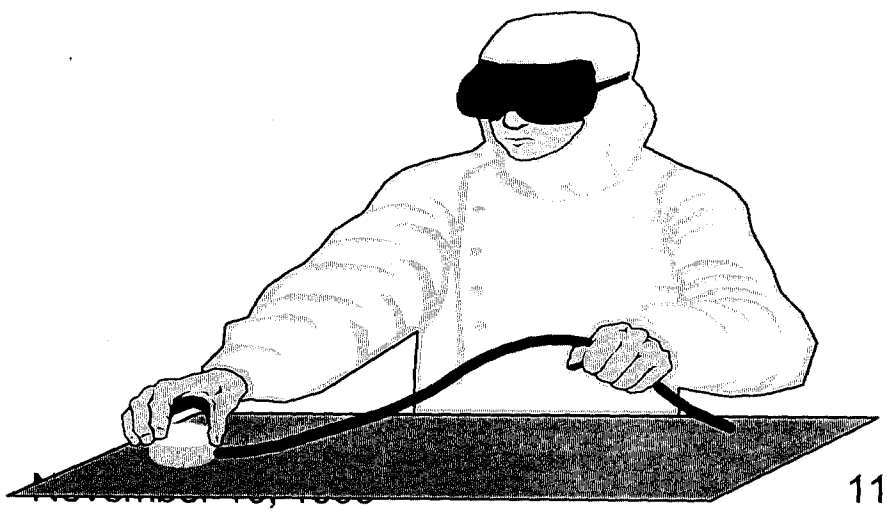
GLOVE-BOX FURNACE DOOR FELL

- IMPLEMENT AND PRACTICE EWP/ISM
- ENGINEERING WITH THE WORK FORCE

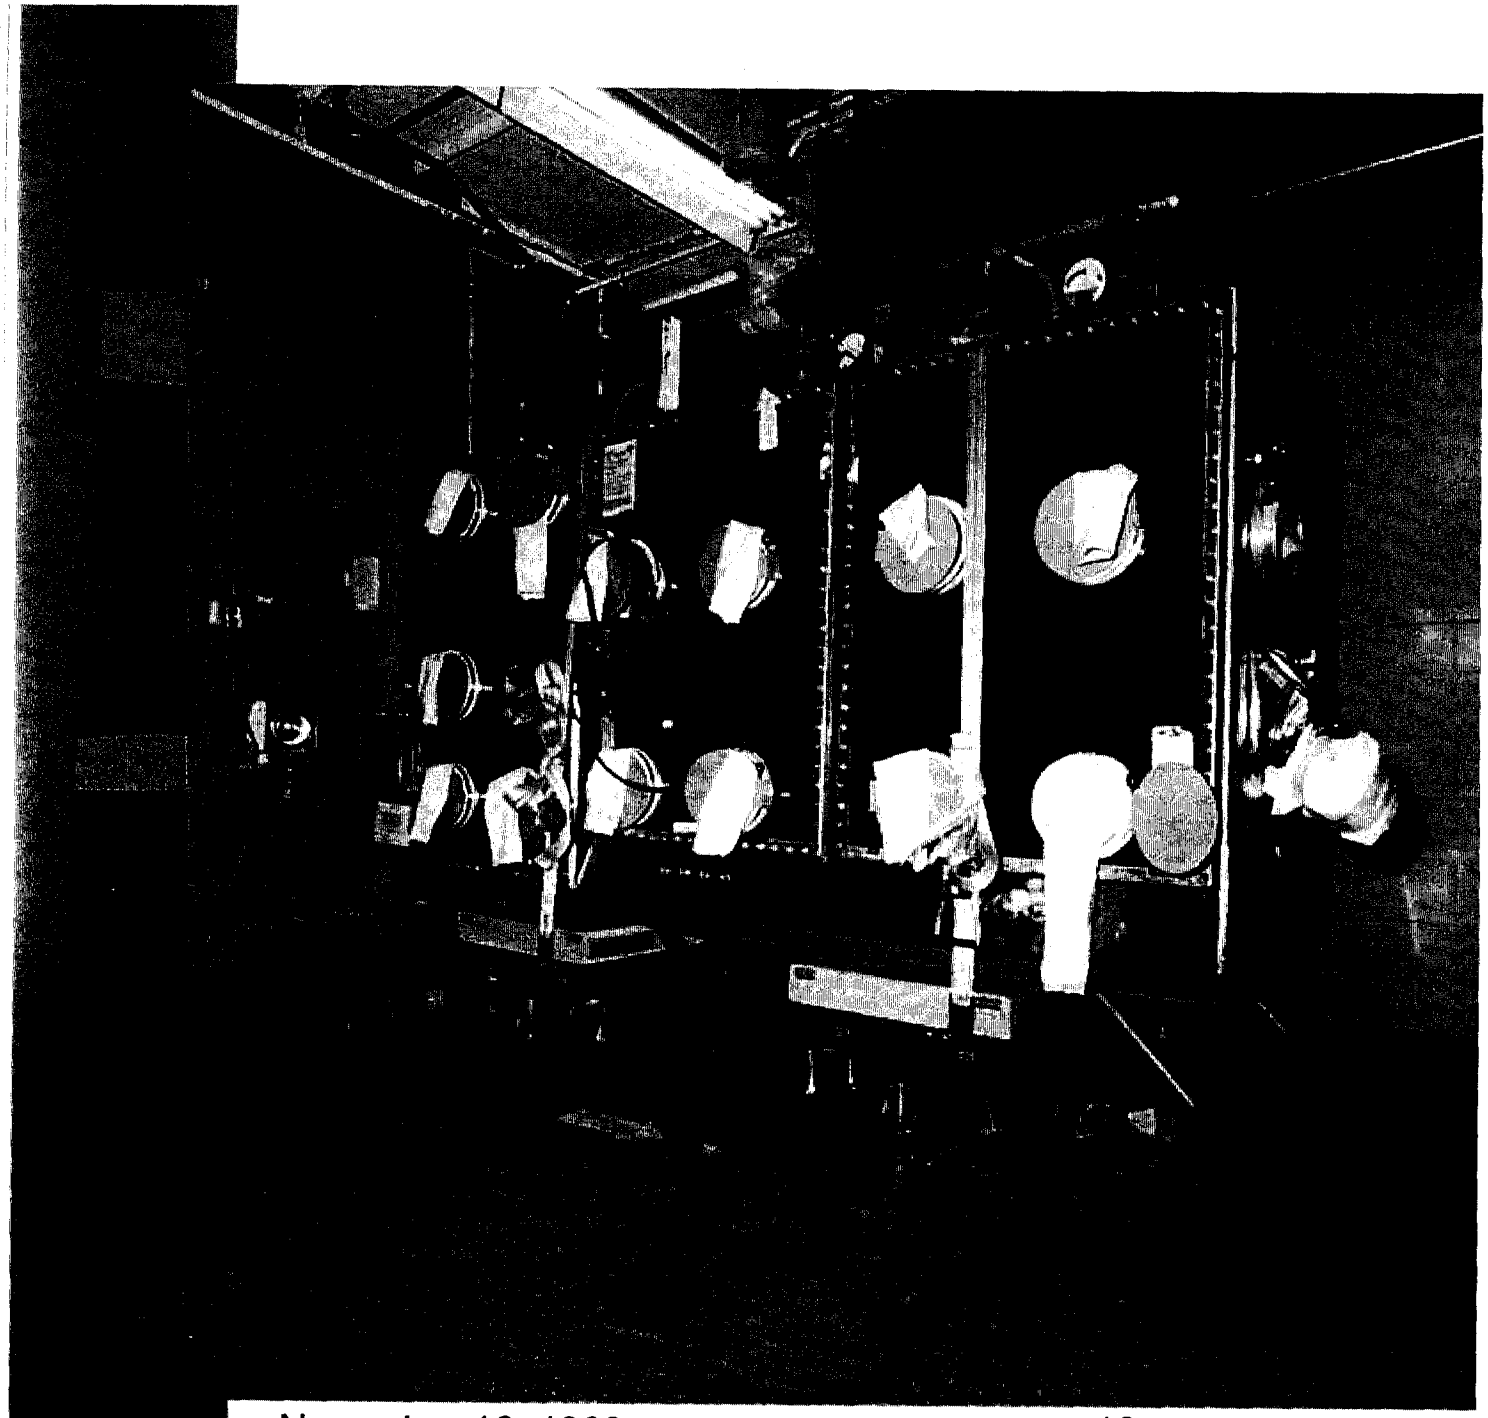
Building 779 Room 228

MANUAL FIRE PHONE ACTIVATED DURING GLOVEBOX MOVE

Glovebox 192 Dual Lifts

- WORK PACKAGES SHALL INCLUDE SPECIFIC MOVING INSTRUCTIONS
- MOVE PLANS REQUIRED FOR EACH GLOVE-BOX MOVE
- ENGINEERING INPUT WITH MODIFICATIONS

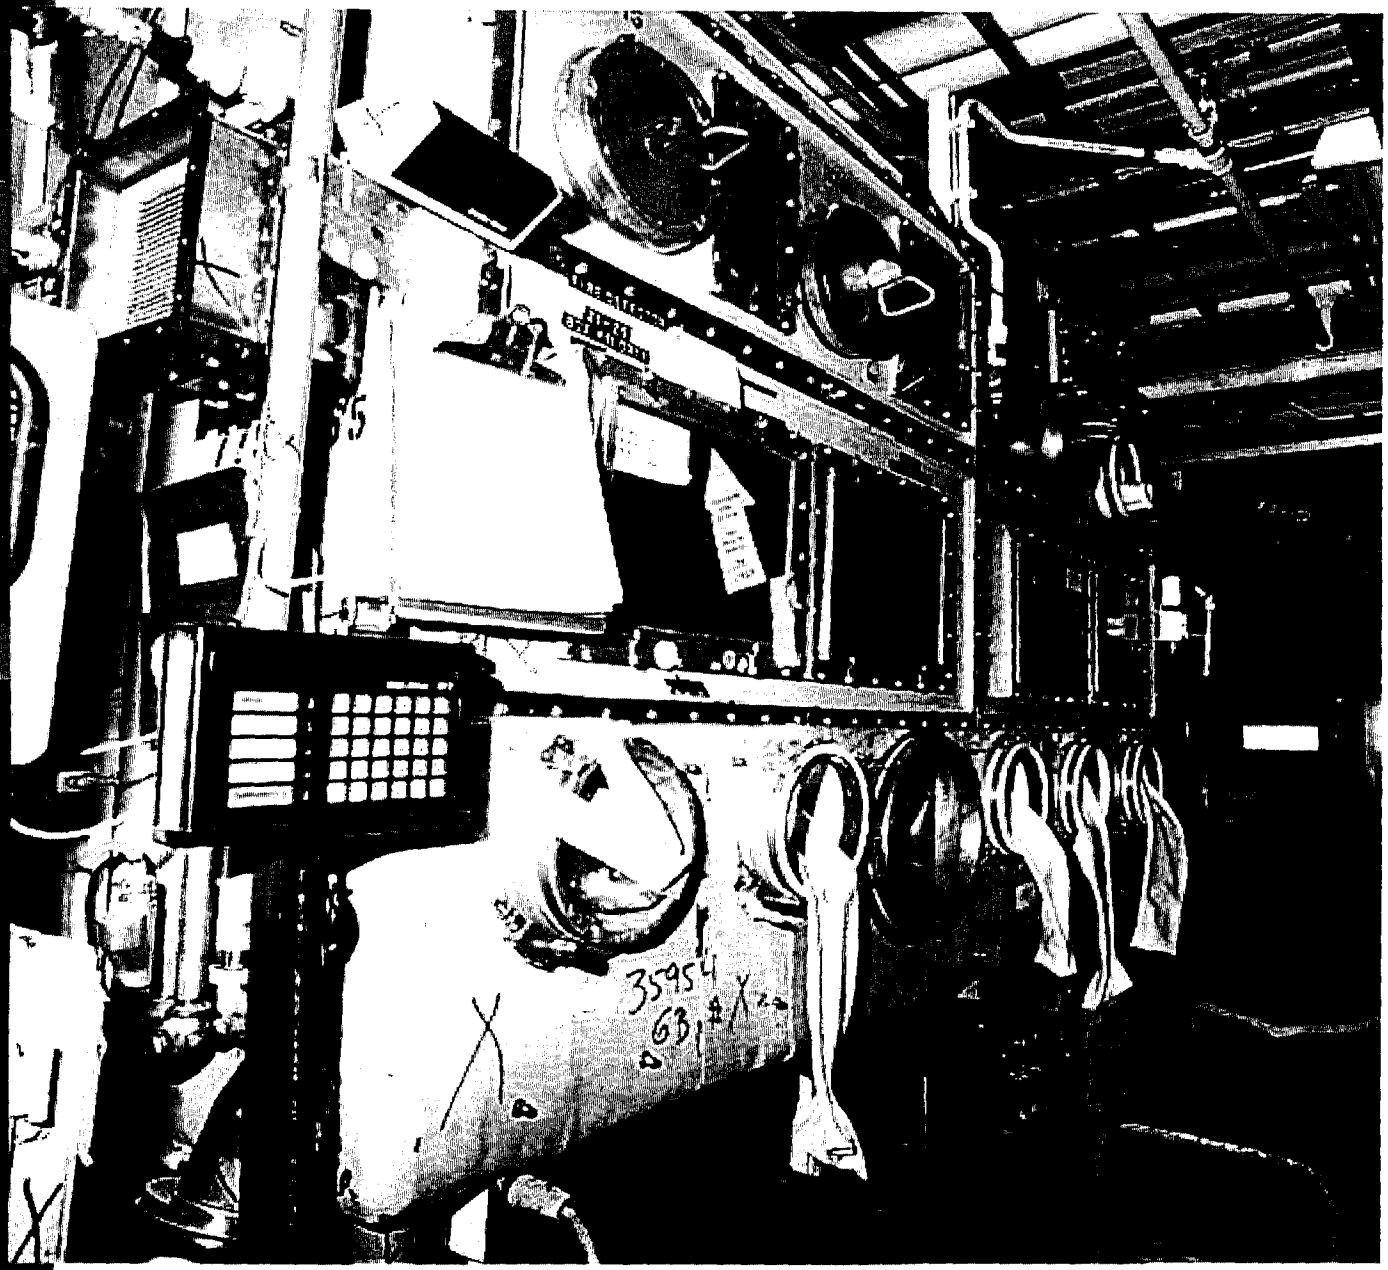
Building 779 - Room 154 Glovebox 1363 Before Removal

PYROPHORIC REACTION DURING SIZE REDUCTION

- EXTENSIVE PRE-PLANNING DONE BY D&D TEAM PREPARED THEM FOR THE WORST CASE SCENARIO. ALL PERSONNEL RESPONDED APPROPRIATELY TO THE INCIDENT.

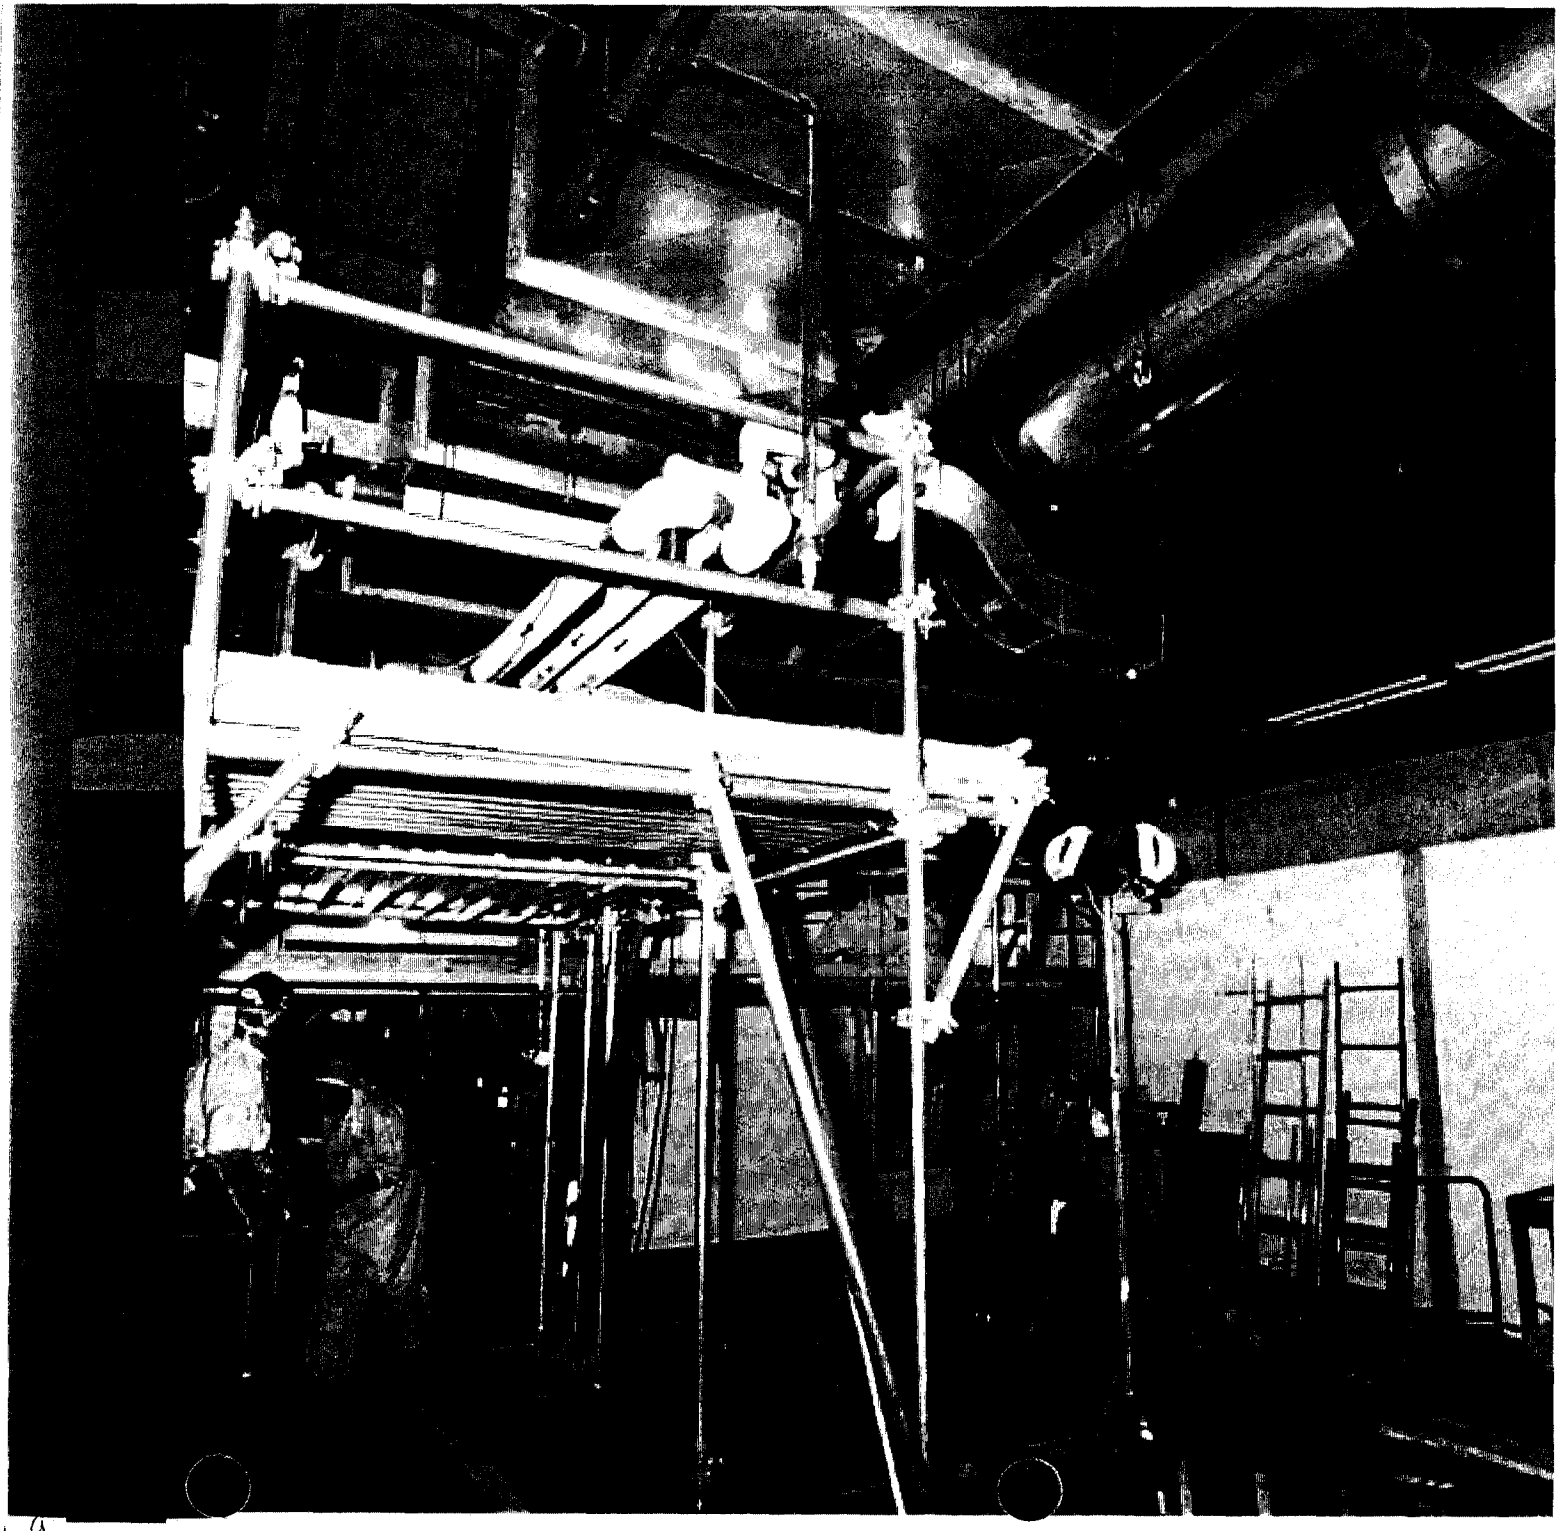
Building 779 - Rooms 146 & 151

SEVERED SIO CABLE

Ceiling, Beginning Removal and Walls Gone

- IT IS IMPERATIVE THAT SYSTEM BOUNDARIES ARE IDENTIFIED CLEARLY AND SUCCINCTLY.

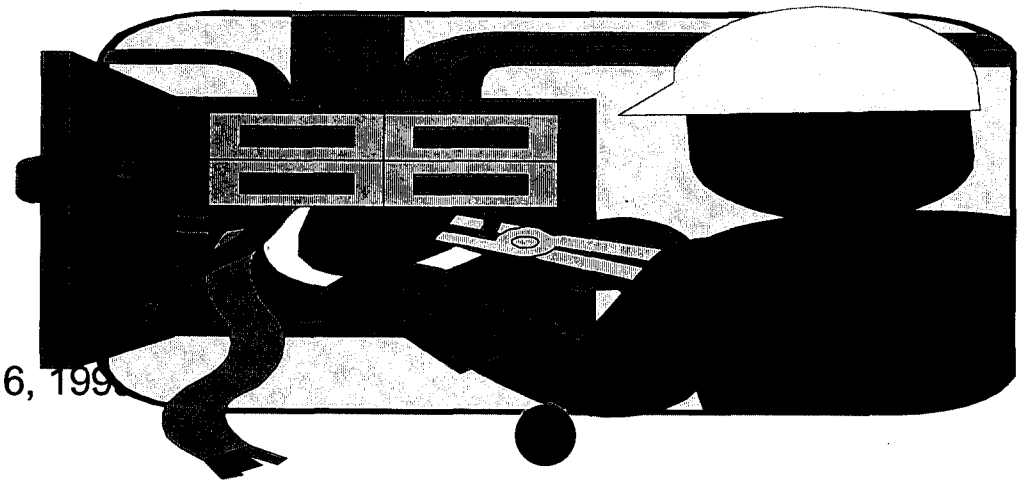
TELECOM TECH DRILL INTO ENERGIZED LINE

- ALL OUTSIDE GROUP INSTALLATIONS MUST INCLUDE A JHA/AHA
- UTILITY LOCATE SHALL BE USED PRIOR TO INTRUSIVE ACTIVITIES

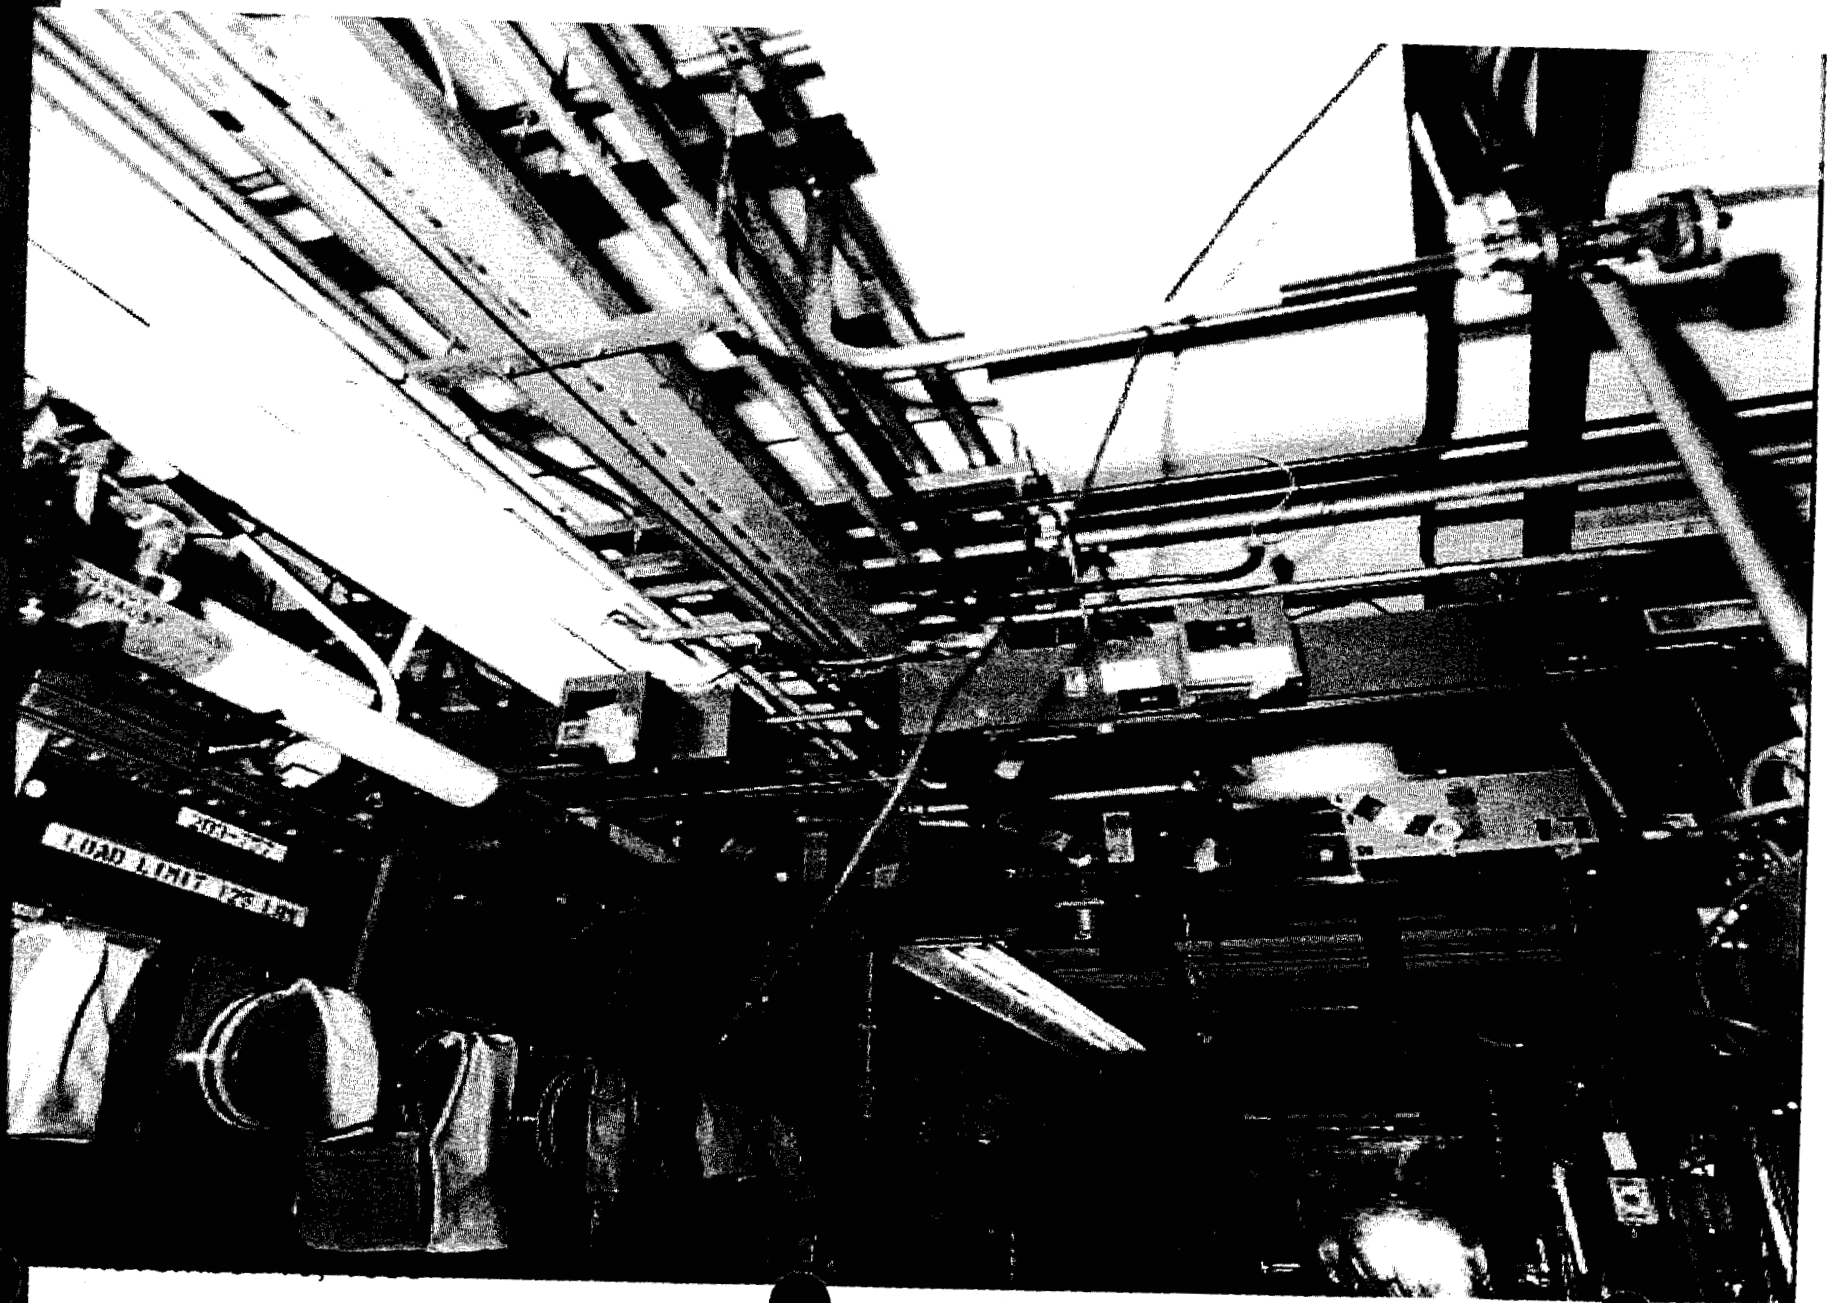
B779, Room 133, Electrical Bus and Pipes

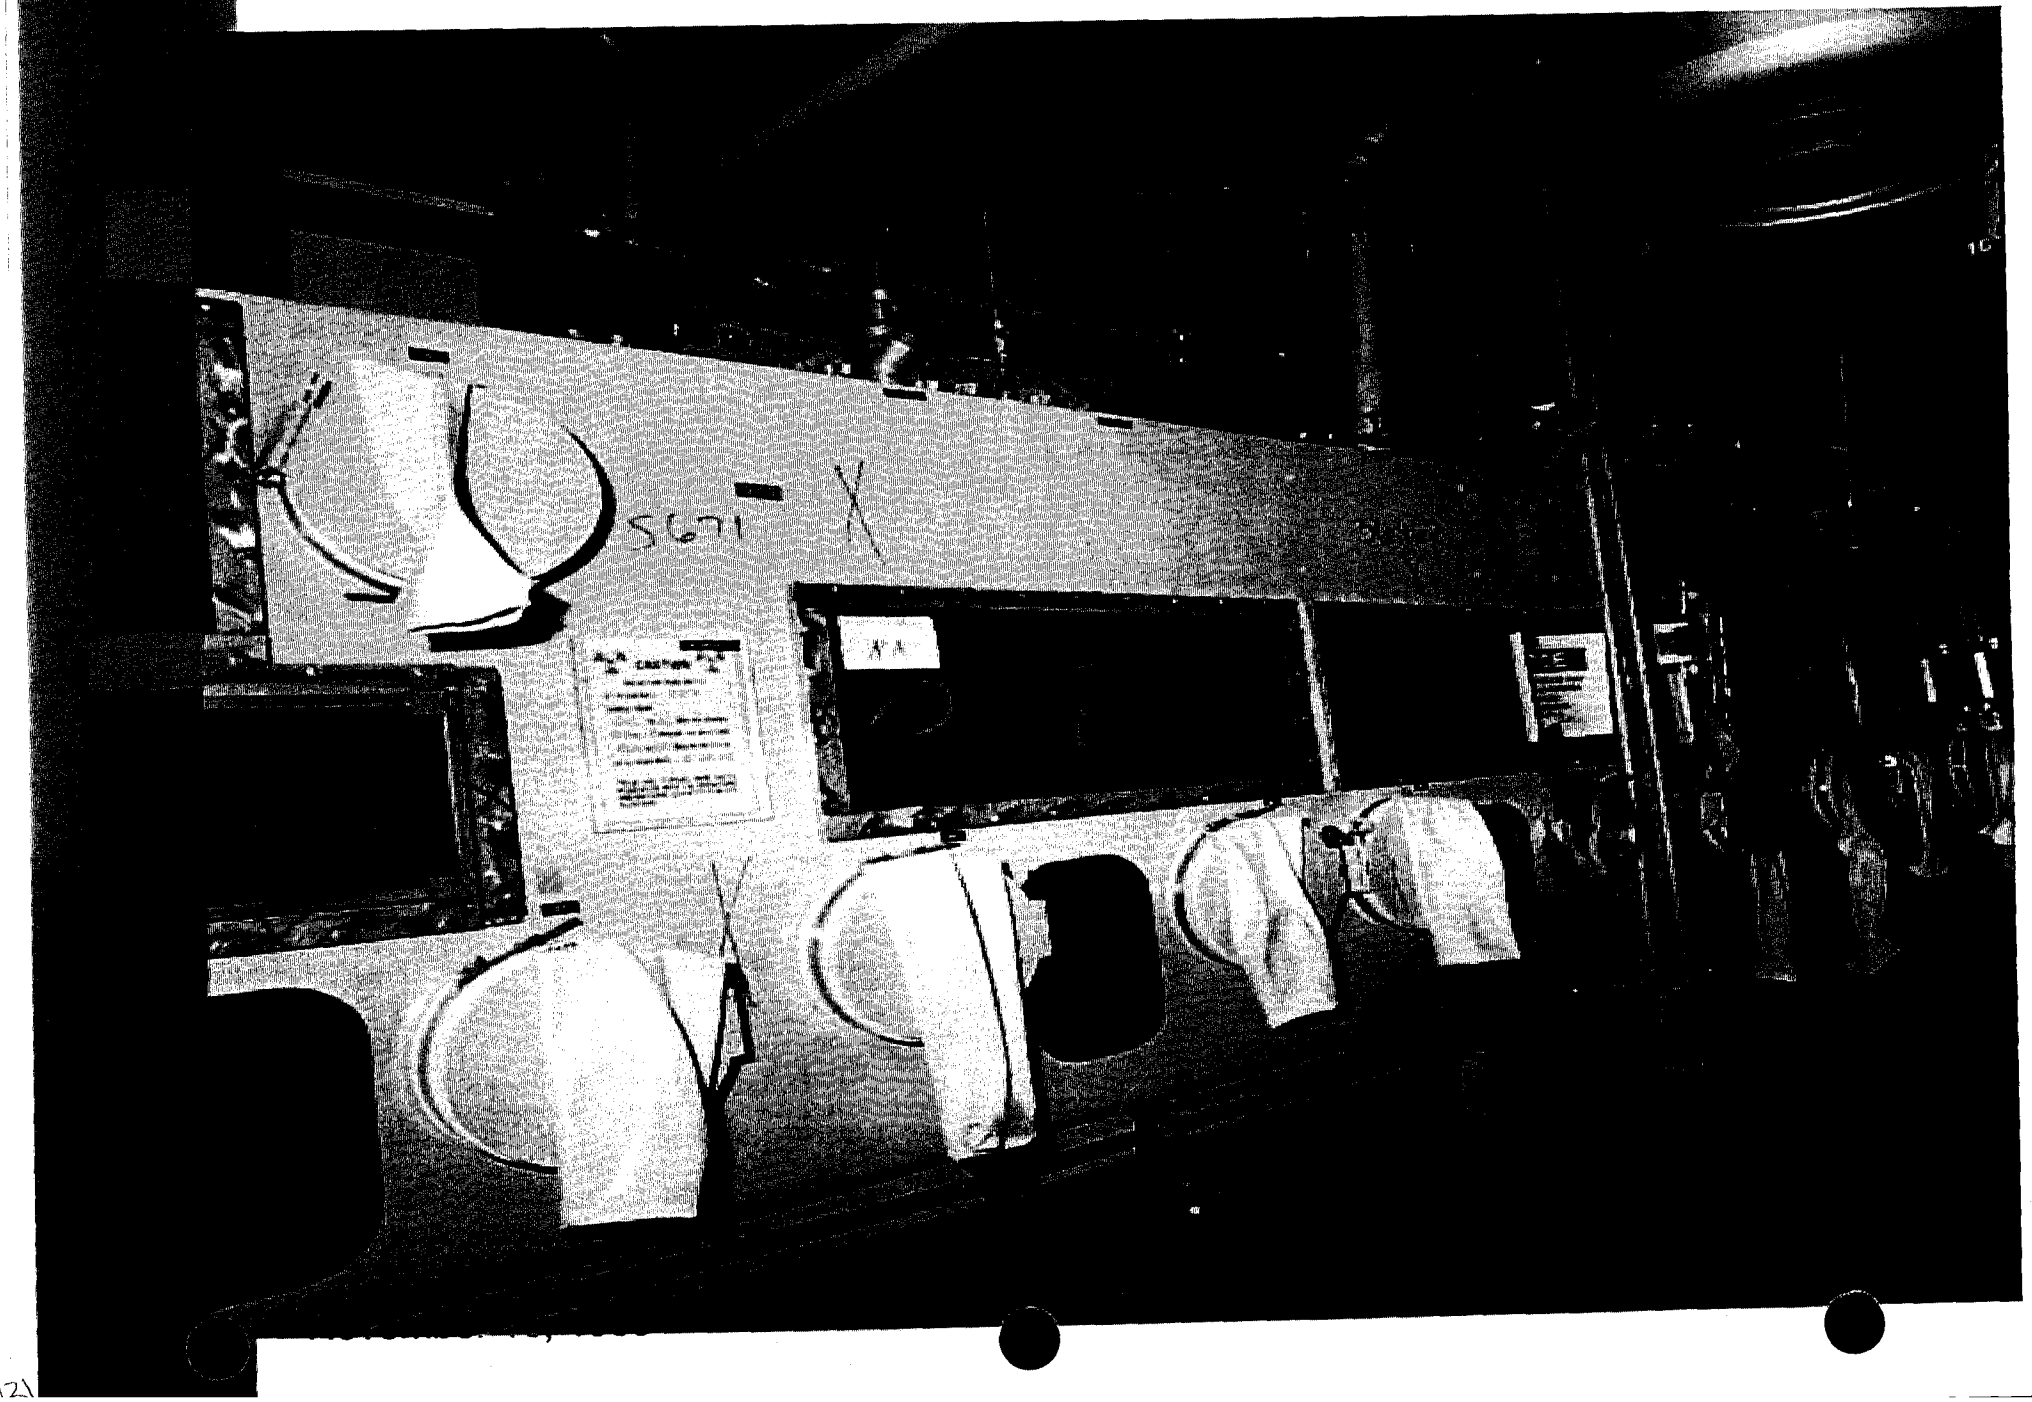
B779, Room 133, Glovebox 959, Before Removal
