RF/RMRS–2000-012.UN

DECOMMISSIONING CLOSEOUT REPORT

779 CLOSURE PROJECT

Revision 0
April 2000

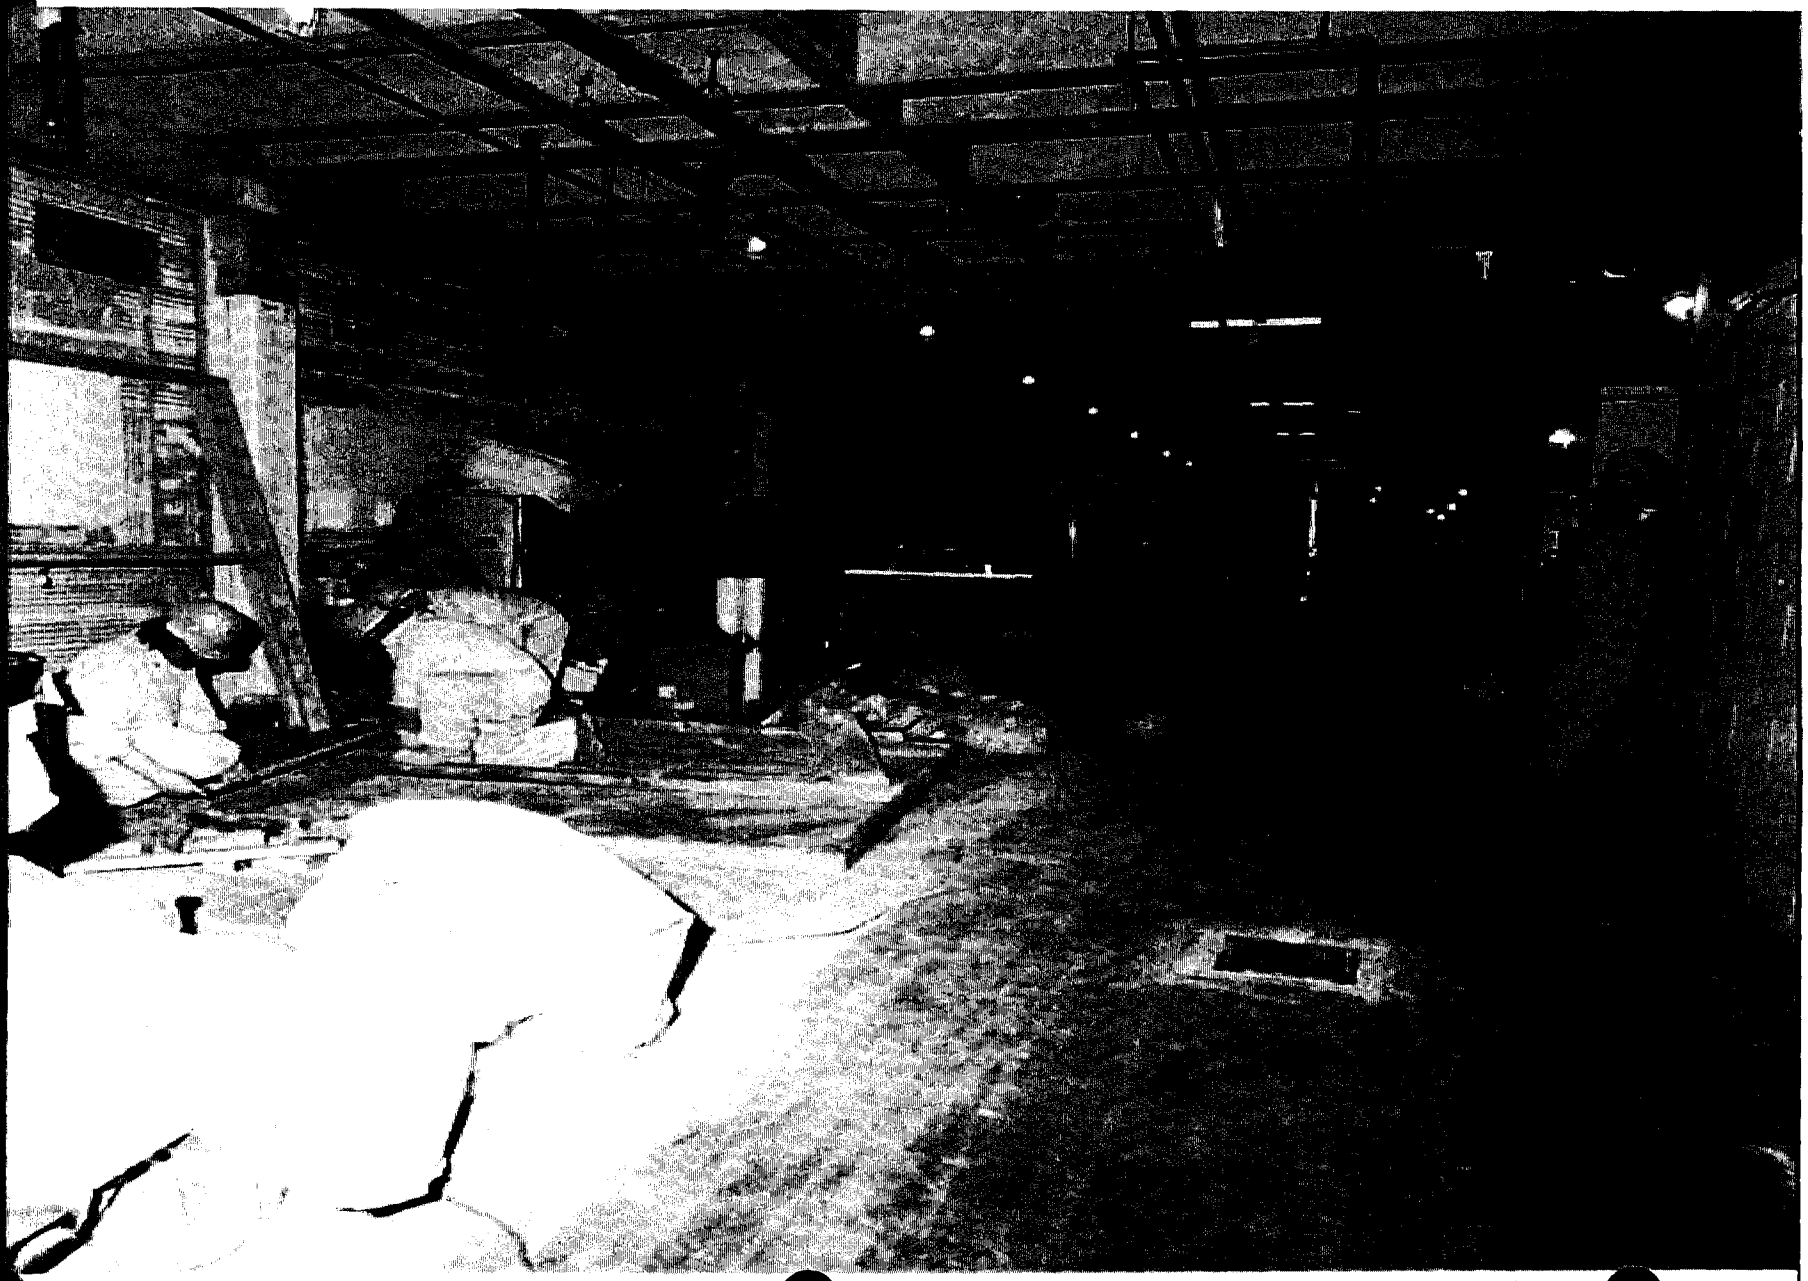
B779, Room 120 and 130 Series Walls Removed

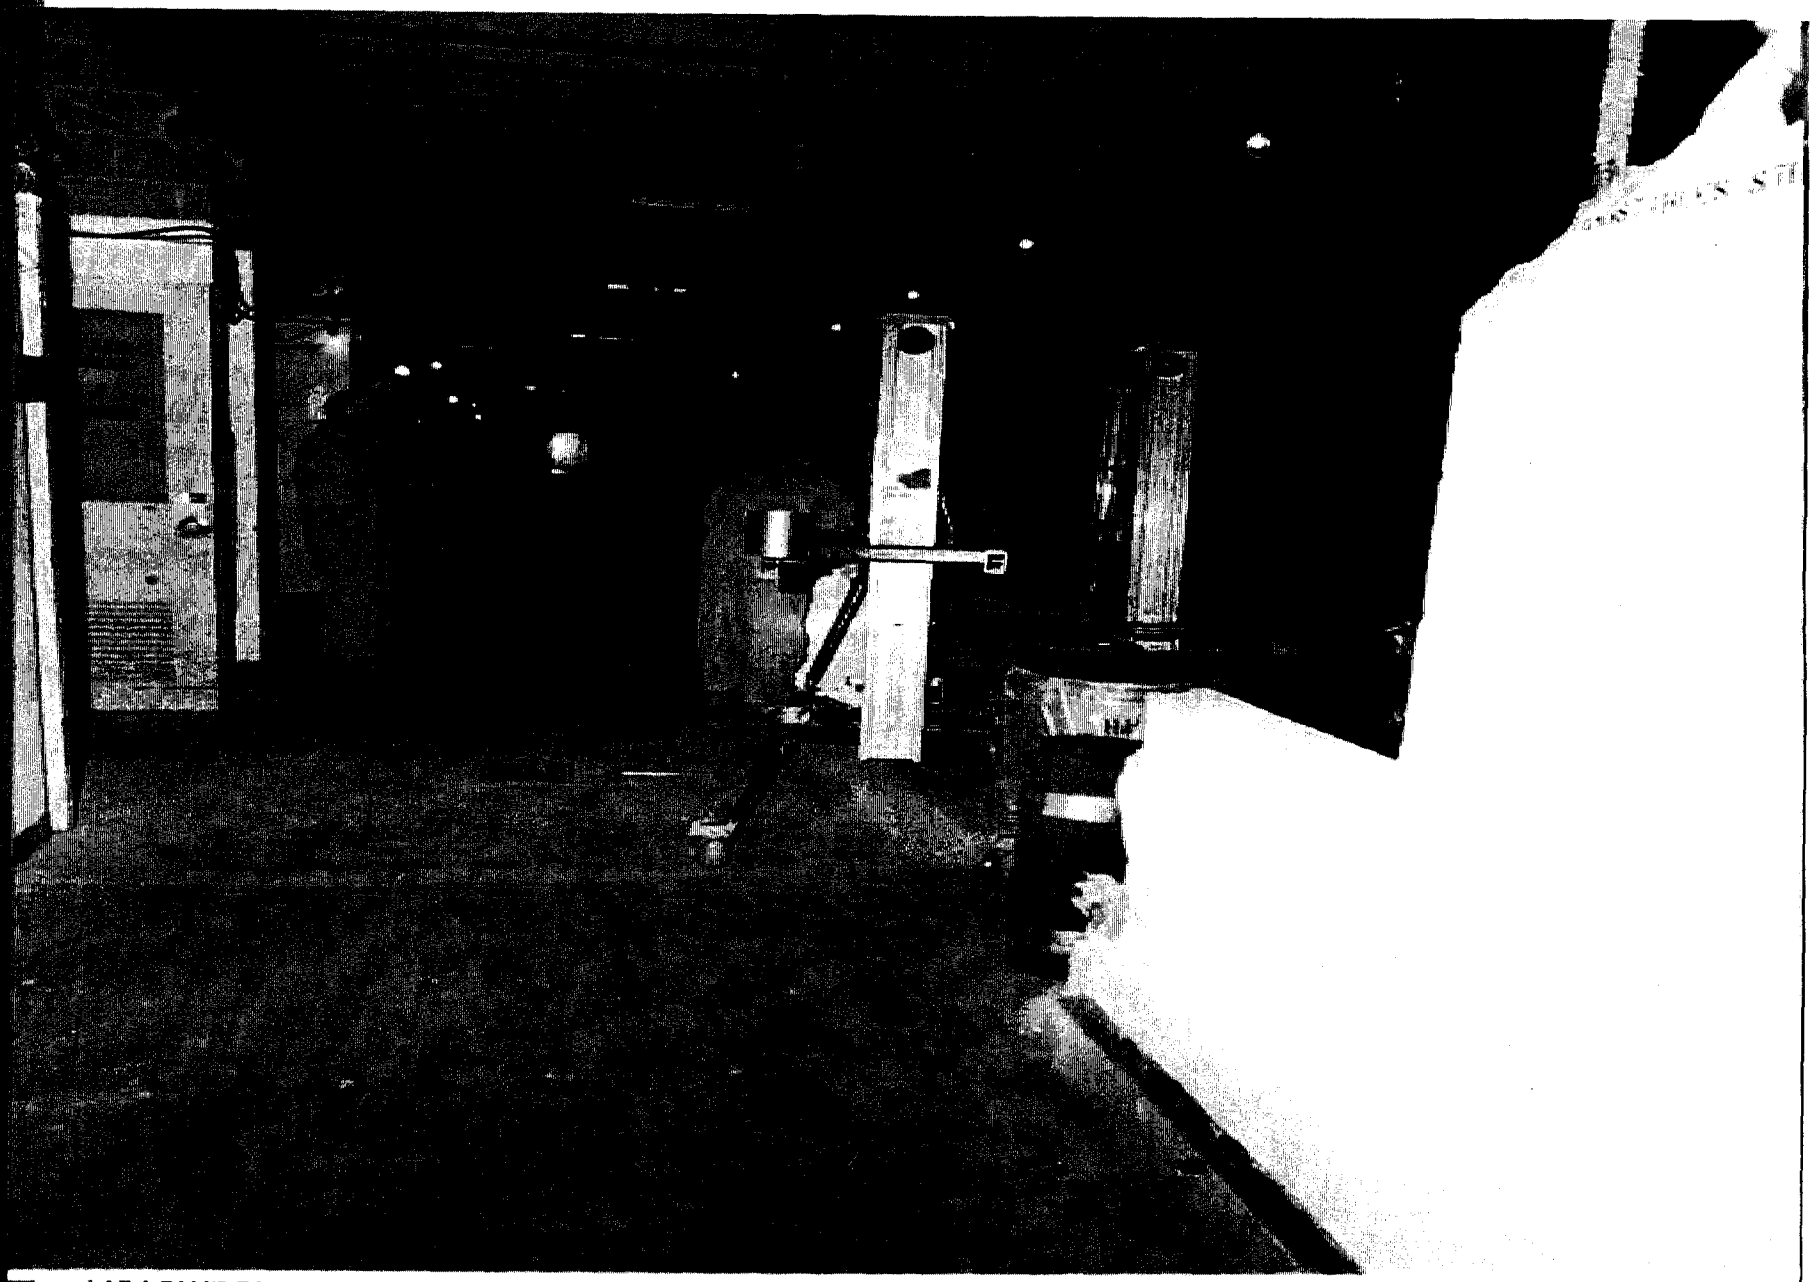
B779, Room 120 and 130 Series Walls During Removal

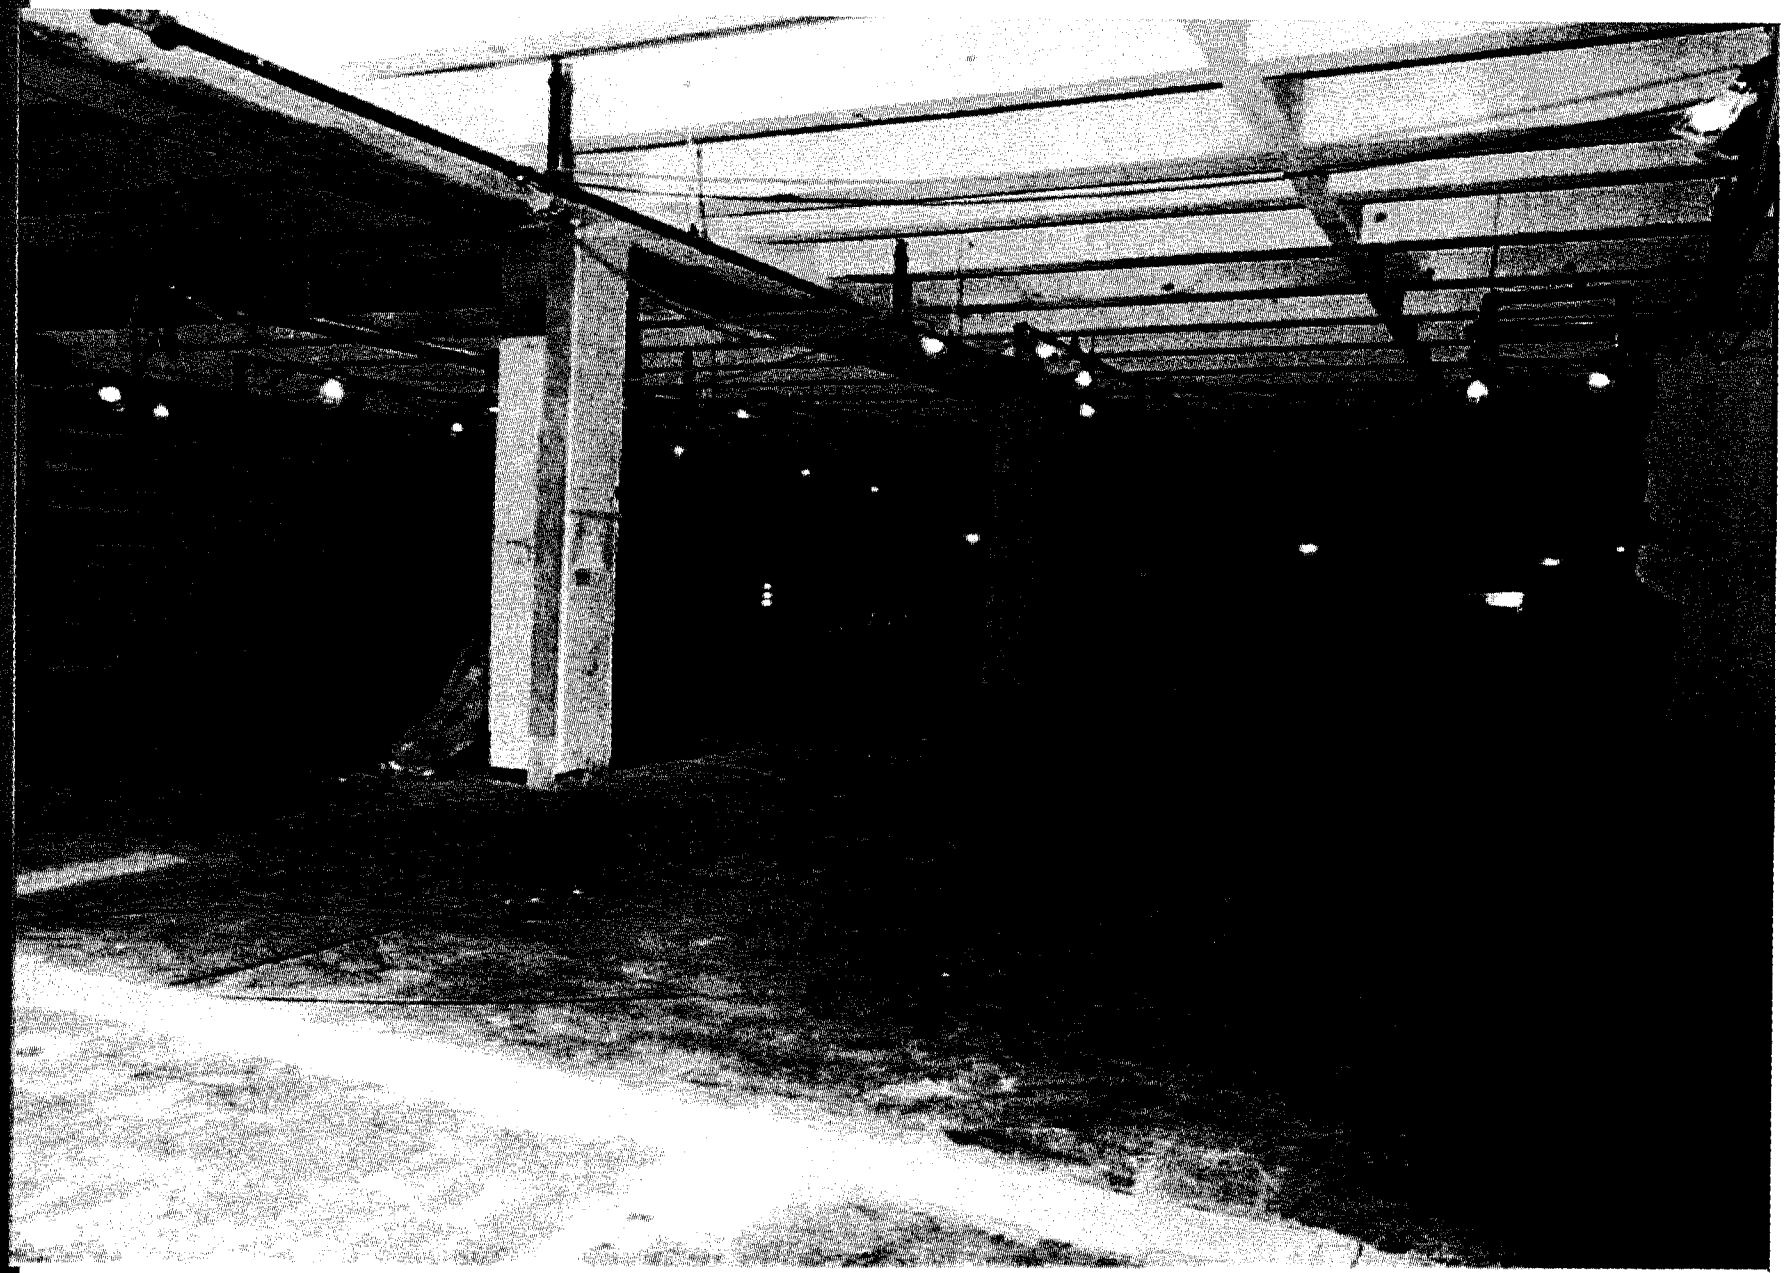
B779, Rooms 133, 137, 140, 141 Series Walls Removed

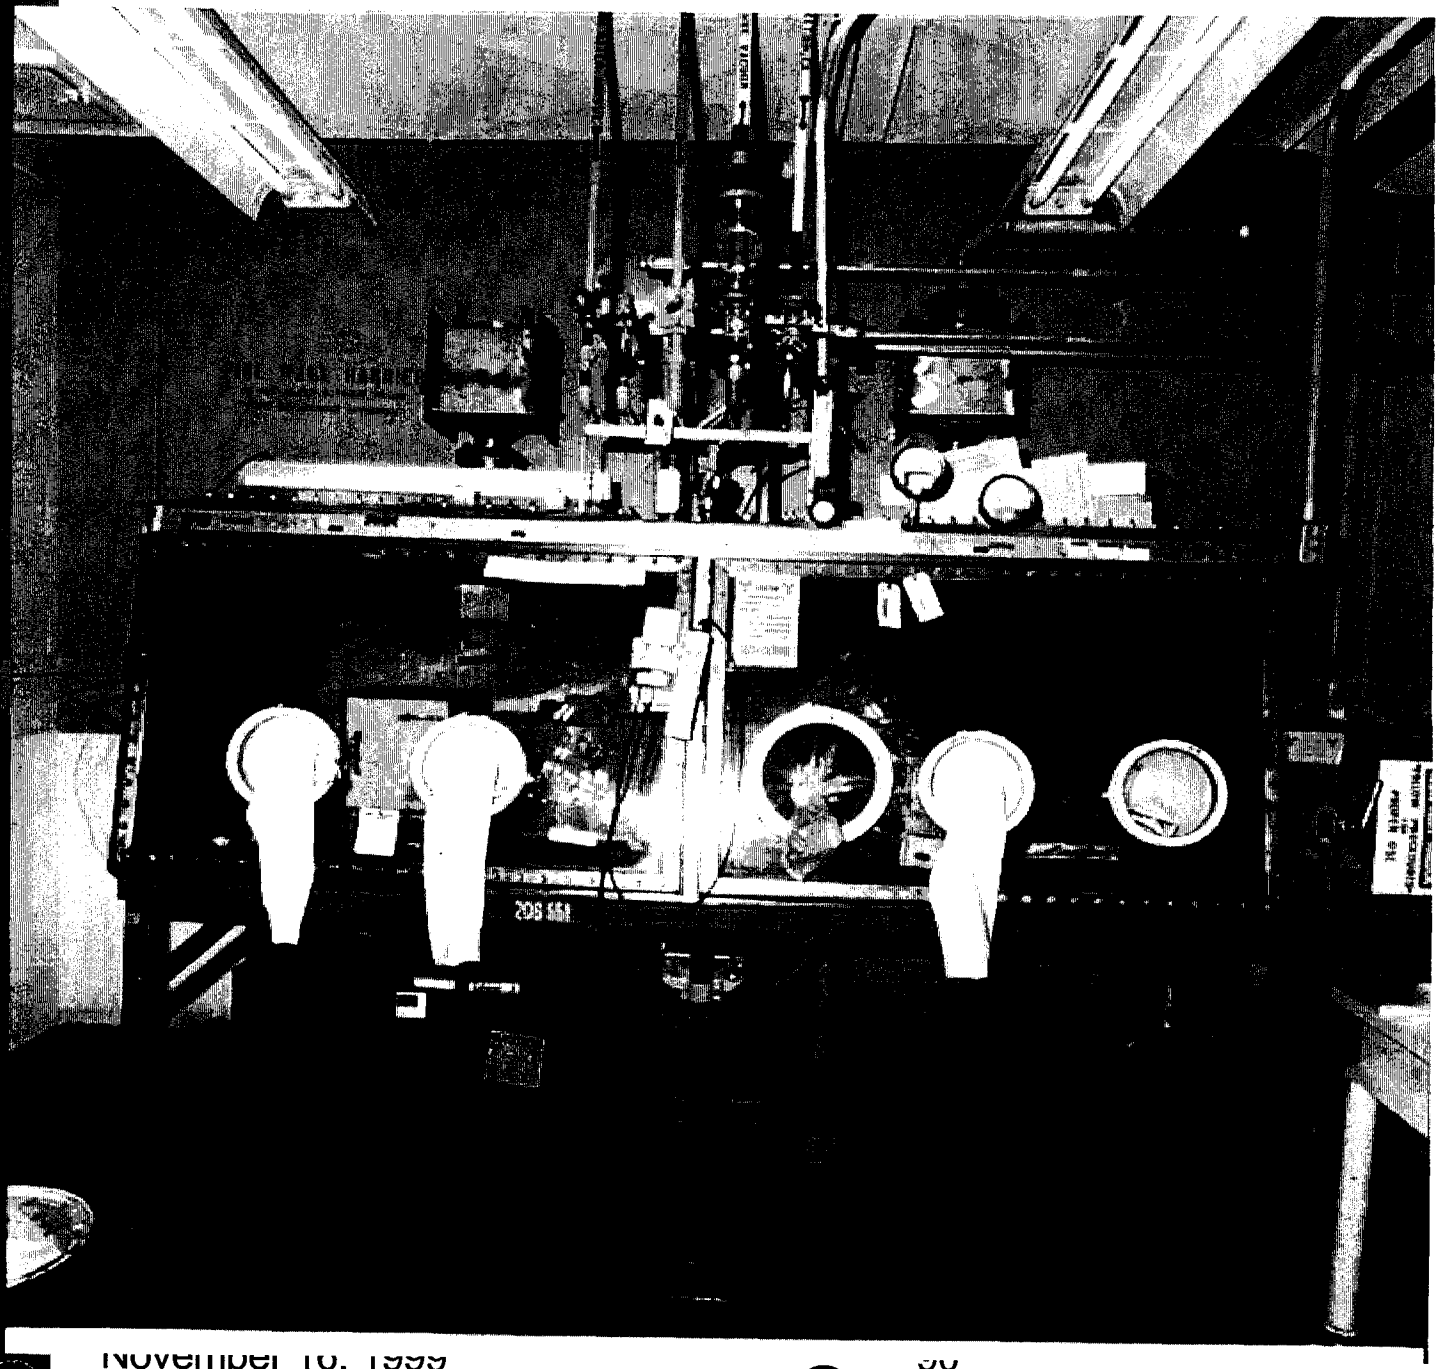
Building 779 - Room 137 *Glovebox 106 Before Removal*

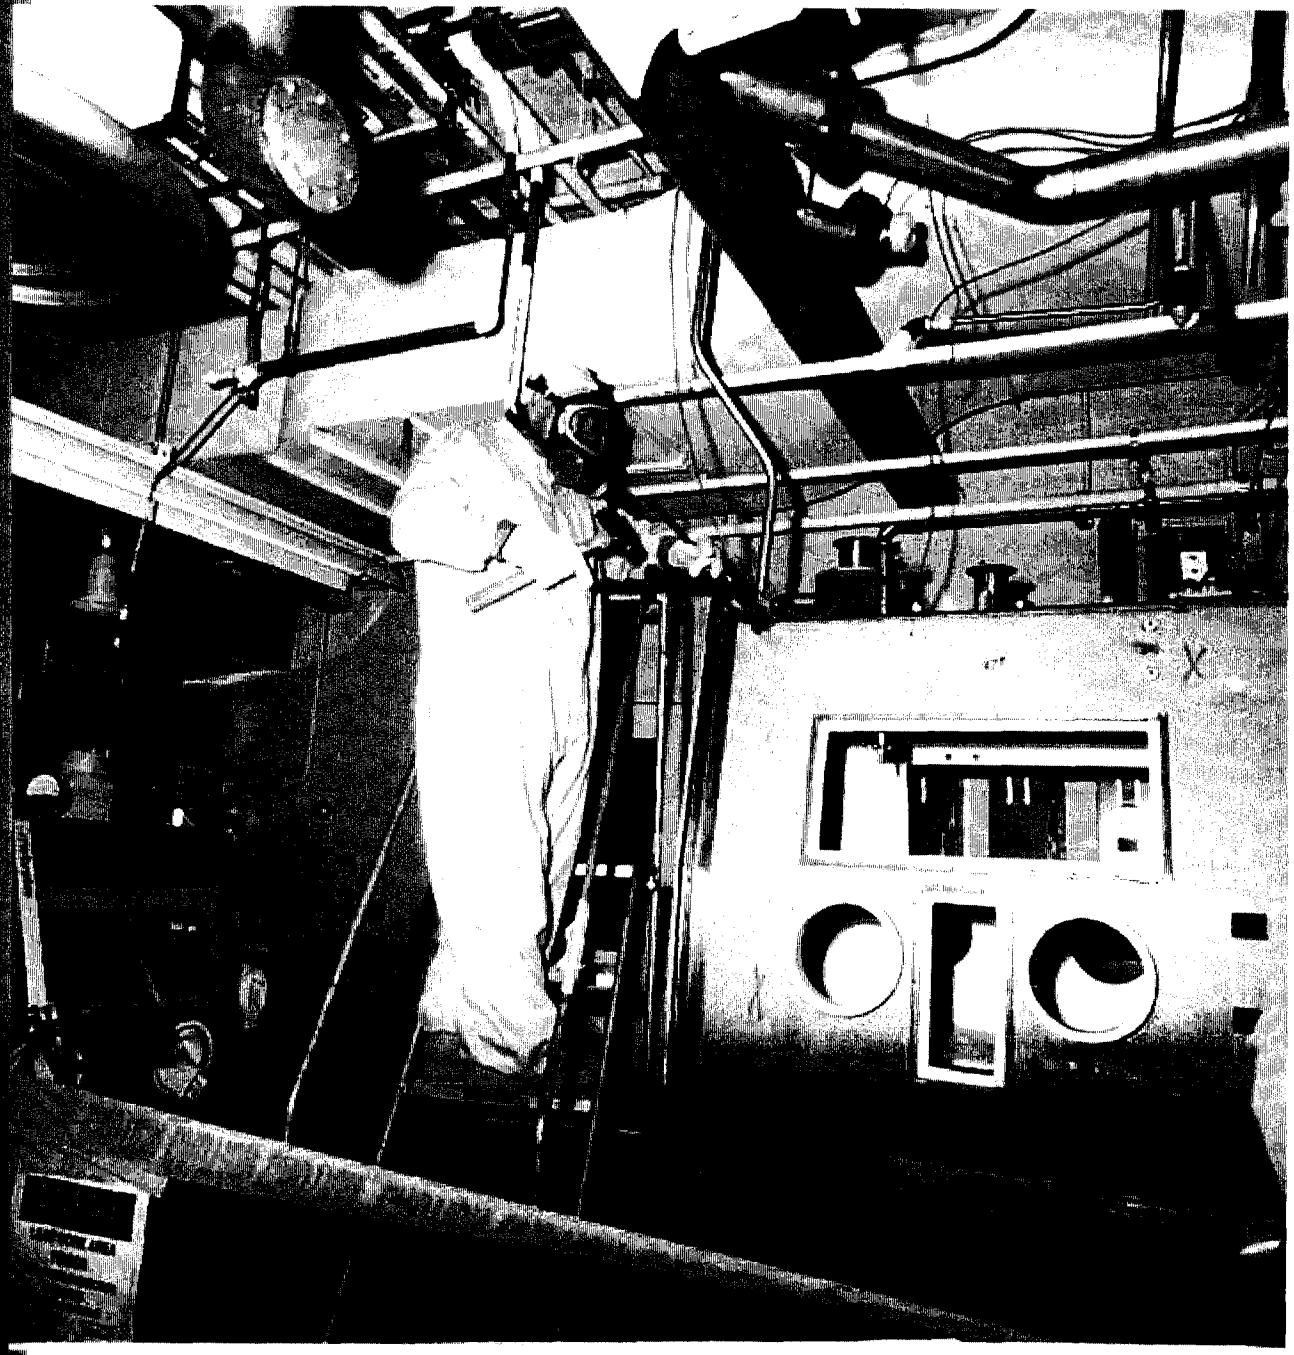
Building 779 - Room 222 Glovebox lead removal

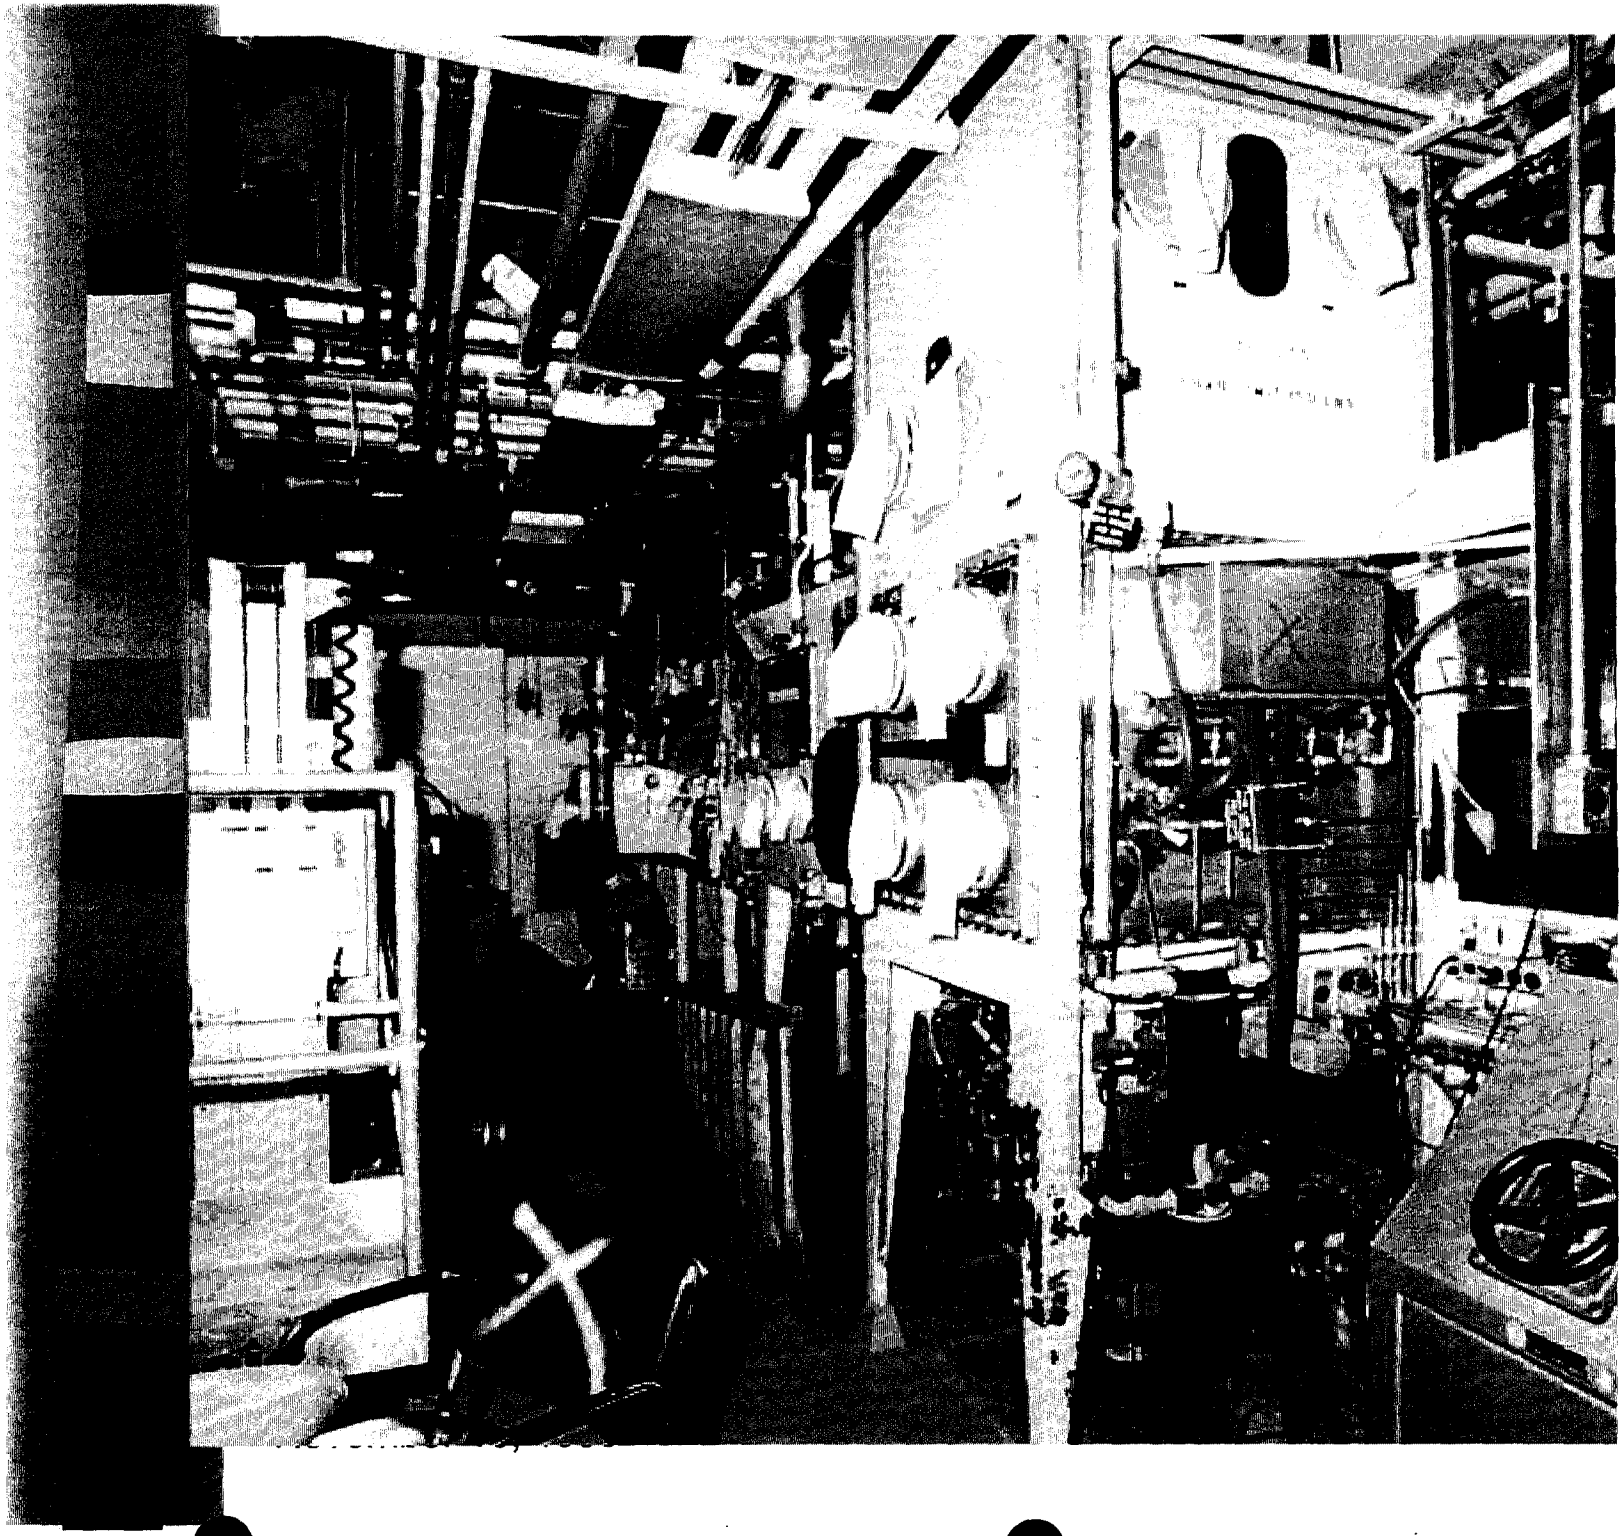
Building 779 - Room 152 GBs 208, 211 Before Removal

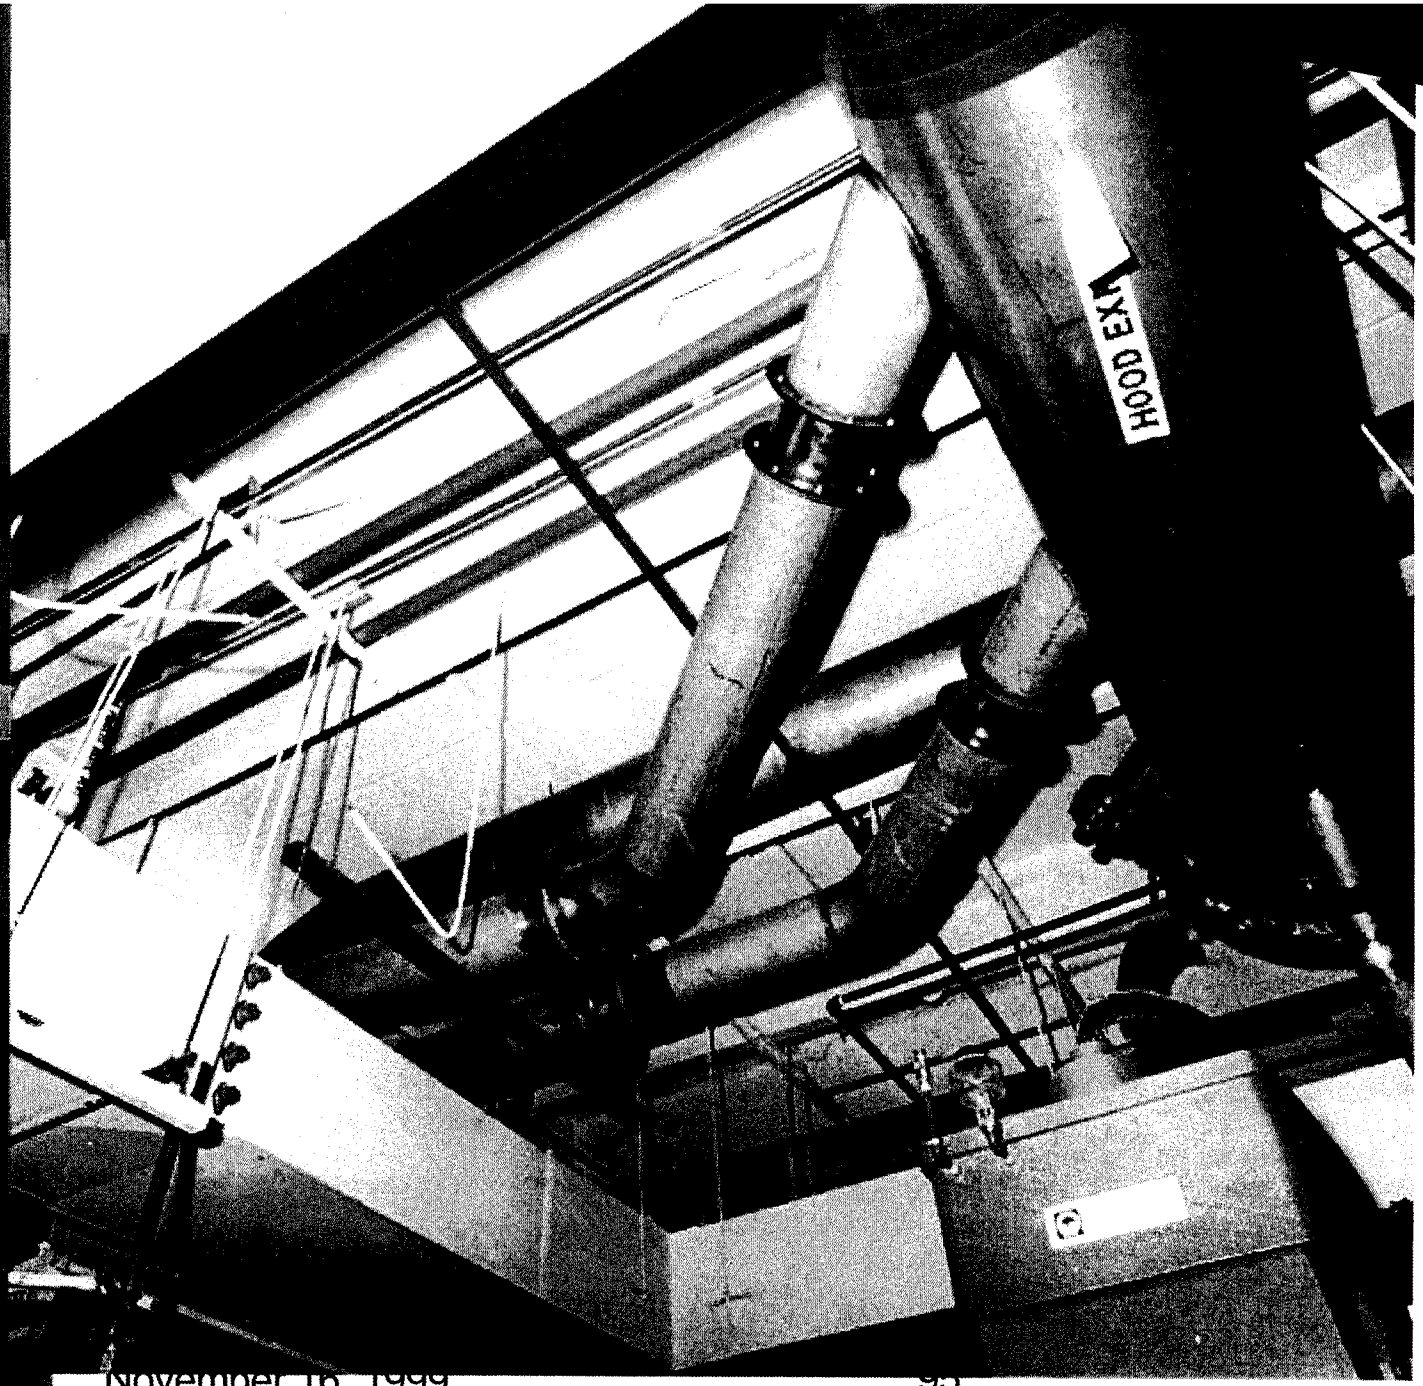
Building 779 - Room 150 Exhaust Hood and Piping

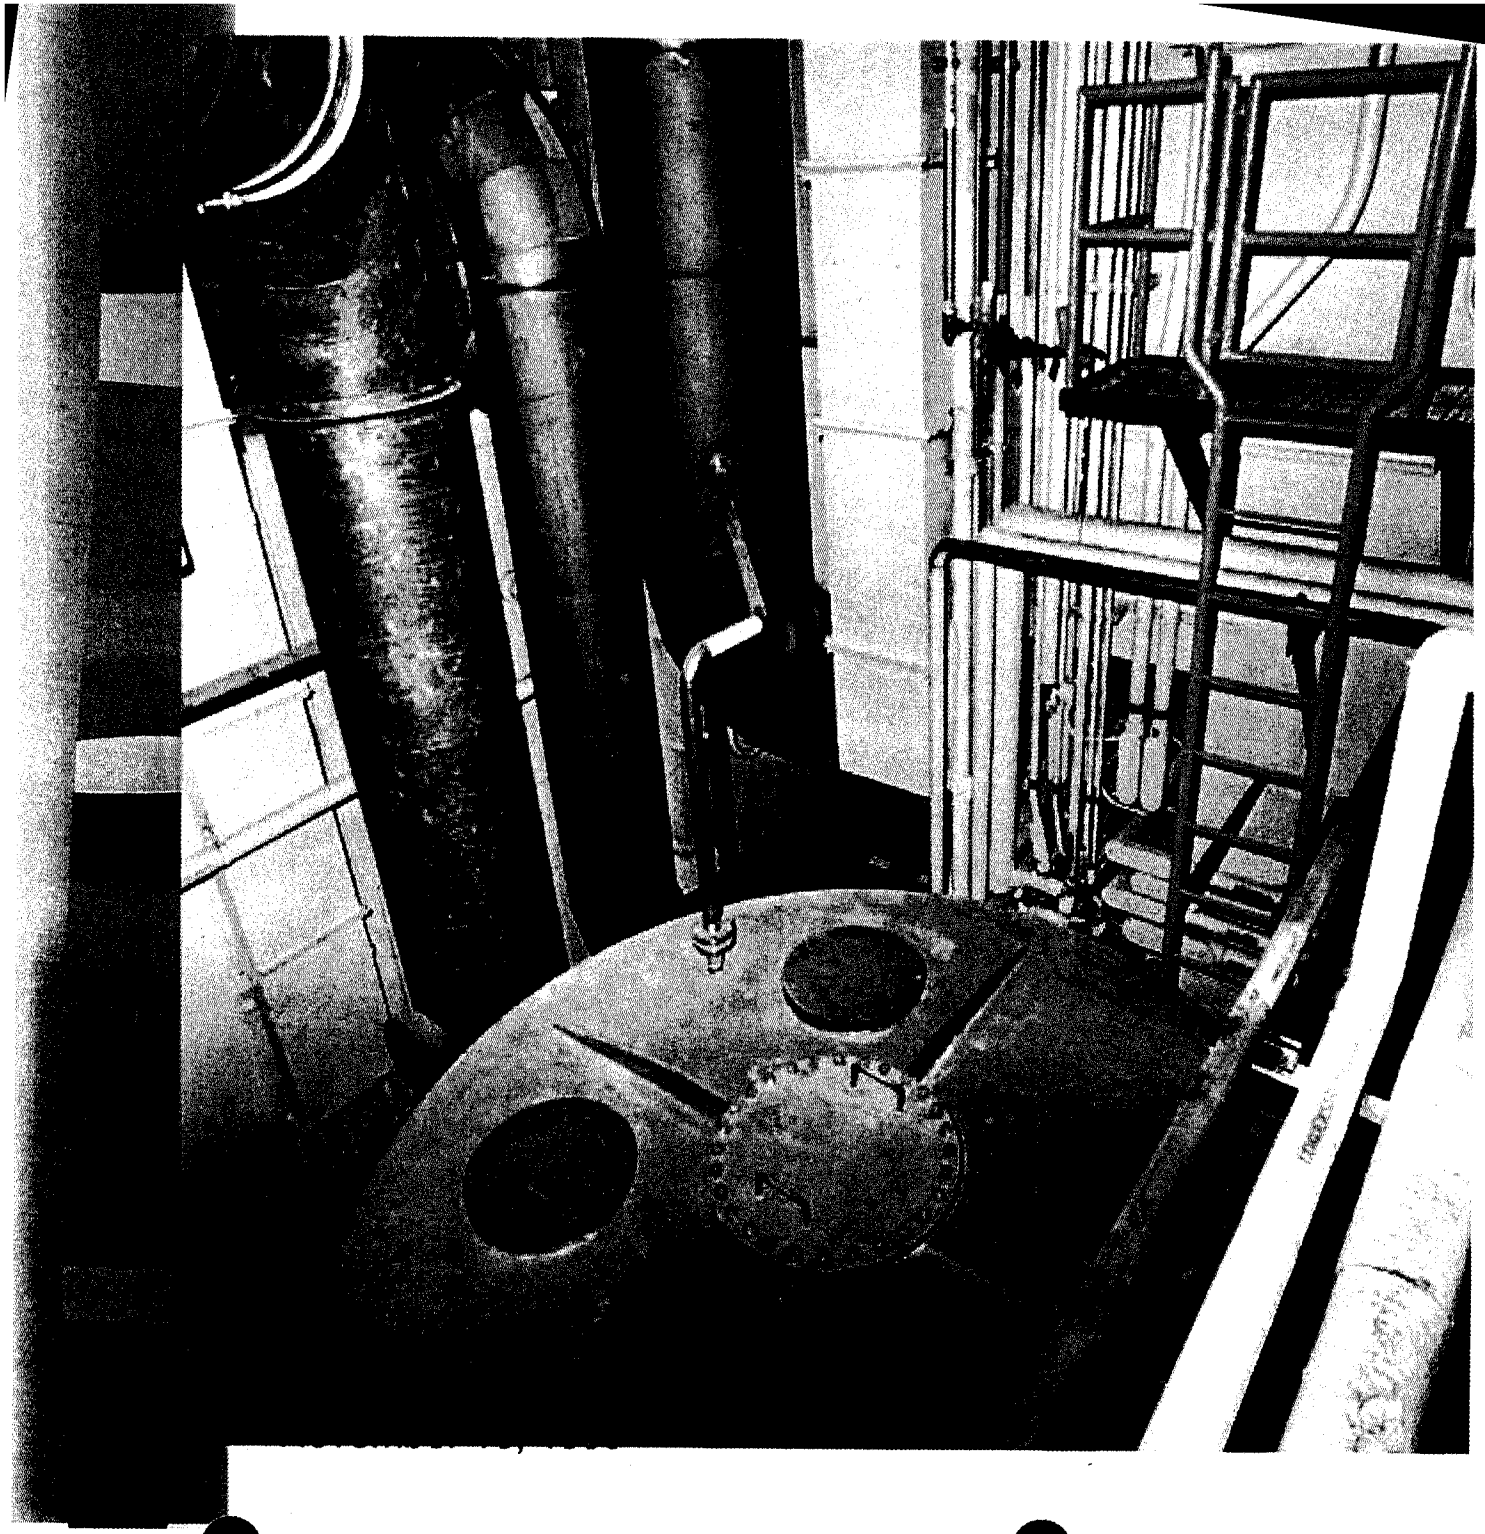
Building 782 Tank & Ductwork
