Rocky Flats Environmental Technology Site

PRE-DEMOLITION SURVEY REPORT (PDSR)

BUILDING 883 CLOSURE PROJECT

January 27, 2005

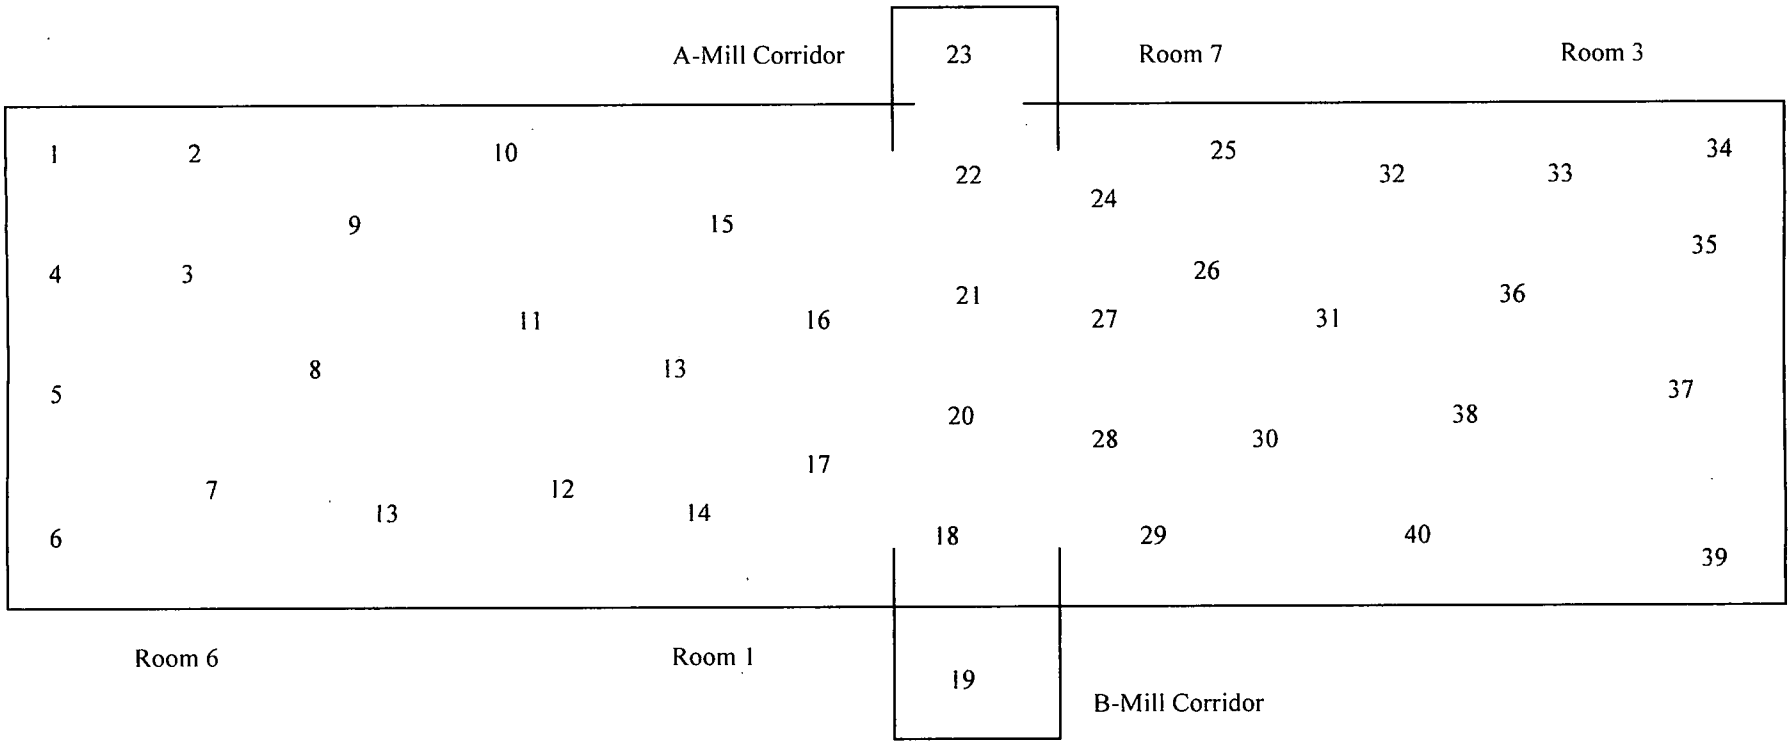
Floor, Walls and Overhead
Post-Decontamination Characterization Map

Approximate locations of readings are shown on map. See attached Contamination Data Summary sheets for activity levels seen and various surfaces surveyed. Readings taken were biased to find highest levels possible. All readings were taken after pressure washing and before application of fixatives to the general areas of the basement.
