ROCKY FLATS CLEANUP AGREEMENT (RFCA) STANDARD OPERATING PROTOCOL (RSOP) FOR FACILITY DISPOSITION - NOTIFICATION LETTER FOR 998 TUNNEL
FEG-002-04

991 TUNNEL (VAULT 998) RSOP NOTIFICATION FOR FACILITY DISPOSITION

2. **Calculation Title:** B998 VAULT & TUNNEL STRUCTURAL ANALYSIS FOR THE PREDICTION OF LONG TERM CONDITION

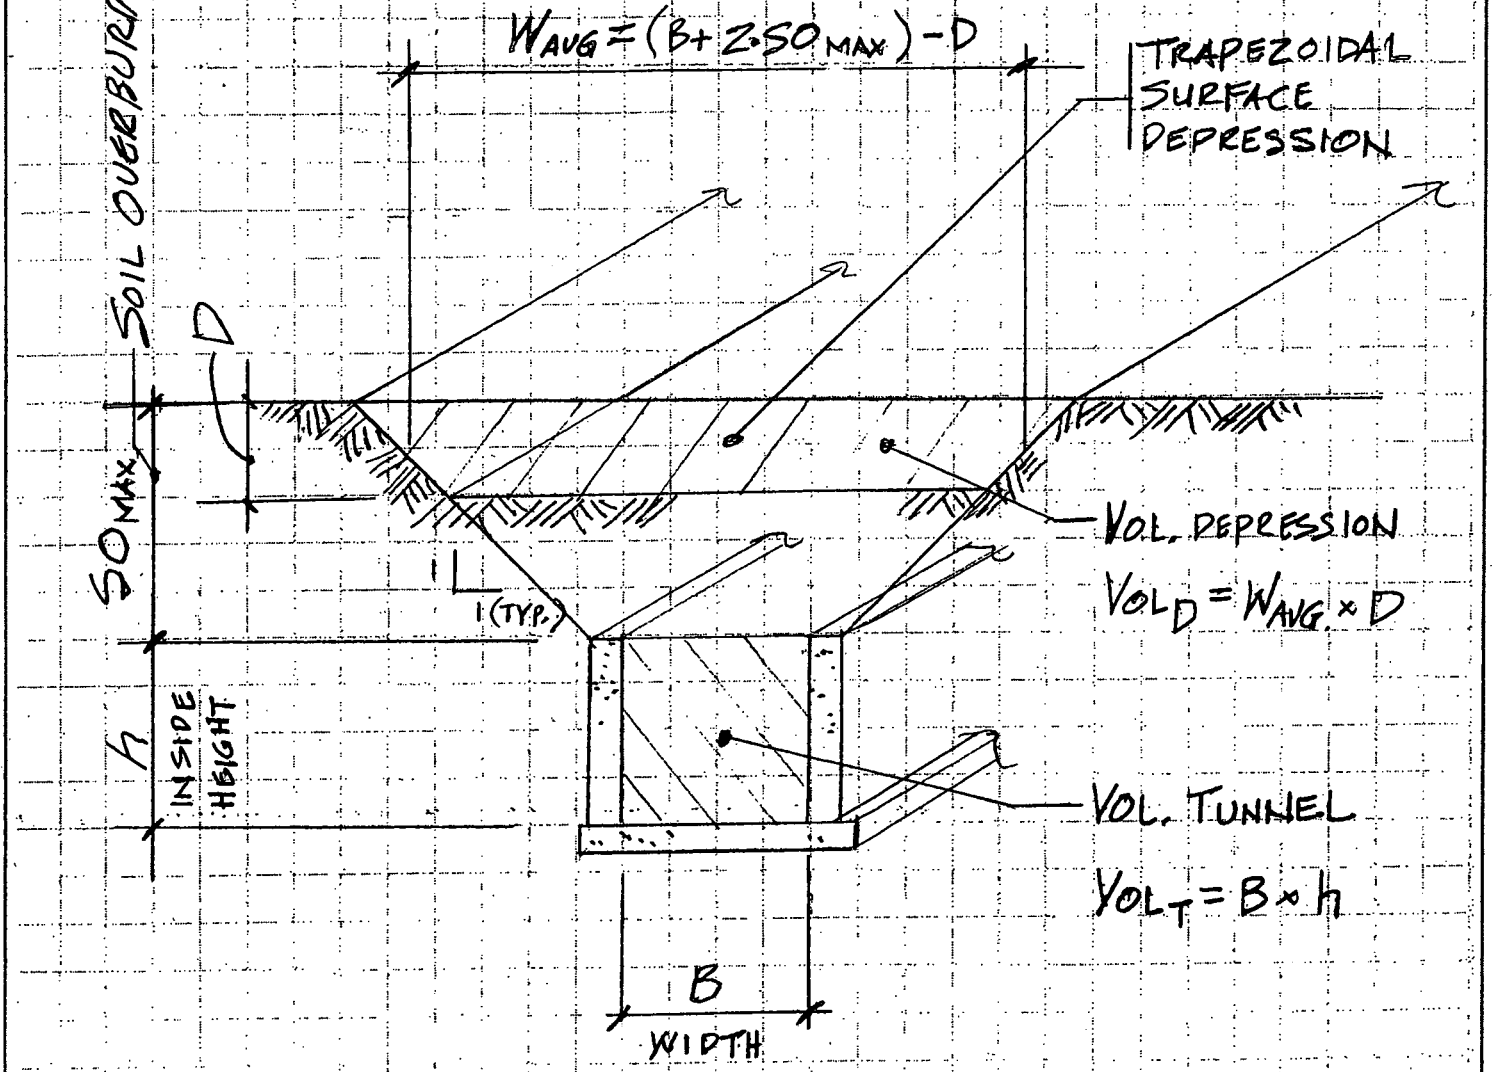
SECTION THROUGH TUNNEL

The deterioration of the vault and tunnel will be from ground water seepage into the concrete resulting in corrosion of the reinforcement. At some period of time, the reinforcement may become ineffective. The final strength of the vault and tunnel will depend on the uncracked ultimate tensile (rupture) strength of the concrete. When the concrete eventually deteriorates and cracks, the roofs will lose all strength and collapse. The collapse of the roof will cause the soil overburden to fill the vault and tunnel and cause a depression on the ground surface.

TUNNEL SURFACE DEPRESSION AFTER TUNNEL EVENTUALLY COLLAPSES

SURFACE DEPRESSION (TRAPEZOIDAL SHAPED) AFTER ROOF FAILURE

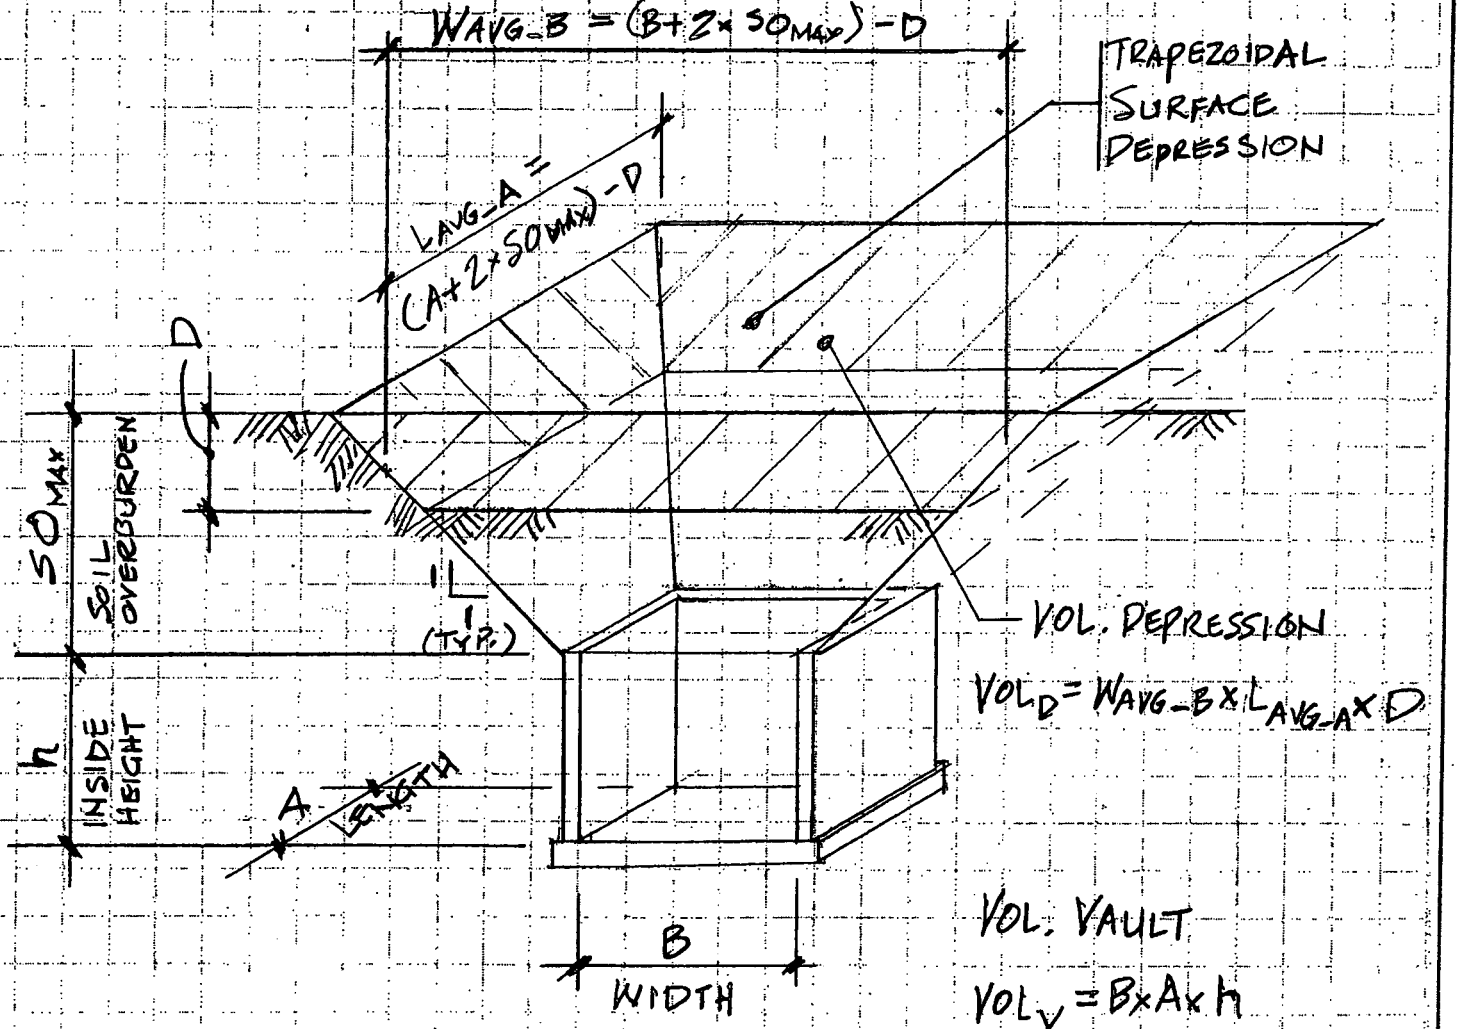
SECTION THROUGH VAULT

VAULT SURFACE DEPRESSION AFTER VAULT EVENTUALLY COLLAPSES

SURFACE DEPRESSION (TRAPEZOIDAL SHAPED) AFTER ROOF FAILURE

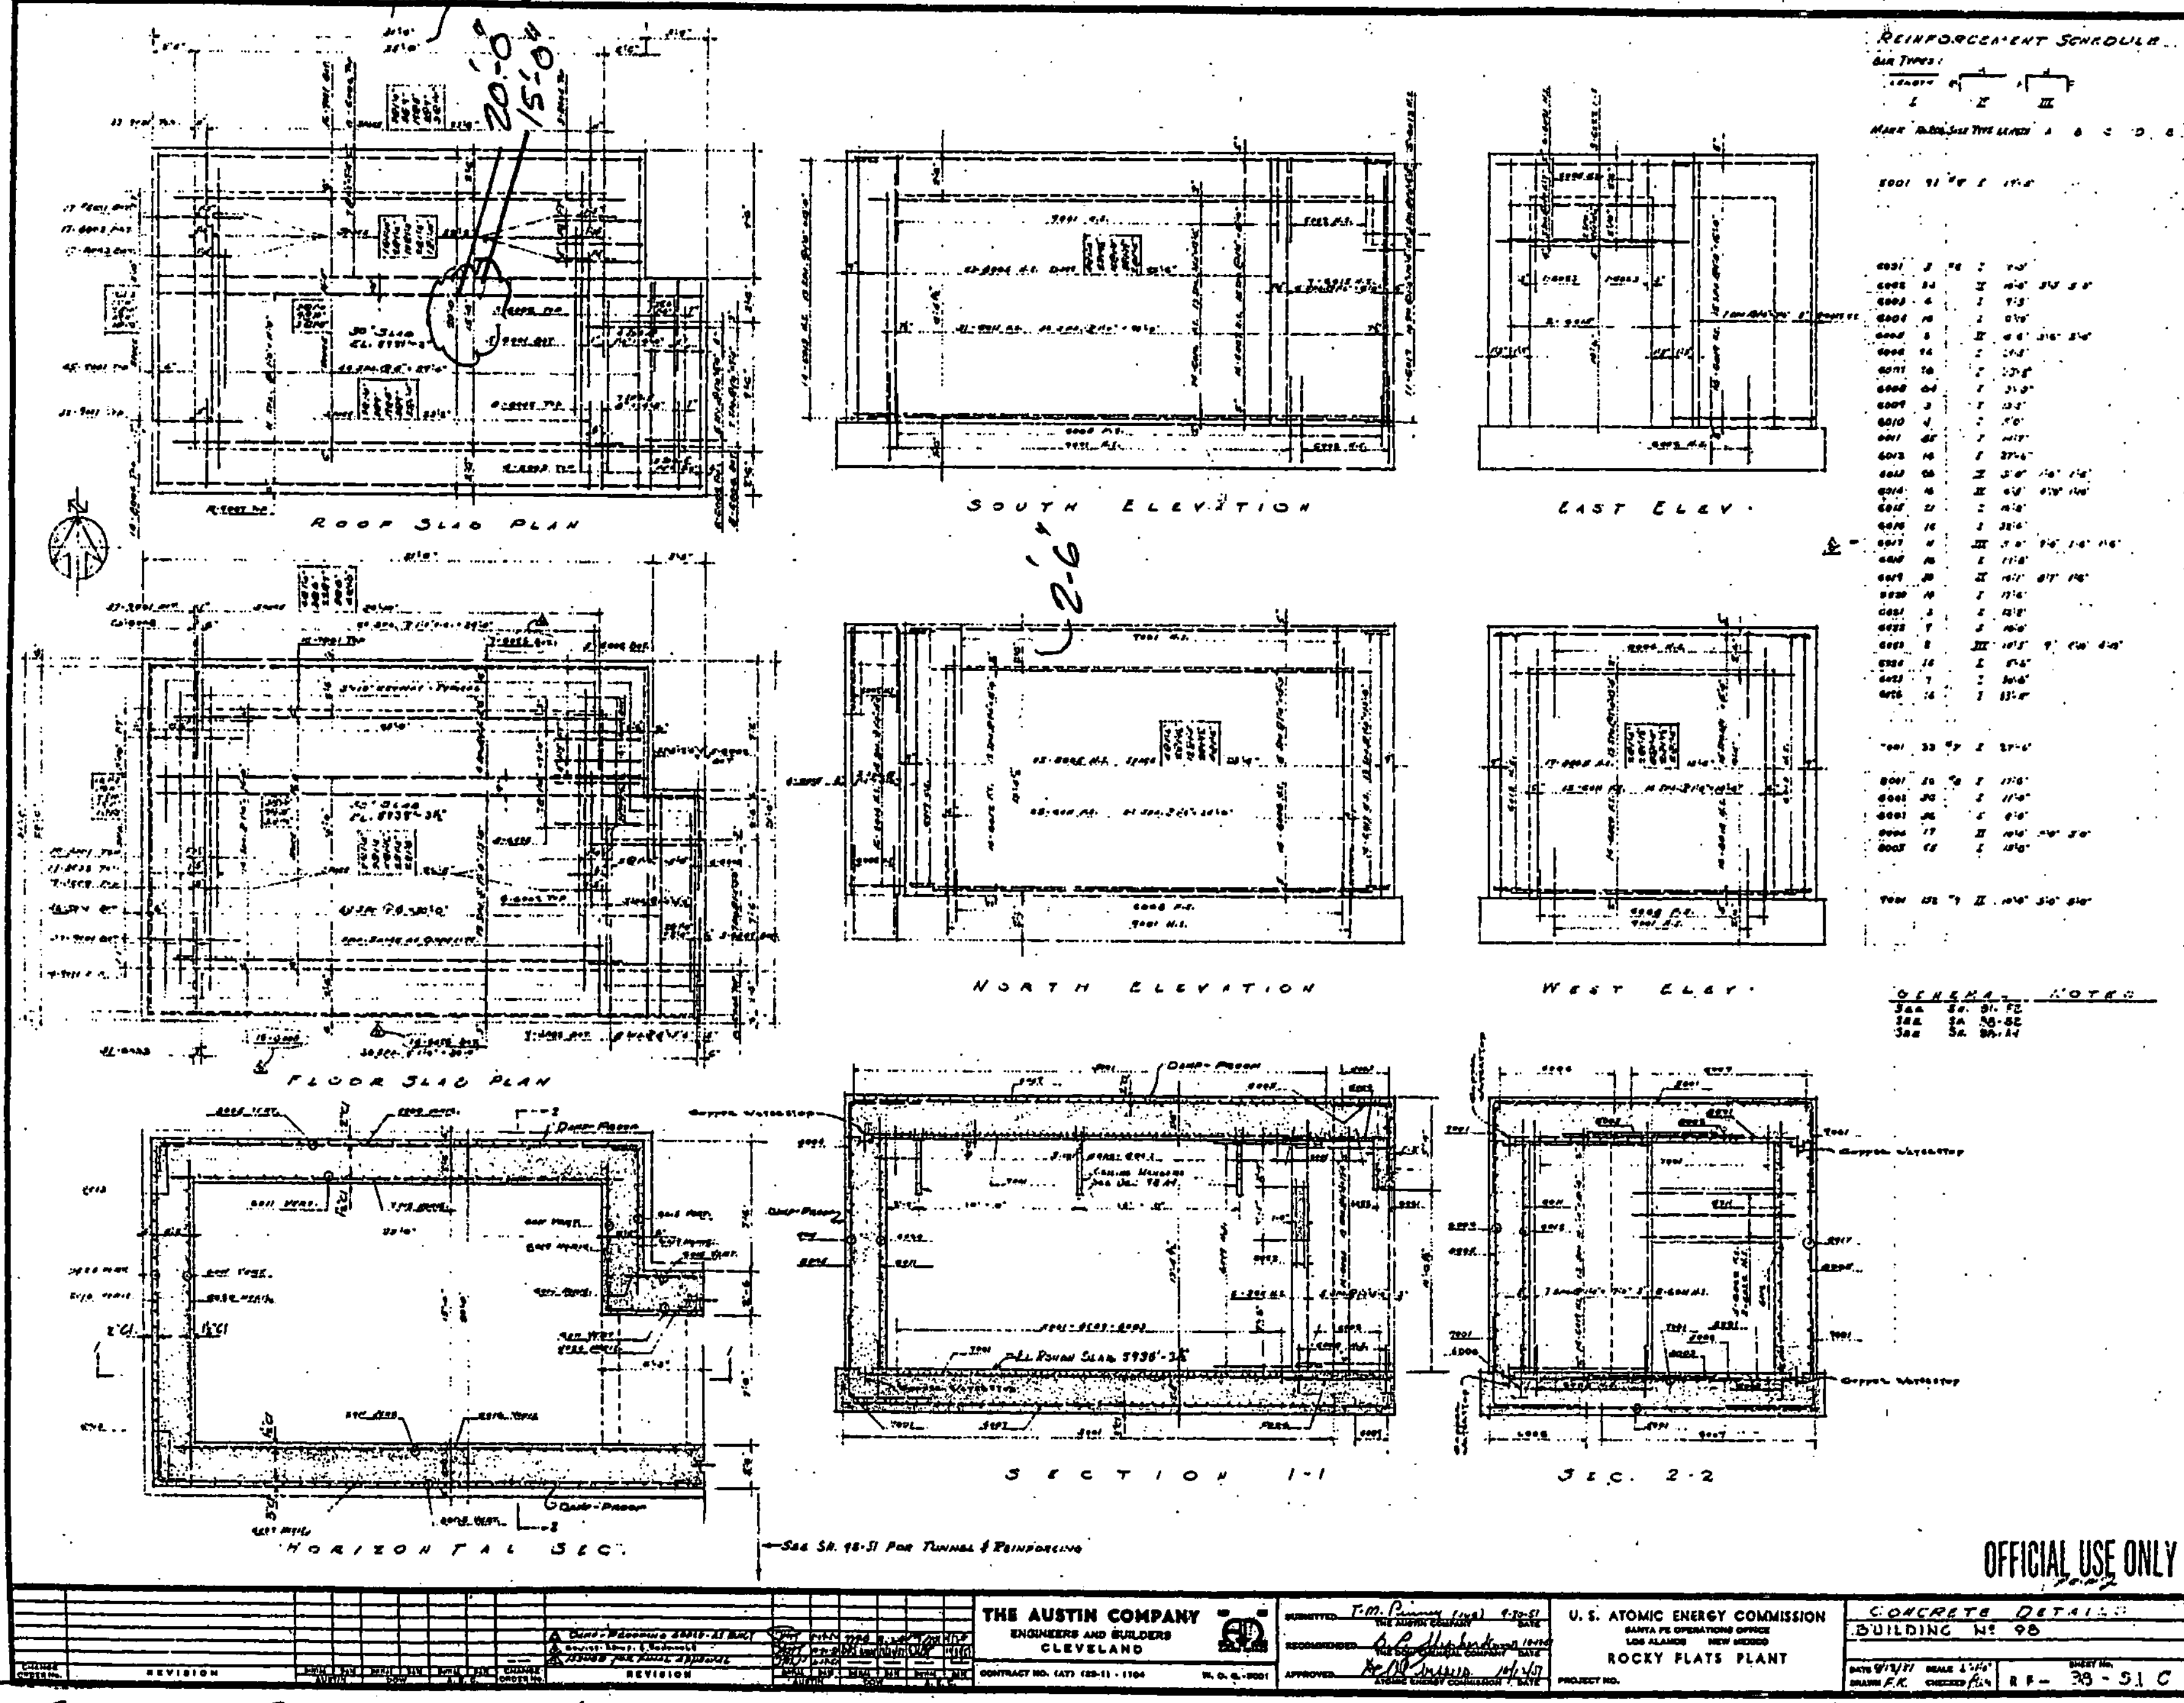
RFETS B998 DWG. No. & DISCIPLINE (00A01-007V) (ARCH)

The B998 vault and tunnel are in good condition with no evidence of corrosion, movements or settlements. There are no cracks except at one location (approx. 52 ft. North of B991) that was repaired (5-6-87) (see dwg. 38072-001). The D & D plan for B998 vault and tunnel is to demolish the first 60 ft. of the tunnel from B991 and foam the end. The rest of the tunnel and vault will be left in place and covered with soil.
