IHSS GROUP SW-2
ORIGINAL LANDFILL (IHSS-115)
ROCKY FLATS ENVIRONMENTAL TECHNOLOGY SITE
CONSTRUCTION COMPLETION AND CERTIFICATION REPORT

ATTACHMENT A OF THE
FINAL CLOSEOUT REPORT

VOLUME III

CONSTRUCTION QUALITY CONTROL DOCUMENTATION

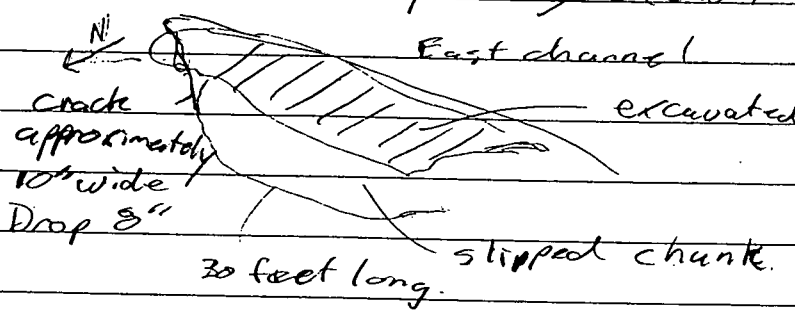
- Walkdown excated area on east channel No fill had taken place between last Friday and this Monday. Area above excavation had cracked fairly extensively "Iceberg area", pointed oval in shape. Appox 10' in middle and tapering down on ends to

Engineer Scott Powel on site to assess. Gave direction to fill channel with RFA and pack on toe area. This to build a buttress area. Cause deemed to be lack of below support during excavation. "Iceburg" will be trenched to observe soil condition
