Overview of the 3rd Quarter 2007 Surveillance and Maintenance Report for the DOE LM Rocky Flats Site

Rocky Flats Stewardship Council

February 4, 2008

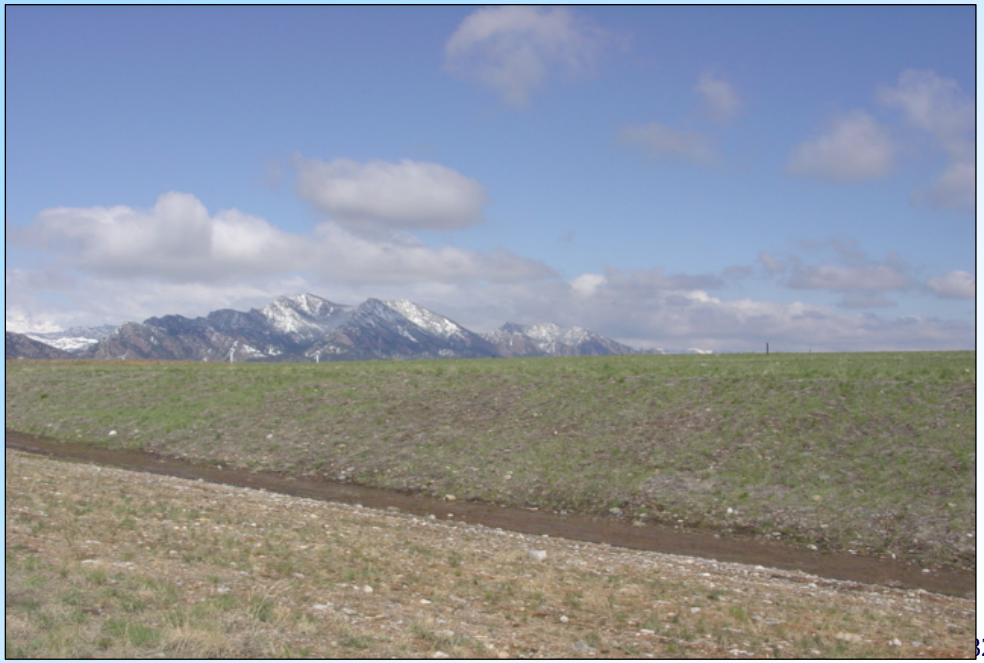
- **Present Landfill**
  - Inspections performed July 25, August 27, and September 27
  - Vegetative cover inspected July 11, August 8, and September 12
  - Followed prescribed checklist in Monitoring and Maintenance Plan (May 2006)
  - **No significant concerns**
