SUBJECT: Contract No. DE-AC01-02GJ79491, Stoller
Task Order Number ST07-110, LM Fernald LTS&M
Transmittal of the March 2007 Fernald Site Inspection Checklist

Fernald Site Area Post-Closure Inspection Checklist

FERNALD SITE - MARCH 2007
QUARTERLY SITE INSPECTION FINDINGS
Legend:
Priority Maintenance Zone
Red Notation - Priority Issues/Areas
Black Notation - Will be addressed as time permits
Types of Items Identified:
Thistle - Area where thistle needs treated.
Debris - Includes concrete, gravel, felt, metal, tile, plastic, etc.
Erosion - Consists of rills/gullies unless otherwise noted.
Ruts - Off-road vehicle damage.
Signs - Signs that have fallen or broken.
Nest - Goose nests.
Animal Burrow - Groundhog, muskrat, other.
Fence - Broken or fallen fencing.
SCALE
400 200 0 400 FEET
Tree tubes need removal. Trash around entrance.
Open Holes @ abandoned well #2679
Signs Covered
Fence Low
Broken Signs
Signs along road have fallen down
Backward Sign
Tubing needs to be removed from plants in wetland
Animal Hut
Garlic & Mustard in Pines
Silt Fence needs repair/removal
Sapling Fences Knocked Down
Cell 4/5 Cap Fence Post Exposed
Fence Damage

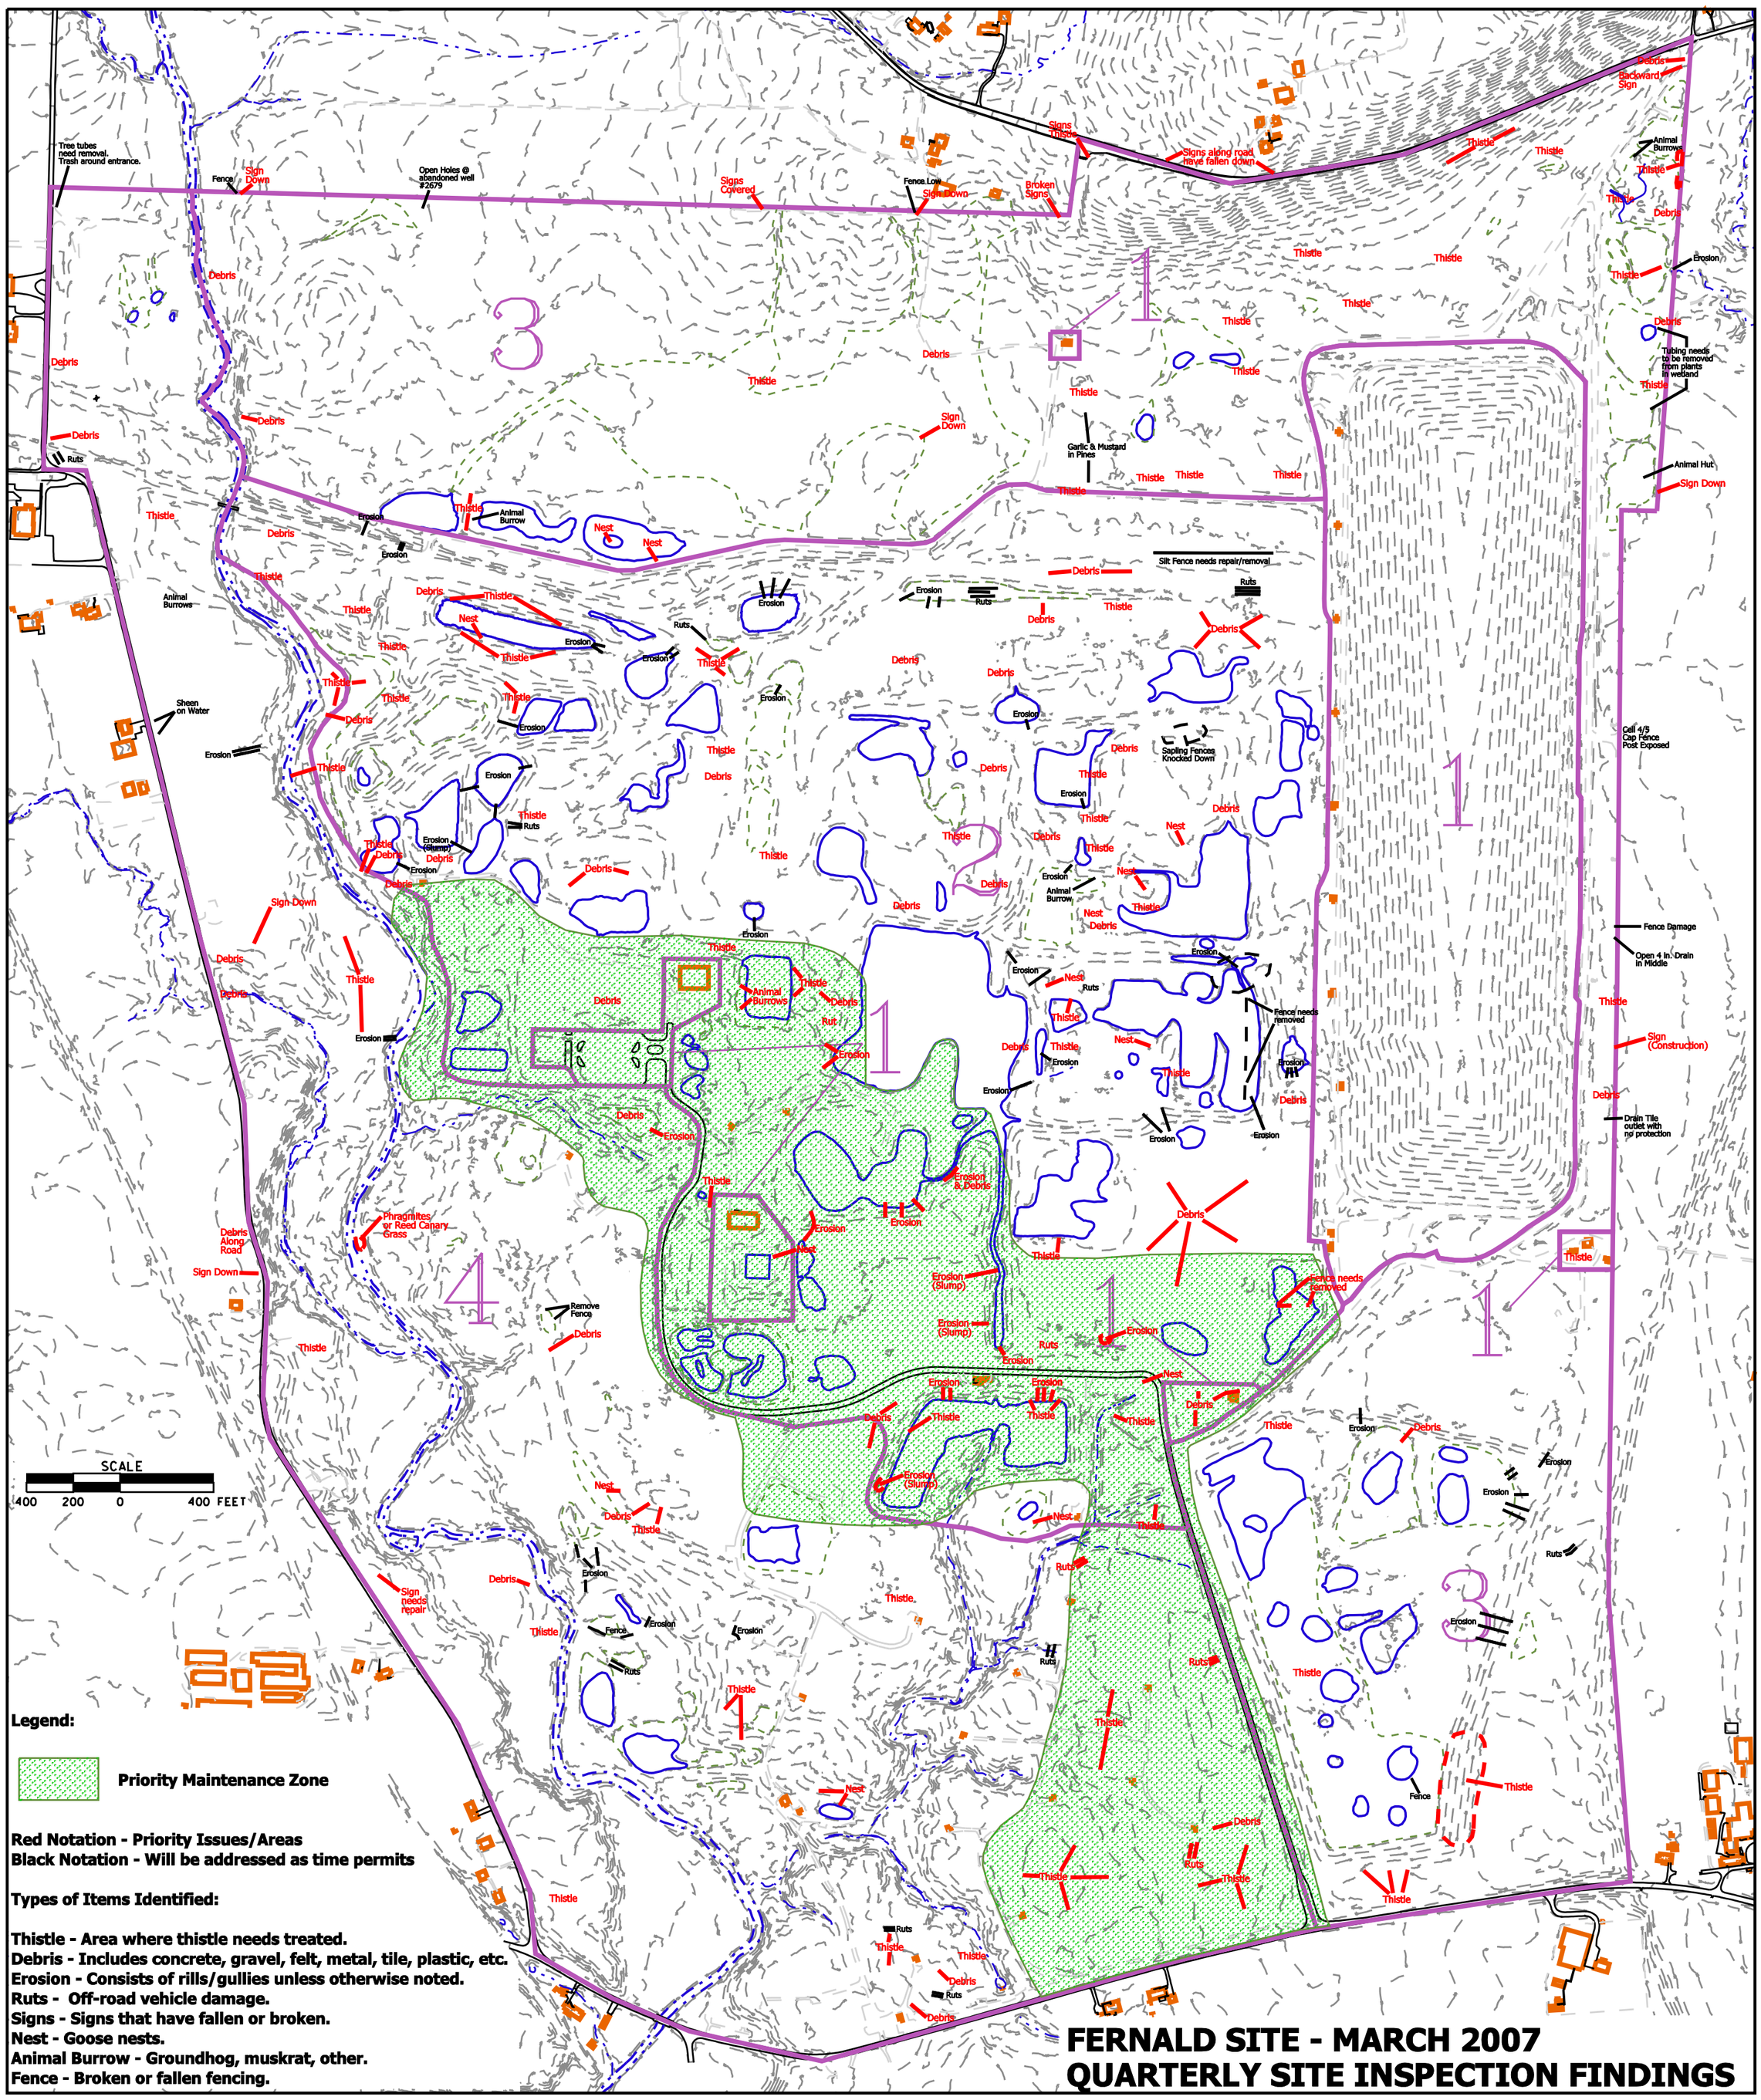
No signs of unauthorized use were observed. Institutional controls appeared to be functioning. Access points, gates, fencing, signs, and other infrastructure seemed to be secure and in good condition. Roads, parking lots, and walkways were generally in good condition. Restored areas are progressing as planned. However, a number of findings were observed during the site walkdowns. Findings were categorized as follows on the enclosed map:

- **Thistle** – indicates that a species of thistle is growing and needs to be treated with herbicide or cut
- **Animal burrows** – indicates an area where an unwanted burrow was present, either from a ground hog, muskrat, or other undesirable animal
- **Nests** – indicates a goose nest was present

- **Erosion** – indicates an area where erosion is occurring and needs to be monitored or addressed
- **Debris** – indicates that some form of debris is present that needs to be removed. Debris could include concrete, drain tile, glazed tile, gravel piles, felt, other construction debris
- **Signs** – indicates that a sign is down or is otherwise illegible and needs repaired or modified
- **Fence** – indicates that fencing is down or damaged and needs addressed
- **Ruts** – indicates areas where deep ruts exist that need to be addressed

Open 4 in. Drain in Middle
Fence needs removed
Sign (Construction)
Drain Tile outlet with no protection
Phragmites or Reed Canary Grass
Debris Along Road
Remove Fence
Sign needs repair
Sheen on Water

Corrective actions to address findings from this inspection will be handled in two ways. First, the enclosed figure depicts a "priority maintenance zone" that has been established along the paved road to the Converted Advanced Wastewater Treatment (CAWWT) and the future Visitors Center. Priority will be given for corrective actions in this area. Second, several findings that require immediate action either to prevent more long-term problems or to ensure compliance with the LMICP will be prioritized as well. Examples of such site-wide findings include control of thistle, goose nests, debris and signage. These types of findings are indicated in red on the attached figure.

Corrective actions are under way. Thistle and other noxious and invasive plant species will be physically removed, trimmed, and/or treated with herbicide by a licensed herbicide applicator. The type of herbicide used will vary depending on the location of the weed and the type of vegetation surrounding it. Herbicide application began May 10, 2007.

Debris was marked in the field with a pin flag. Unexpected debris will be characterized by Radiological Control personnel as stated in the LMICP. Non-contaminated debris will be disposed of in a regular dumpster and contaminated debris will be disposed of in the Radioactive Materials Area dumpster located in the CAWWT facility. Radiological survey work is under way. To date, no debris identified during the site inspection has been contaminated.

Plans are under way to address areas of erosion. In some cases, more detailed design is required. Bioengineering and natural channel design principals will be used whenever possible.
