DOE/ID/12584–244
GJPO–OXN–04

Summary Environmental Site Assessment Report for the U.S. Department of Energy Oxnard Facility, Oxnard, California

February 1996

U.S. Department of Energy
Grand Junction Projects Office

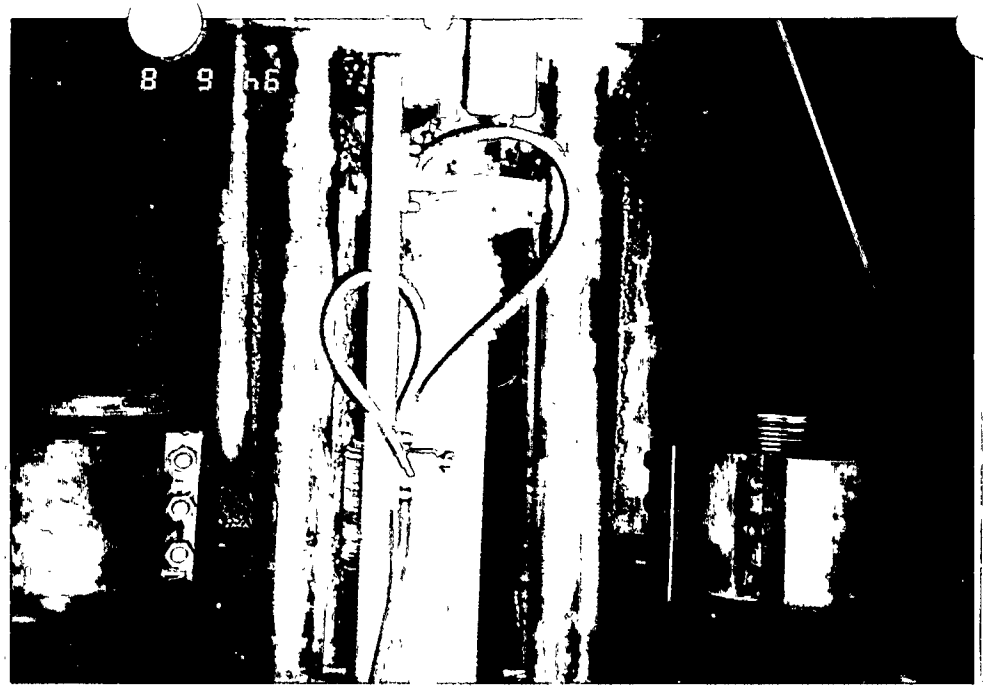
Building #6
Forging Hammer Trench
Hydraulic Hosing
&
Hammer Dampeners

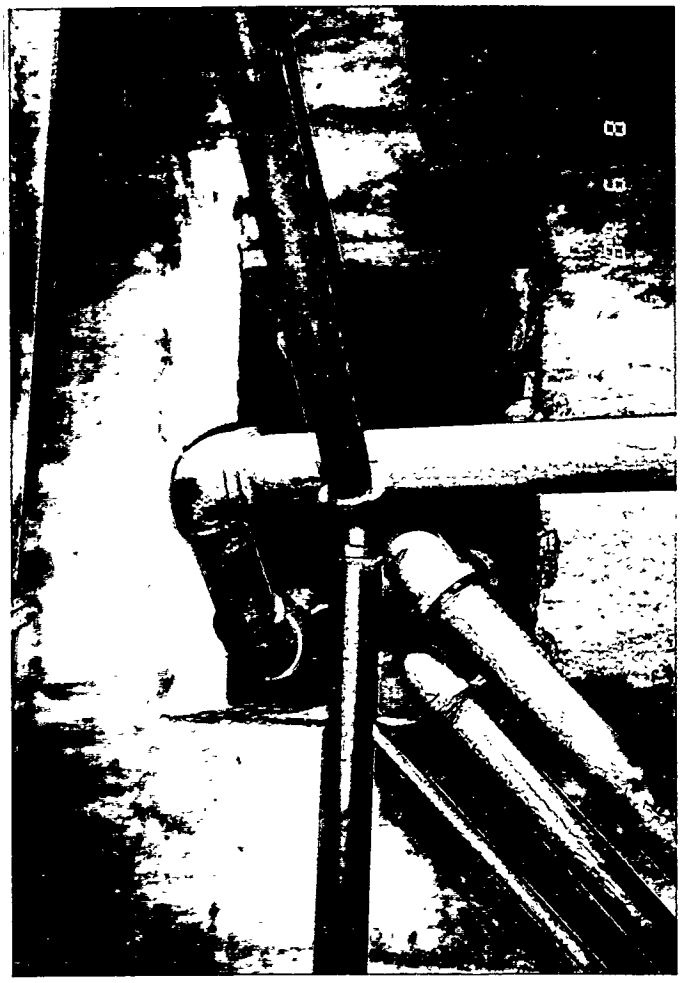
Building #6
Forging Hammer Trench
Metallic Oily Water Sludge
Beneath Grating

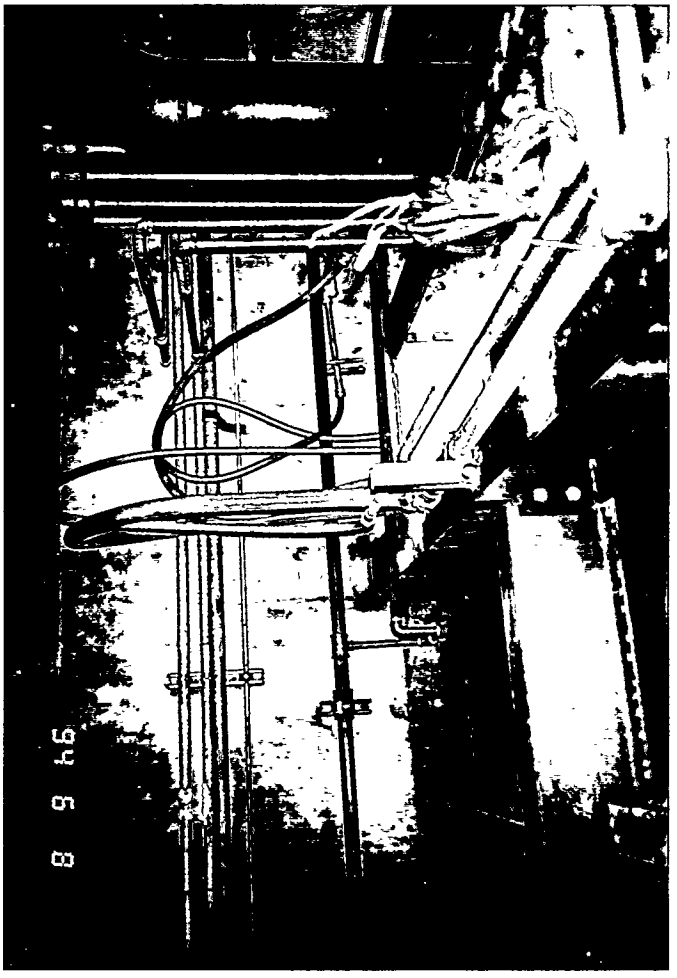
Building #6
Forging Hammer Trench
Hammer Pedestal Bench
Oily Sheen

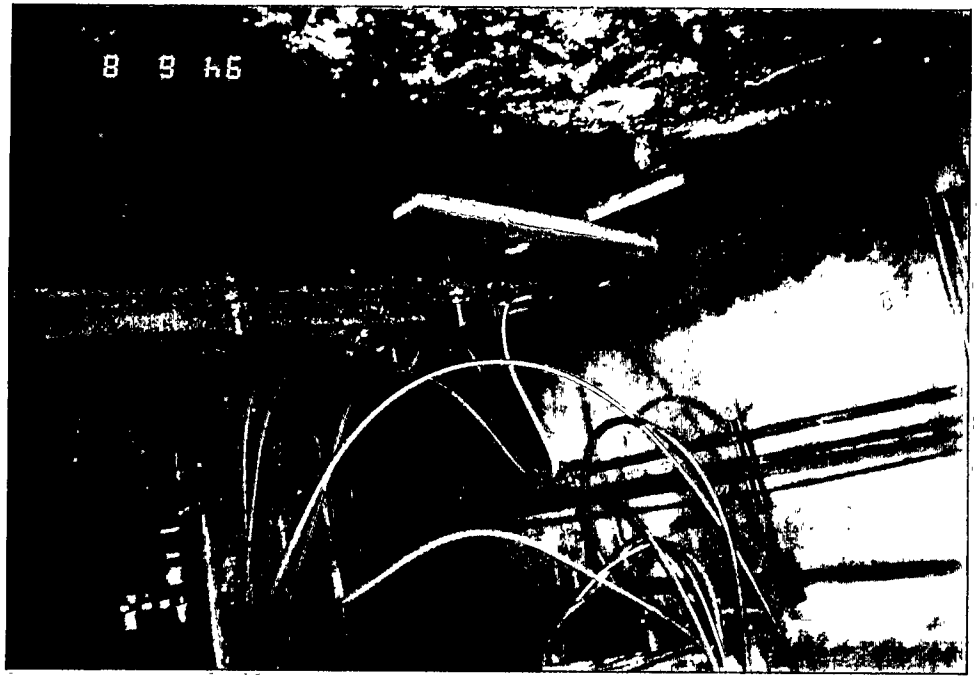
Building #6
Forging Hammer Trench
Oily Metal Shavings

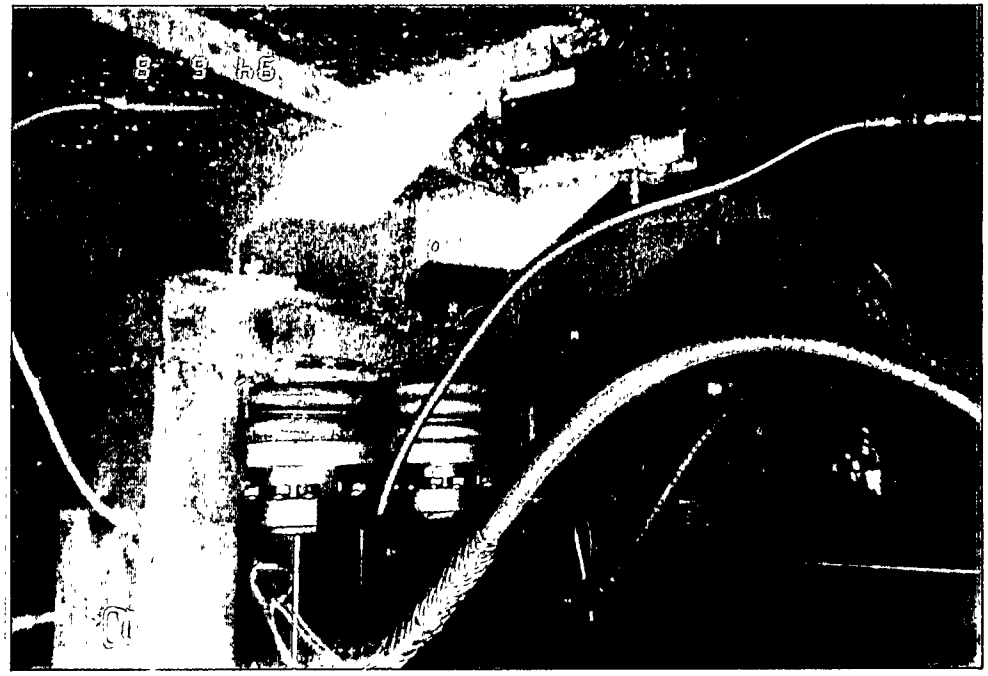
Building #7
Lubrication Stores
Oil/Water Filtration

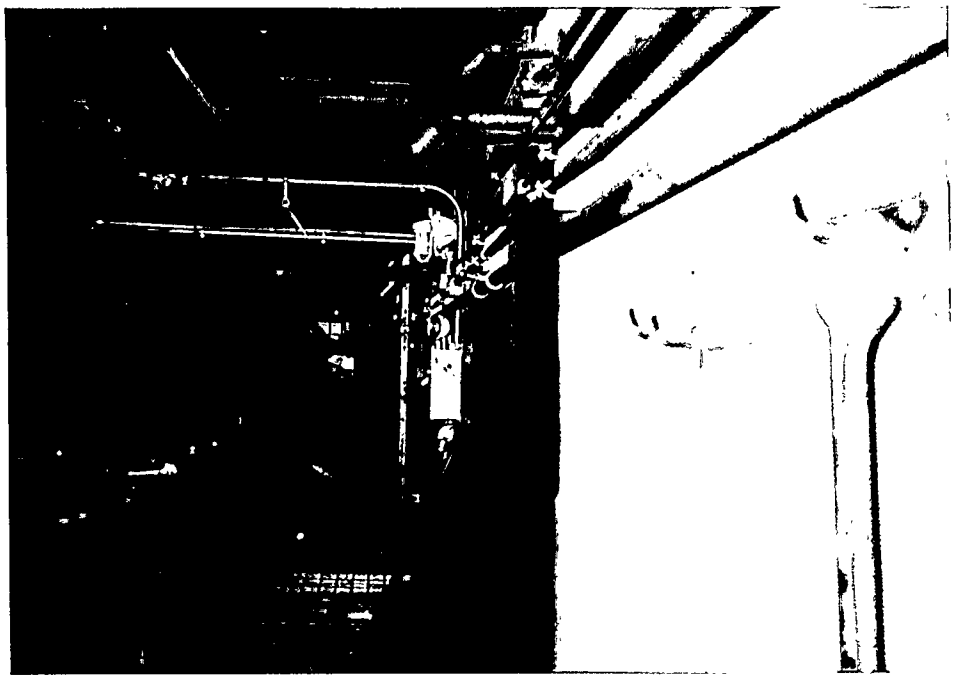
Boneyard
Equipment Storage
Oily Residue in Secondary
Containment Tray

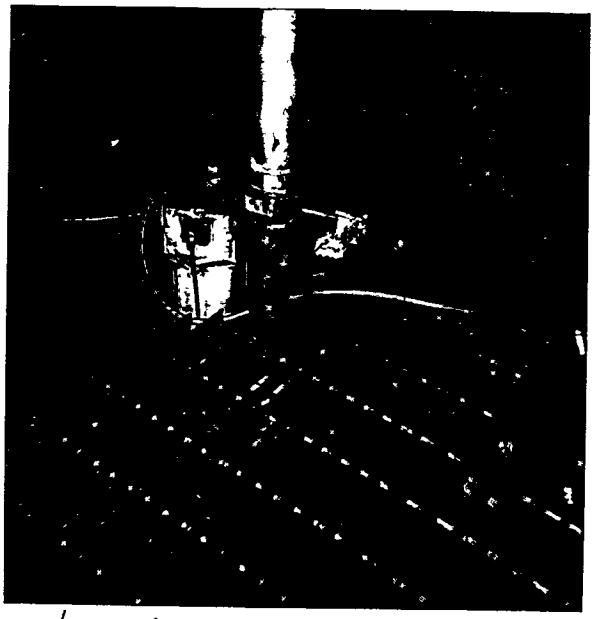
BLDG #6 CONNECTION TRENCH 1/3 BETWEEN EAST TRENCH AND WEST (MAIN) COLLECTION TRENCH

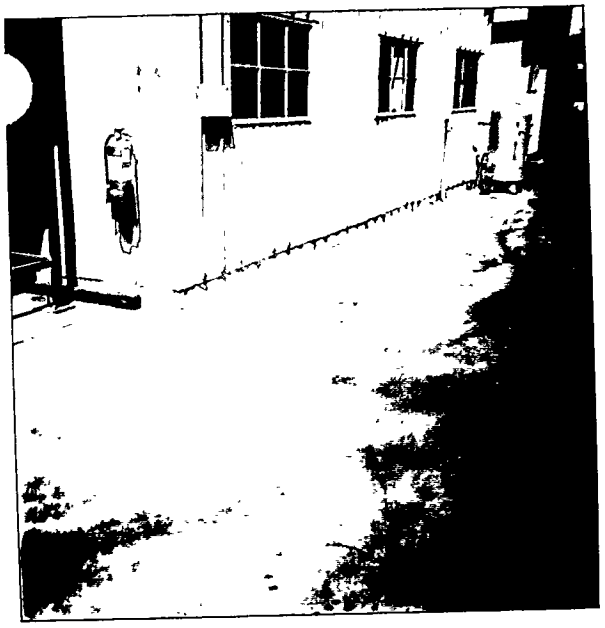
HAND PIPING - VACUUM SUCTION TO O/W TANK FM. 3500 TON PRESS CELLAR.
